**NYC Department of Education
Building Condition Assessment Survey 2023-2024**

Architectural Inspection

R074

Asset: 3K CENTER @ 10 ELM STREET - STATEN ISLAND, 10 ELM STREET, STATEN ISLAND, NY, 10310

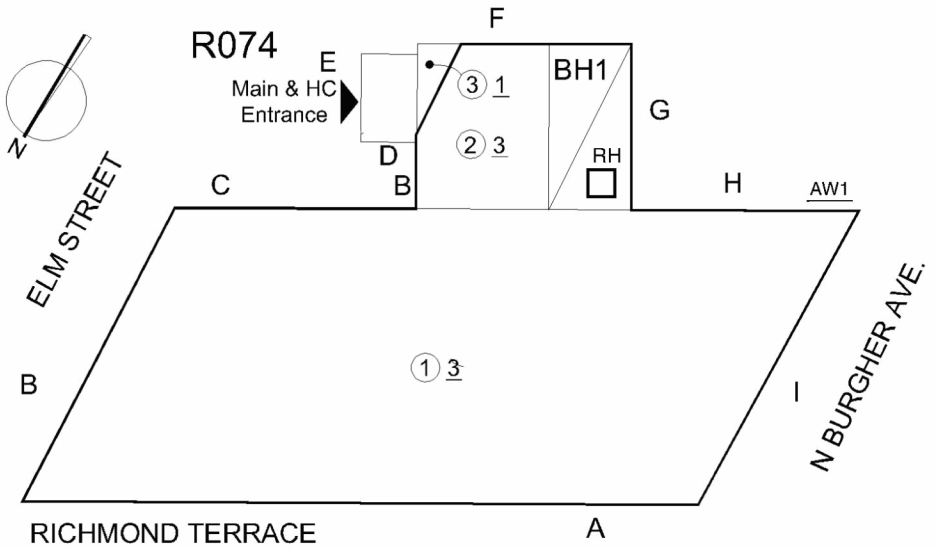
Question	Response
Architectural	
EXTERIOR	Inspected
AREAWAY	Inspected
Instance on AW1	Inspected
Instance Condition	3- Fair
Instance Quantity	1
Instance Quantity Uom	EACH
Deficiency	AREAWAY WALLS:DETERIORATED JOINTS
Deficiency Location/Instance

Deficiency Quantity	30
Quantity Uom	S.F.
Potential Action	REPAIR
Urgency of Action	PRIORITY 3
Purpose of Action	LEVEL 2
Deficiency Photo 1
