**NYC Department of Education
Building Condition Assessment Survey 2023-2024**

Architectural Inspection

Asset: P.S. 236 - BRONX, 1871 WALTON AVENUE, BRONX, NY, 10453

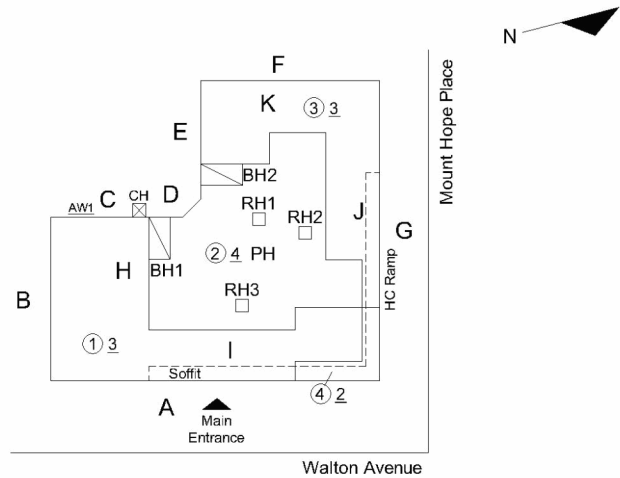
| Question | Response |
|---|--|
| Instance Condition | 2- Between Good and Fair |
| Deficiency | AREAWAY WALLS:DETERIORATED JOINTS AT COPING STONES |
| Deficiency Quantity | 15 |
