**NYC Department of Education
Building Condition Assessment Survey 2023-2024**

Architectural Inspection

X880

Asset: P.S. 69 ANNEX - BRONX, 639 THERIOT AVENUE, BRONX, NY, 10472

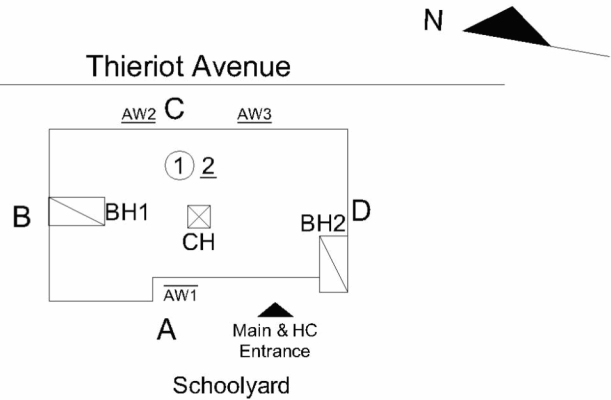
Question	Response
Architectural	
EXTERIOR	Inspected
AREAWAY	Inspected
Instance on AW1-AW3	Inspected
Instance Condition	3- Fair
Instance Quantity	3
Instance Quantity Uom	EACH
Deficiency	AREAWAY GRATINGS:MAJOR RUSTING / OR BROKEN
Deficiency Location/Instance	
Deficiency Quantity	25
Quantity Uom	S.F.
Potential Action	REPLACE
Urgency of Action	PRIORITY 3
Purpose of Action	LEVEL 2
