**NYC Department of Education
Building Condition Assessment Survey 2023-2024**

Architectural Inspection

Asset: P.S. 93 MINISCHOOL - BRONX, 1535 STORY AVENUE, BRONX, NY, 10473

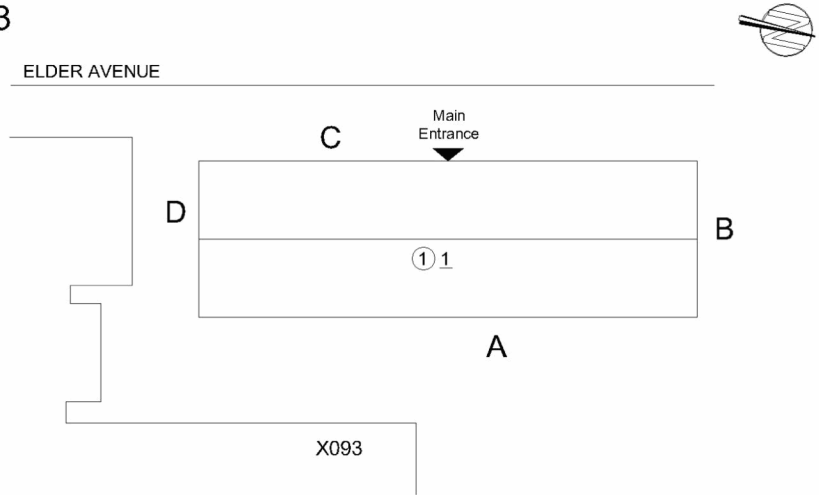
Question	Response
Architectural	
EXTERIOR	Inspected
AREAWAY	Does not exist
AWNINGS AND CANOPIES	Inspected
Condition	2- Between Good and Fair
Deficiency	No deficiencies recorded
CHIMNEY	Does not exist
COPING	Does not exist
CORNICE	Does not exist
DOORS	Inspected
DOORS AND FRAMES	Inspected
Condition	2- Between Good and Fair
Deficiency	No deficiencies recorded
DOOR HARDWARE	Inspected
Condition	2- Between Good and Fair
Deficiency	No deficiencies recorded
LINTELS	Does not exist
TRANSOM/SIDE LIGHT	Does not exist
EXTERIOR WALLS	Inspected
Material Type(s)	Steel
Replacement Quantity	7,200
Replacement Uom	S.F.
Instance on All Facades	Inspected
Instance Condition	3- Fair
Instance Quantity	7,200
Instance Quantity Uom	S.F.
Deficiency	METAL PANEL:SEVERE DENTS
Roof Plan Reference	X893
