**NYC Department of Education
Building Condition Assessment Survey 2023-2024**

Architectural Inspection

Asset: P.S. 121 TEMP. C.R. BLDG. - BRONX, 2750 THROOP AVENUE, BRONX, NY, 10469

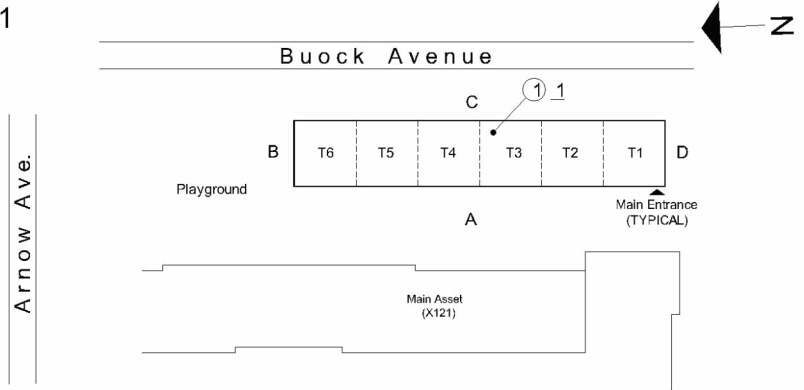
Question	Response
Architectural	
EXTERIOR	Inspected
AREAWAY	Does not exist
AWNINGS AND CANOPIES	Does not exist
CHIMNEY	Does not exist
COPING	Does not exist
CORNICE	Does not exist
DOORS	Inspected
DOORS AND FRAMES	Inspected
Condition	5- Poor
Deficiency	METAL:DETERIORATED DOOR AND FRAME - MAJOR DETERIORATION
Deficiency Location/Instance

Deficiency Quantity	6
Quantity Uom	EACH
Potential Action	REPLACE
Urgency of Action	PRIORITY 4
Purpose of Action	LEVEL 2
Deficiency Photo 1
