**NYC Department of Education
Building Condition Assessment Survey 2023-2024**

Architectural Inspection

X961

Asset: MORRIS HS TRANSPORTABLE - BRONX, 1110 BOSTON ROAD, BRONX, NY, 10456

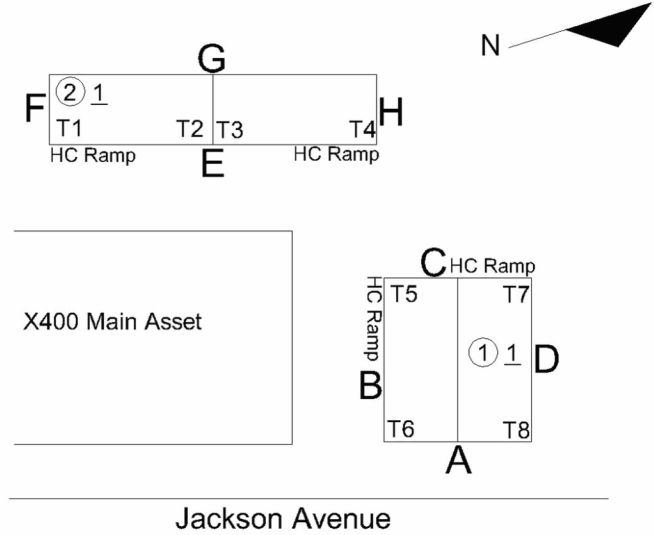
Question	Response
Architectural	
EXTERIOR	Inspected
AREAWAY	Does not exist
AWNINGS AND CANOPIES	Does not exist
CHIMNEY	Does not exist
COPING	Does not exist
CORNICE	Does not exist
DOORS	Inspected
DOORS AND FRAMES	Inspected
Condition	2- Between Good and Fair
Deficiency	No deficiencies recorded
DOOR HARDWARE	Inspected
Condition	3- Fair
Deficiency	No deficiencies recorded
LINTELS	Does not exist
TRANSOM/SIDE LIGHT	Does not exist
EXTERIOR WALLS	Inspected
Material Type(s)	Steel
Replacement Quantity	3,500
Replacement Uom	S.F.
Instance on All Facades	Inspected
Instance Condition	5- Poor
Instance Quantity	3,500
Instance Quantity Uom	S.F.
Deficiency	METAL PANEL:SEVERE DENTS
Roof Plan Reference
