# PROPERTY INSPECTION REPORT

**1234 Some Place**  
**Anytown IN 46033**

**Tuesday, 5/14/2013**

**Full Home Inspection**

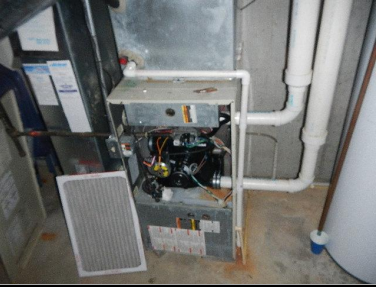
**8**

- **Item:** Heating General Condition  
- **Location:** General View Of Furnace  
- **Condition:** General View Of Furnace

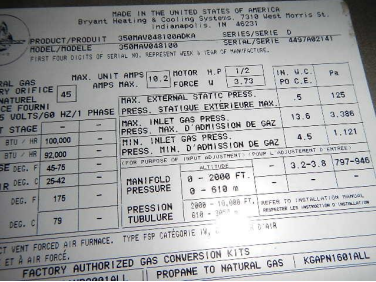
**9**

- **Item:** Heating General Condition  
- **Location:** General View Of Furnace Rating Plate  
- **Condition:** General View Of Furnace Rating Plate

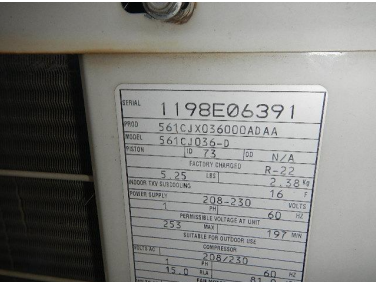
**10**

- **Item:** A / C General Condition  
- **Condition:** General View Of The A / C Rating Plate

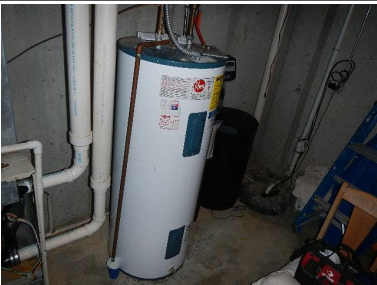
**4**

- Item: Water Heater
- Location: General View Of Water Heater
- Condition: General View Of Water Heater

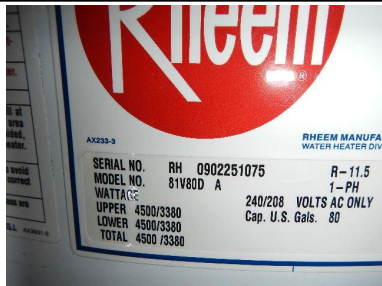
5

- Item: Water Heater
- Location:
- Condition: General View Of Water Heater Rating Plate

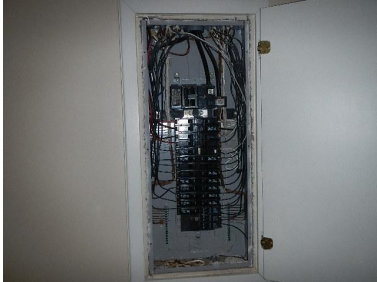
3

- Item: **Panel**
- Location:
- Condition: **General View Of The Main Panel**

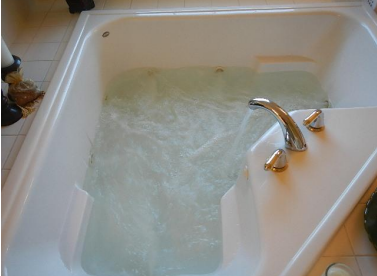
<b>7</b>

<ul style="list-style-type: none"> <li>- <b>Item:</b> Whirlpool Tubs- General View Of The Whirlpool Tub In Operation.</li> </ul>
----------	--	--

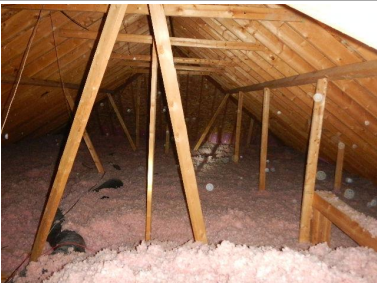
<p><b>ACCESSIBILITY</b></p> <ul style="list-style-type: none"> <li>- Item: Accessibility</li> <li>- Condition: - General View Of The Attic</li> </ul>

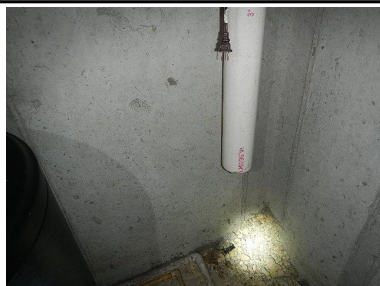
8

- Item: **Mechanicals**
  - Location: **S W Corner Of Basement**
  - Condition: **Pre Installed Radon Mitigation Pipe**
- Pipe Is Ready For Mitigation System If It Becomes Or Is Found To Be Necessary.
