FONTENELLE DAM, RIRIE DAM, AND TETON DAM – AN EXAMINATION OF THE INFLUENCE OF ORGANIZATIONAL CULTURE ON DECISION-MAKING

Fontenelle Dam, near Fontenelle, Wyoming, built by the Bureau of Reclamation between 1960 and 1964, had a serious incident in 1965 that nearly caused a breach of the structure that could have released more than 300,000 acre-feet of water. Teton Dam, near Rexburg, Idaho, built by the Bureau of Reclamation between 1972 and 1976, failed in 1976 releasing more than 250,000 acre-feet of water and causing 11 fatalities. Ririe Dam, also near Rexburg Idaho, was built in geologic conditions similar to Teton by the Walla Walla District of the Corps of Engineers between 1970 and 1976 – was subsequently transferred to Reclamation – and has performed well over its life. The dams are all located within 150 miles of each other. The story of why Teton Dam failed is more complex than the technical details surrounding its construction and destruction. The Teton disaster is a story of engineering judgment, communication, decision-making, economics, organization, culture, and individual and organizational hubris. To tell this story, one needs to examine the organizational cultures i

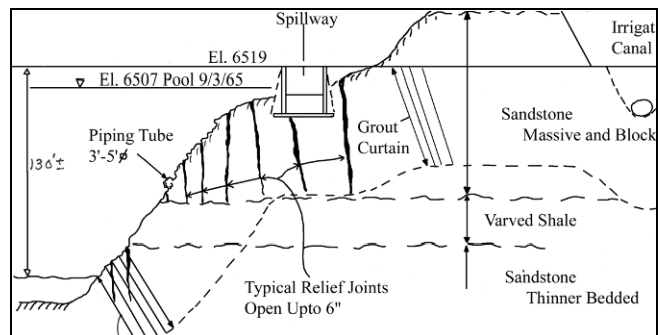
Despite the intensity and width of the fractures in the right abutment, the planned designs relied entirely on 'special compaction' and the grout curtain to reduce the erosive forces at the contact between the cutoff trench and the grout cap. It appears that the designers did not fully appreciate the hydraulic gradient that would occur across the bottom of the cutoff and the relatively narrow grout curtain.

Figure 3B. Profile looking downstream of Fontenelle Dam, the right abutment at the spillway, and the location of the internal erosion incident.

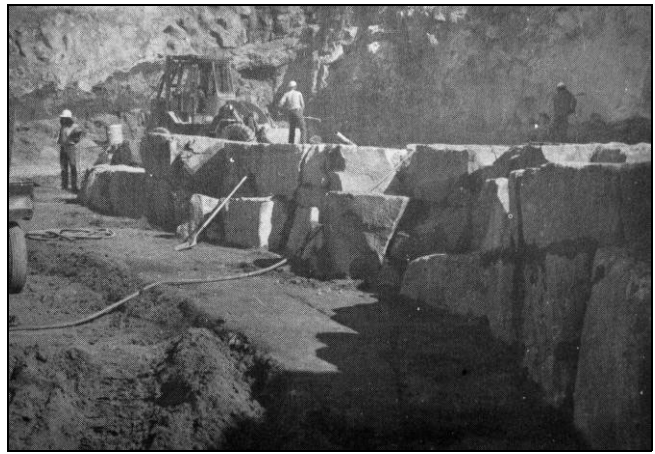
The basalt layers contain both open and silt- and clay-filled joints and fractures resulting from gentle folding and arching. The open and filled joints range from minute fractures to one-foot openings. Most of the joints and fractures have been predominantly filled with silty clay materials. Figures 10A and 10B illustrate the nature of the foundation at Ririe.

Figure 10B. Construction photo of Ririe right abutment.

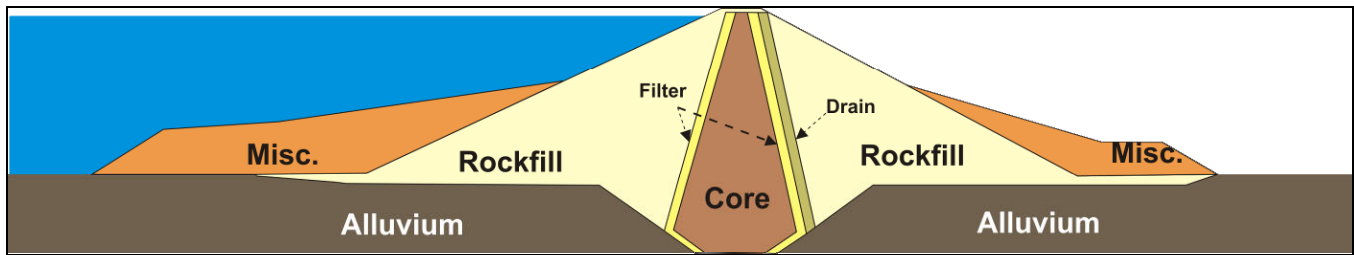
Before designs were envisioned, the Corps was concerned about the competence of the foundation of Ririe Dam. The first published design which was planned in the early 1960's and included in the design report in 1966 is shown in Figure 11. Interestingly, the design included a 10' wide chimney filter and 10' wide chimney and blanket drain. It had a wide core, but did not include a cutoff trench. Following substantial exploration at the dam site and review comments from headquarters, the design was changed in 1971 as shown in Figure 12. This design change added a cutoff to competent rock and reduced the size of the core.

Figure 12. Ririe Dam Cross Section 1971

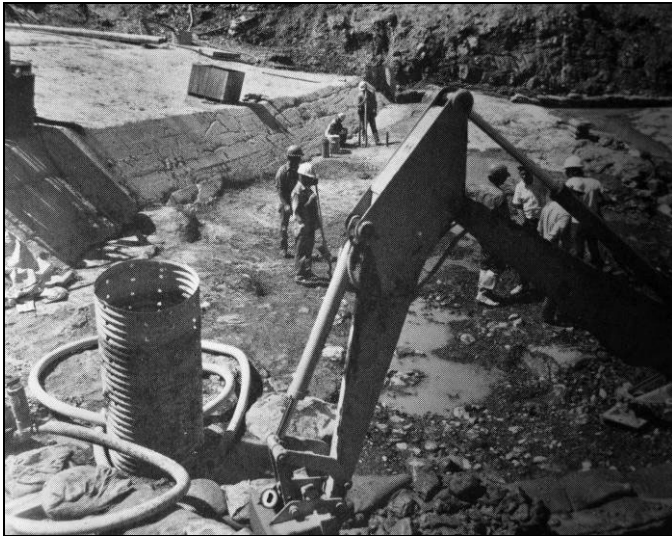
A number of foundation preparation and surface treatment provisions were employed to deal with the many foundation defects encountered during construction. The Corps extensively documented methods and locations, and numerous construction photos exist (Figures 14A and 14B). Zones of concern were protected by a shotcrete cover layer or mass dental concrete. The Corps began applying the lessons learned from Ken Lane's trip report about the Fontenelle Dam incident by specifying conservative treatment of contact surfaces between dams and their foundations and the contact surfaces of adjacent zones of different materials. At about the same time that the Corps was using shotcrete to protect the foundation, a few miles away, Reclamation was rejecting the use of shotcrete for a key trench in very similar material.

Figure 14A. Construction photo from Ririe showing dental concrete and foundation cleanup.
