Re: Report No. 2
FERC Independent Consultants Review Panel
Silver Lake Dam

REPORT NO. 2
FERC INDEPENDENT CONSULTANTS REVIEW PANEL
SILVER LAKE DAM

December, 2003

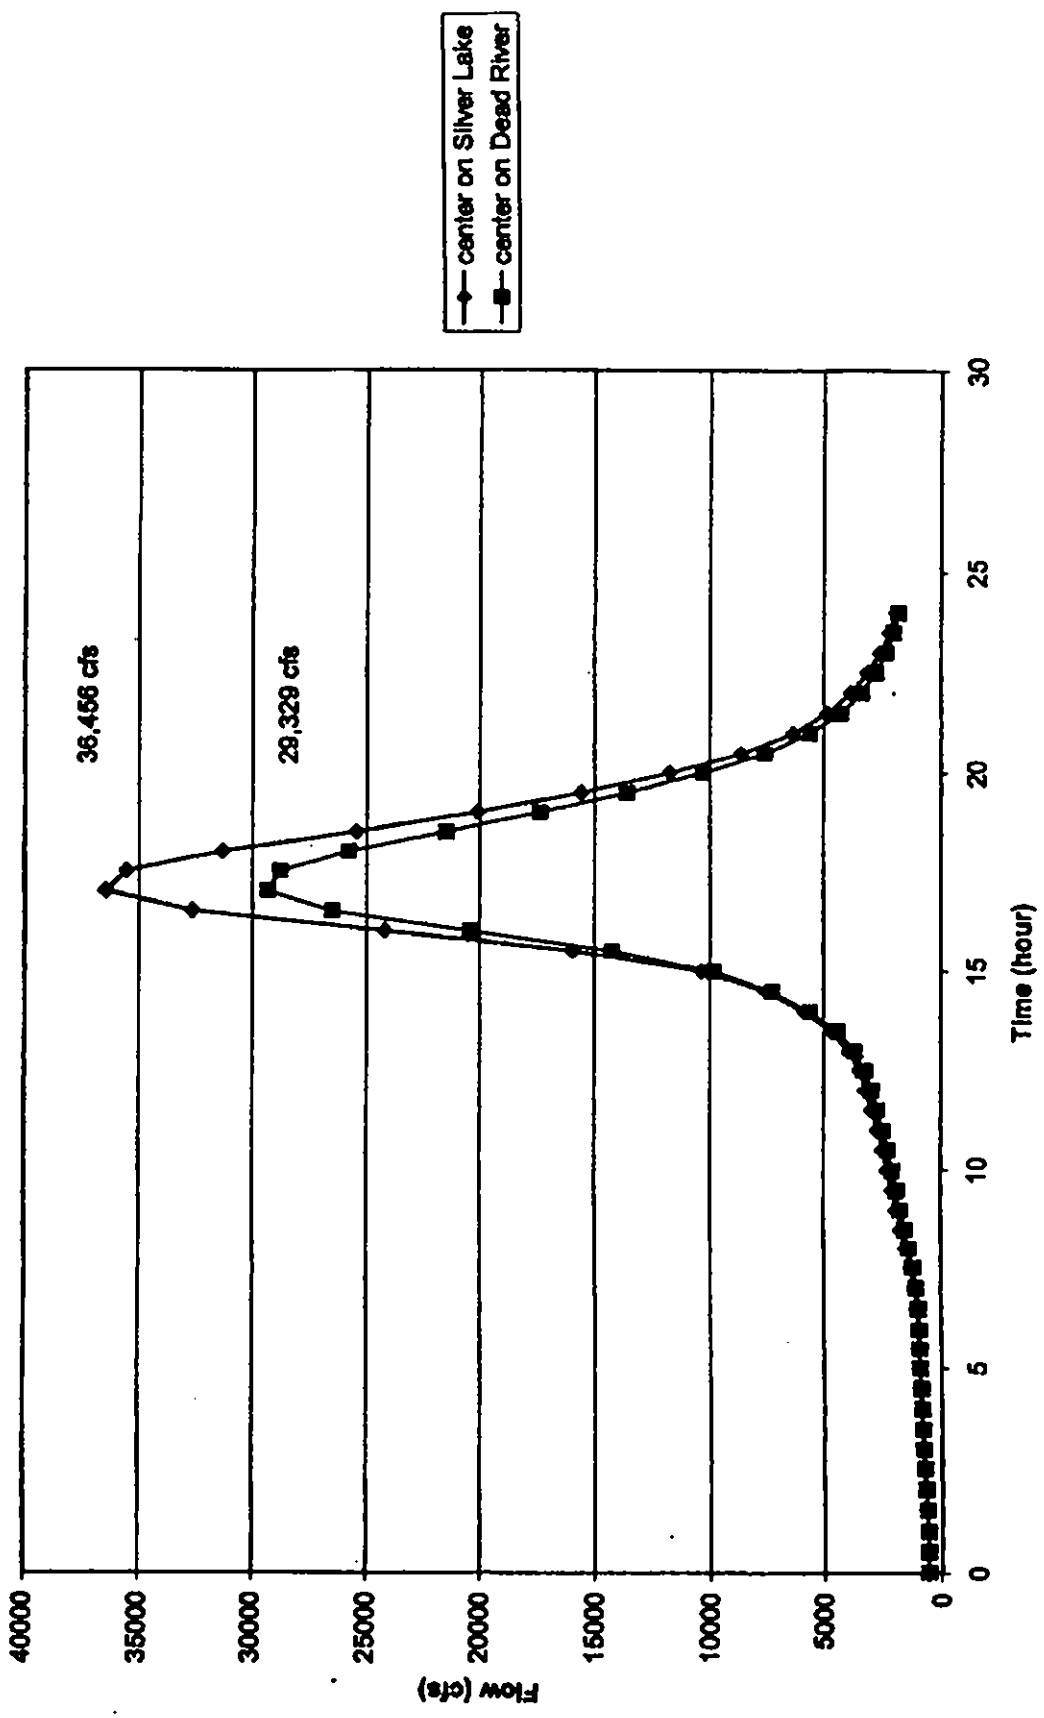
Figure 2.2 -1

For this design, the PMF inflow shown in Figure 2.2-1, for a reservoir starting level of 1481.5, and the bottom outlet discharging 280 cfs (8 m³/s), results in an outflow of about 20,600 cfs (585 m³/s) for a maximum reservoir elevation of about 1488.45.

The Panel requested the Chicago FERC office to do a calculation for the PMF hydrograph inflow shown in Figure 2.2-1 routed through the Silver Lake reservoir for an initial reservoir elevation of 1481.5 and considering the low level outlet to operate at 280 cfs (8 m³/s) starting 20 hours into the inflow hydrograph. It was assumed that all bays in the concrete spillway, including the stop logs in the 4th bay, had an ogee elevation of 1486.25. It was found that the maximum reservoir level raised to 1490.5 ft [a freeboard of about 1.0 ft (.3 m)]. The hydrograph of the reservoir elevation and spillway discharge versus time is shown in Figure 2.3.2-5. It is noted that the reservoir elevation is shown to be above 1490 ft for about 8 hrs.

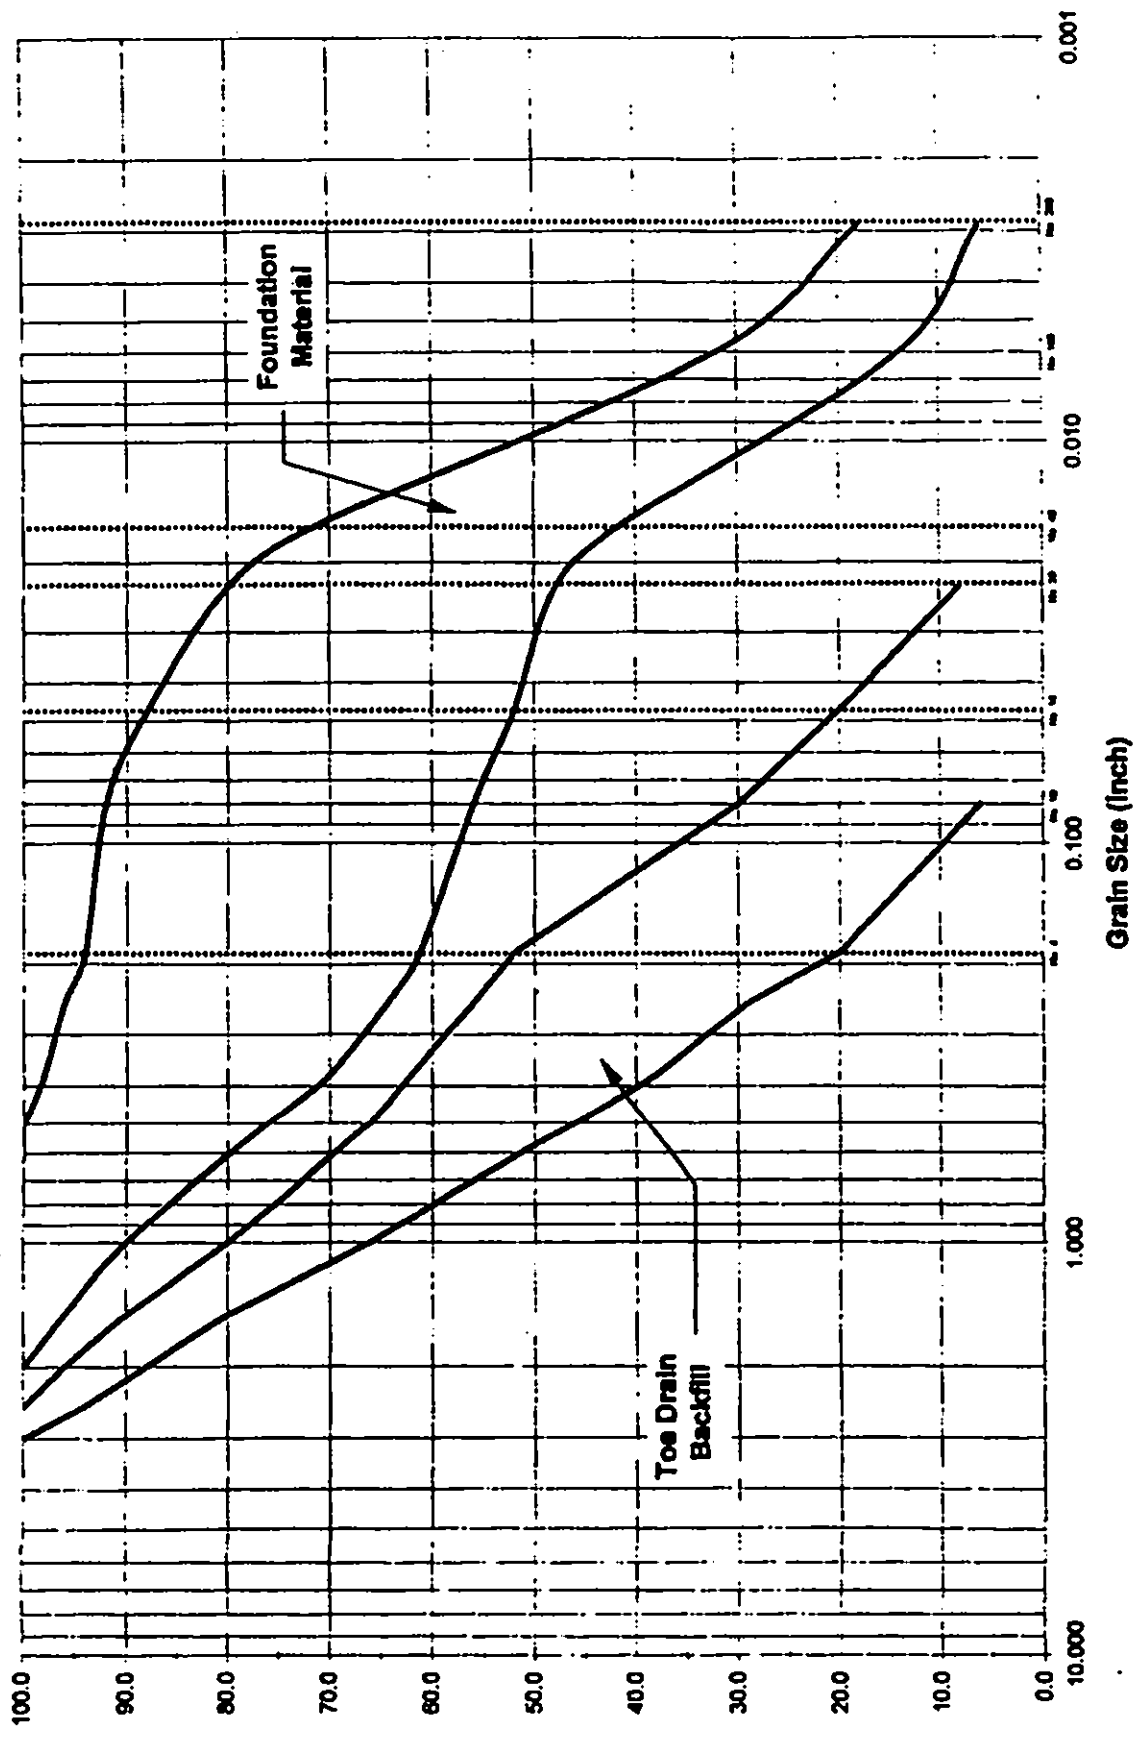
The natural foundation materials at the Silver Lake Dam-Fuse Plug are a complex series of glacial tills and glacial outwash materials. Although there were no known exploratory borings at the site of the fuse-plug during the design phase, Figure 9 of the MWH Design Report gives the designers' impression of the grain size distribution curve of the foundation materials. This curve is shown on Figure 4.4.1-1 in this report. It is noted that 61-74% passes the #4 sieve and that from 41-71% passes the #40 size. About 6-18% passes the #200 sieve. Thus the foundation materials would be classified as a sand in the Unified Soil Classification System. The classification could be SP, SW, SW-SM, SP-SM, or SM, assuming that the fines were non-plastic.

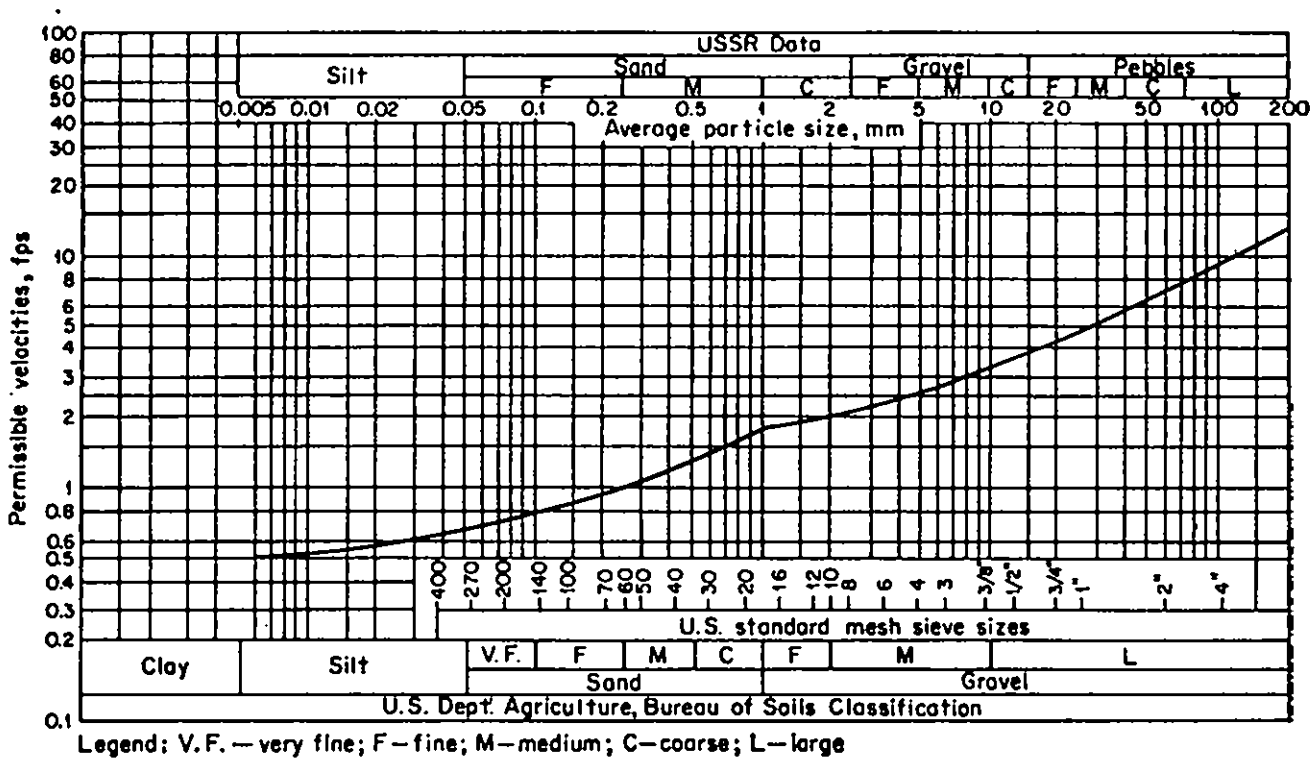
FIG. 7-3. U.S. and U.S.S.R. data on permissible velocities for noncohesive soils.

In 1936, Russian data was presented regarding permissible velocities for various sizes of cohesionless soils. This data is presented in Figure 7-3 of Chow and in Figure 4.4.2-3 of this report. As shown in Figure 4.4.2-3, the permissible velocity for fine sand is 0.75 fps (0.23 m/s) and for the material retained on the #4 sieve is 2.5 fps (0.76 m/s). Thus for coarse sand or fine gravel the limit of 2.5 fps (0.76 m/s) is the same as given in Figures 4.4.2-1 and 4.4.2-2.

In section 4.3 of this report it is shown that the channel velocities could have ranged between 8.5 fps (2.6 m/s) and 10 fps (3.0 m/s) for the May 14, 2003 event. It is clear that these velocities exceeded the 2.5 fps (0.76 m/s) permissible velocities for no grass cover for a channel composed of cohesionless sands. This is the root technical cause for the most significant aspect of the behavior of the fuse plug, which was the fact that erosion did not stop at the base of the fuse plug at El. 1481 ft. The erosion proceeded downward through the
