REPORT ON

LEAK AT FONTENELLE DAM  
SEEDSKADEE PROJECT, WYOMING

September 1965

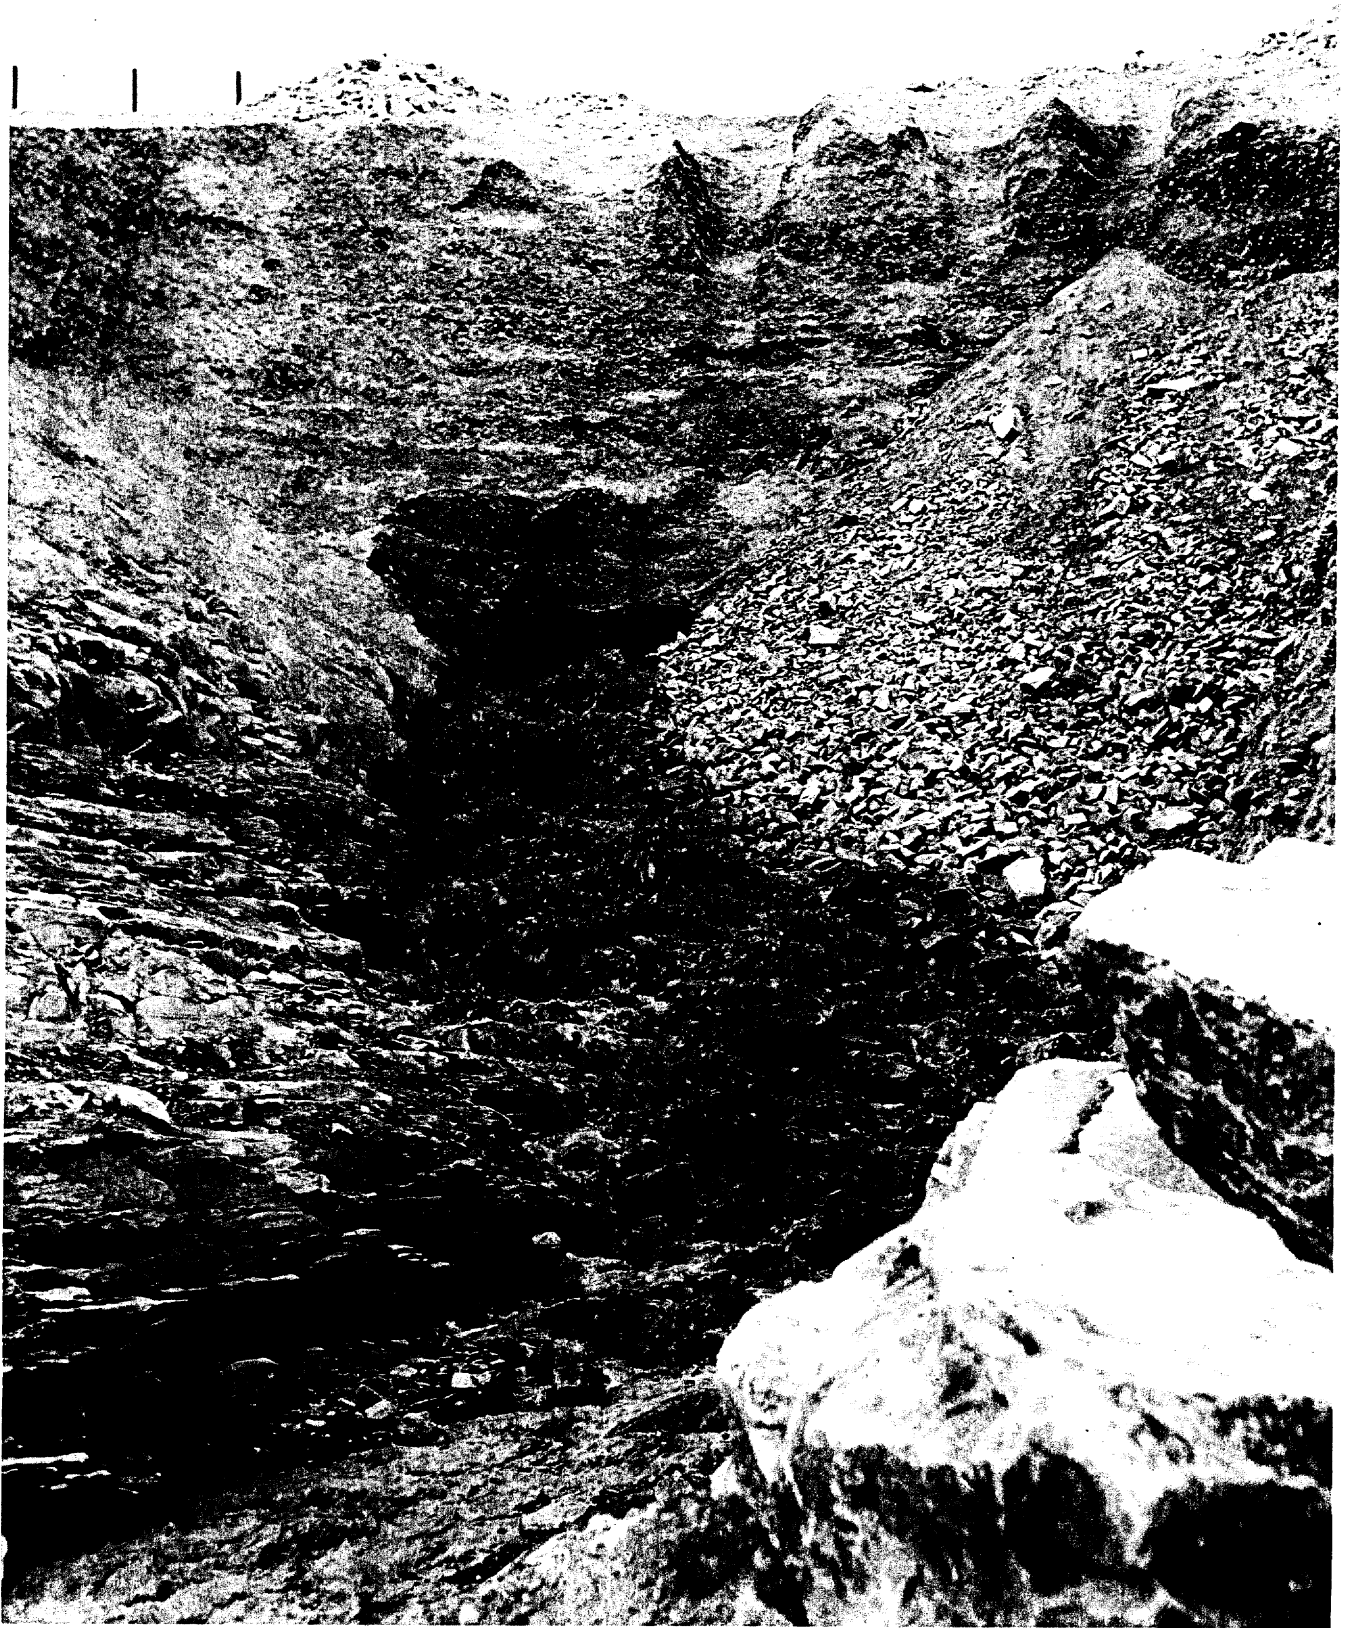
PHOTOGRAPH 7

At about 3 p.m. the flow of water from the leak began a series of rather violent surges. During each surge of flow, the volume of discharge increased significantly and the emerging flow was much more heavily laden with suspended materials. (See Photograph 7.) Following each surge, the leak flow dropped off to a very small amount, giving the appearance that the flows were momentarily stopped. It was the consensus that the rockfill was damming the emerging leak flows, causing and accelerating the erosion and internal caving of the embankment.

At the peak of each surge in leak flow, muddy water gushed from opening in notably increased volume. Surges began before 3 p.m., Sunday, September 5.

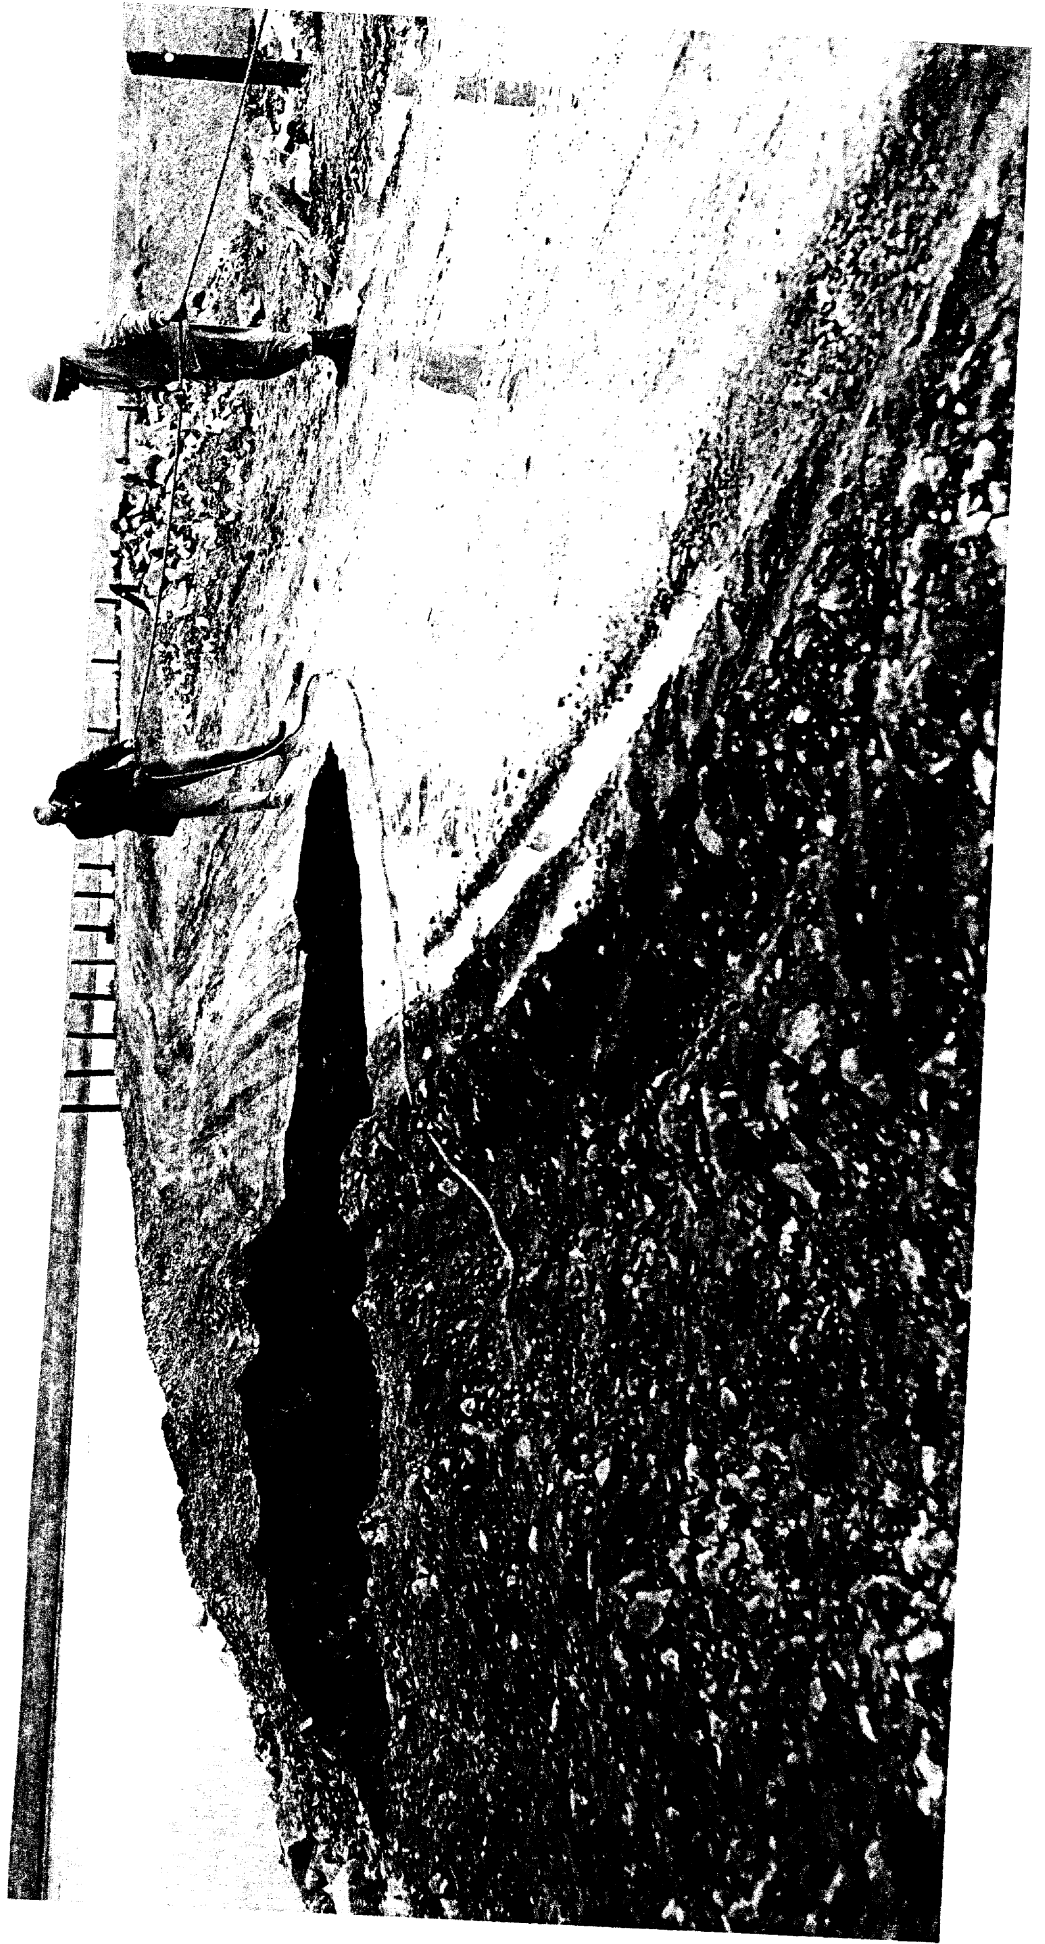
PHOTOGRAPH 11

At about 4:45 p.m. a sudden and alarming incident occurred. A 15' x 20' area on the upstream half of the crest road on the dam adjacent to the spillway bridge suddenly and completely collapsed. (See Photograph 10.) This collapsed area was referred to as the "sink hole." Immediate inspection of the sink hole was made by Project Construction Engineer Hatch and his men. (See Photograph 11.) By measurement it was determined to be 30 feet deep and was observed to bell out or widen to the east and to the south. The widening to the south was in

The danger at this time was that further collapsing could bring about the beginning of a breach in the dam, since the water surface level at that time was about 11 feet higher than the bottom of the 30-foot sink hole, and only 45 feet of undisturbed embankment (of which only 15 feet was Zone 1 fill) stood between the sink hole and the water surface of the reservoir. (See Figures 3 and 4.) As far as could be observed, the collapsing, which formed the sink hole, did not affect the discharge from the leak.

Project Construction Engineer John Hatch and his men immediately measured the depth of sink hole at about 30 feet; observed water flowing from exposed bedrock on the west side of sink hole (nearest camera); and noted that the bottom of the hole belled out to the east and south (toward leak cavity).  
Monday afternoon, September 6.

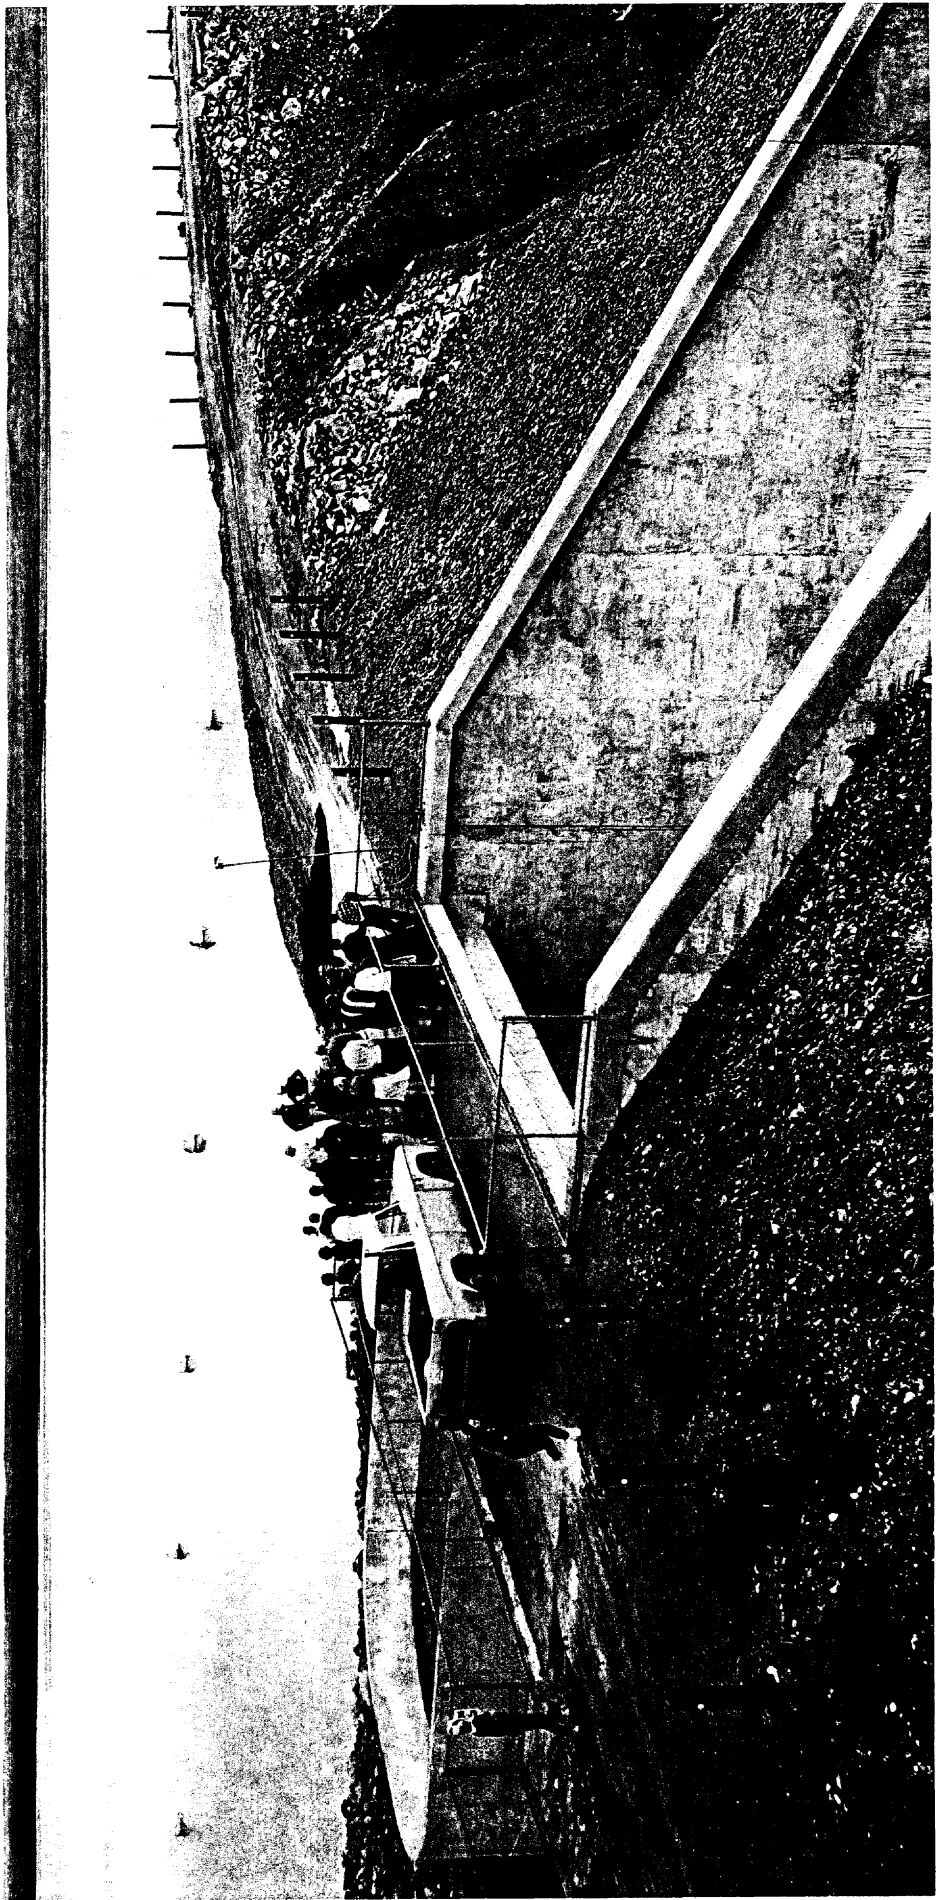
Monday afternoon, September 6.

Immediately following observation of the size and shape of the sink hole, the bulldozer pushed riprap from upstream face of dam into the sink hole to fill and stabilize the collapsed area.

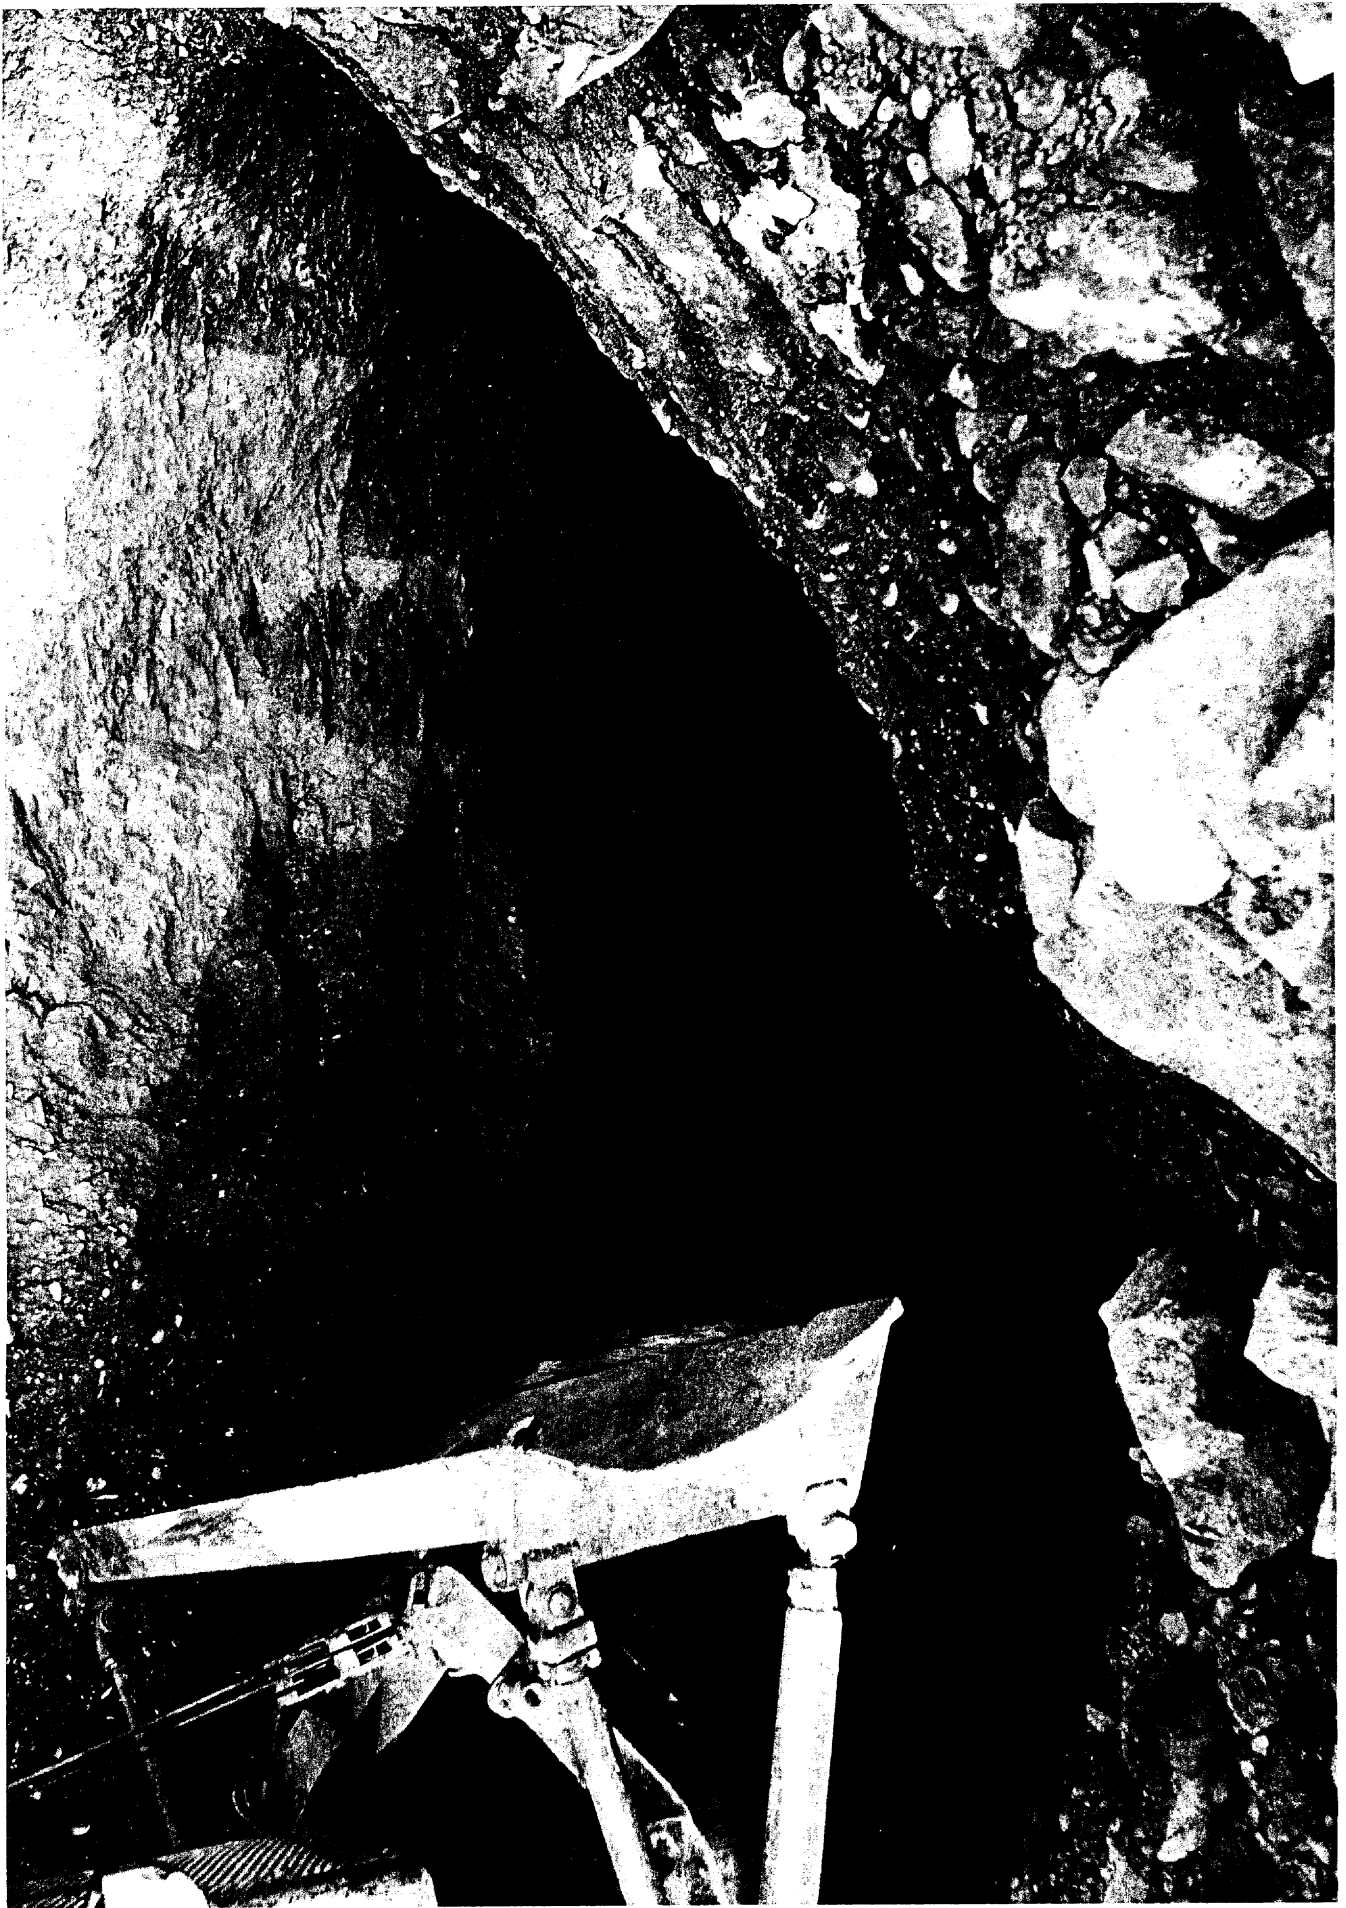
PHOTOGRAPH 13

Looking into sink hole as it is being filled by bulldozer,  
Monday afternoon, September 6.

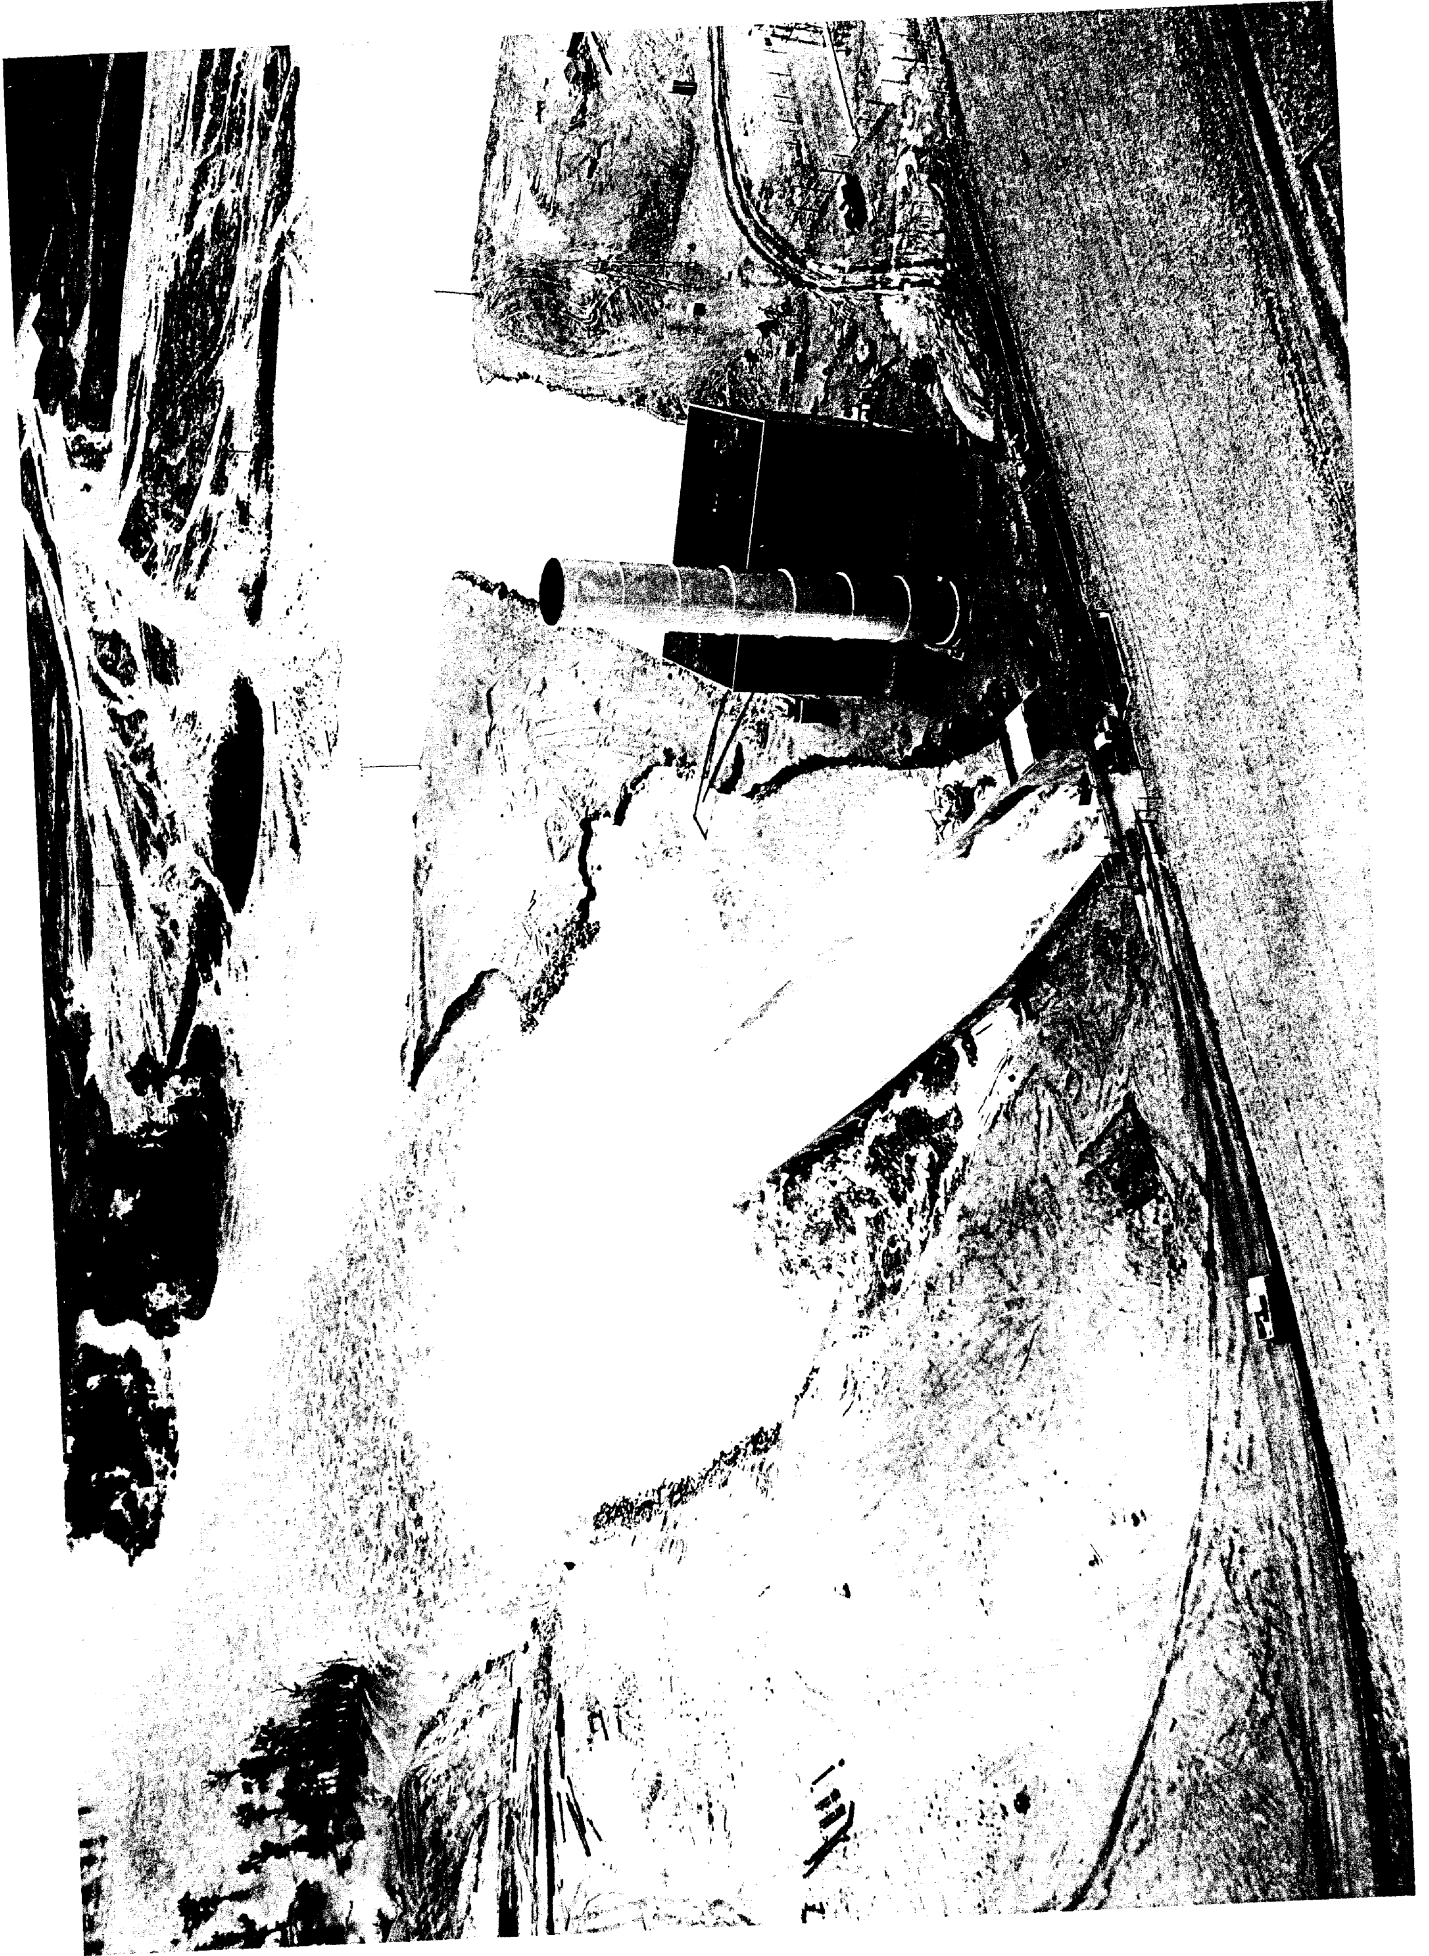
PHOTOGRAPH 14

Discharge of 15,780 c.f.s. on Thursday, September 9, fills channels around the Fontenelle Powerplant which sits on bed-rock. Upper left is delta built by discharge from West Canal.

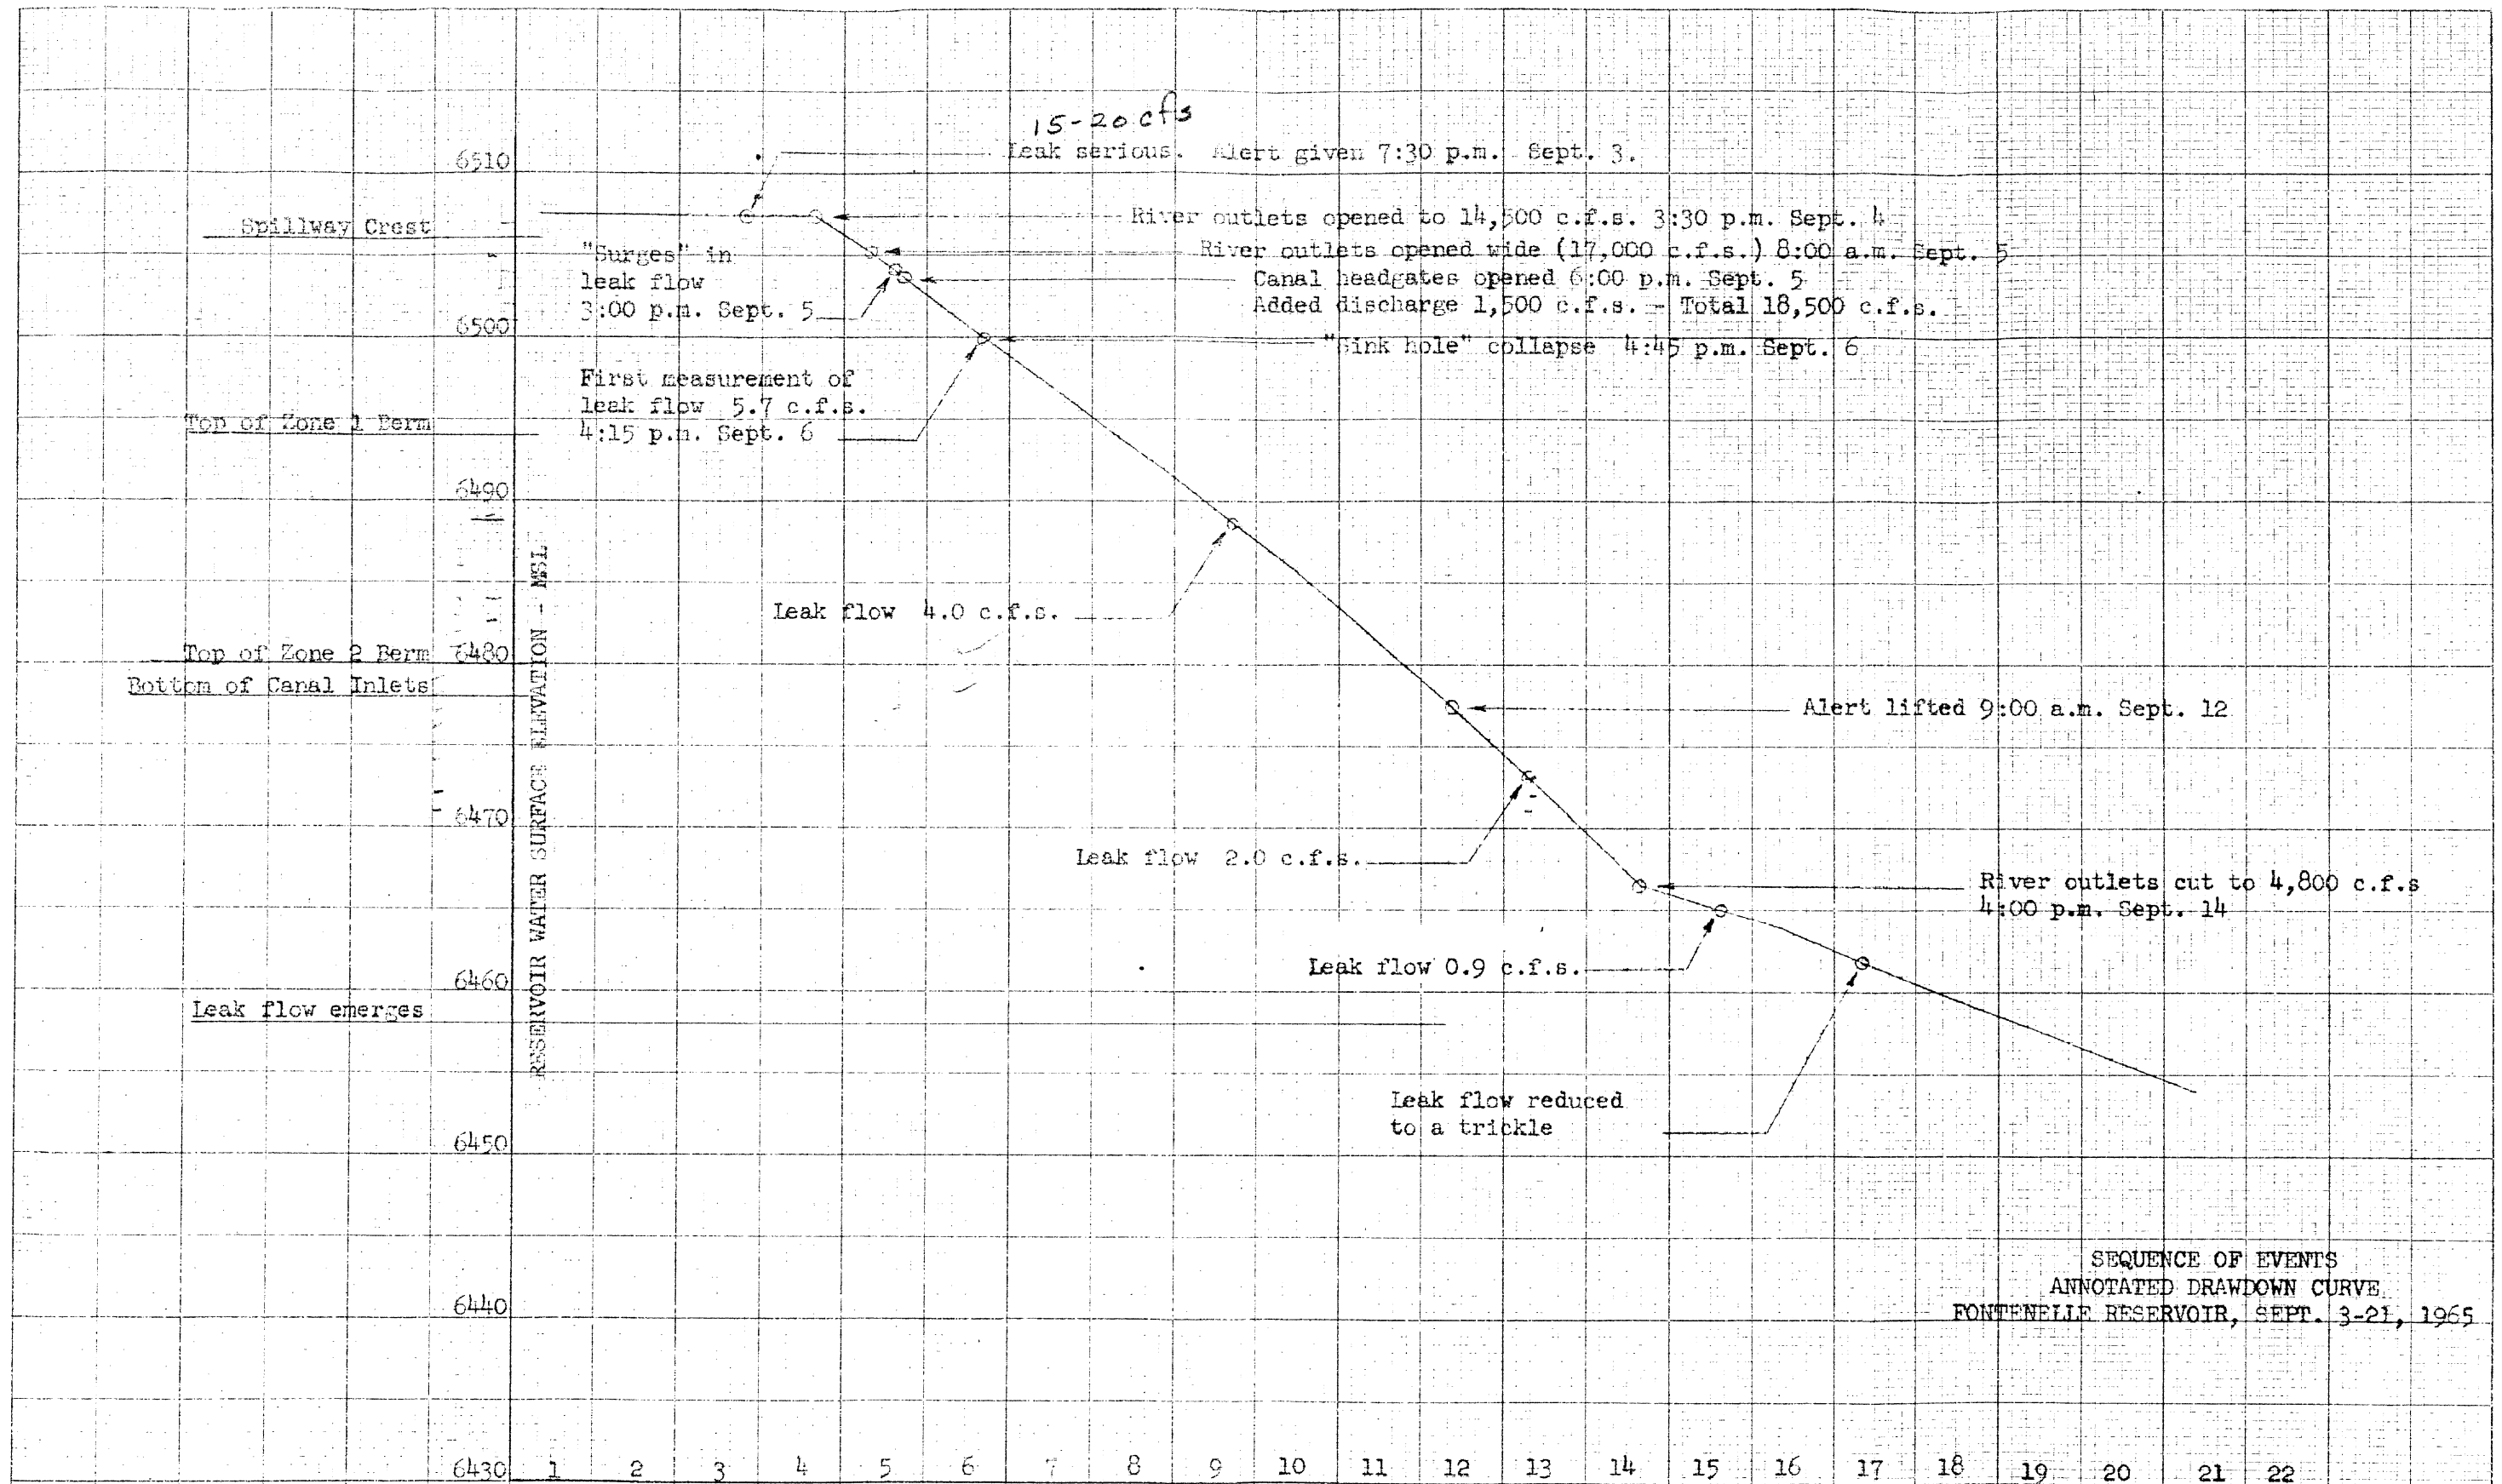
FIGURE 1

Drawdown of Fontenelle Reservoir continued at the rate of about 4 feet per day. The rain of the two previous days ceased with clearing weather. The leak flows diminished slightly which seemed to be a response to the decreasing head as the reservoir was lowered. (See Figures 1 and 5.)

SEQUENCE OF EVENTS  
 ANNOTATED DRAWDOWN CURVE  
 FONTENELLE RESERVOIR, SEPT. 3-21, 1965

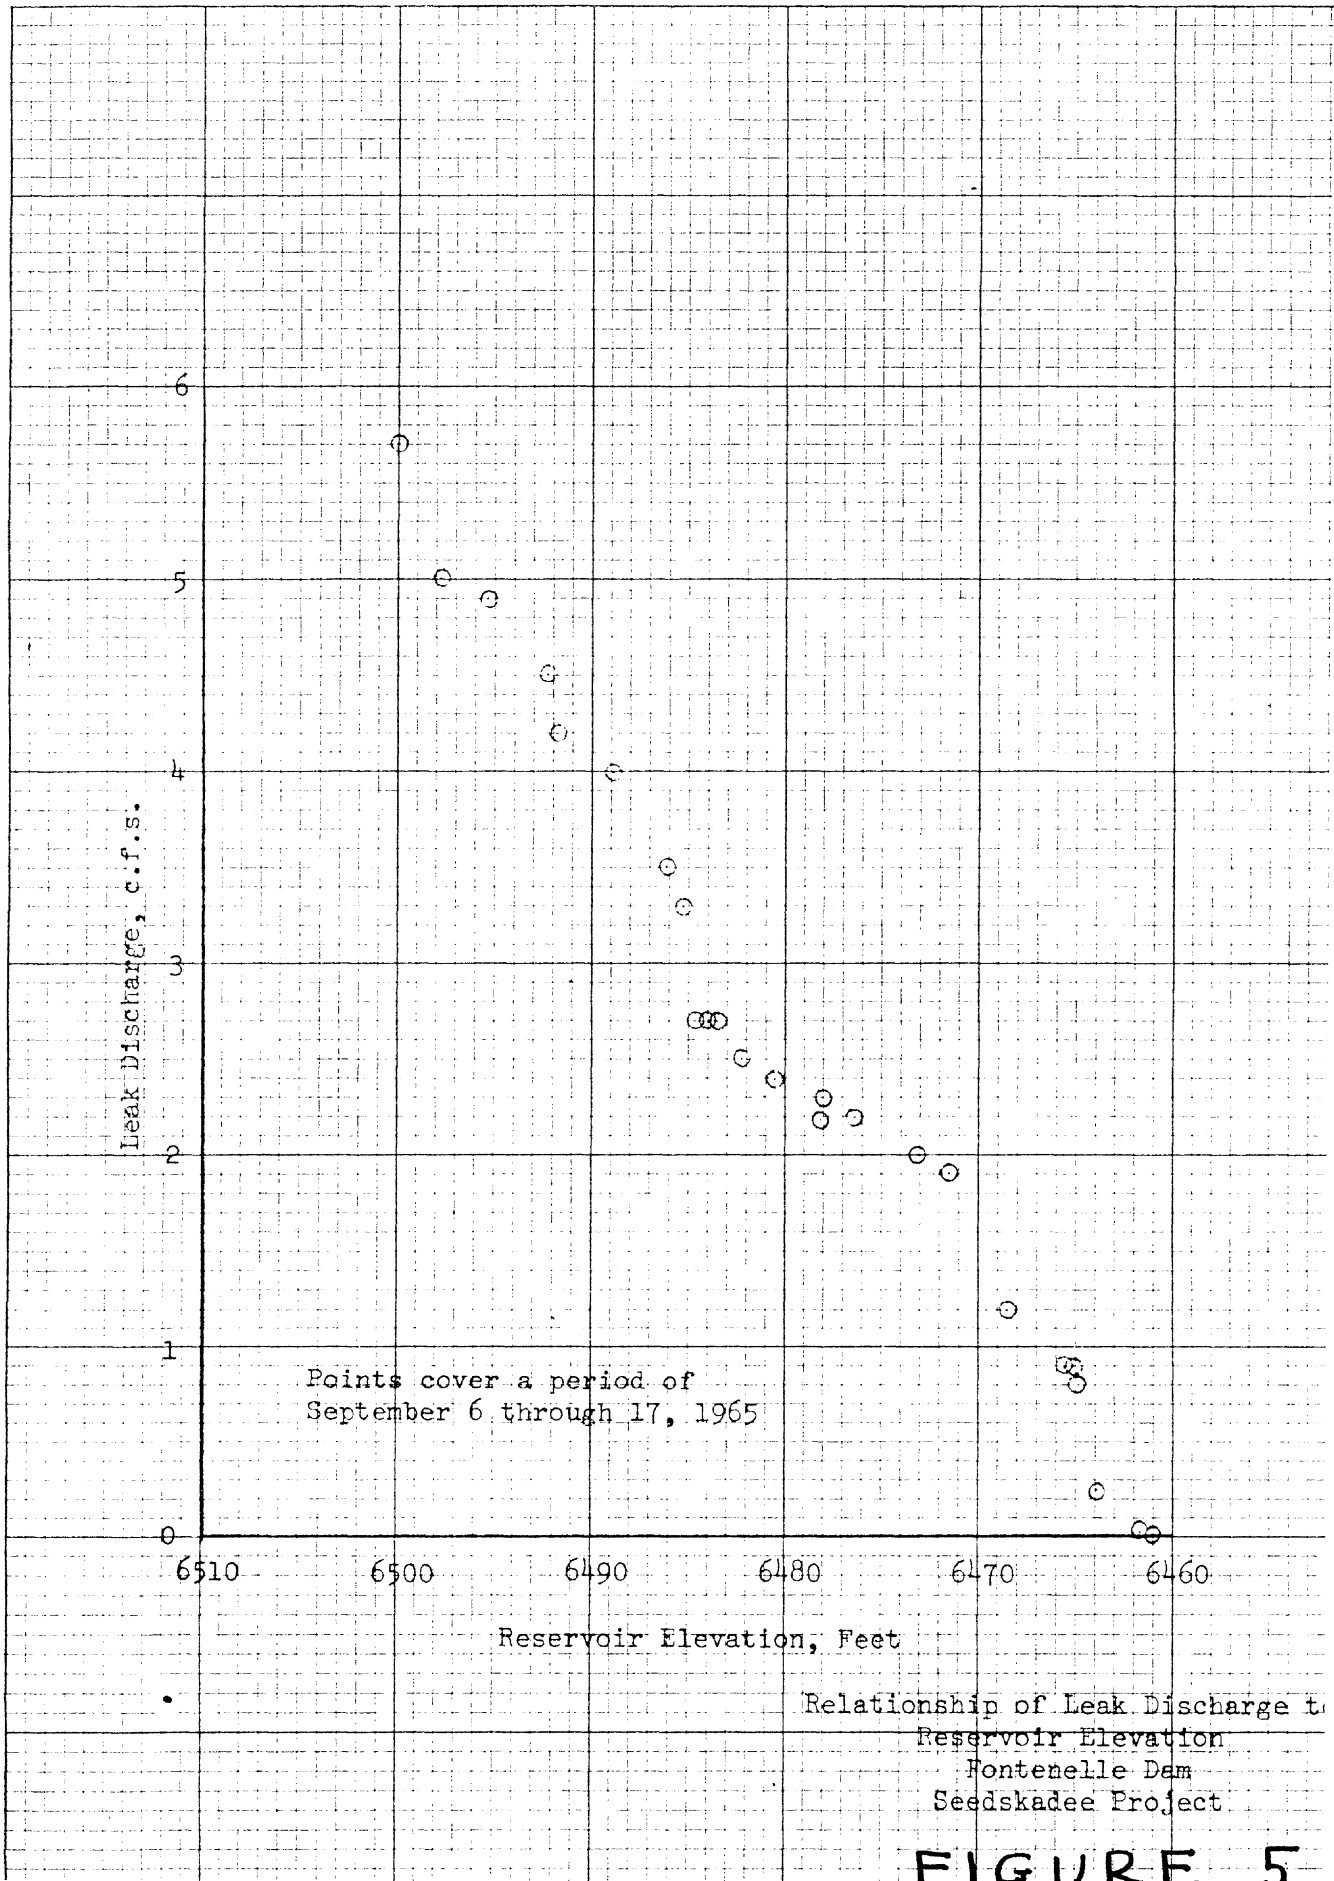
**FIGURE 5**

As shown in the photographs taken prior to this time (see Photograph 9), the leak flows were entirely or partially discharging over the east spillway wall into the toe of the spillway chute. On the morning of September 6, equipment was moved into the area below the leak and the leak flows channelled parallel to the east wall of the spillway. A 4-foot weir was installed adjacent to the lower end of the spillway wall with the leak flows directed over the weir. The first measurement of the leak flow was made by the United States Geological Survey early on the afternoon of September 6. They measured the flow as 5.7 c.f.s. (See Figure 5 for subsequent leak flow measurements as the reservoir was drawn down.)

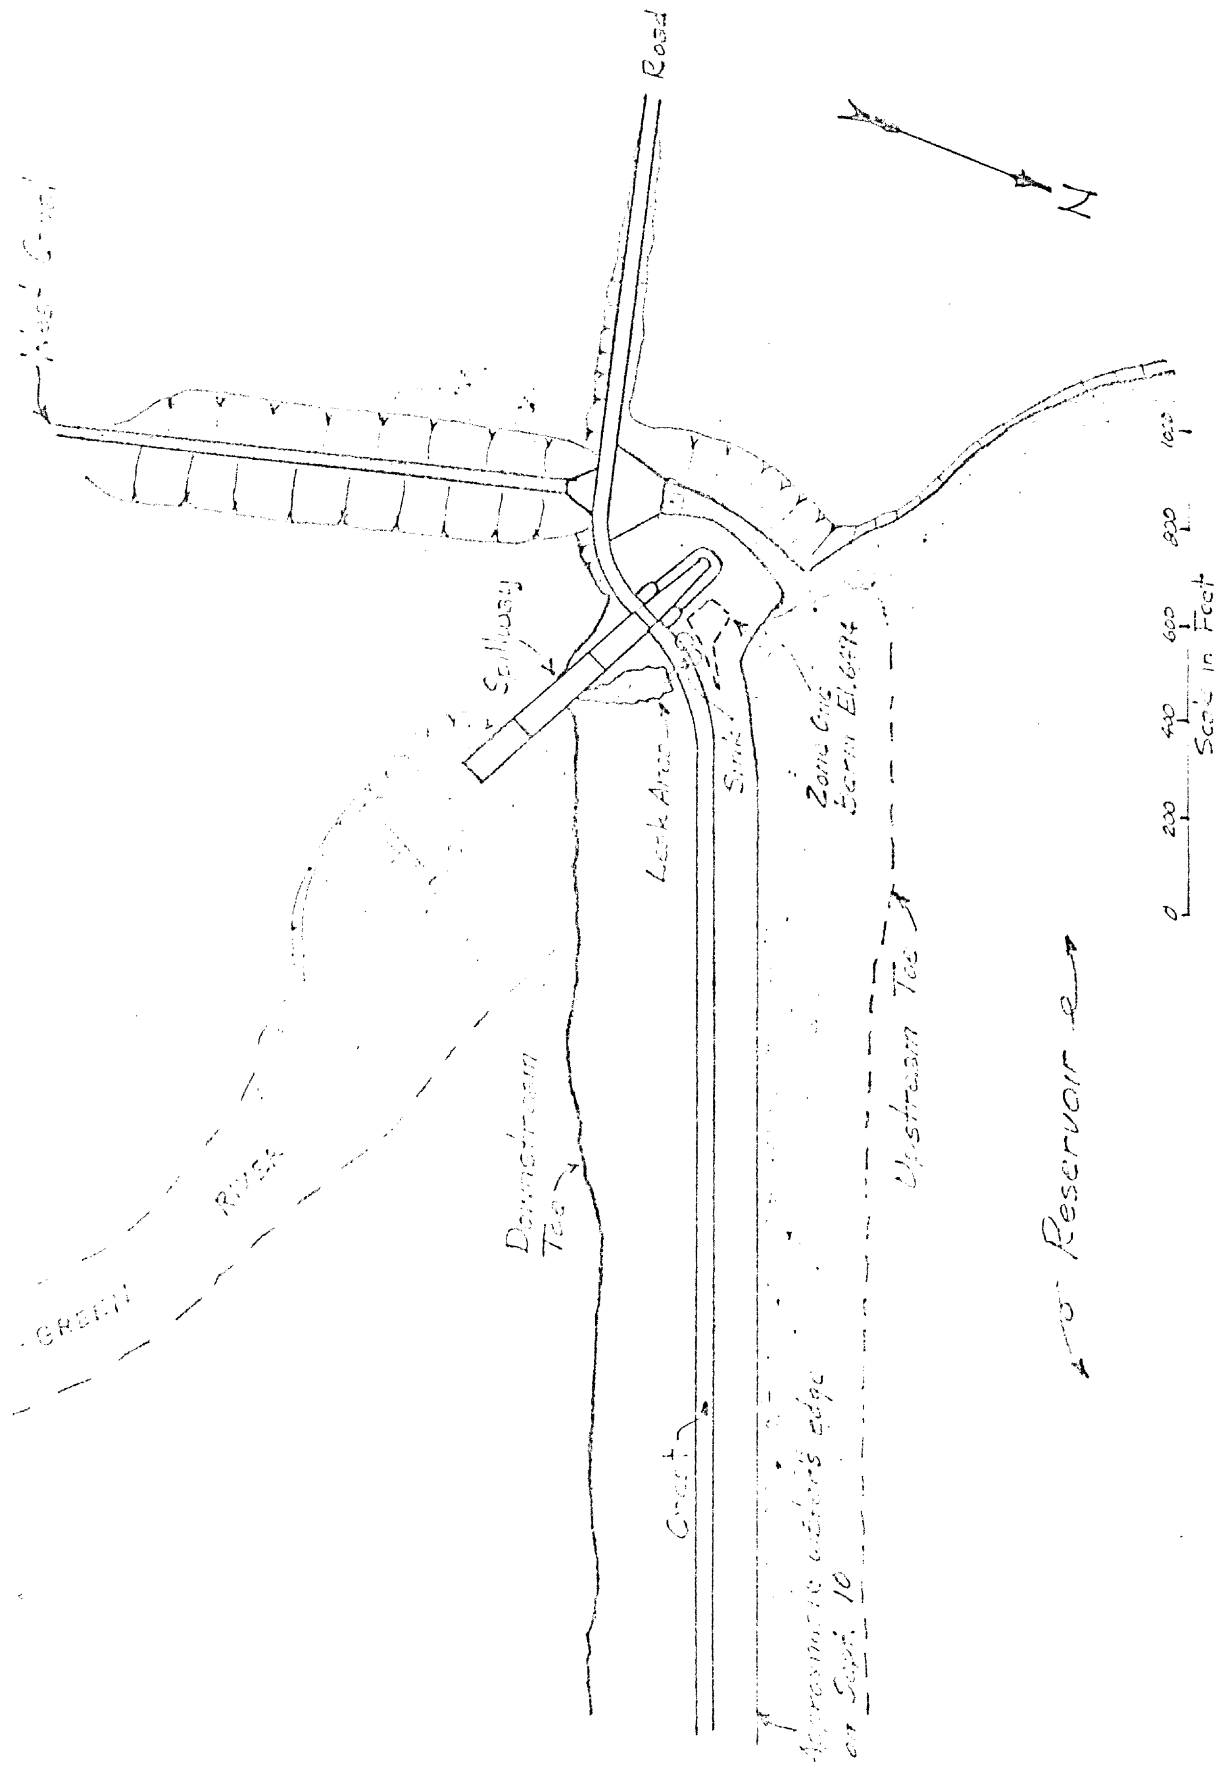
FIGURE 6

Harrison of the Saguaro Construction Company. Mr. Bellport's assessment of the situation was that it "remained serious but was improving rapidly" as the reservoir level was drawn down. The reasoning behind this conclusion was the fact that the leak was slowly diminishing combined with the gain of a 3-foot width of earth embankment for every one foot of drawdown in the lake level. Furthermore, the drawdown of the lake would soon reach a much thicker section of Zone 1 material below elevation 6,494 feet--the top of a wedge-shaped, Zone 1 berm or terrace, adjacent to the right abutment rock. (See Figure 6.)

On the morning of September 8 the reservoir level fell below the important Zone 1 berm at elevation 6,494 feet. (See Figure 6.) For the first time a feeling of moving out of a serious situation began to be felt. The placement of this Zone 1 berm was a change made during construction of the dam to better cover the rock of the right abutment. The realization of the significance of the conservative approach to earth dam design, as evidenced by the presence of this Zone 1 berm adjacent to the troublesome right abutment rock, was accentuated as this berm level was reached.
