REPORT ON

LEAK AT FONTENELLE DAM  
SEEDSKADEE PROJECT, WYOMING

September 1965

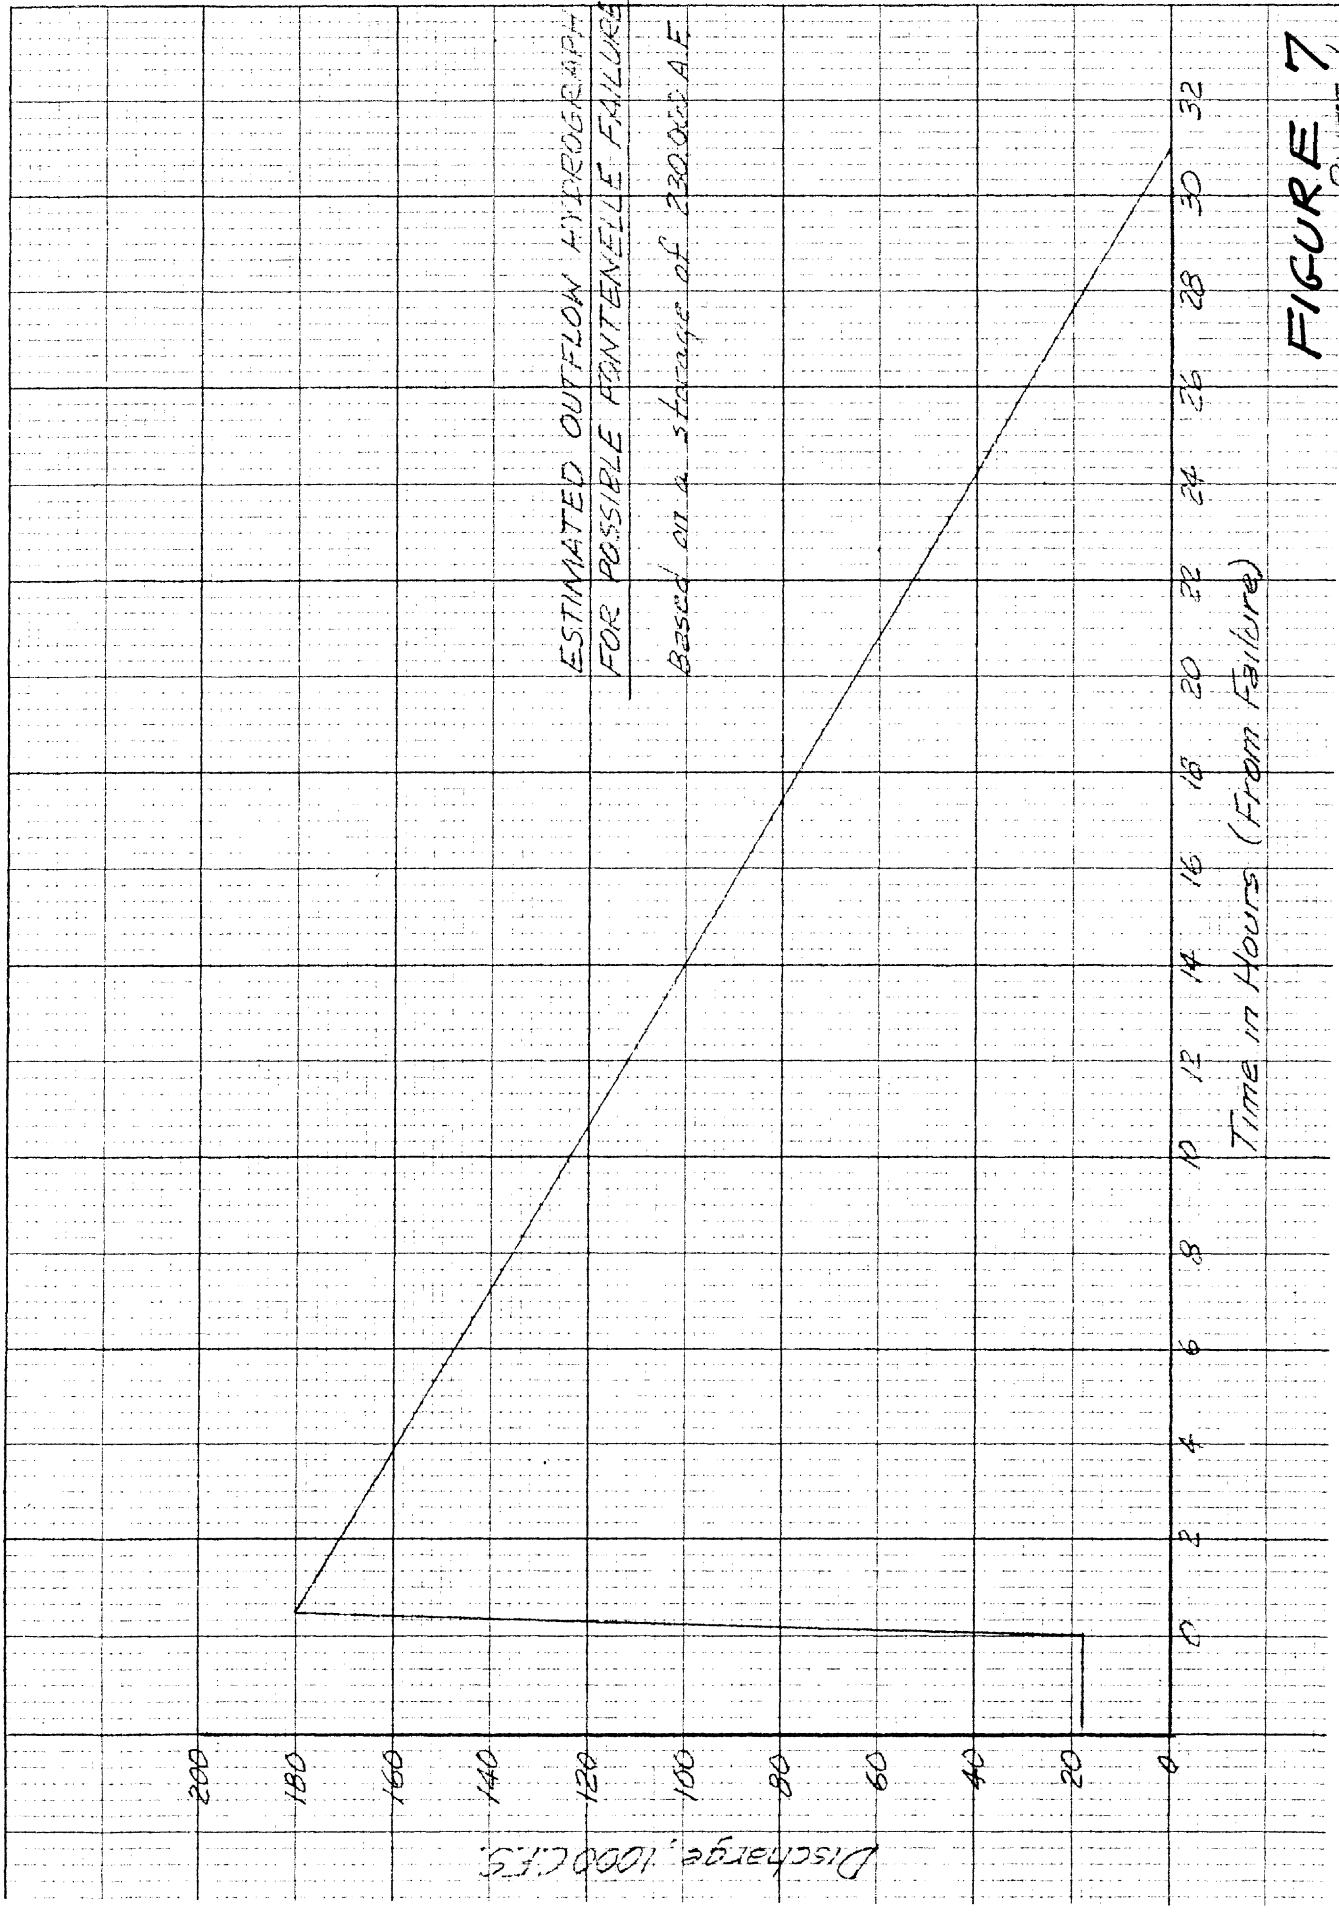
FIGURE 7

break was that a rise in the river level at Green River would be experienced within two hours but that the peak flow would arrive in about 16 hours and would total 120,000 c.f.s. The crest of that peak discharge would be about 40 feet above the river level prevailing at that time, and the peak would probably inundate all of the portion of the city of Green River located south of U. S. Highway 30. Estimated hydrographs of the flow of the Green River at Fontenelle Dam and at Green River, Wyoming, assuming failure of the dam, are attached. (See Figures 7 and 8.)

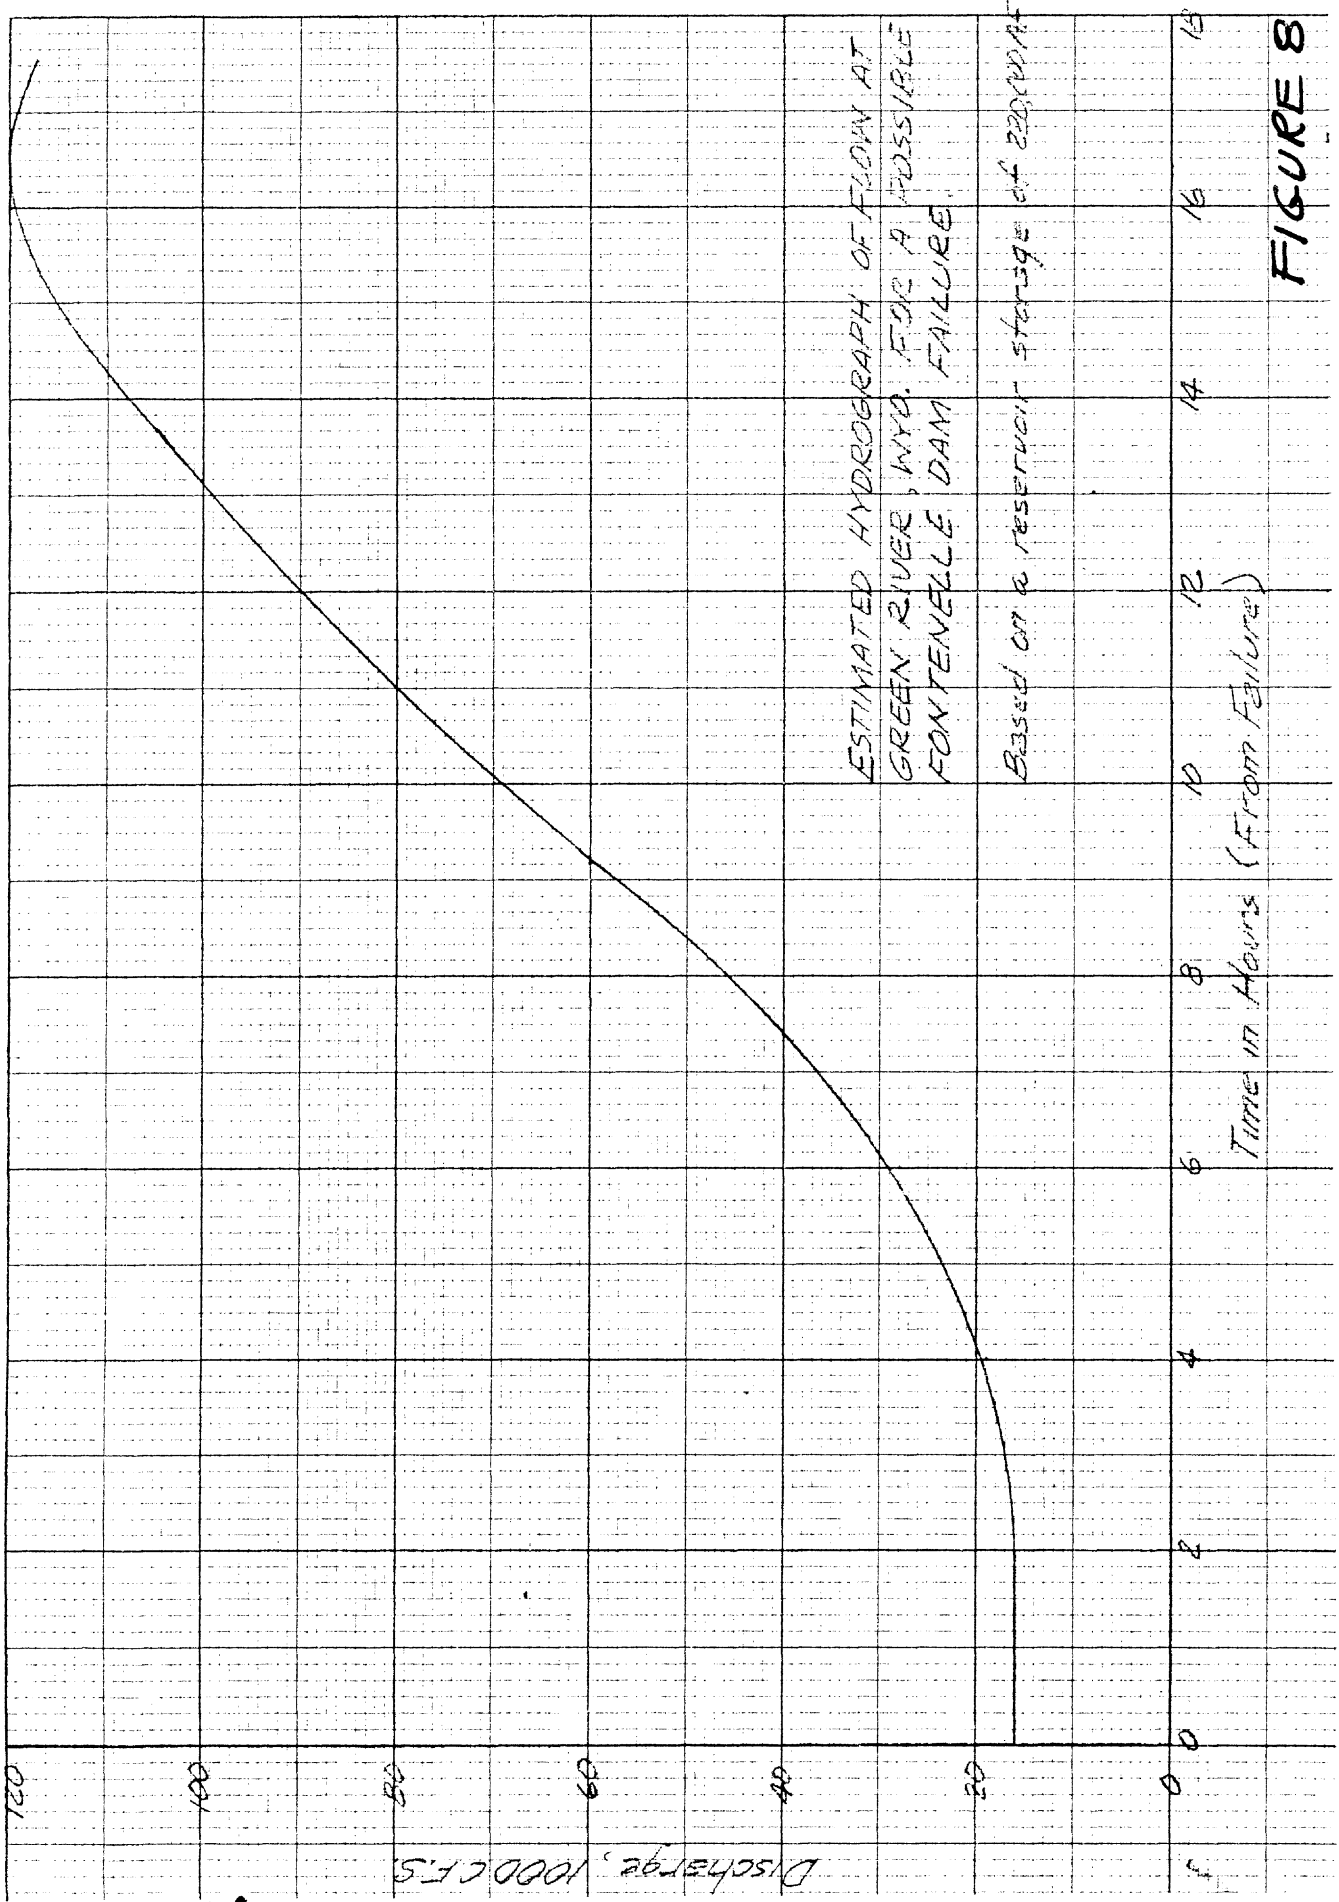
ESTIMATED HYDROGRAPH OF FLOW AT  
 GREEN RIVER, WYO. FOR A POSSIBLE  
 FONTENELLE DAM FAILURE.

BASED ON A RESERVOIR STORAGE OF 220,000 A.C.
