INVESTIGATION OF FAILURES OF EDENVILLE AND SANFORD DAMS

SEPTEMBER 13, 2021

Executive Summary

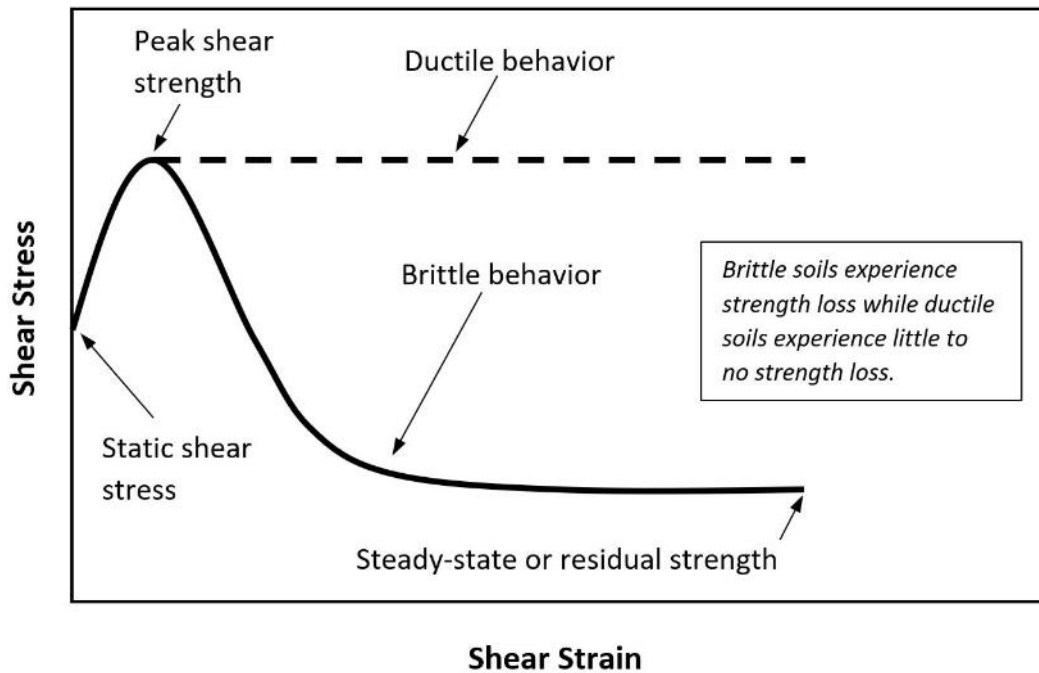
Figure 23: Brittle, strain-softening stress-strain curve

Such failures can only occur with soils that have a brittle, strain-softening stress-strain curve in which the mobilized strength drops substantially with relatively little strain. This behavior is illustrated by the solid line in Figure 23, which shows the stress-strain curve for a saturated, loose sand in undrained shear – shear without drainage of the pore water in the soil mass. As shown in Figure 23, initially the shear stress increases from an initial static shear stress as the sample is strained (deformed) until it reaches a peak value (peak strength), after which the shear strength drops quickly with further straining to a much lower strength (steady-state or residual strength), which is lower than the initial static shear stress. For saturated,

For comparison, the dashed line in Figure 23 illustrates ductile stress-strain behavior in which there is little or no reduction in shear strength with further straining after the peak strength is reached, which is typical of a saturated, loose sand in drained shear.

For brittle stress-strain behavior, if the steady-state or residual strength is much less than the static shear stress, the rapid and substantial strength decrease can cause sufficient force imbalance to create acceleration and velocity, as observed in the Edenville Dam failure. The large difference between applied forces (stresses) and resisting forces (strengths) causes acceleration of the soil mass.

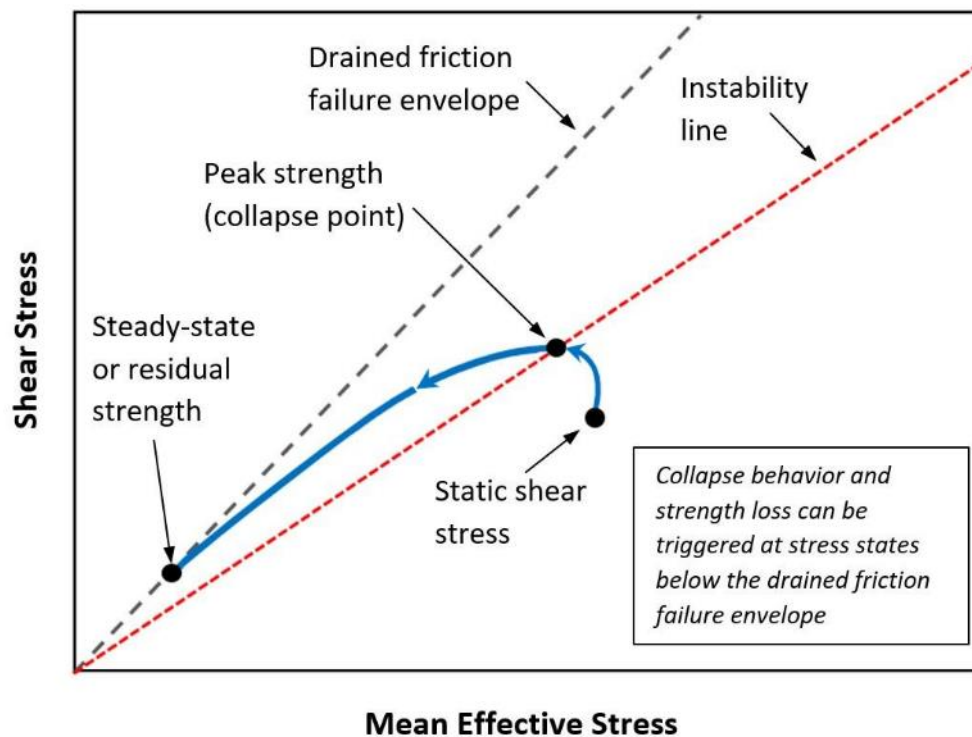
Figure 24: Illustration of initiation of collapse behavior at stress state below the drained friction failure envelope

Research, principally by tailings dam practitioners, has shown that collapse behavior in saturated, loose sands can be triggered at stress states below those at the drained friction failure envelope, which is normally taken to indicate the available strength of the soil if the loading is not seismic. Figure 24 shows a stress path for the undrained triaxial shear test of the saturated, loose sand in Figure 23. The stress path is a plot of the relationship between the applied shear stress and confining stress (portrayed in the figure as mean effective stress) as the soil is sheared. The stress path starts at the point labeled “Static shear stress” in Figure 24, which corresponds to the point of zero shear strain in Figure 23, indicating the initial undeformed state of the soil. As the soil is strained (deformed), the stress path moves to the point labeled “Peak strength (collapse point)” in Figure 24, which corresponds to the point labeled “Peak shear strength” in Figure 23. Finally, the stress path continues to the point labeled “Steady-state or residual strength” in Figure 24, which corresponds to the point labeled the same in Figure 23. Stress path movement toward the left indicates development of pore water pressure in the soil. From Figure 24, it is seen that some pore water pressure develops as the shear stress increases to the peak strength, but this is followed by a large increase in pore water pressure, reducing the strength to the steady-state or residual strength.

If the test illustrated in Figure 24 is conducted using “load control,” that is with the load producing the shear stress applied with dead weights, a collapse behavior is observed. As the weights are slowly added, there is a small amount of strain and some increase in pore water pressure as the shear stress increases to the peak strength. After the peak strength is reached, the pore water pressure and the strain both increase rapidly and the sample effectively collapses because the pore water pressure dramatically decreases the strength. The same behavior occurs in the field in a flow slide failure of saturated, loose sand. Because of this observed behavior, the line of undrained peak strengths shown on Figure 24 has been called the collapse line or instability line. Because the collapse or instability line is significantly below the drained friction failure envelope, as shown in Figure 24, the shear stress required to reach the collapse or instability line is less than that at the drained friction failure envelope. Hence, in a stability analysis, the factor of safety against reaching the instability line would be less than that against reaching the drained friction failure envelope.

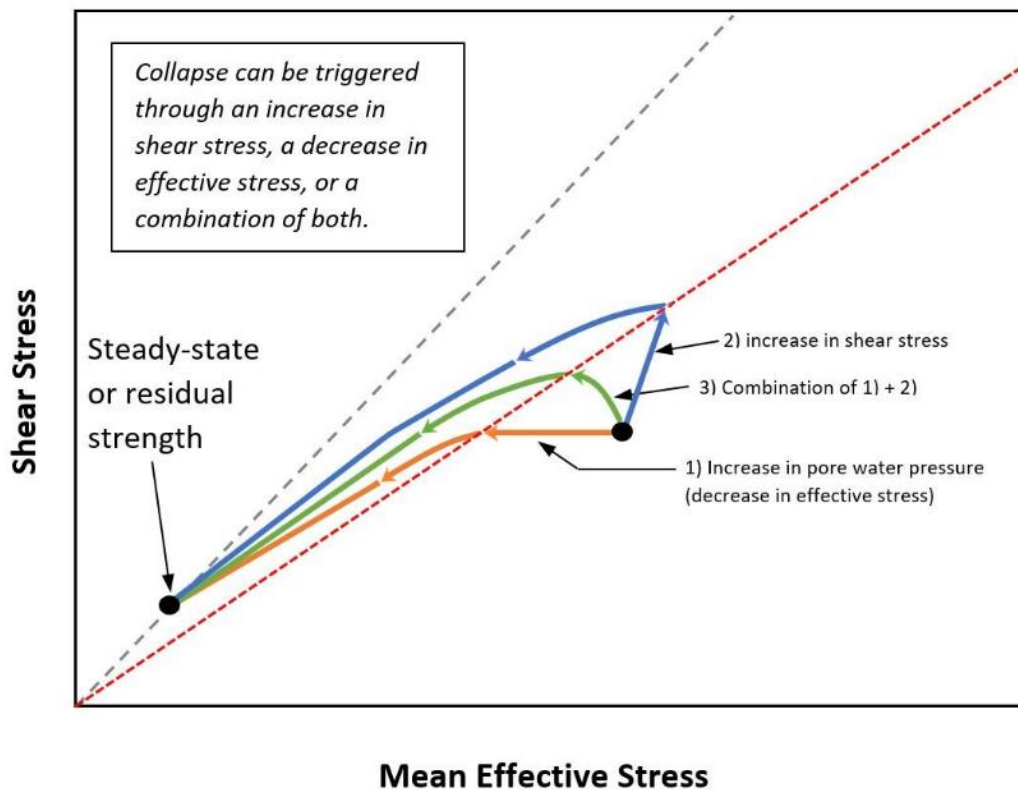
Figure 25: Conceptual stress paths to reach the instability line

Research has also shown that the instability line, where collapse is triggered, can be reached by (1) an increase in pore water pressure (decrease in effective stress), (2) an increase in shear stress, or (3) a combination of the two, as shown in Figure 25. Path 1, the orange path in Figure 25, shows that an increase in pore water pressure with no change in the applied static shear stress can move the stress path to the left until it intersects the collapse or instability line, at which point pore water pressure increases rapidly, strength decreases dramatically, and collapse/instability results. This behavior is significant, because it indicates that a rise in phreatic surface in an embankment that includes saturated, loose sands can trigger the collapse behavior, without any significant changes in shear stress and at a stress state below the drained friction failure envelope.
