AN INVESTIGATION OF
THE
FAILURE OF LAWN LAKE DAM
LARIMER COUNTY, COLORADO

Conducted by The
Office Of The State Engineer

February 14, 1983

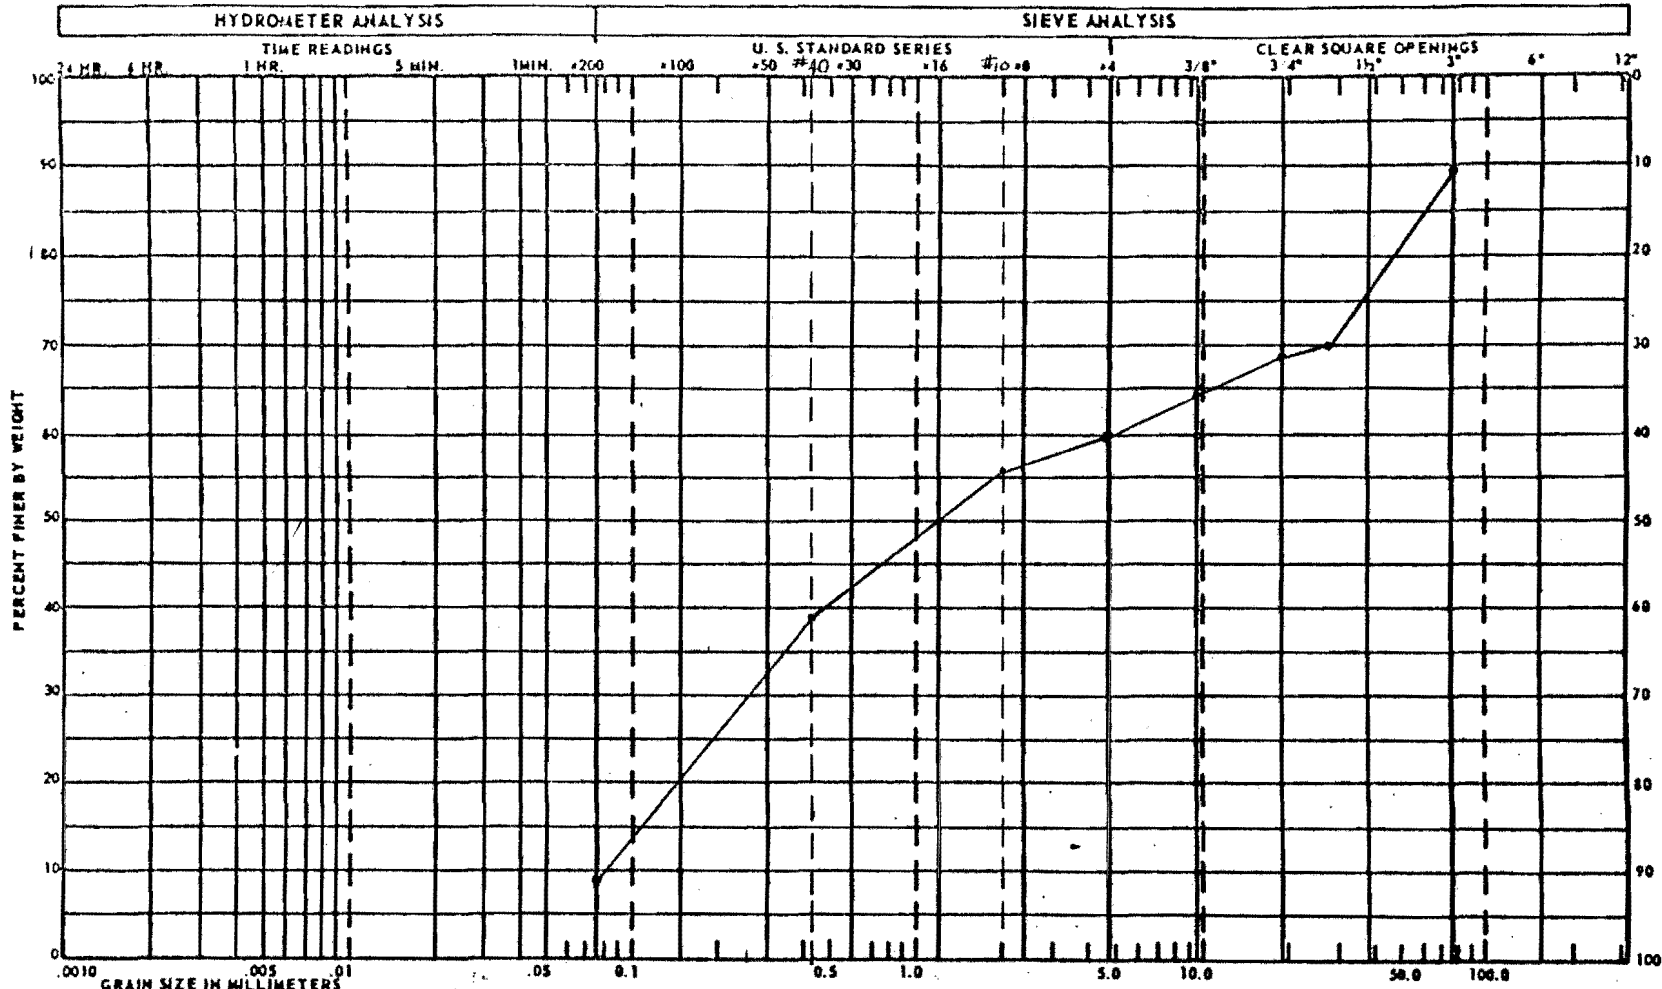
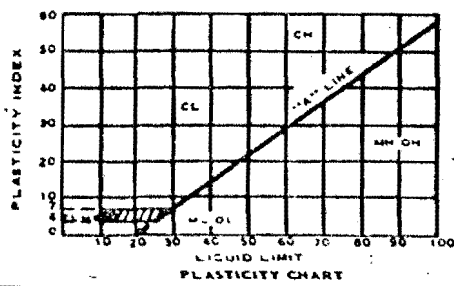
FIGURE B-10

Lab. Classification SP-SM
 Specific Gravity, G_s , = 2.58 = 2.65
 Remarks: From left side of
breach
Non-Plastic 40% gravel
 50% sand
 8% fines

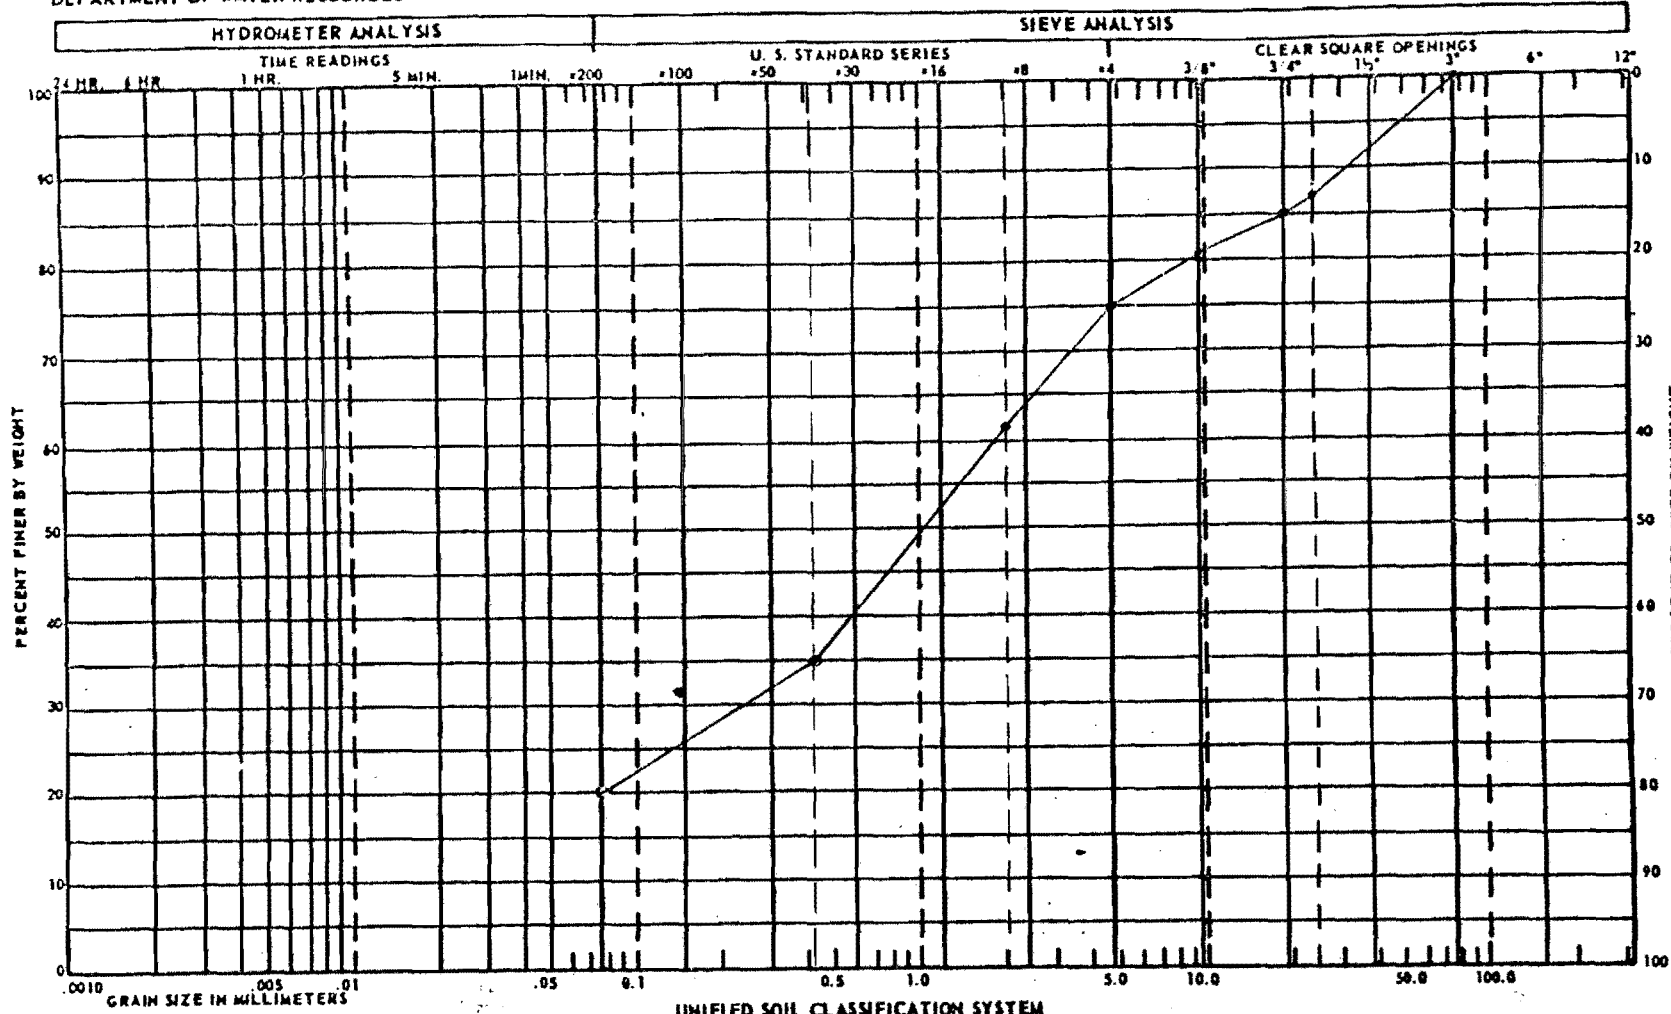
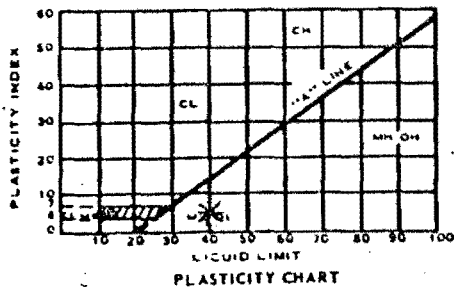
FIGURE B-11

Lab. Classification SM (OL)
 Specific Gravity, G_s , \dots 2.52 \dots 2.57
 Remarks: From left side of breach
LL = 40, PI = 6
25% gravel
55% sand
20% fines

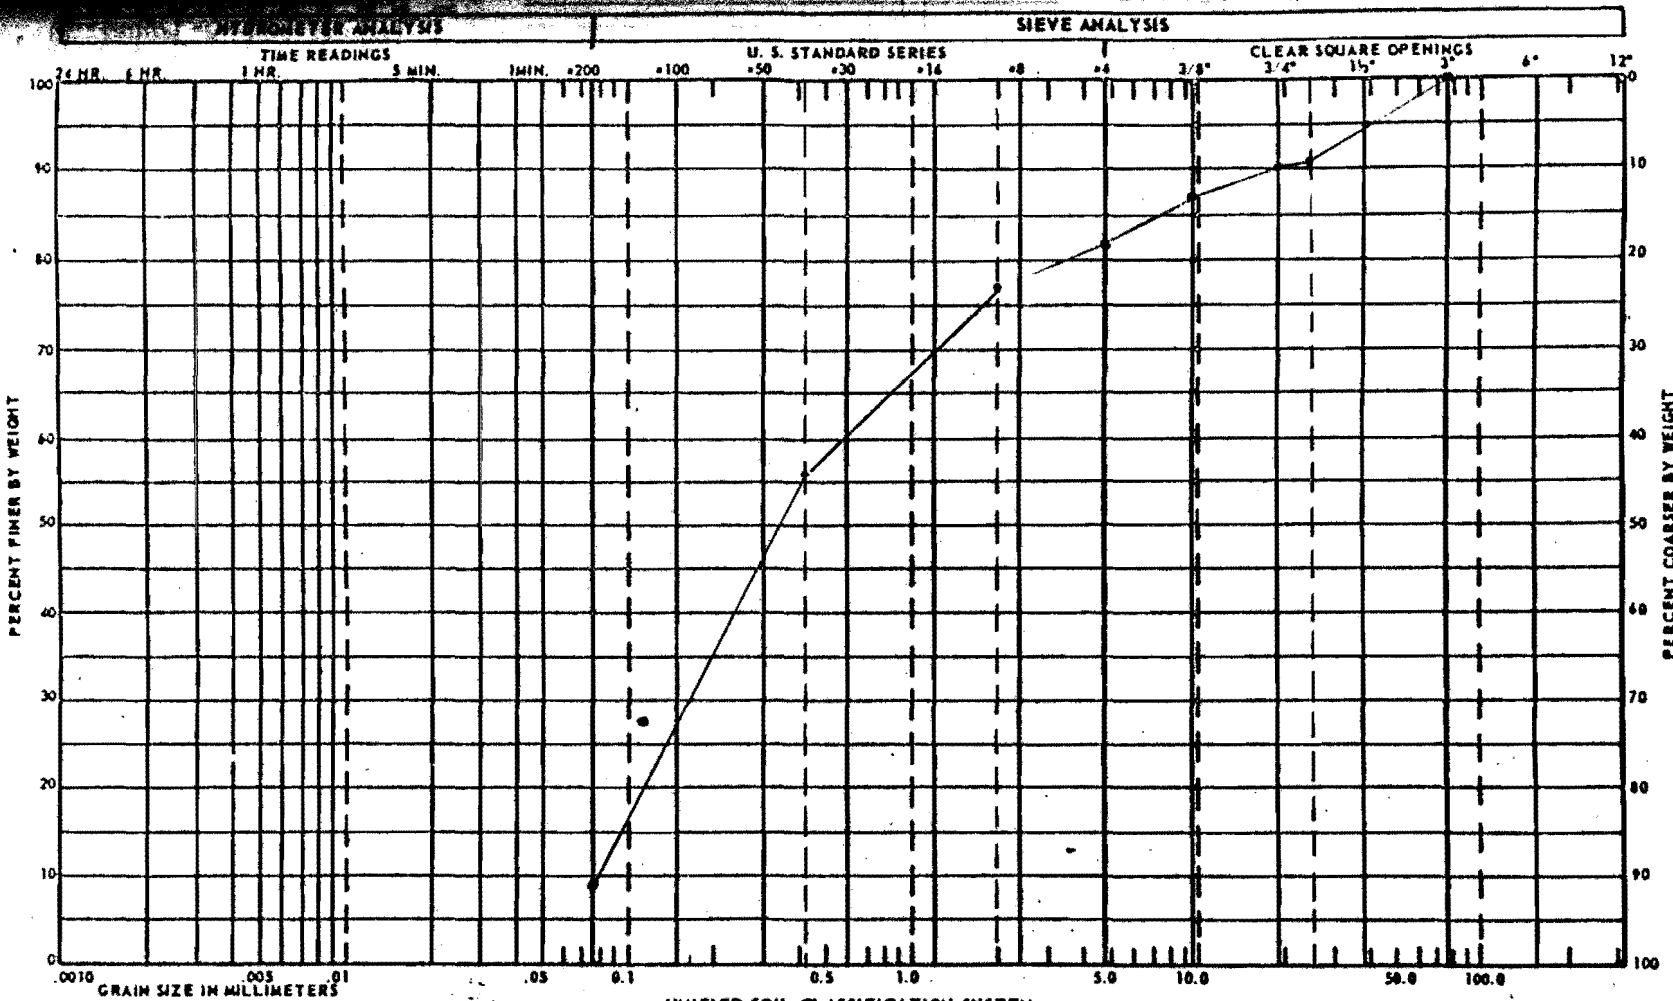
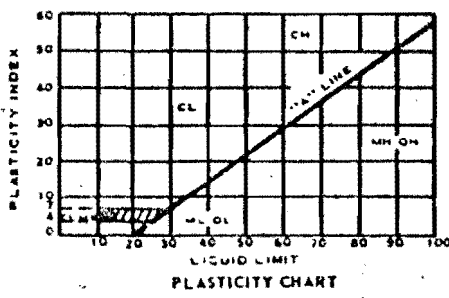
FIGURE B-13

Lab. Classification SP-SM
 Specific Gravity, G_s , = 2.58 = 2.65
 Remarks: From left side of breach
Non-plastic
18% gravel
73% sand
9% fines
 Request No. _____

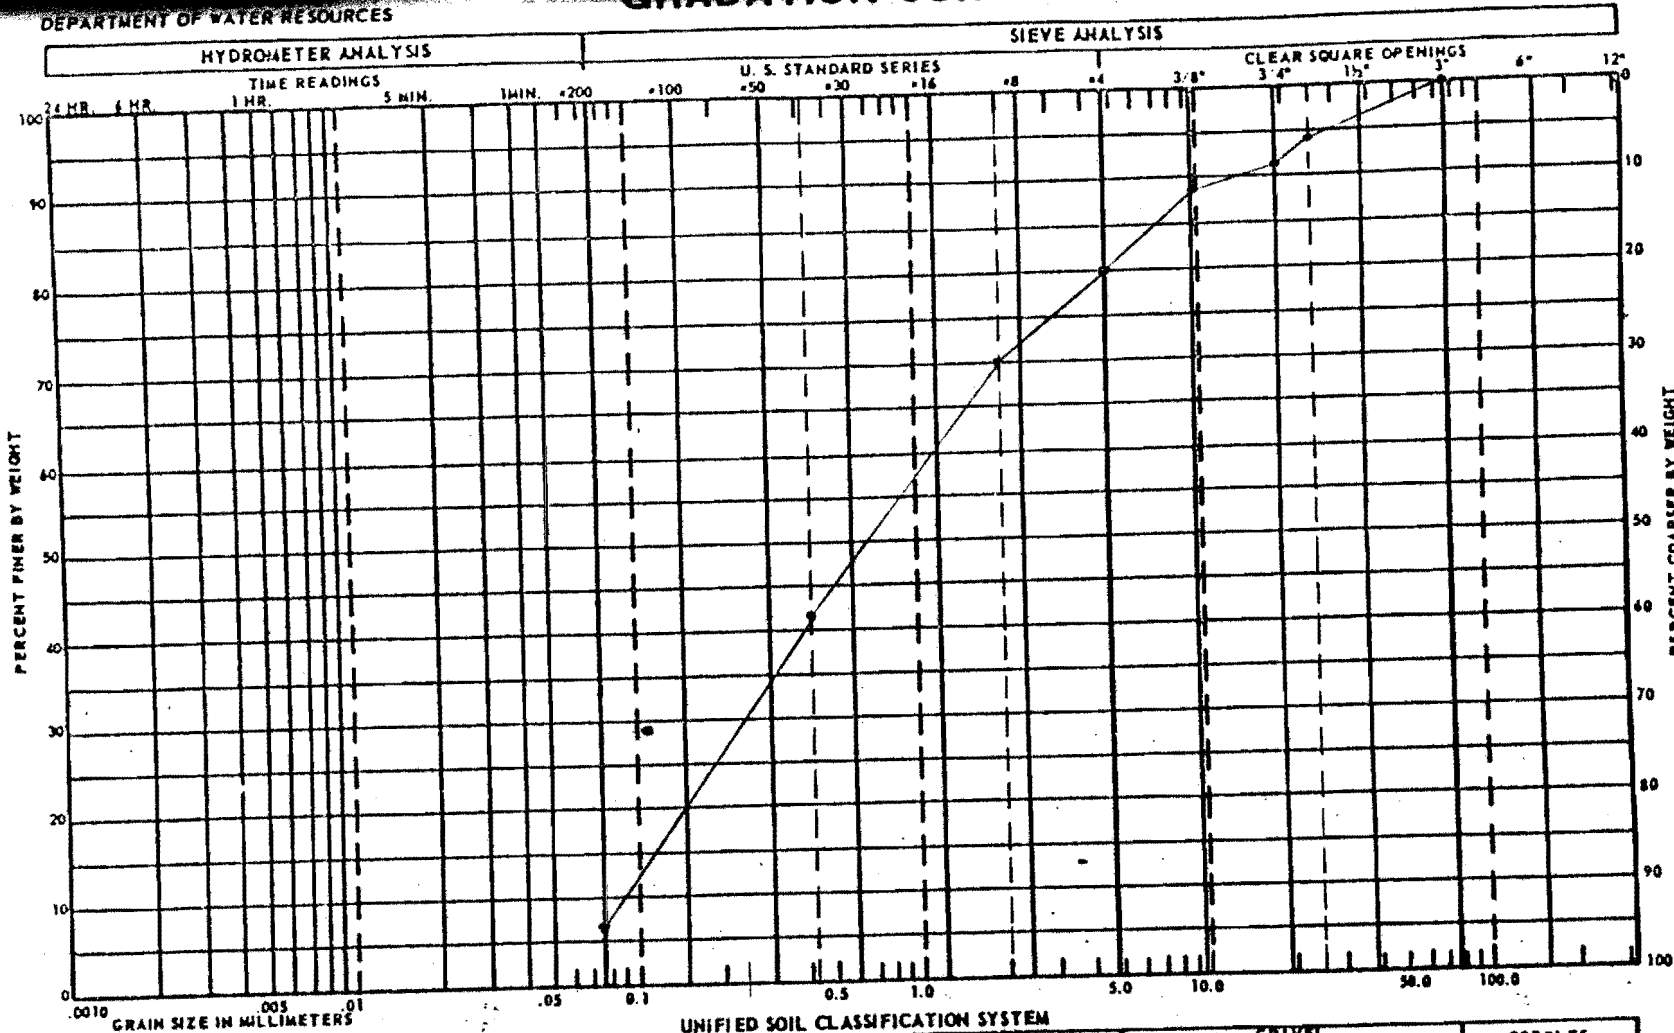
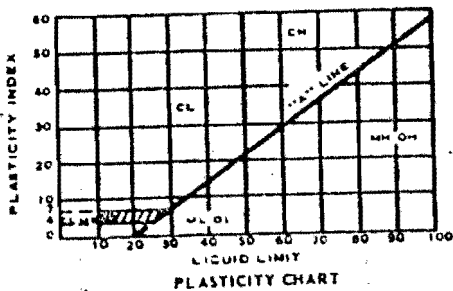
FIGURE B-15

Lab. Classification SP-SM
 Specific Gravity, G_s , = 2.58 -- 2.65
 Remarks: From left side of breach
Non-Plastic
20% gravel
73% sand
7% fines

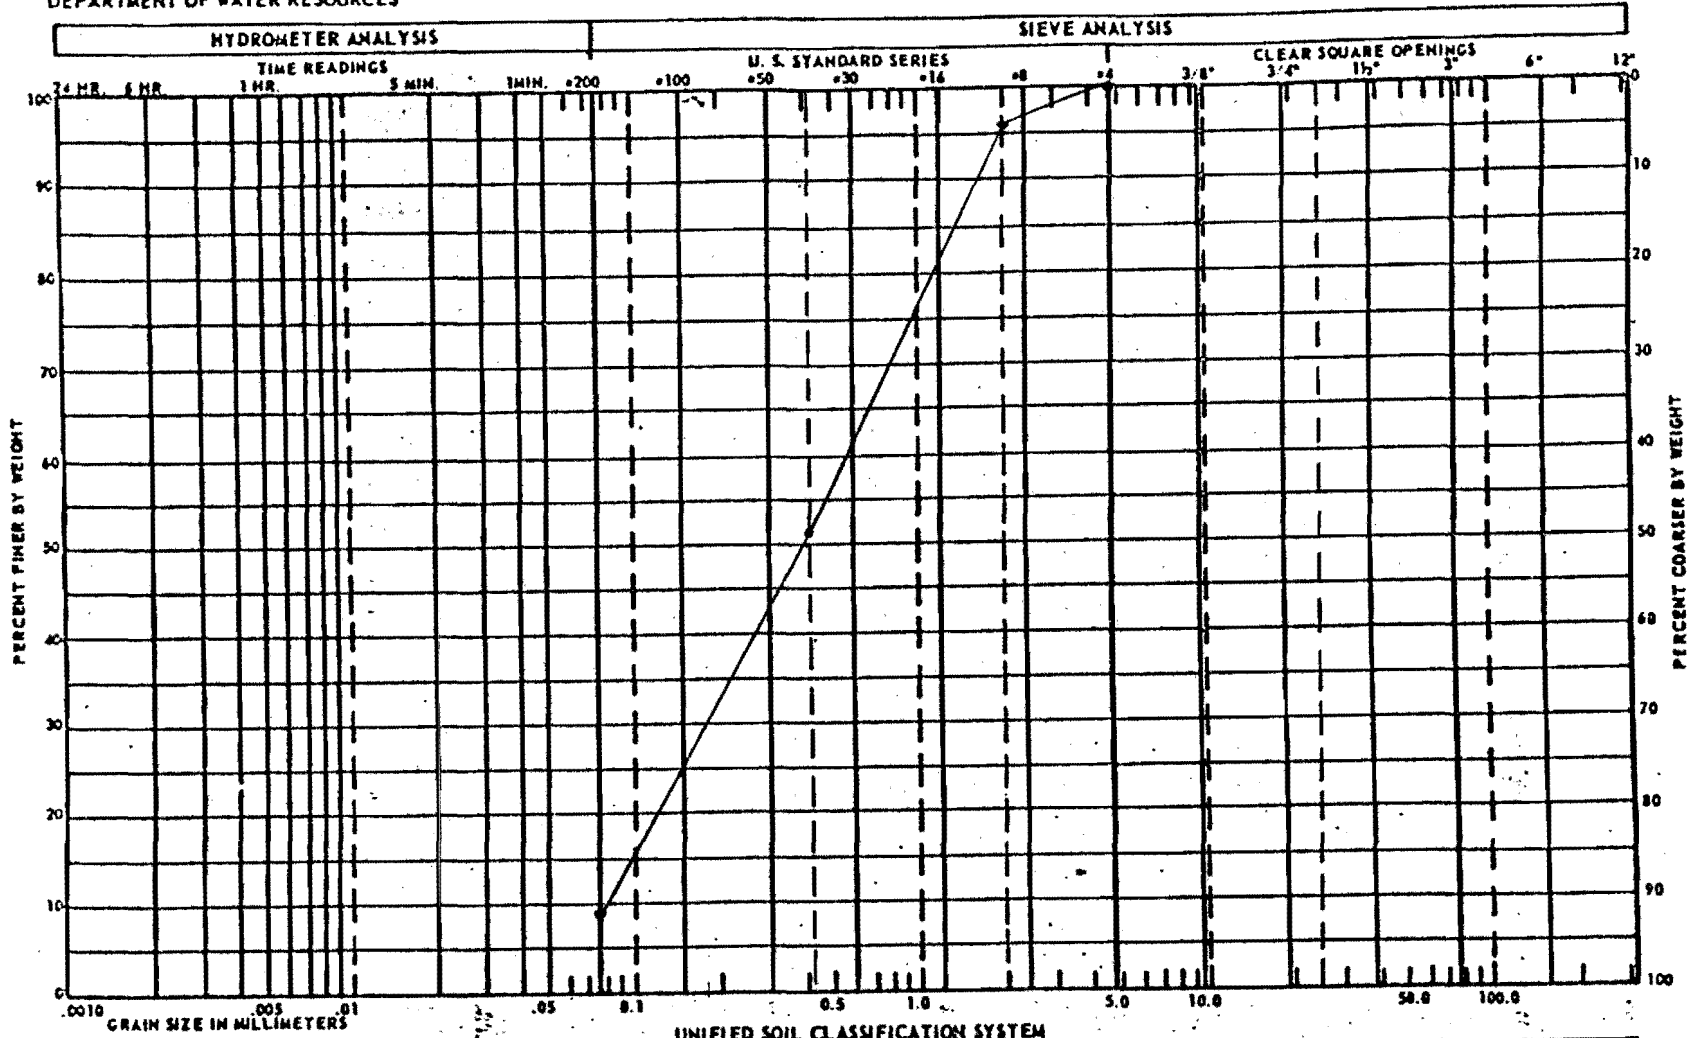
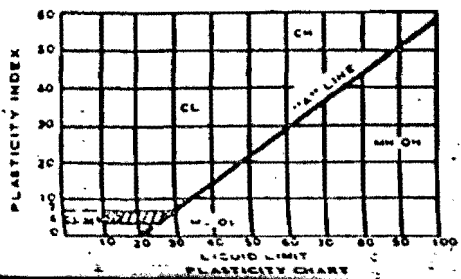
B-20

The most significant difference between material from the right side and material from the left side was the two gravel layers found at a depth of 10 inches and 10' 10" on the right side of the breach. The layer at the 10-inch depth was three inches thick and the layer at the 10' 10" depth was one foot thick. The amount of material passing the #200 sieve in the gravel layers were six percent and four percent, respectively.

Lab. Classification SP-SM
 Specific Gravity, G_s , = 2.64
 Remarks: From right side of
breach (9' sand lens)
0% gravel
91% sand
Non-plastic 9% fines

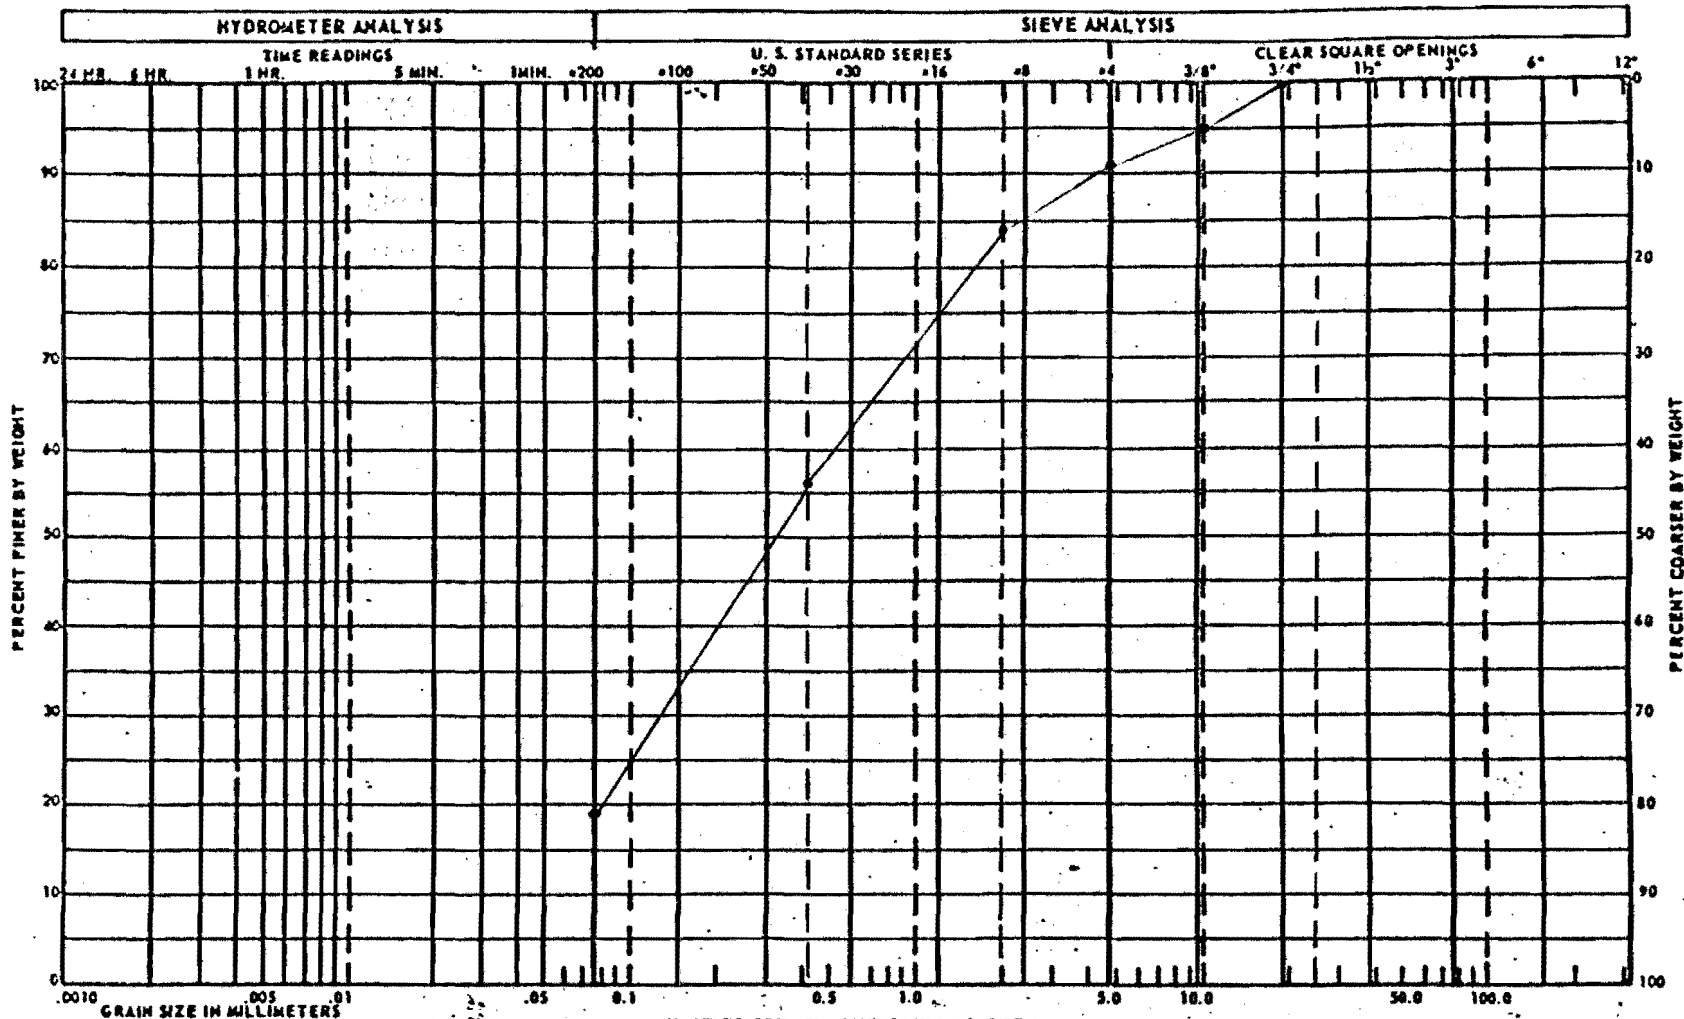
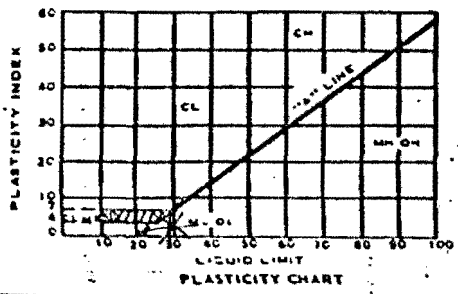
FIGURE B-22

Lab. Classification SM
 Specific Gravity, G_s , = 2.62
 Remarks: From right side of
breach
 9% gravel
 72% sand
 19% fines
 LL = 29
 PI = 3

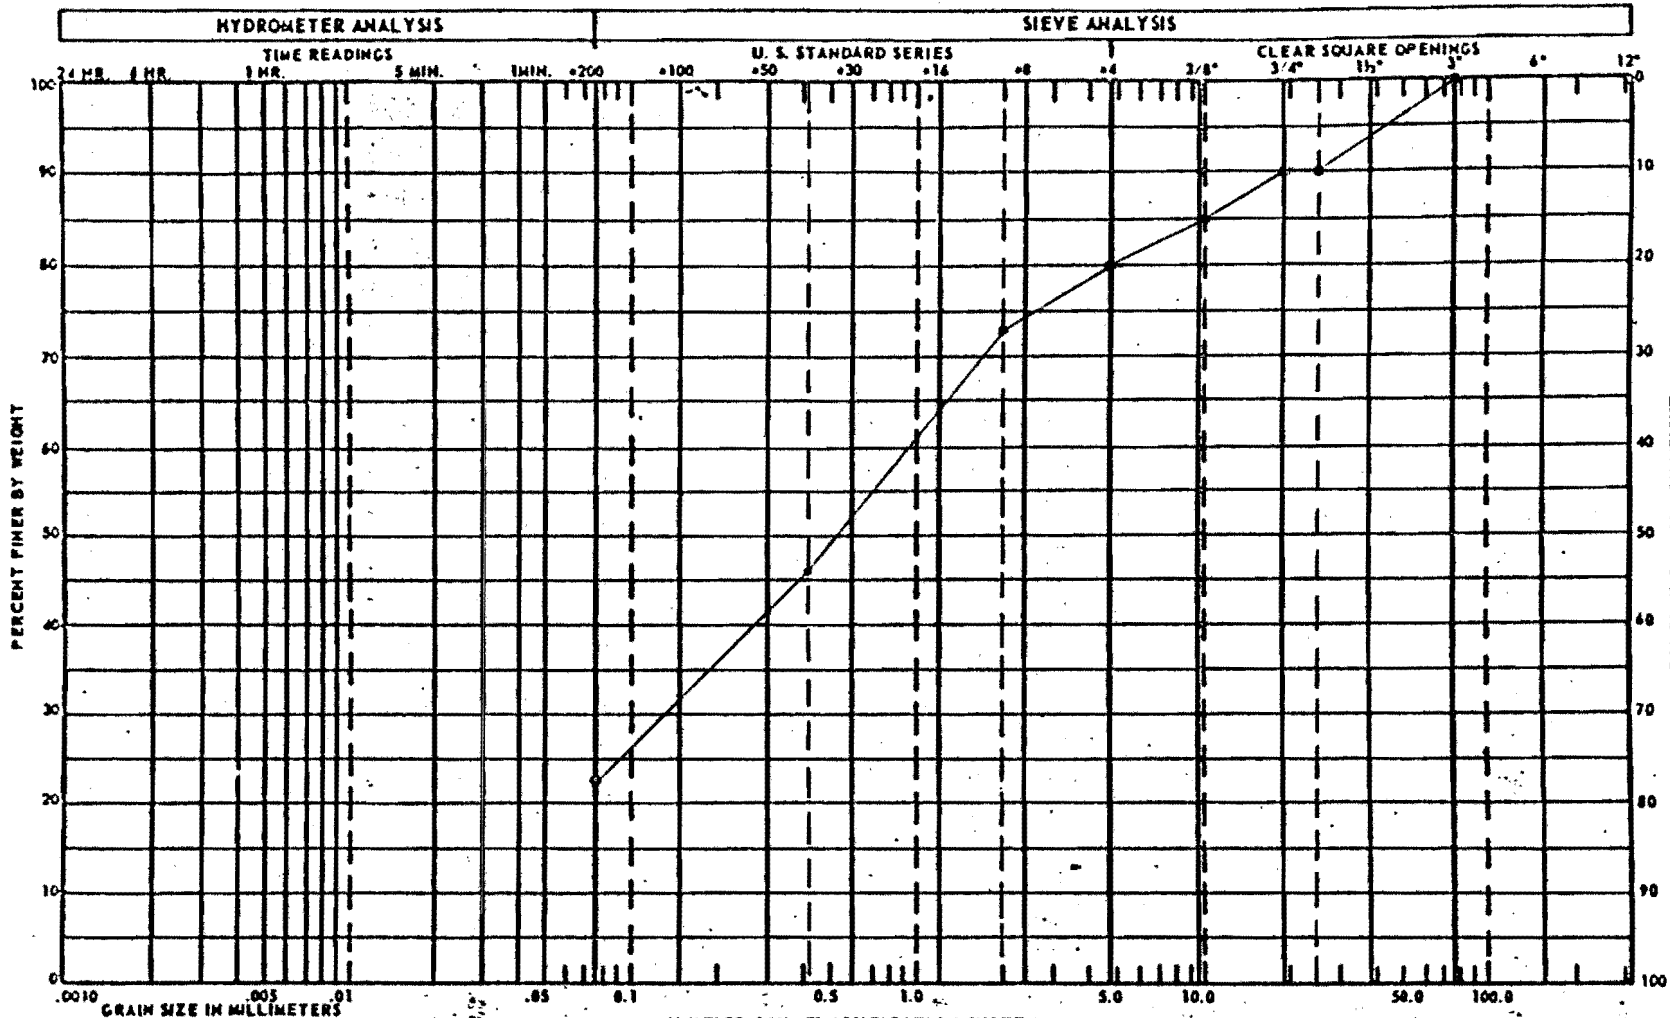
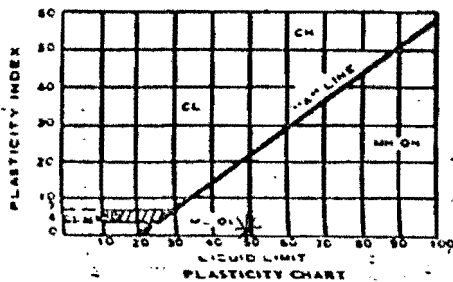
FIGURE B-24

Lab. Classification SM
 Specific Gravity, G_s , $\pm .04$ 2.48
 Remarks: From right side of
breach
 LL = 49 20% gravel
 PI = 2 57% sand
 23% fines
Organics present
 Request No. _____

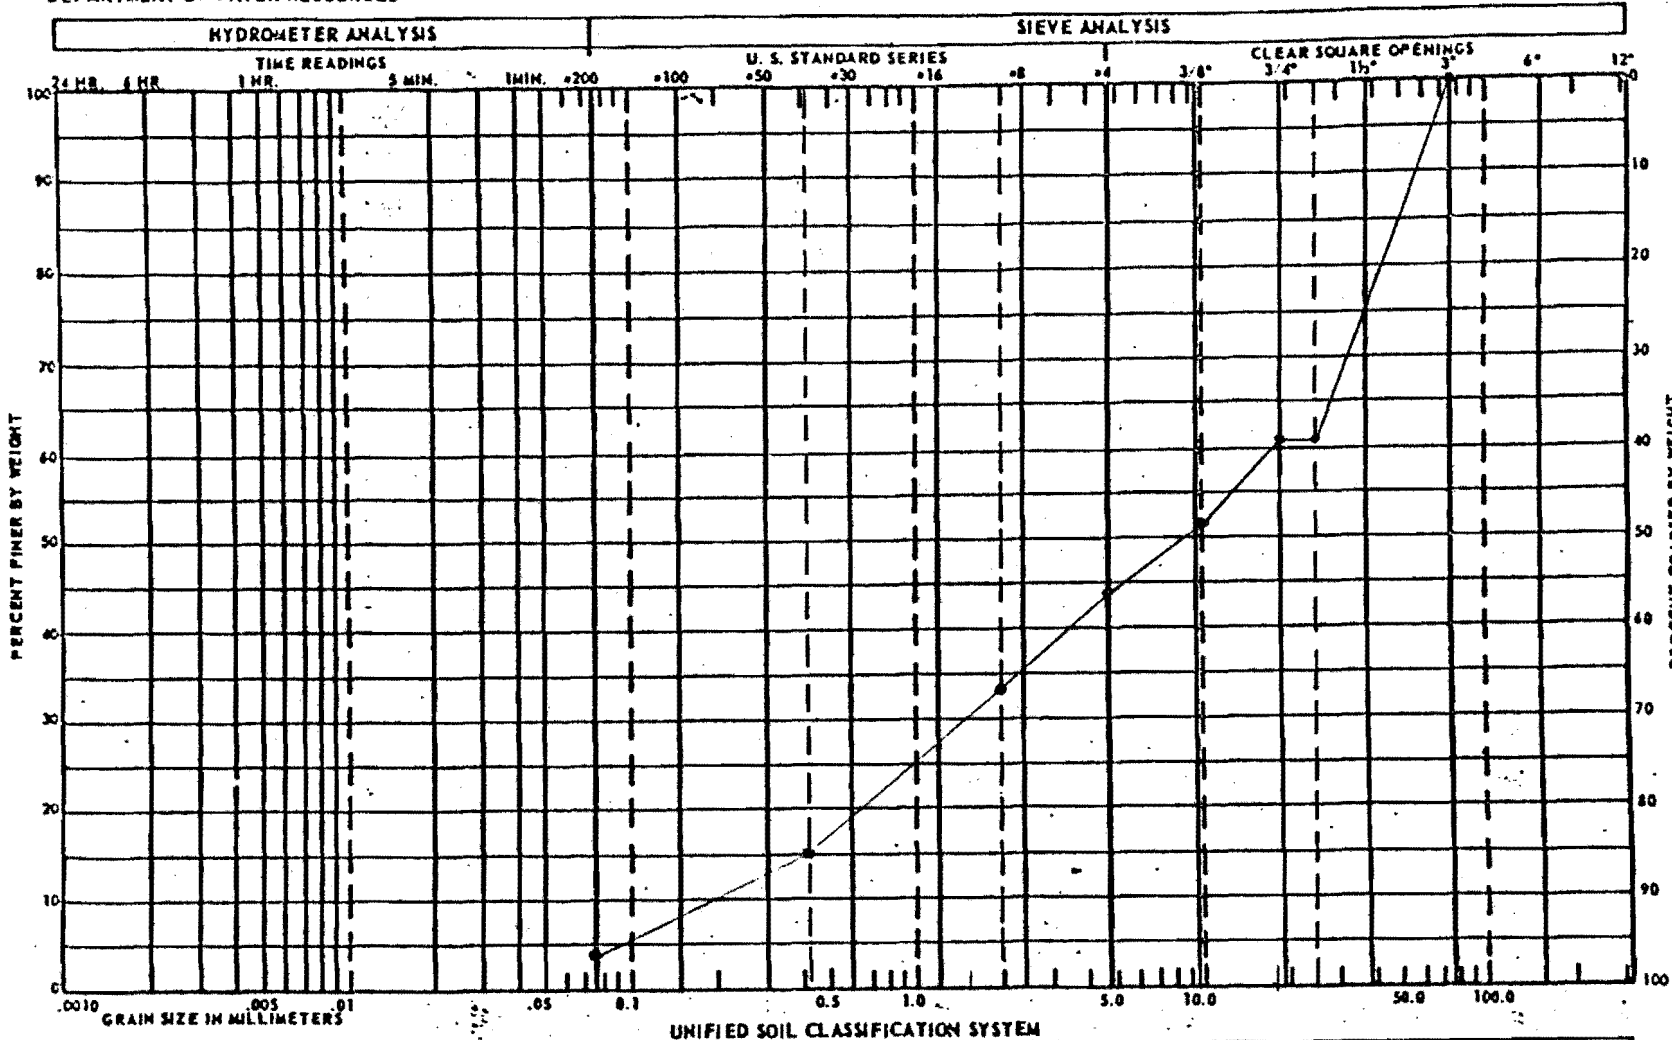
FIGURE B-27

Lab. Classification GW
 Specific Gravity, G_s , = 2.65
 Remarks: From right side of
break
56% gravel
40% sand
Non-plastic 4% fines

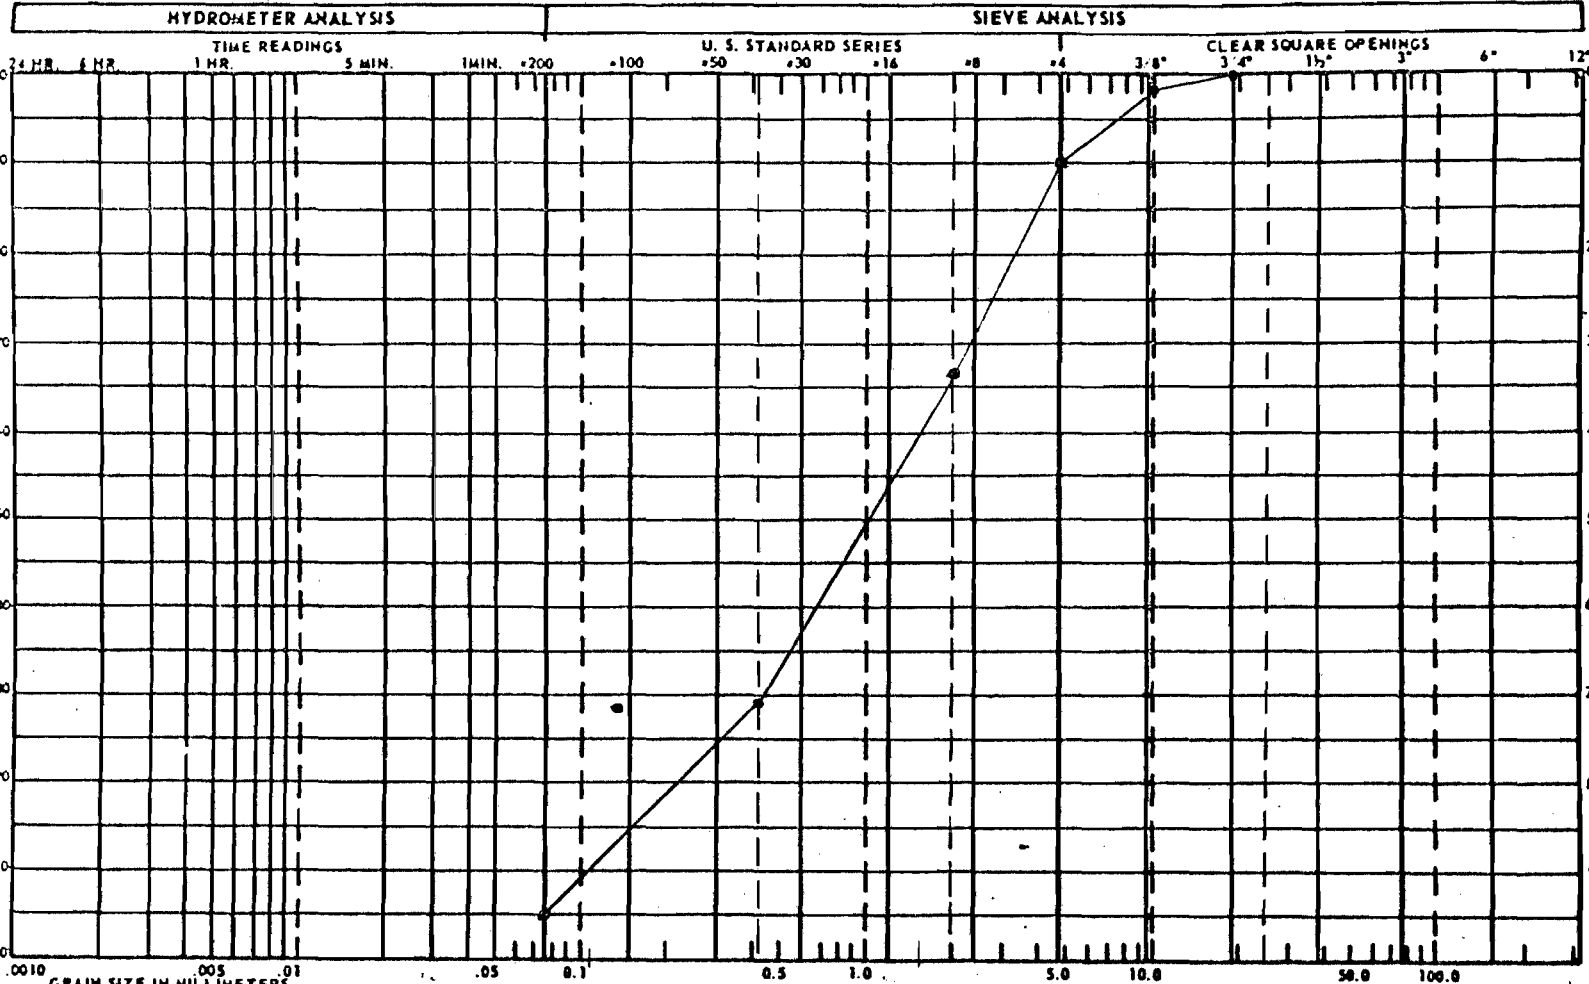
B-28
FIGURE B-28

Lab. Classification: SW-SM

Specific Gravity, G_s : 2.64

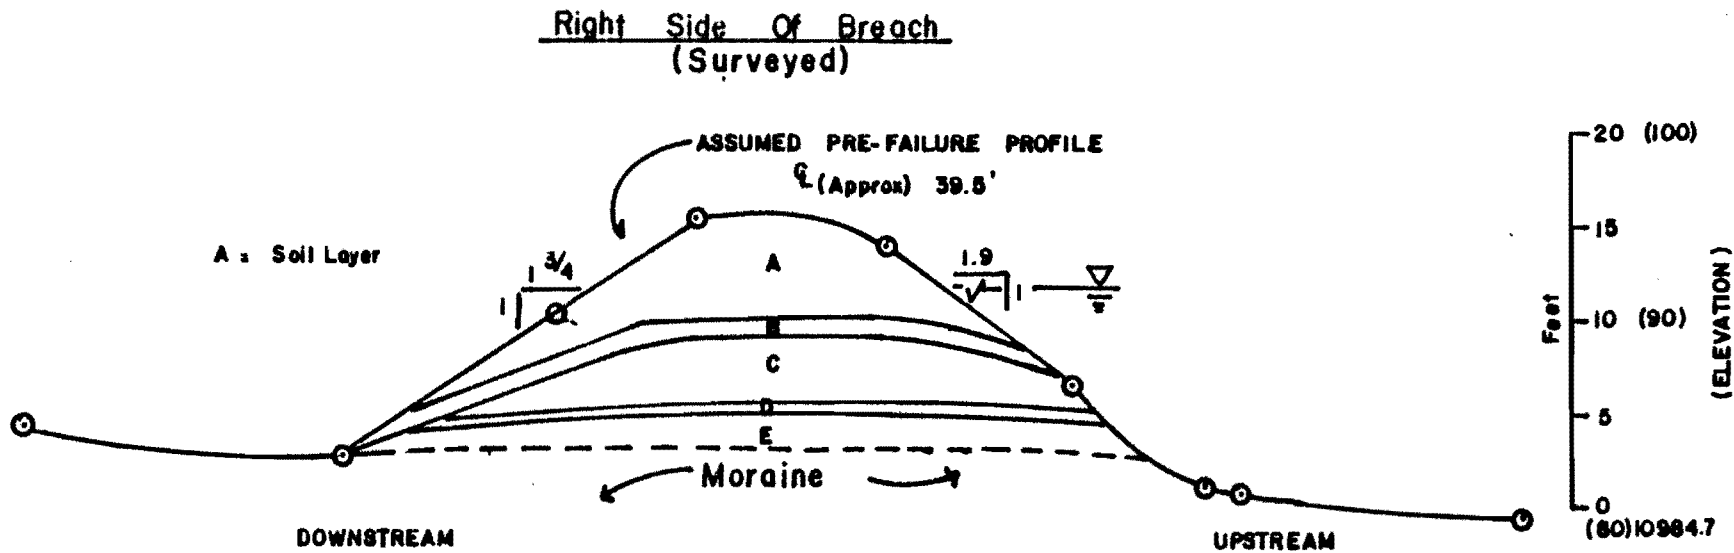
FIGURE C-1

<u>Soil Number</u>	<u>Inplace Density</u> (PCF)	<u>Cohesion</u> (PSI)	ϕ (DEGREES)	<u>TAN ϕ</u>
A	121.7	0.0	30	0.577
B	102.1	1.4	18.4	0.333
C	123.5	0.0	32	0.625
D	115.4	1.3	22	0.408
E	120.0	0.0	32	0.625
<u>FOUNDATION</u>				
(Glacial Moraine)	135.0	100.0	45	1.000

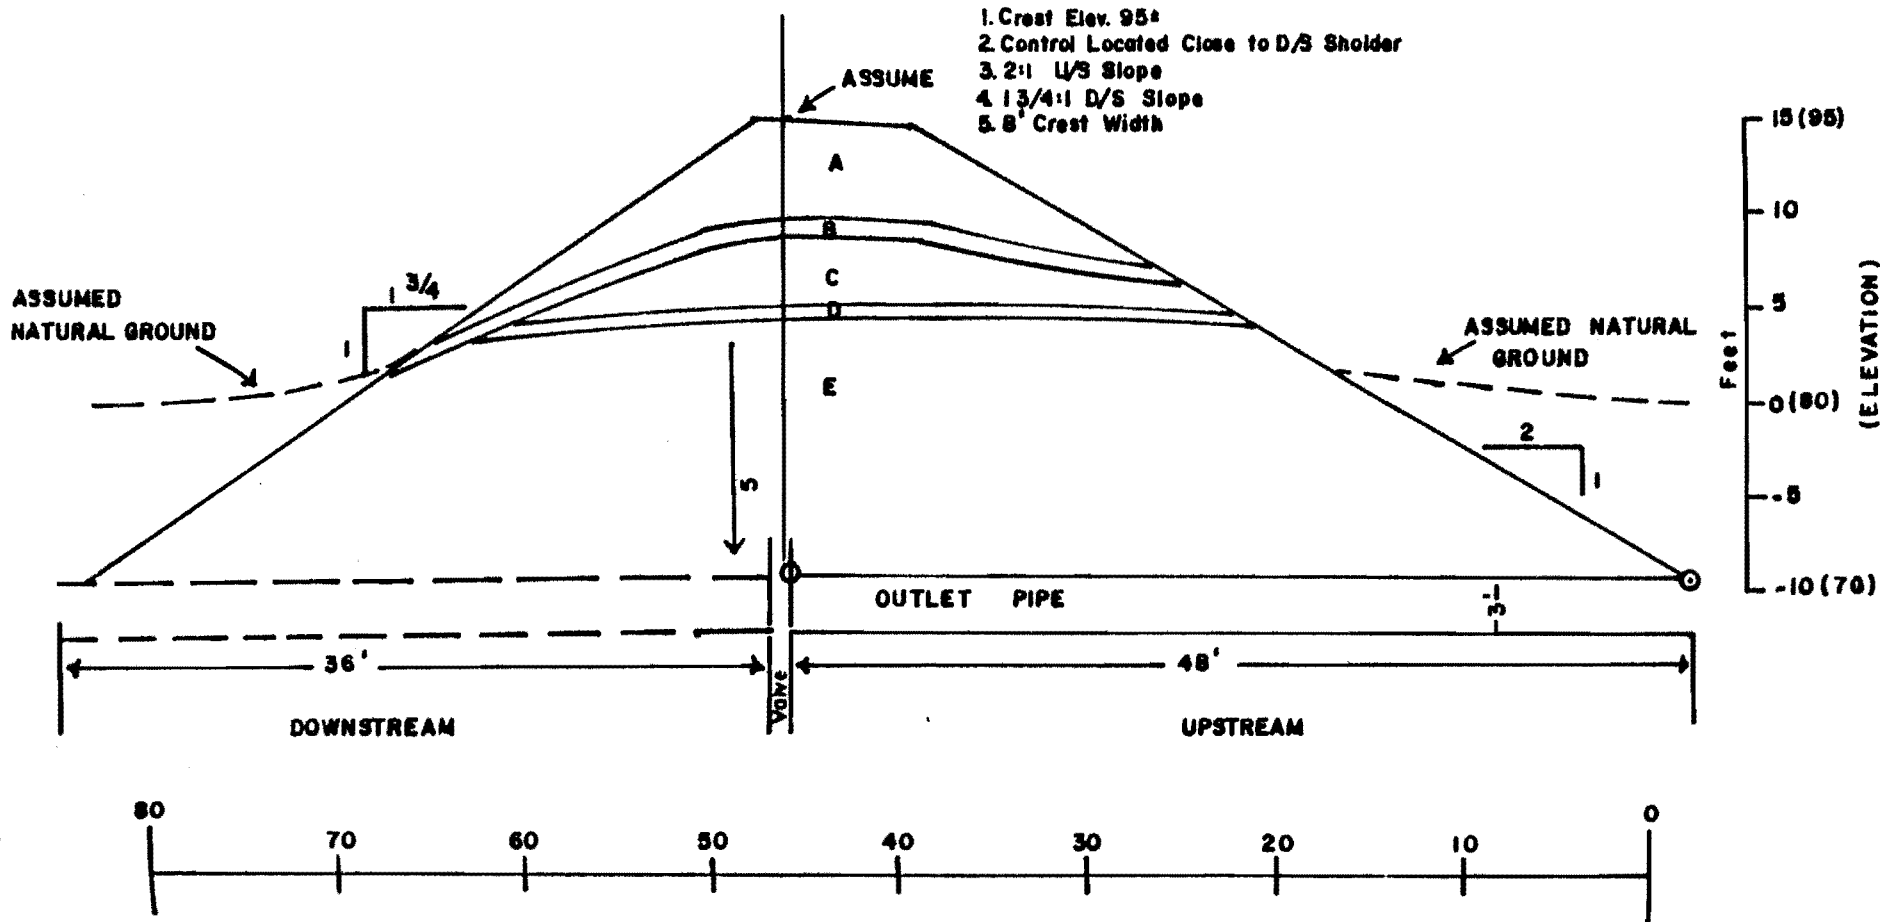
FIGURE C-3

Along Outlet Pipe
 (Assumed)
