INVESTIGATION OF THE CAUSE OF QUAIL CREEK DIKE FAILURE

Report of Independent Review Team

March 7, 1989

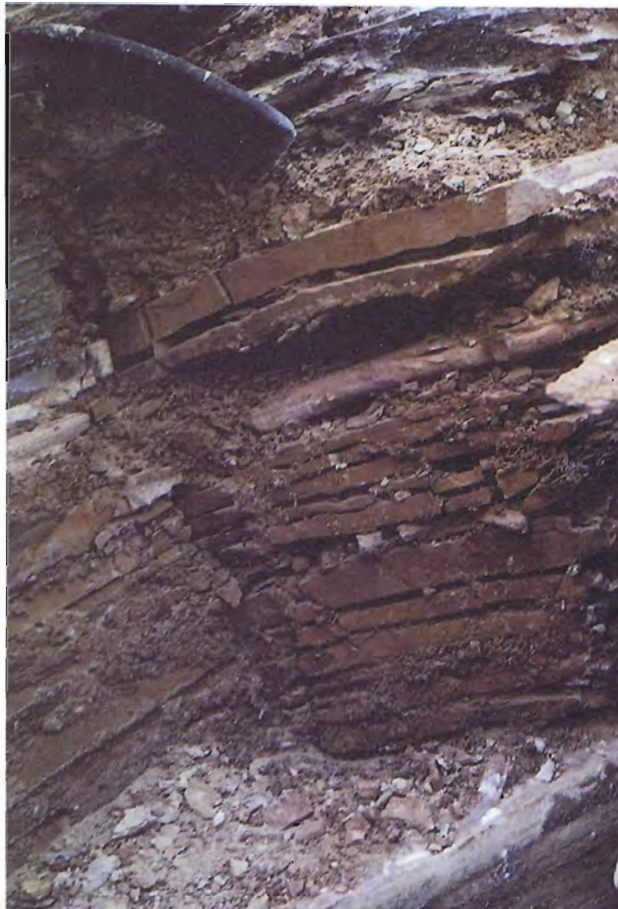
6. Weathered gypsiferous siltstone with open bedding planes; south wall of key trench, station 3 + 16, 10 feet below surface. (12-16-83)

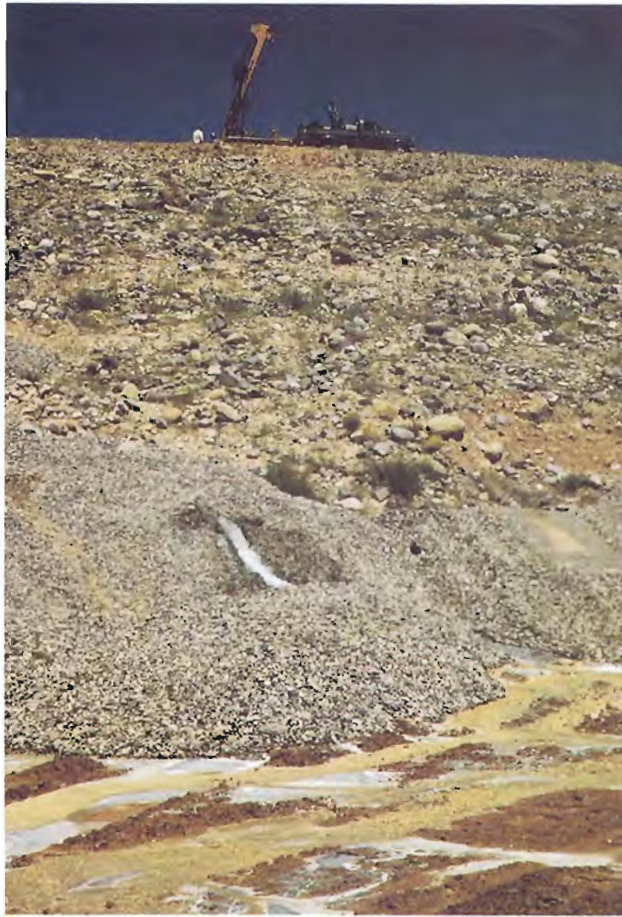
11. Sewer rock dumped on spring at toe of dike, somewhere between 7 + 00 and 8 + 00. (8-3-87)

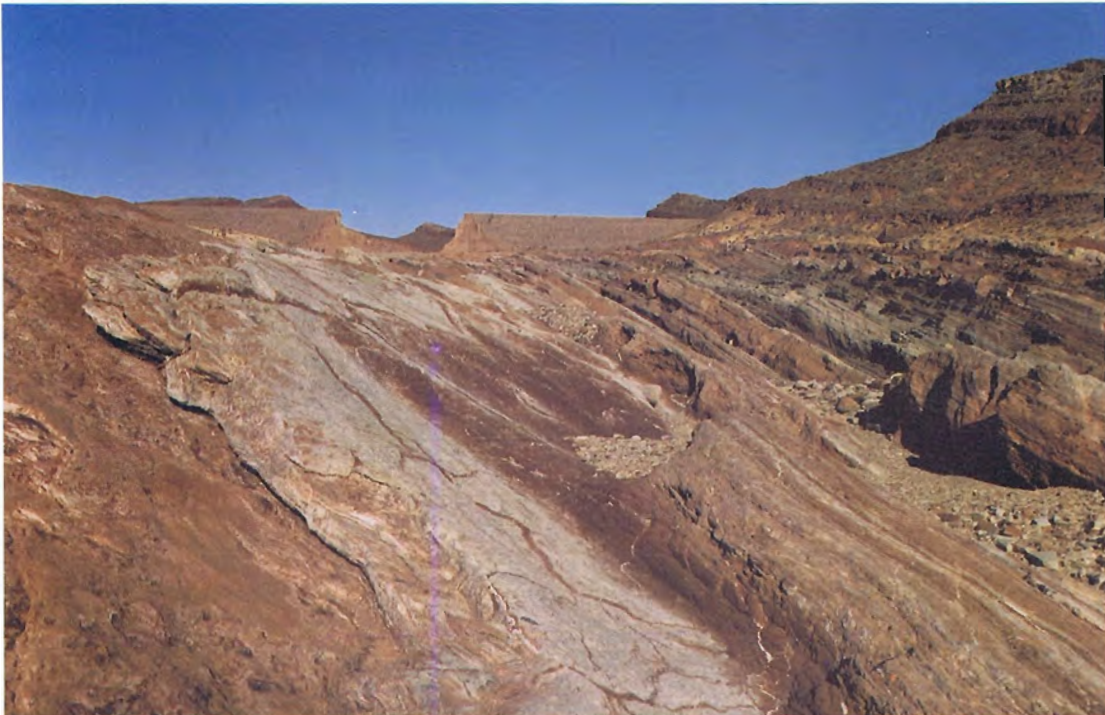
12. Breach from downstream at distance.

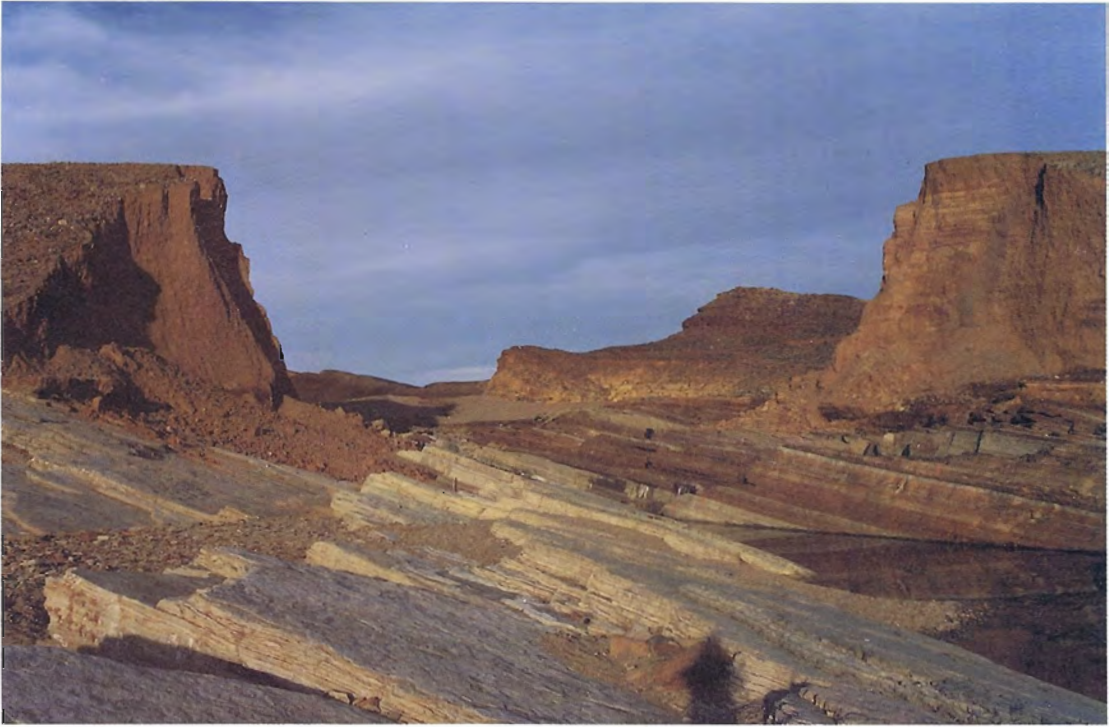
13. Breach from downstream.

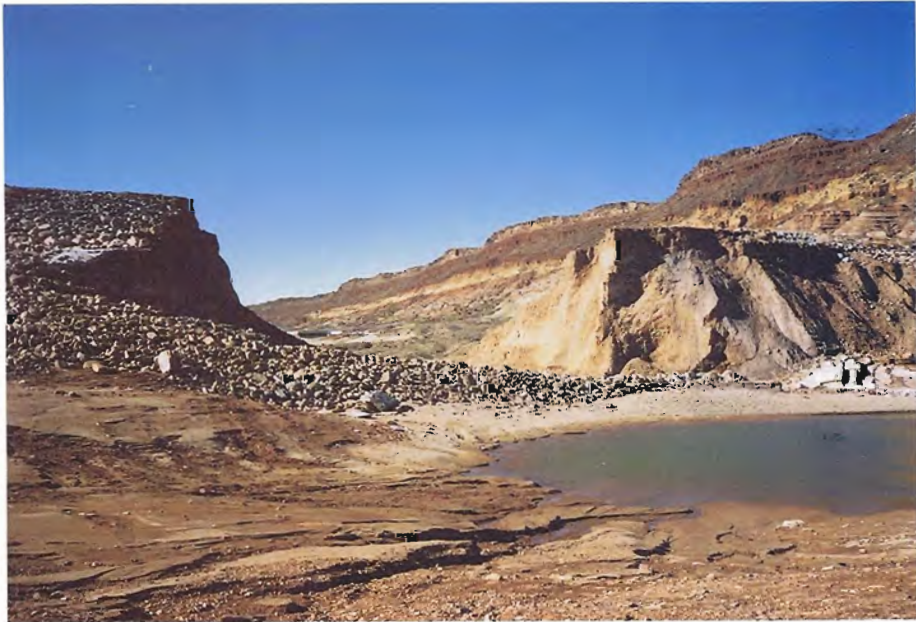
14. Breach from upstream.

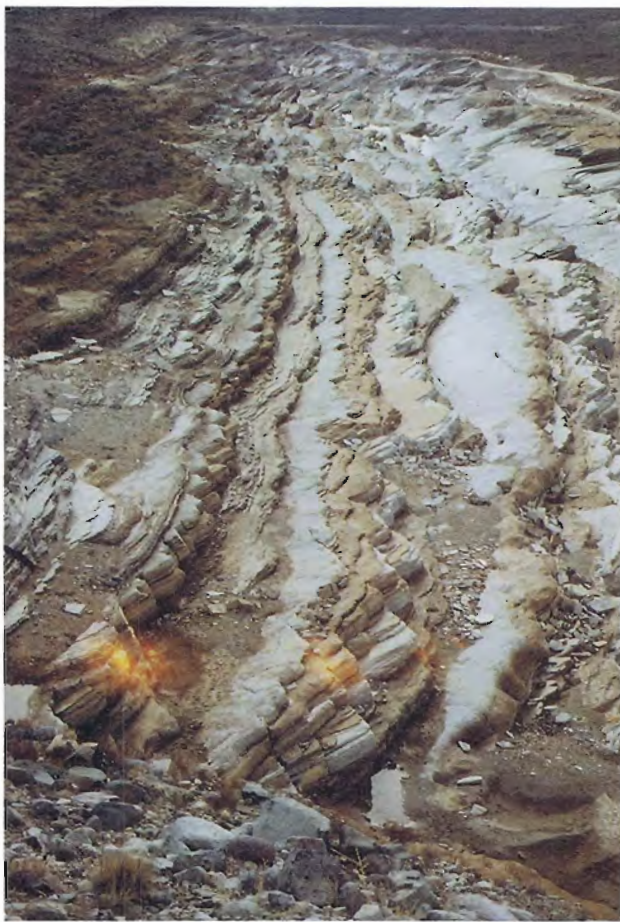
15. Erosion downstream of dam showing dip of beds into left abutment.

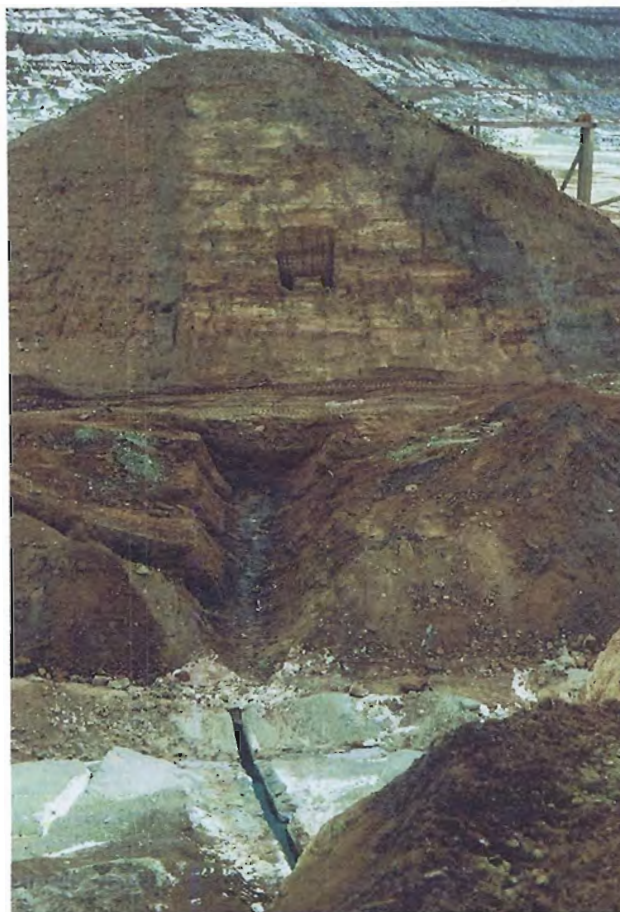
16. Right abutment of breach after excavation of the cutoff trench.

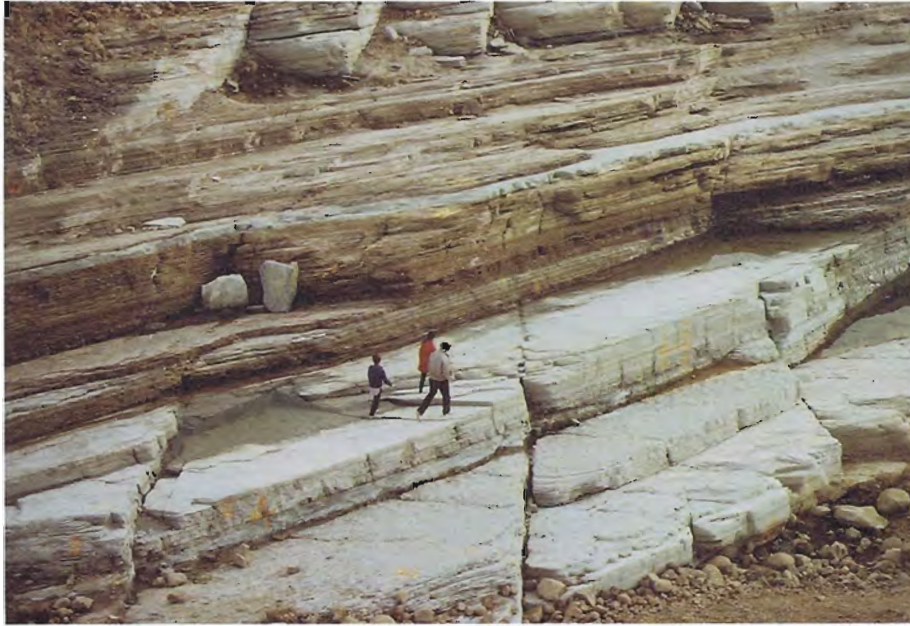
17. Major joint system in units 4 & 5 at site, North 20 degrees West set trends up and down and North 29 degrees East set trends across picture.

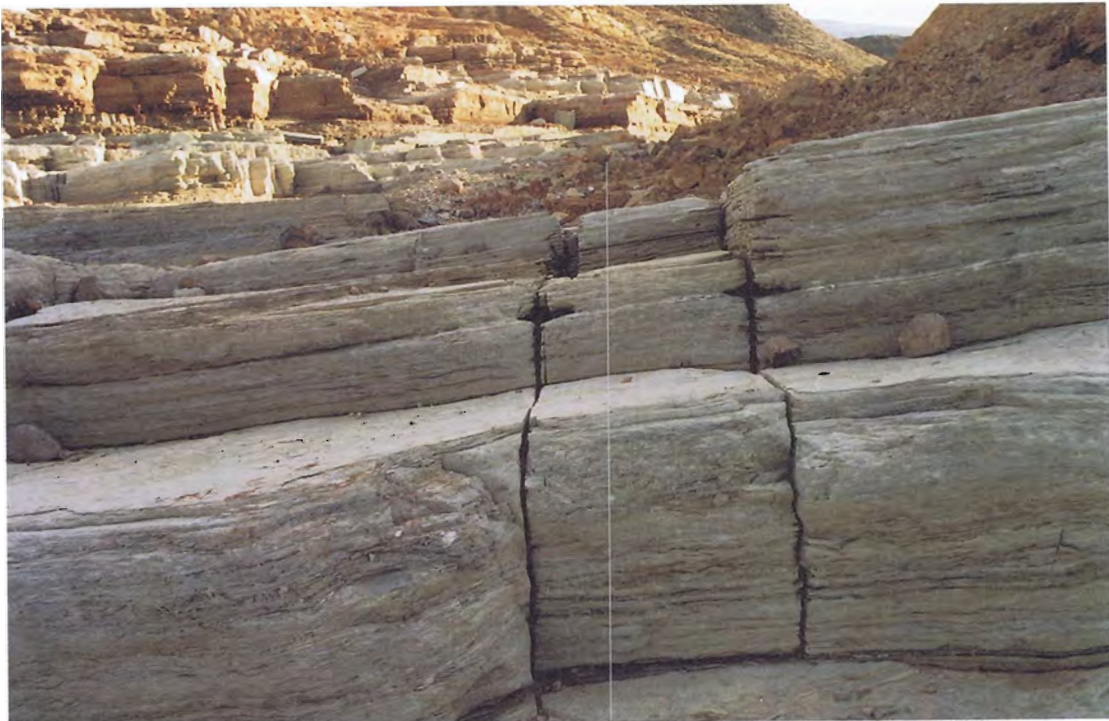
18. Jointing in breach section.

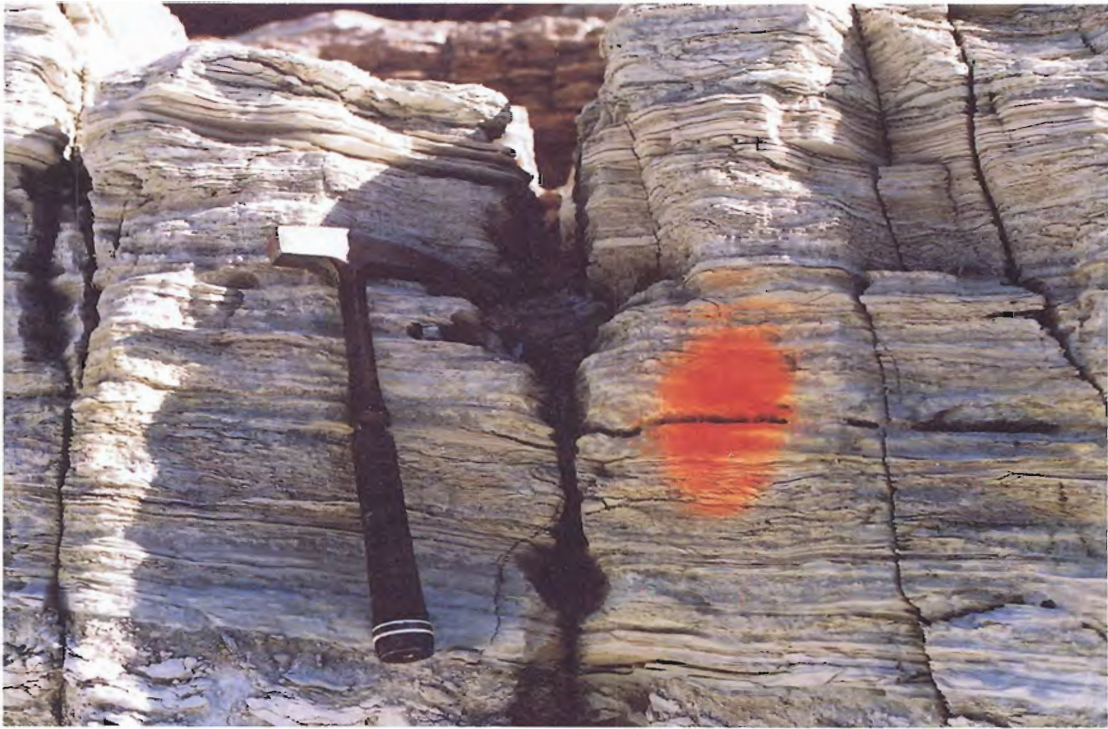
19. Close-up of erosion and solutioning along joints.

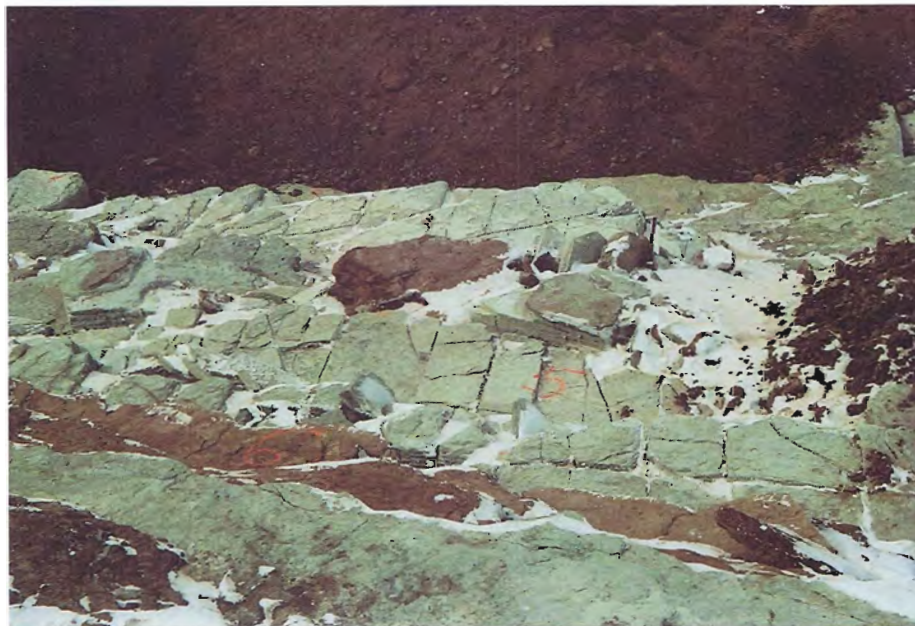
20. Joint pattern in breach area.

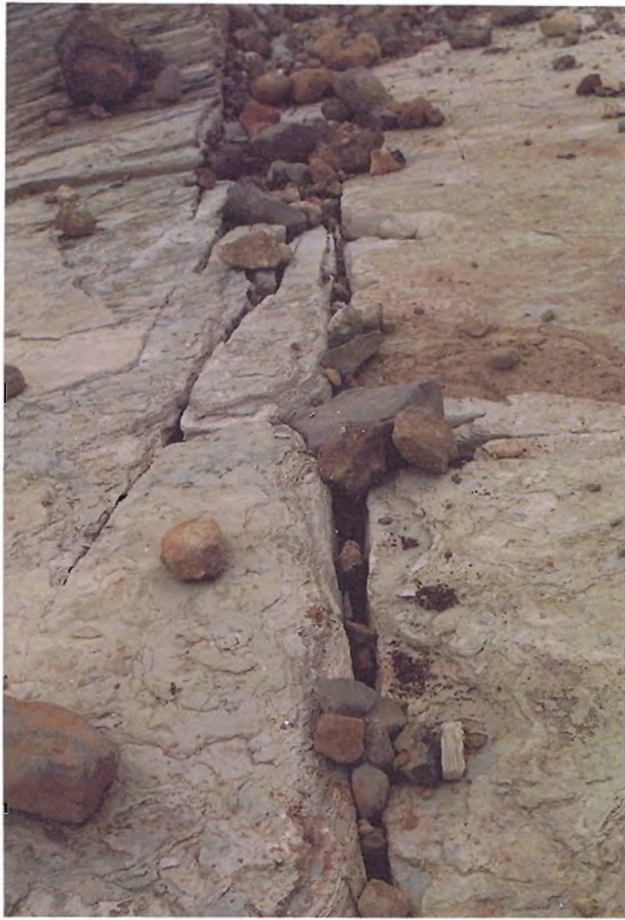
21. Joint exposed in breach section.

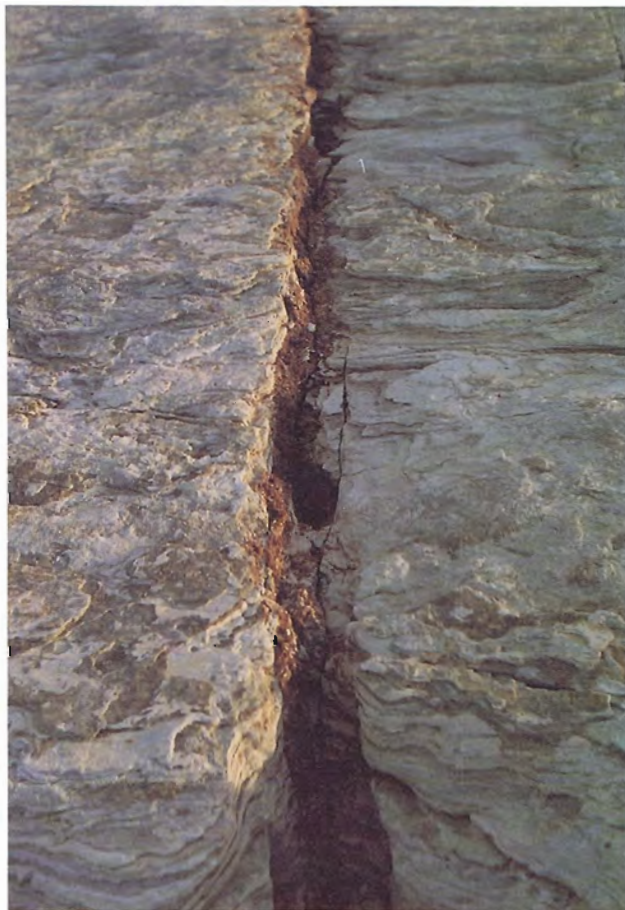
22. Joint with filling downstream of breach.

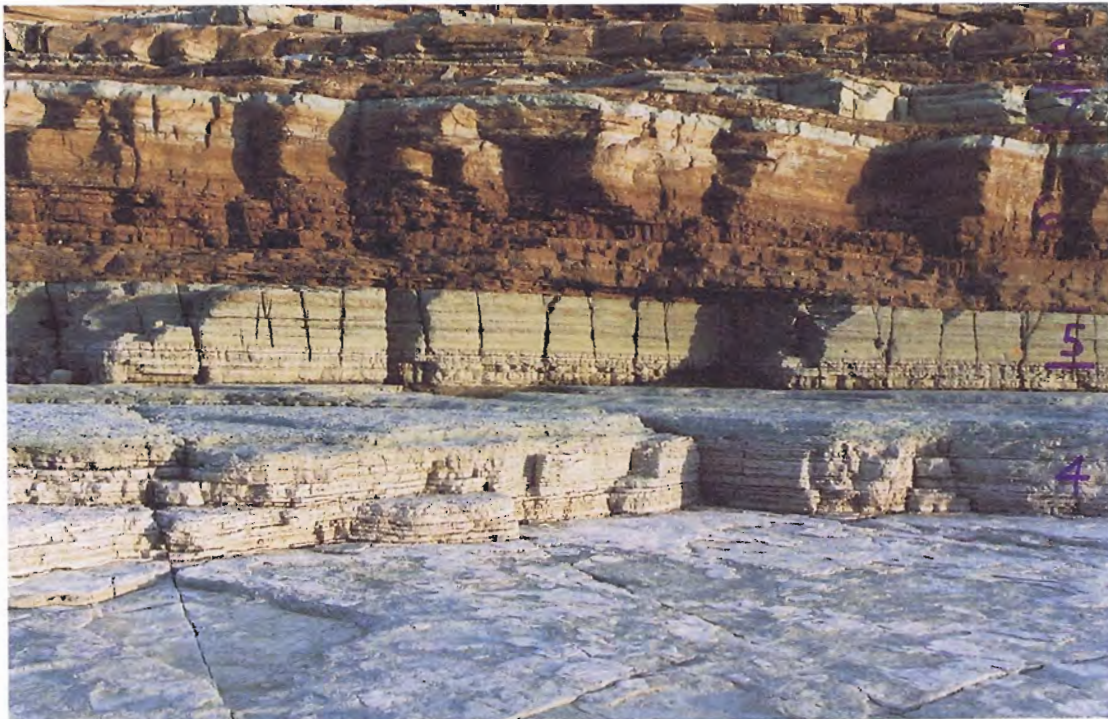
23. Bedded sequence of Shnabkaib member at dike. Bedded units indicated on photo.

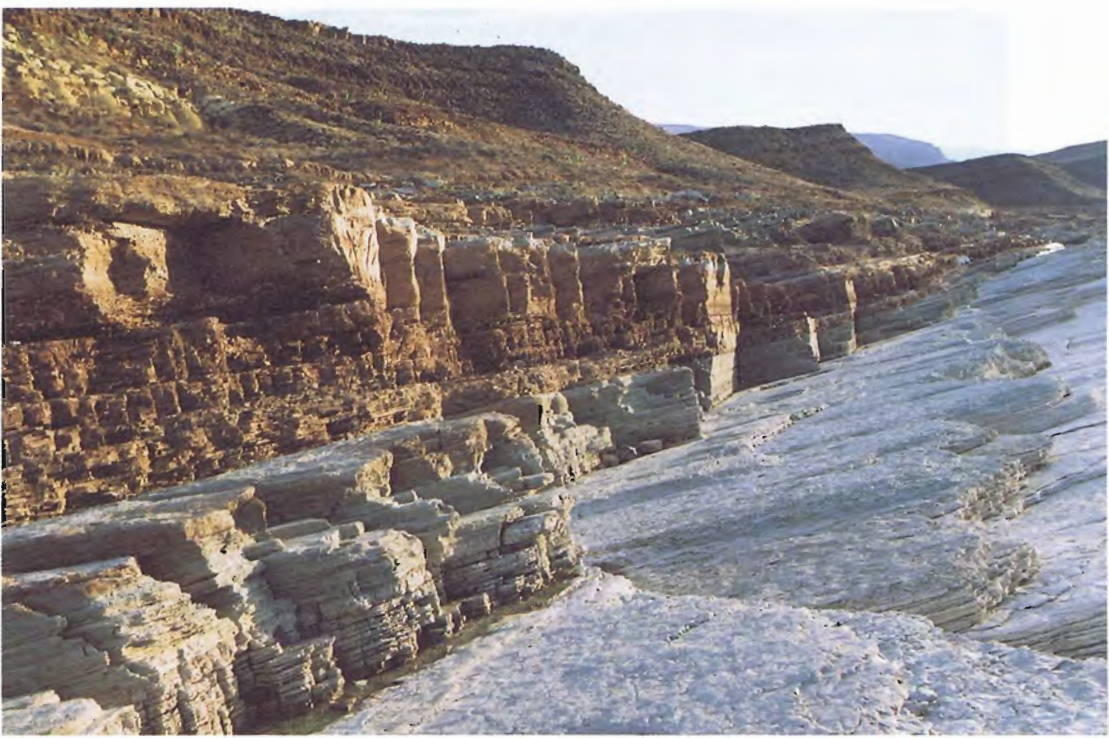
24. View of bedding looking downstream from breach section.

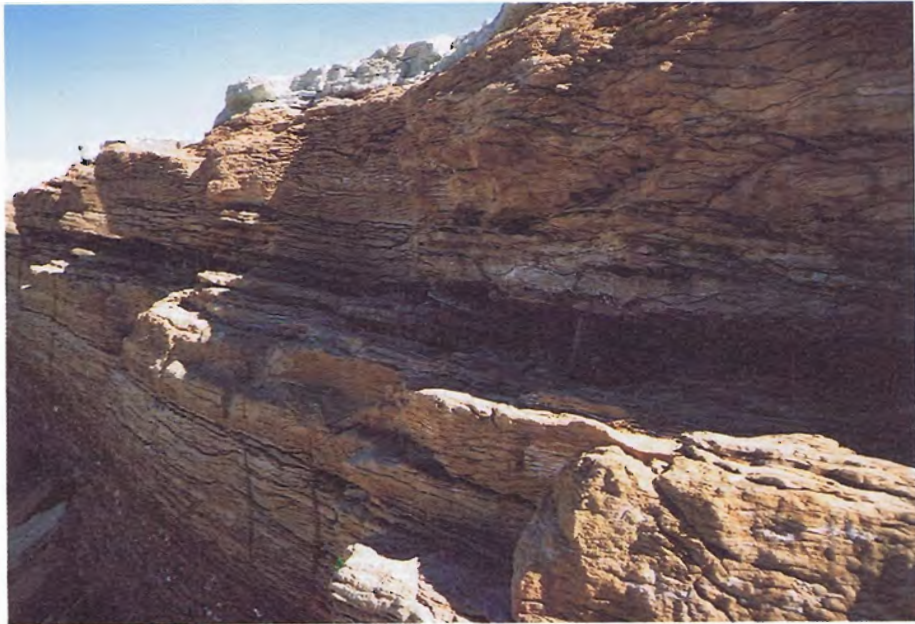
25. Erosion along bedding in breach area.

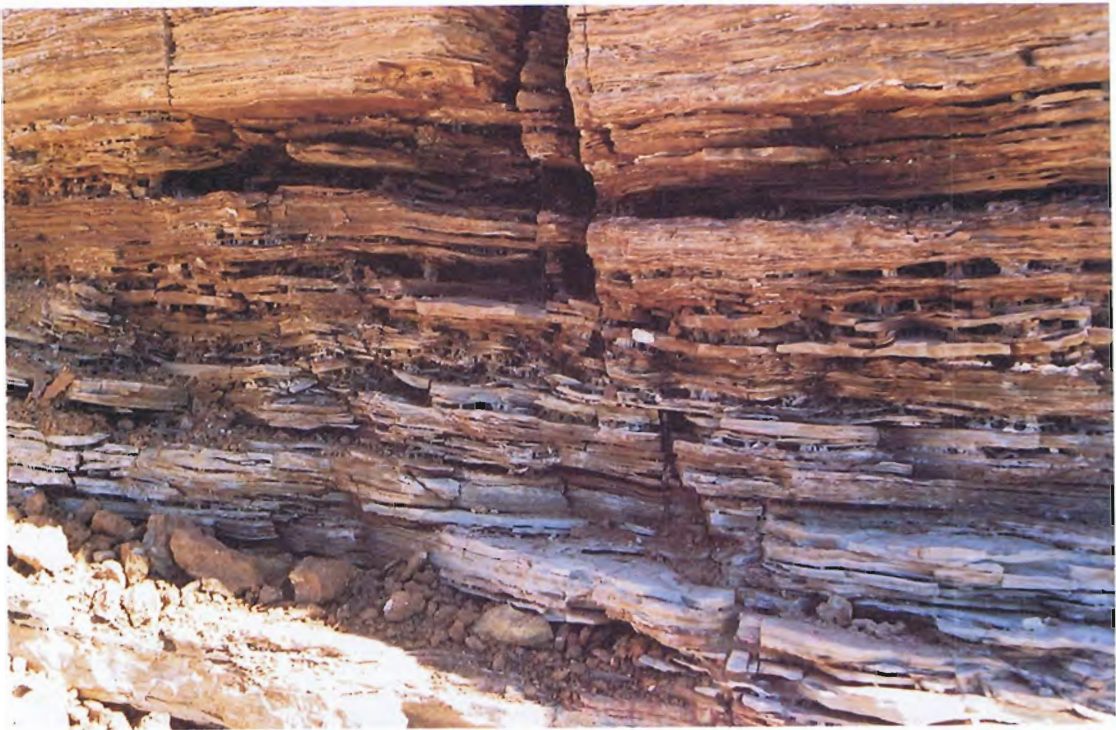
27. View of openings in bedding in breach area.

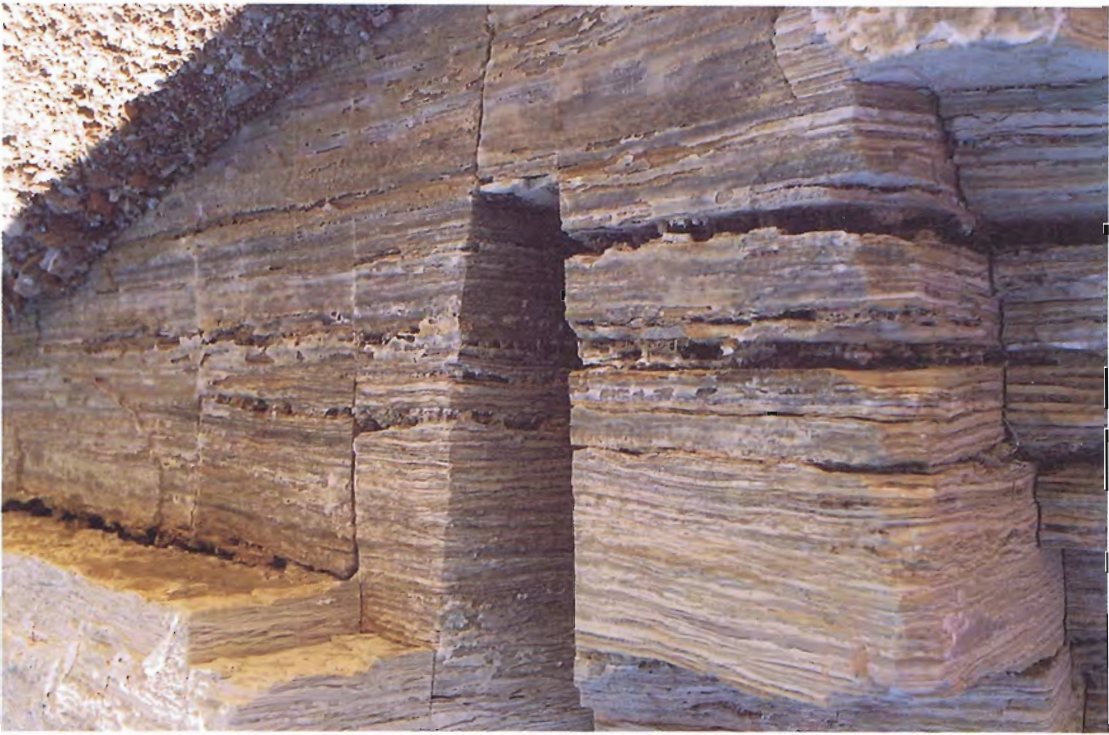
28. View of openings in bedding in breach area.

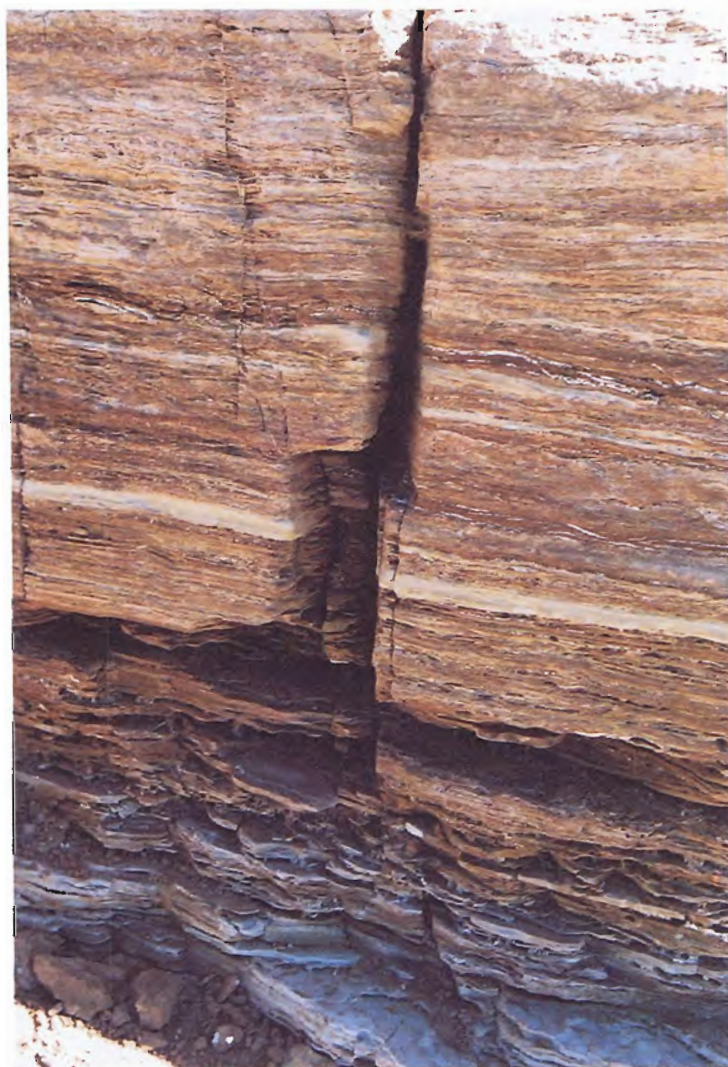
29. View of openings in bedding in breach area.

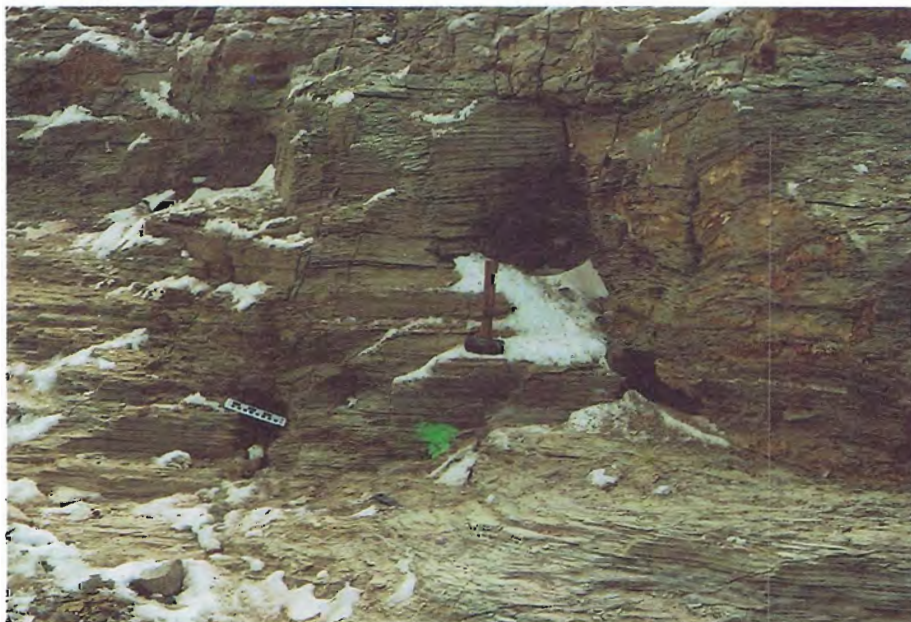
30. View of openings in bedding in breach area.

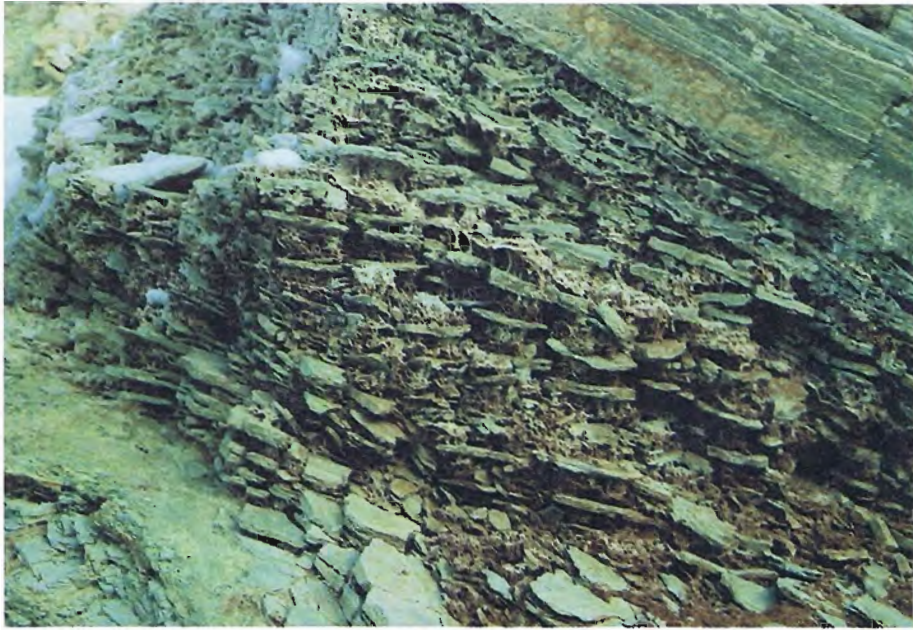
31. View of geologically old solution channels in upstream portion of the breach.

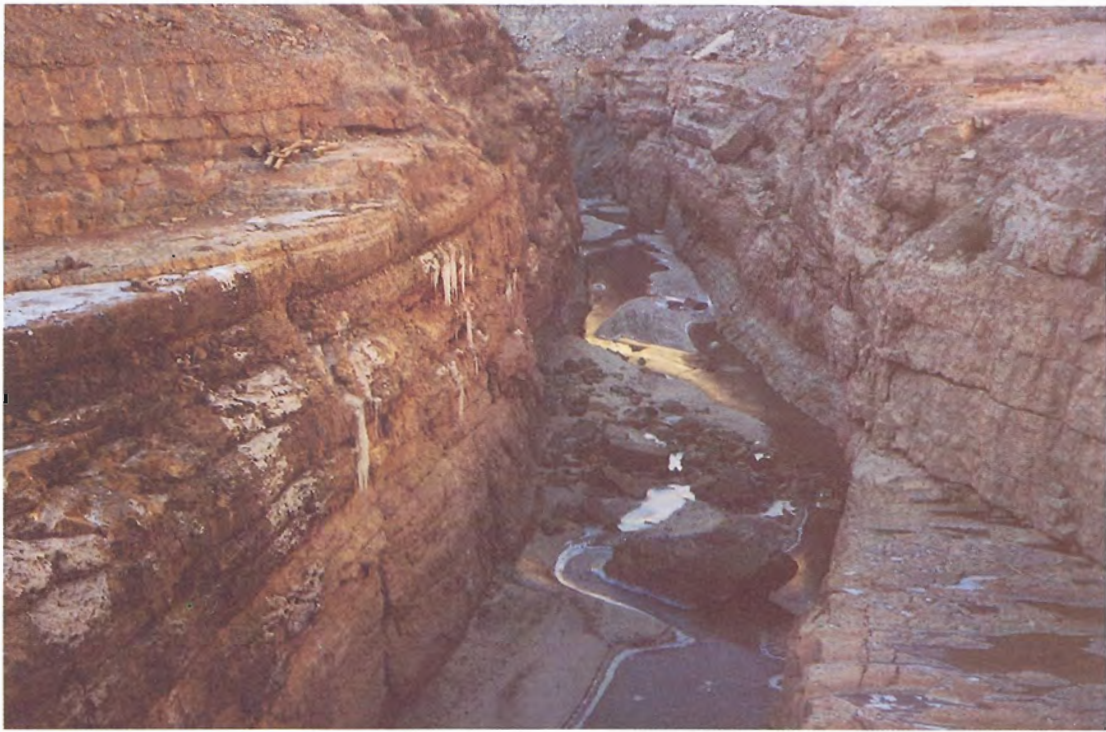
32b. Expanded and differentially eroded beds with high gypsum content.

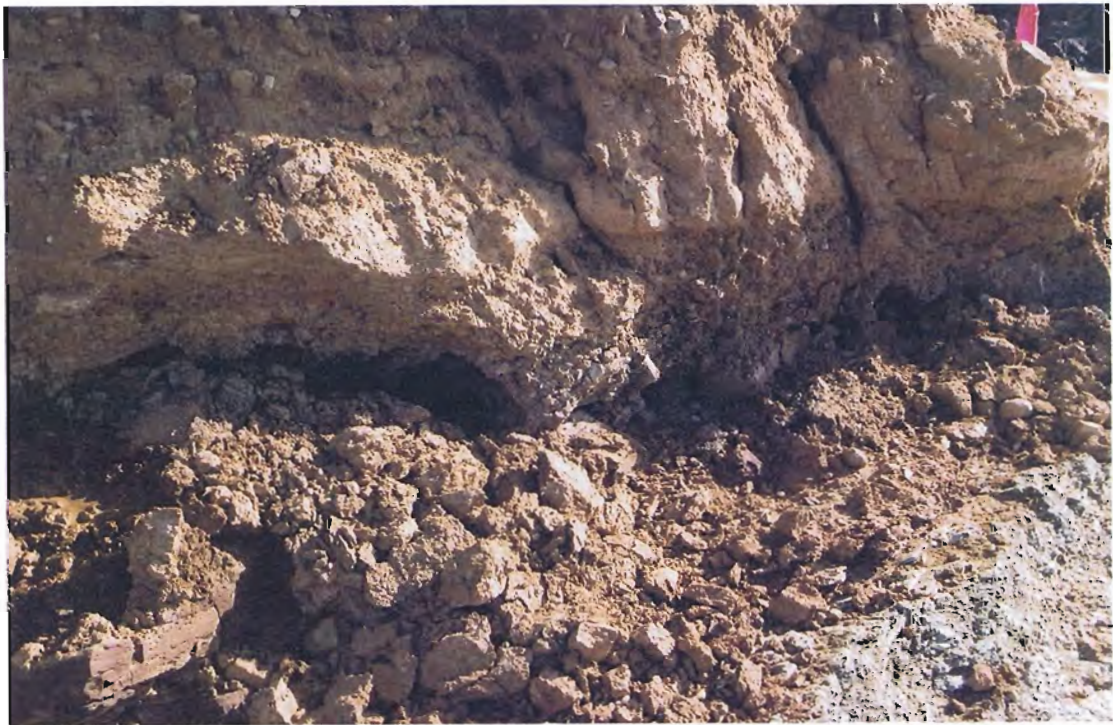
35. Close-up of downstream channels.

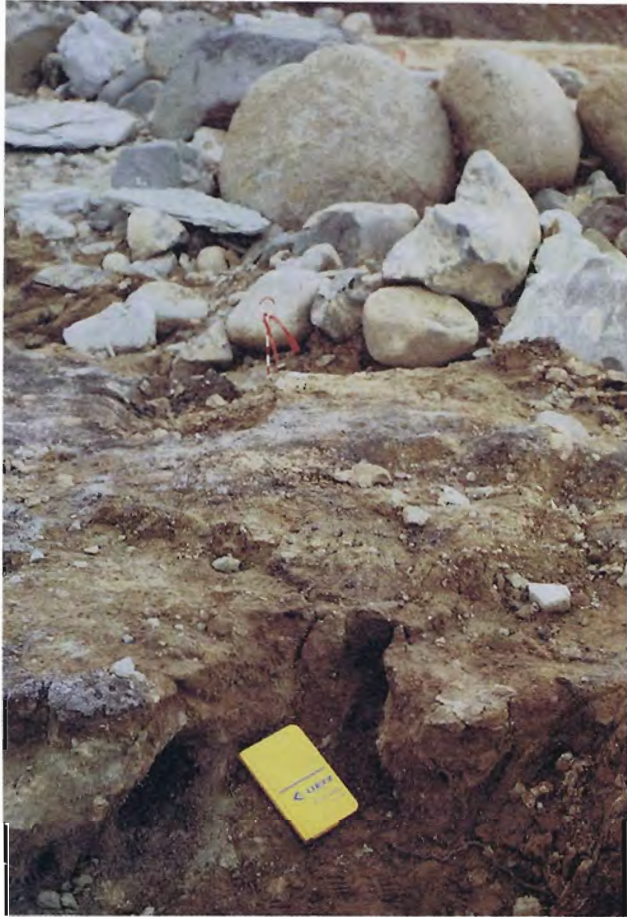
36. Close-up of downstream channels.

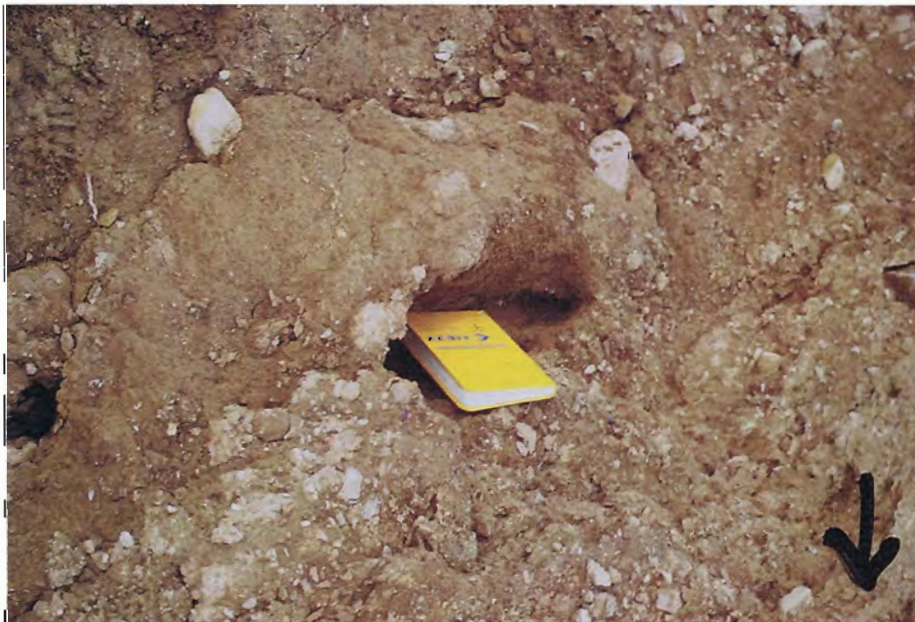
37. View of erosion channels upstream near station 5 + 50.

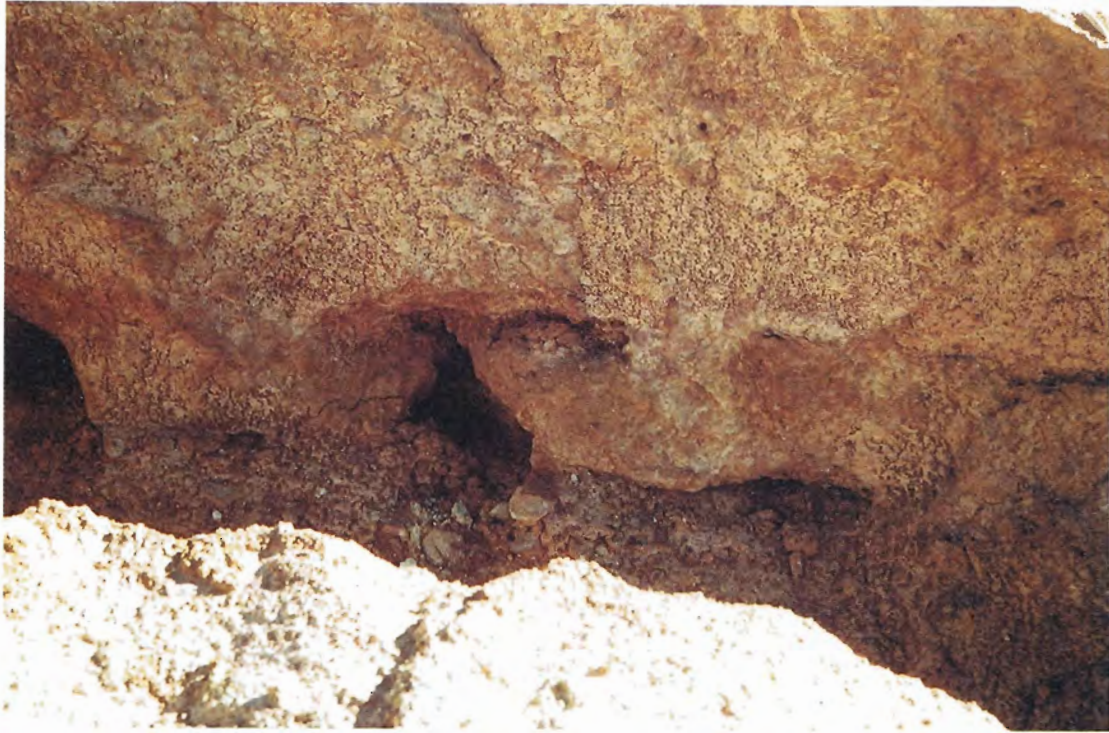
38. View of erosion channels upstream near station 5 + 50.

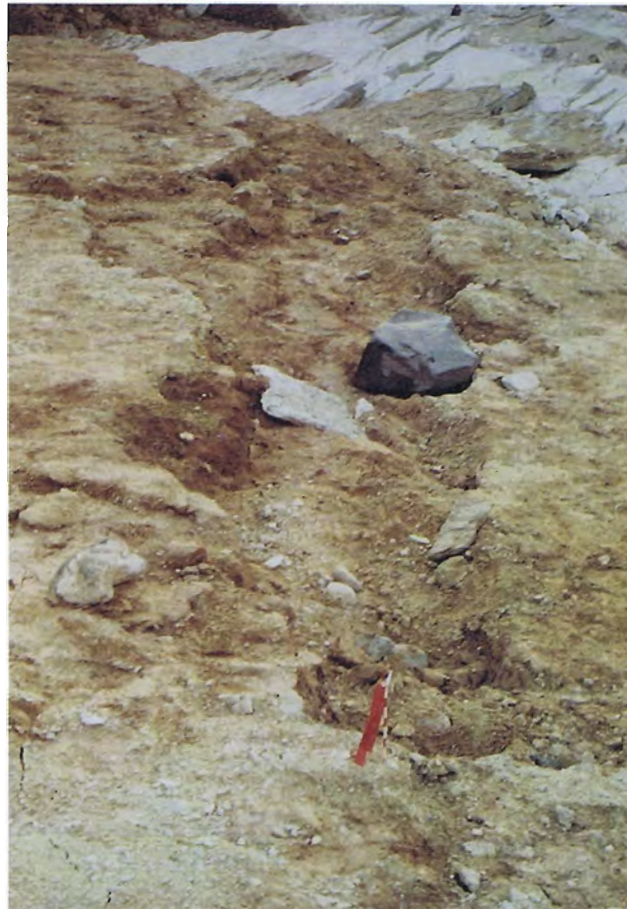
39. View of erosion channels upstream near station 5+50.

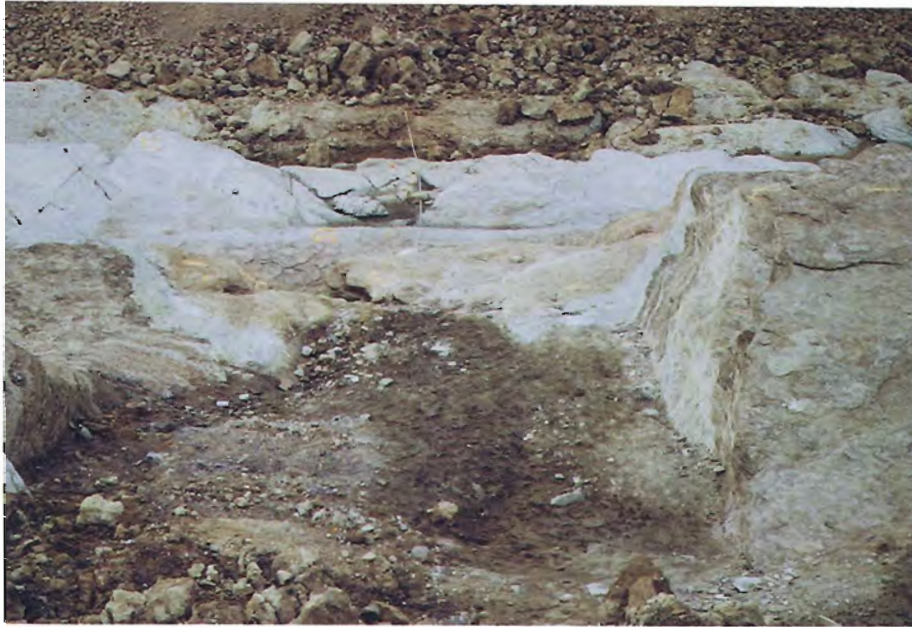
40. View of depression in remaining fill, upstream shell area.

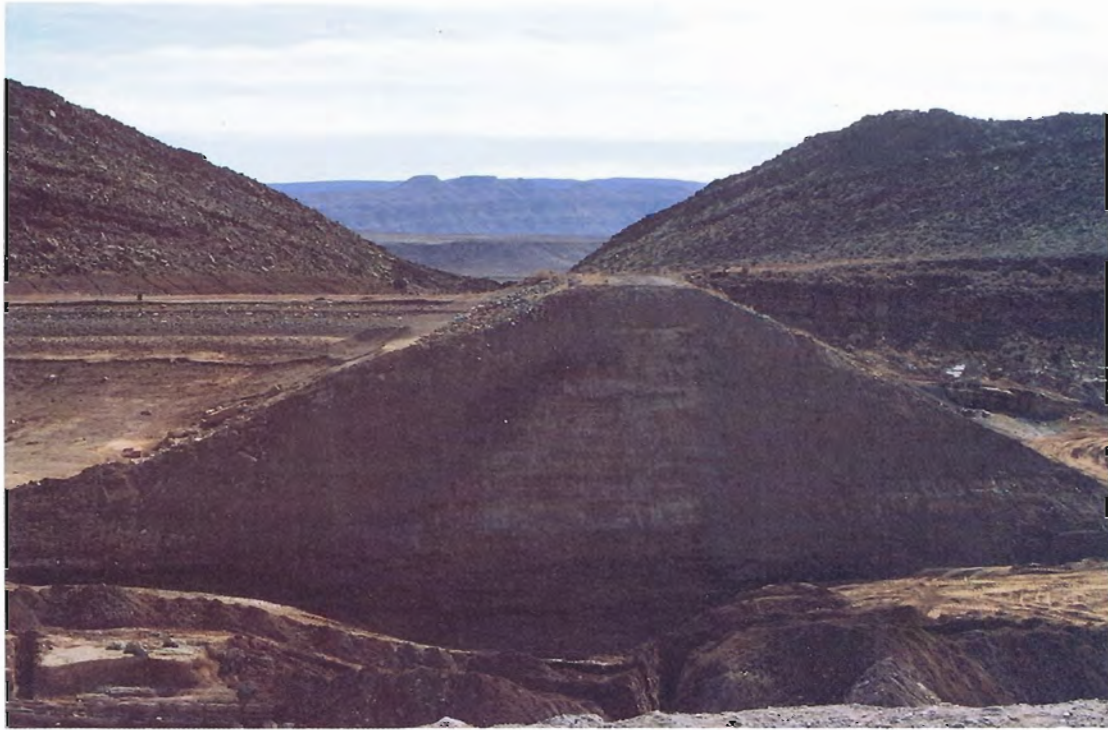
41. View of cutoff trench exposed in breach section.
Zone II embankment was present at base of cutoff trench.

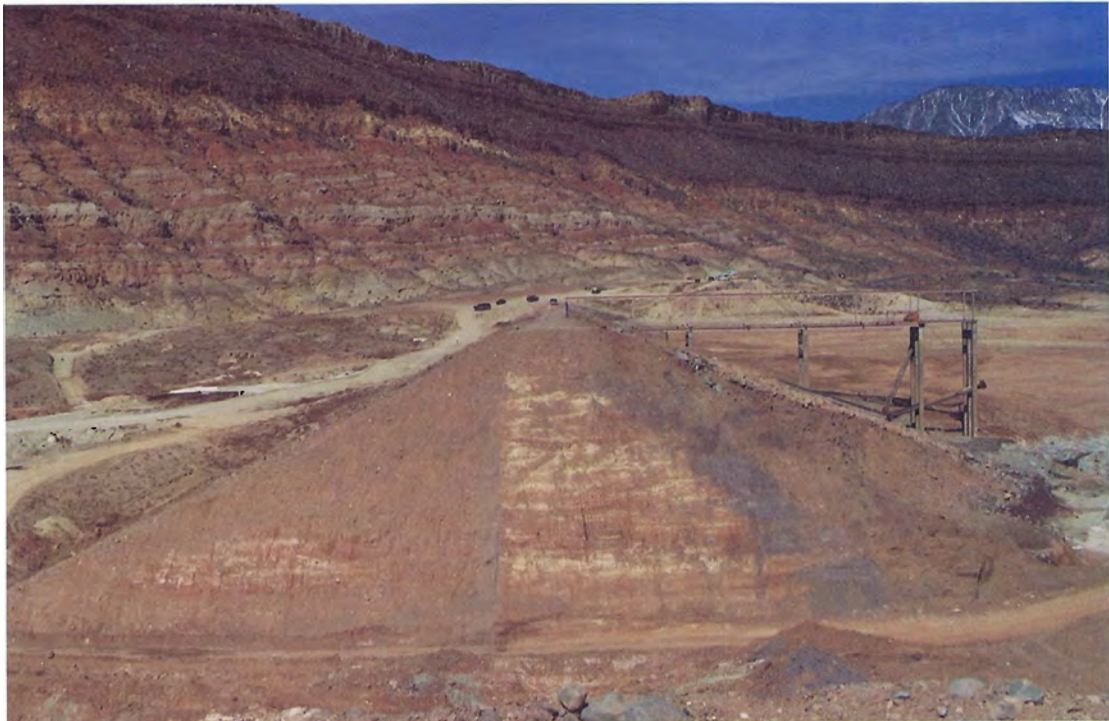
42. View of left embankment showing zoning remaining following sloping of breach side.

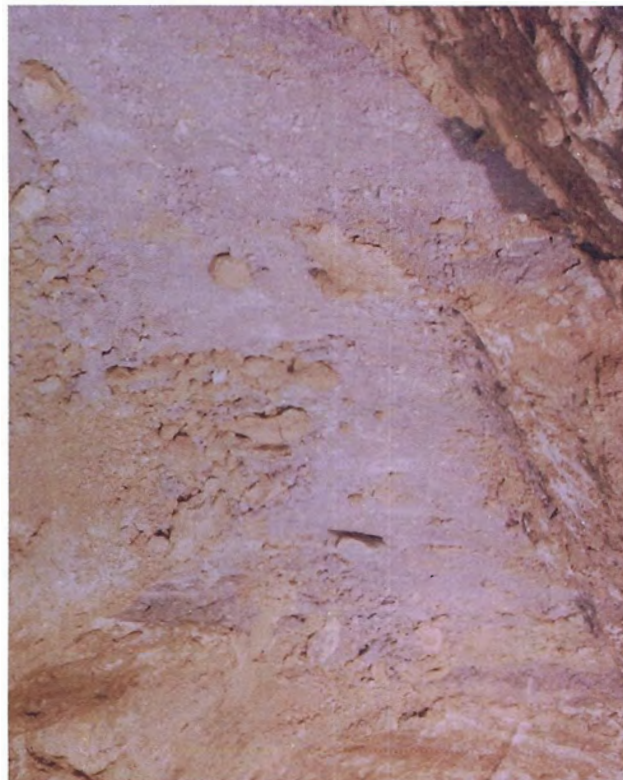
47. Drain pipe encountered in exploratory trench at original downstream toe of dam.

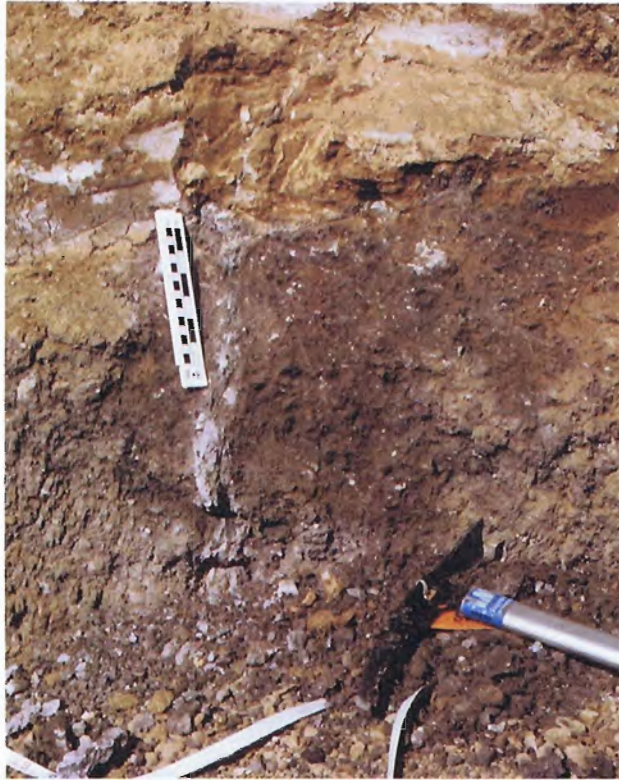
50. Grout contamination in Zone I materials on right side of breach.

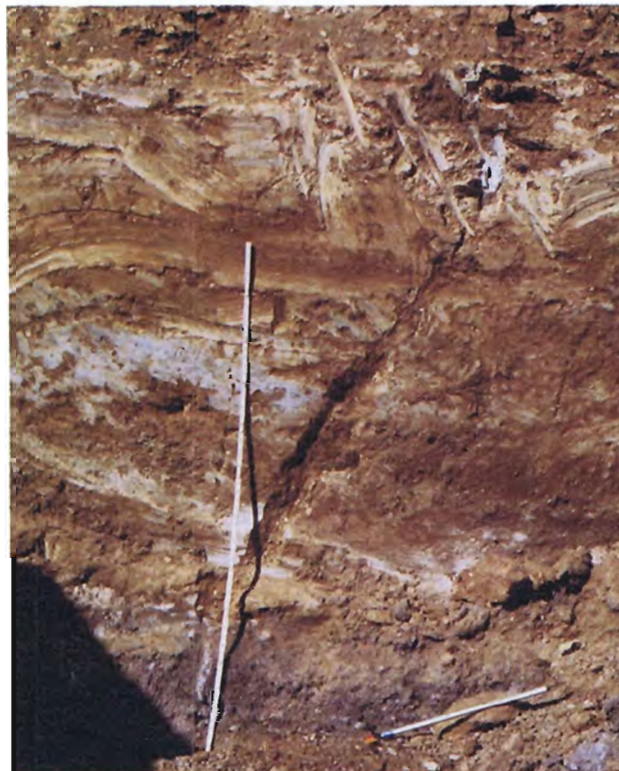
51. Grout extending through Zone I and Zone II on right side of breach at centerline of cutoff trench.

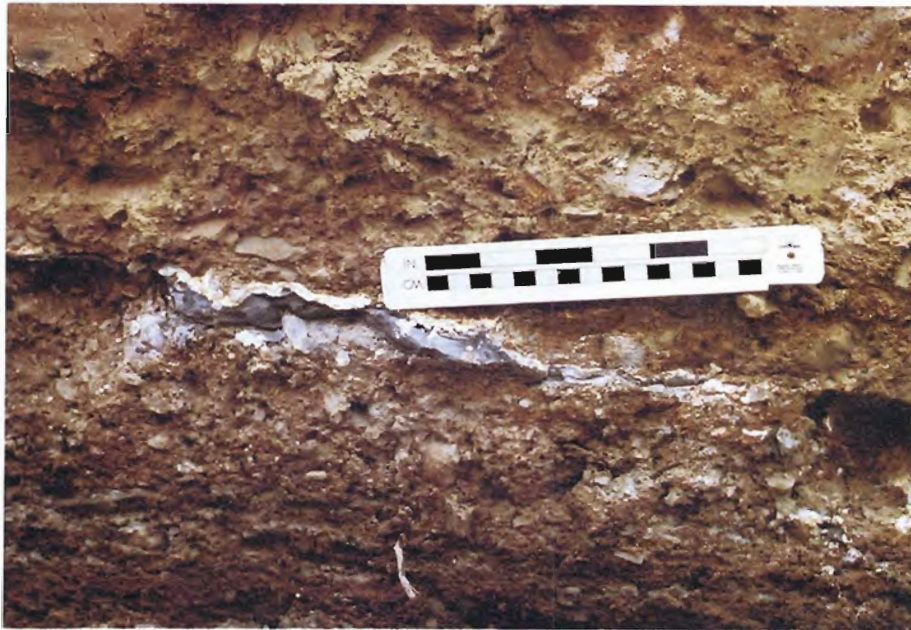
52. Grout intrusion through entire depth of cutoff trench on right side of breach.
