INVESTIGATION OF THE CAUSE OF QUAIL CREEK DIKE FAILURE

Report of Independent Review Team

March 7, 1989

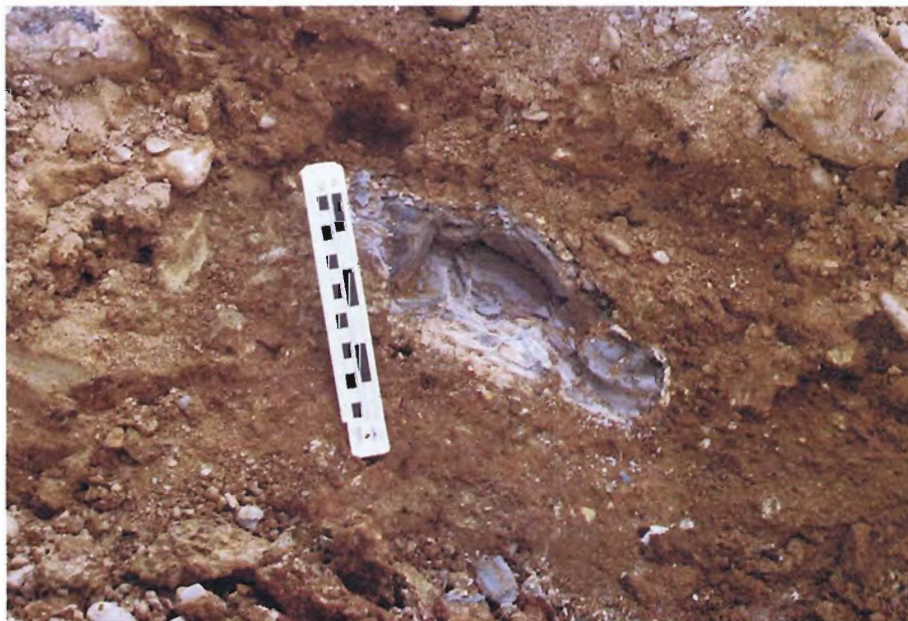
53. Grout intrusion between unit 1 and Zone I fill.

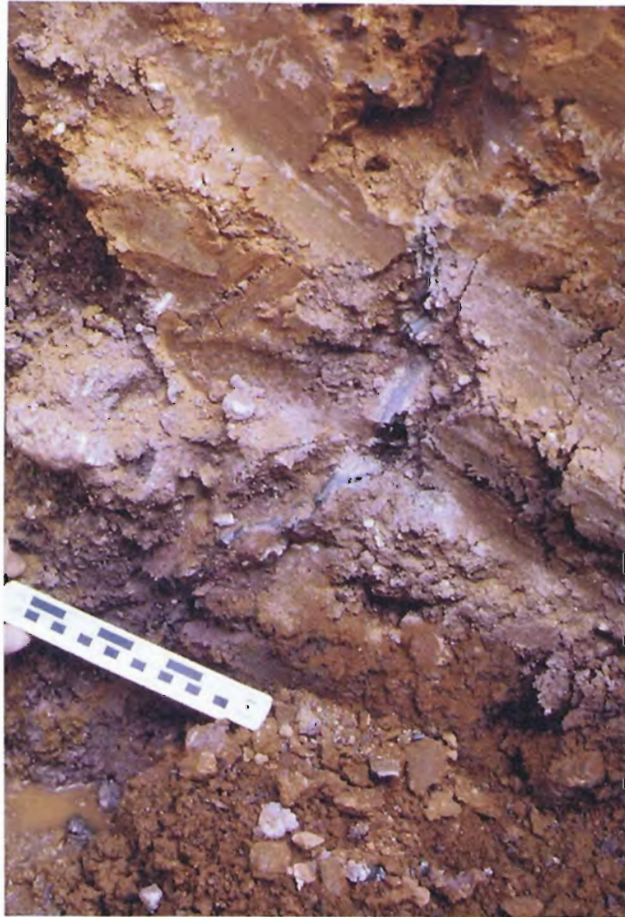
54. Grout plug in Zone I on right side of breach.

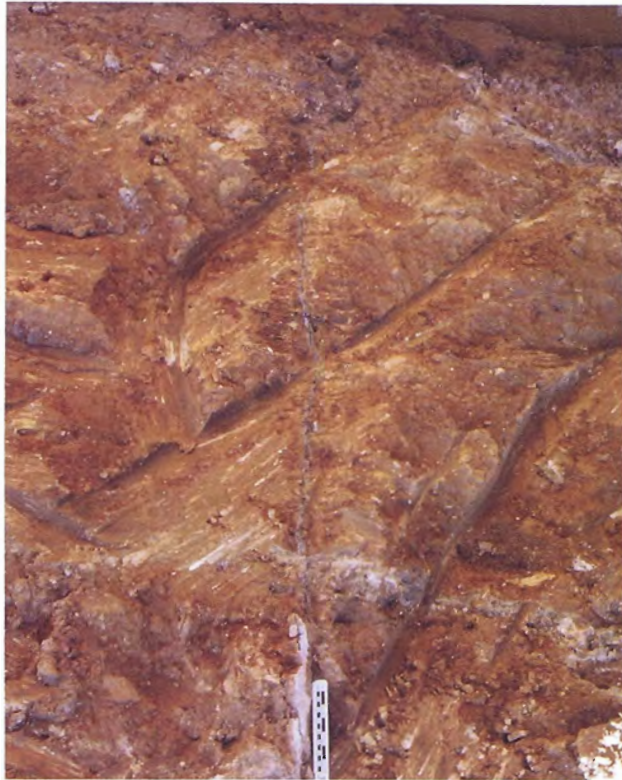
56. Grout intrusion into Zone I
in cutoff trench on left side of breach.

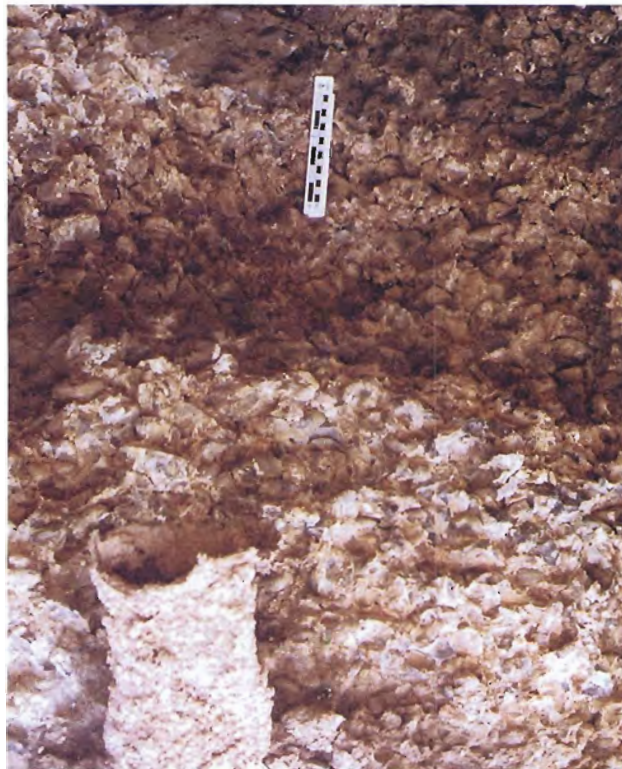
57. Grout-filled seam through Zone I on left side of breach.

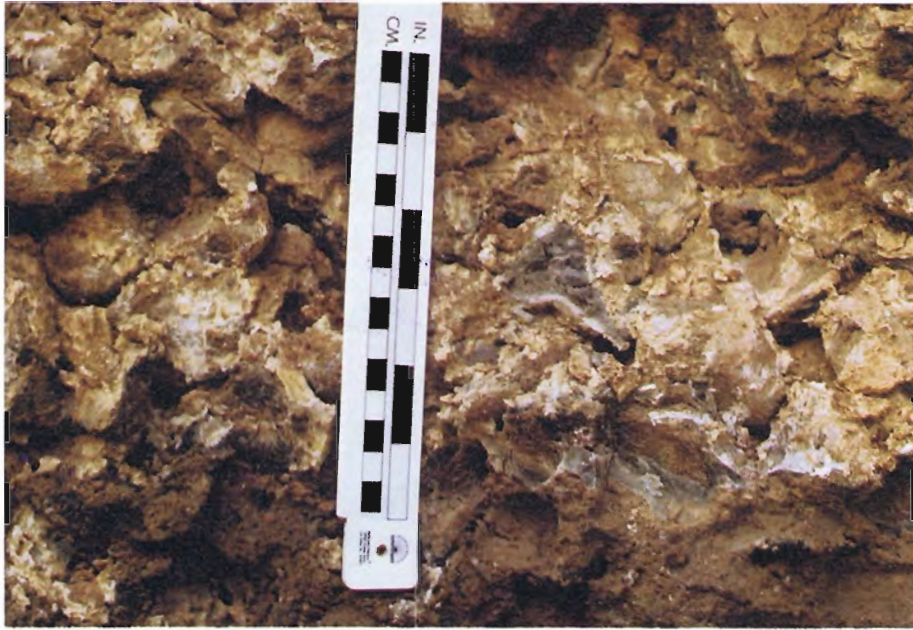
58. Grout-filled toe drains.

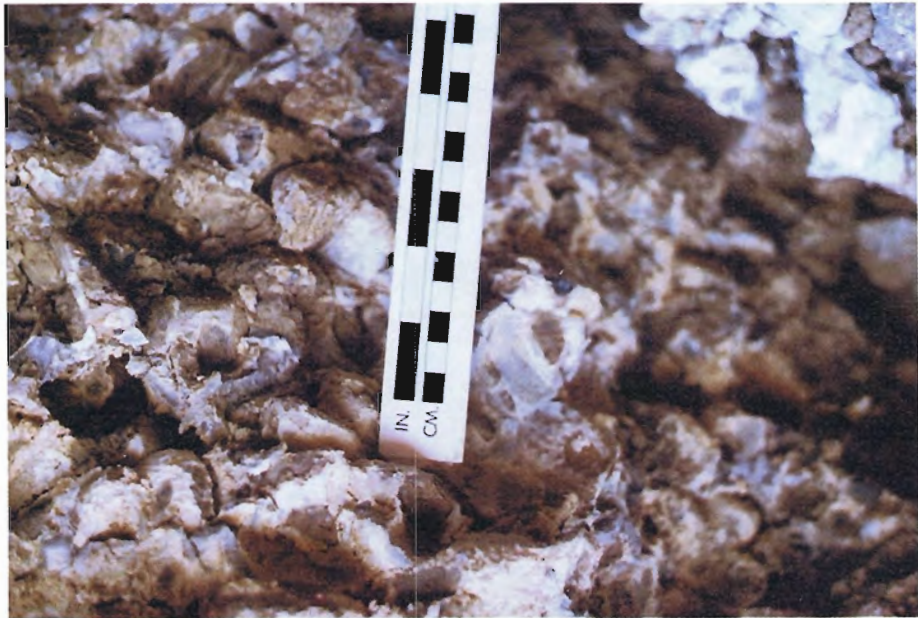
59. Grout-filled toe drains.
