# South Carolina Dam Failure Assessment and Advisement

DR-SC-4241

FEMA P-1801 / December 2016

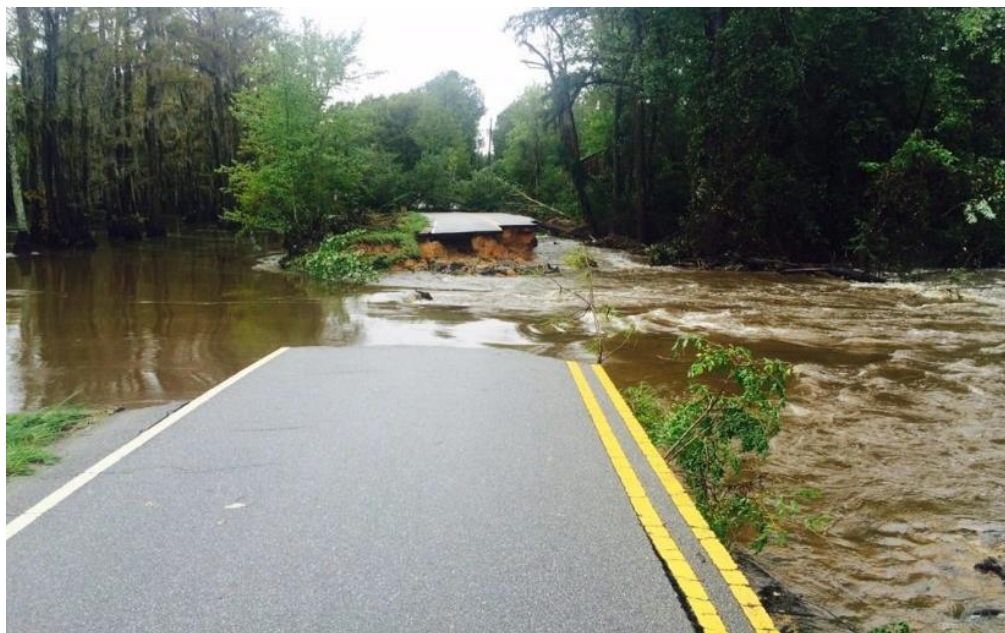
Well before sunrise on Sunday, October 4, record and deadly rains expanded into Clarendon, Orangeburg, Williamsburg, Florence, Sumter, Kershaw, Richland and Lexington counties with rainfalls of 10 inches or higher. An automated Forestry Service rain gage near Santee in Clarendon County indicated that as of 1:44 a.m. 9.81 inches of rain had fallen over the previous 24-hours. Figure 2 below shows flooding on a roadway in Clarendon County.

*Figure 2: Clarendon County, South Carolina (Source: SC DNR Law Enforcement)*

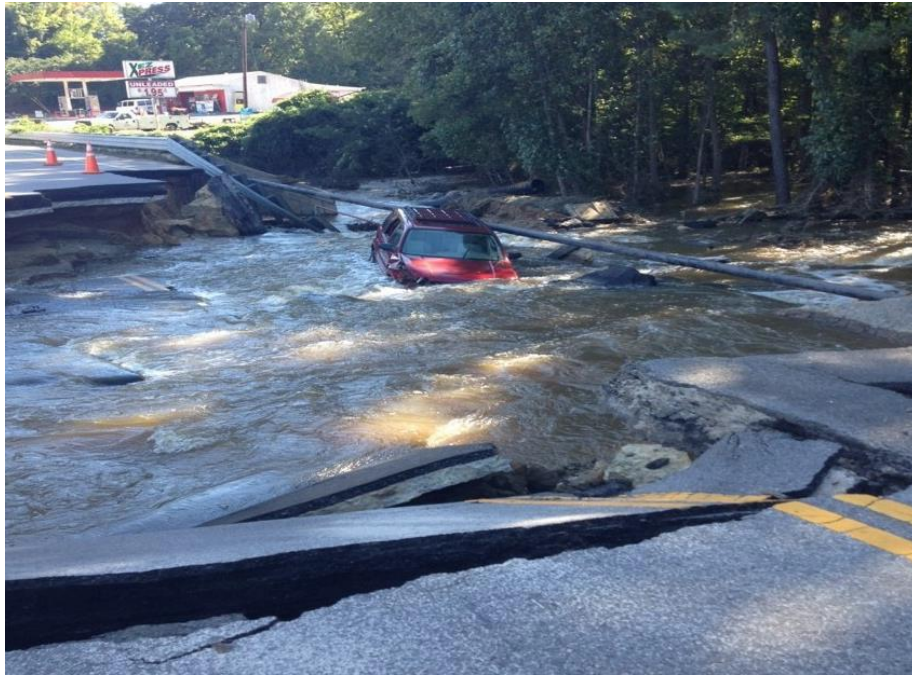
Daylight revealed overflowing roadside ditches moving into streams and creeks and rapidly filling ponds and lakes. Vehicles were swept off of Dentsville’s Decker Boulevard near the intersection of O’Neil Court, trapping occupants and requiring teams of rescue response. Hurried swift water specialists from multiple agencies performed emergency rescues throughout the morning removing homeowners from the Lake Katherine community downstream into the Garners Ferry Road business section. Flooding in Richland County can be seen in Figure 3.

Figure 3: Richland County, South Carolina (Source: SC DNR Law Enforcement)

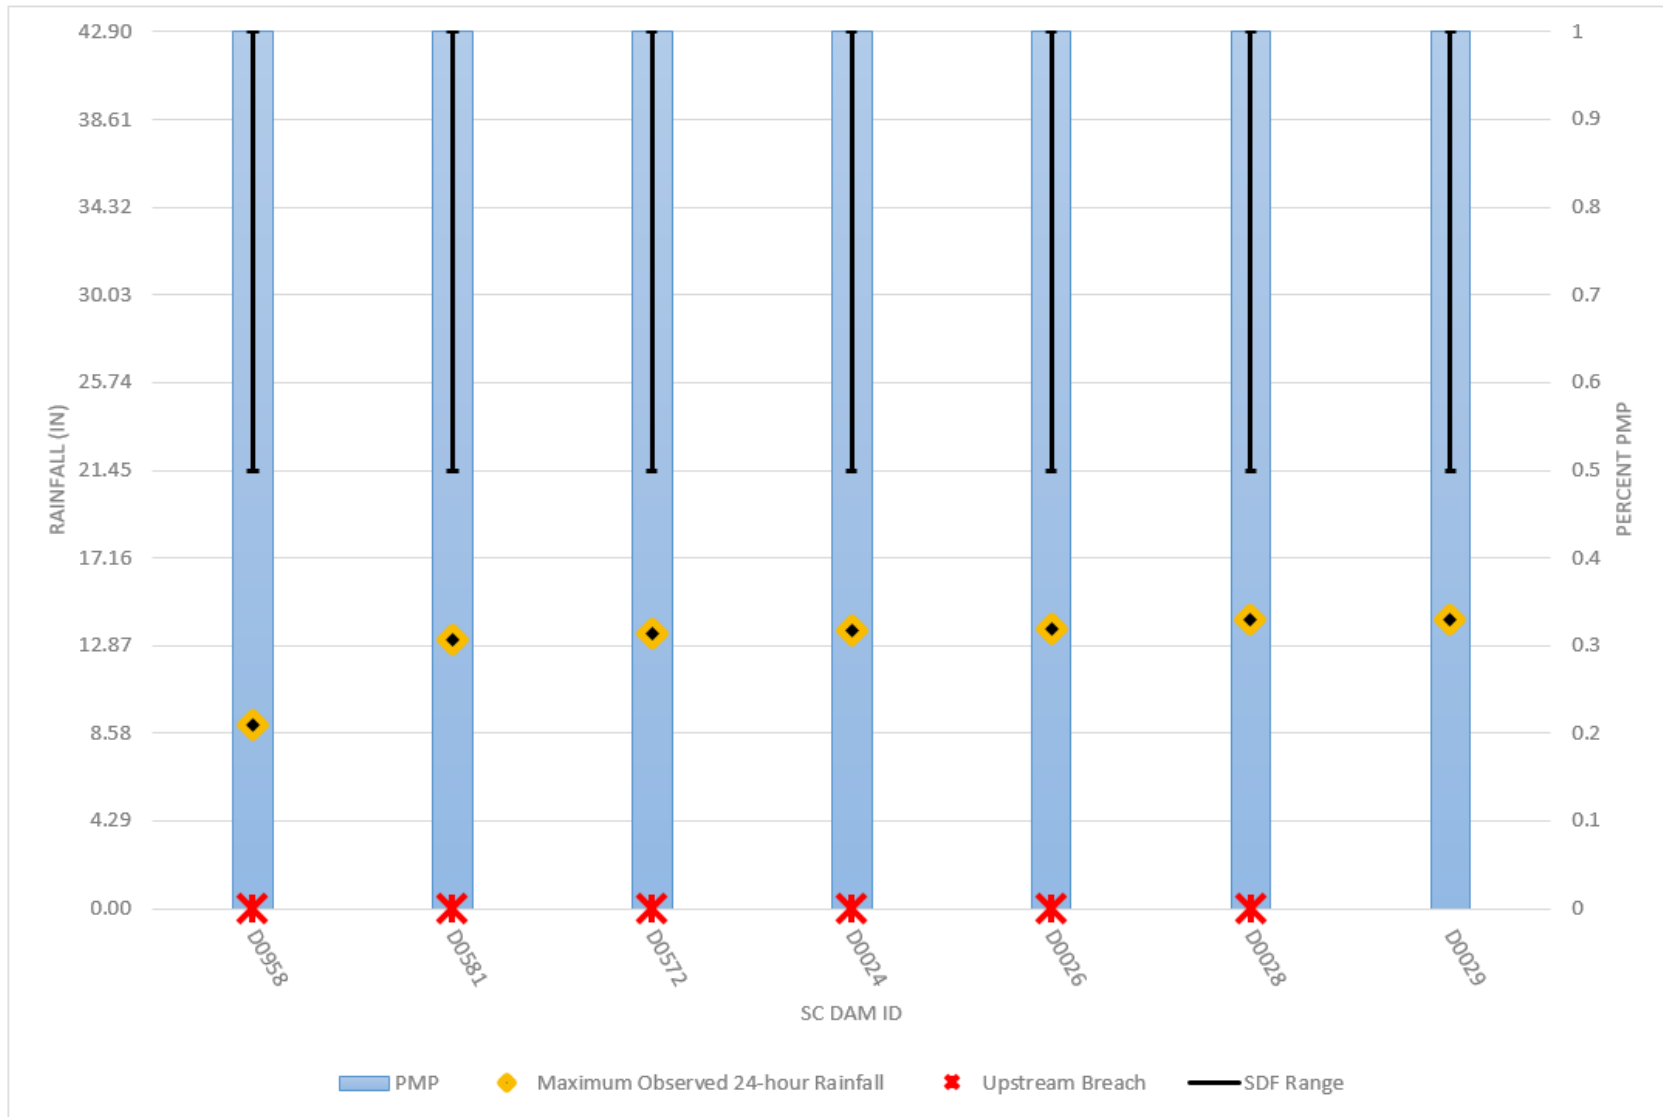
Figure 9: Rainfall Analysis for High Hazard Potential Dams Compared to SC DHEC SDF Design Criteria (Assumes that a 24-hour PMP results in a PMF)

- None of the High Hazard potential dams in Figure 9 received a rainfall loading greater than the minimum or maximum SDF design criteria.
  - However, 6 of 7 High Hazard potential dams experienced an upstream breach which may have potentially resulted in increased volumes entering the impoundments and contributing to their failure. Therefore it is possible that peak inflows were higher than what would be expected from the natural flood event and potentially exceeded the state SDF requirements. All dams were constructed prior to the enactment of the Dams and Reservoirs Safety Act, however, dams D0571 and D0026 are known by SC DHEC to have been modified in 1994 and 1988 respectively.

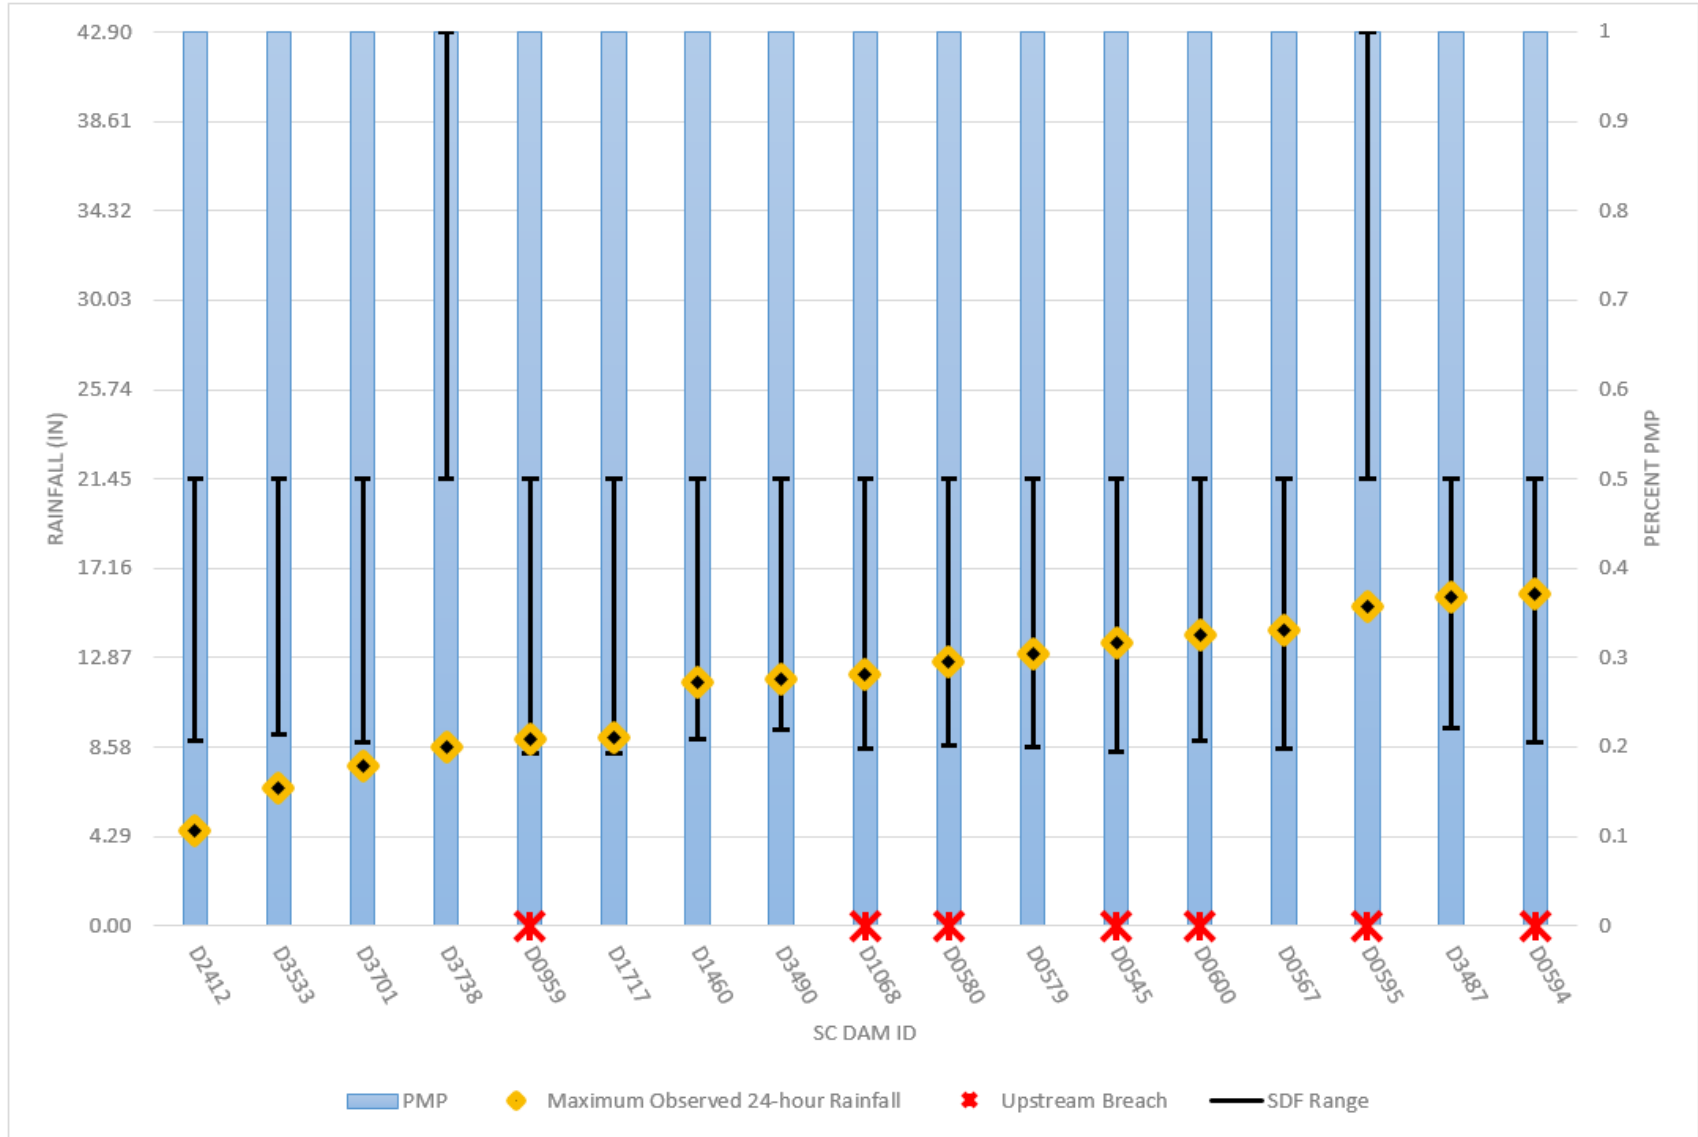
Figure 10: Rainfall Analysis for Significant Hazard Potential Dams Compared to SC DHEC SDF Design Criteria (Assumes that a 24-hour PMP results in a PMF)

- The majority of the Significant Hazard potential dams (12 of 17) in Figure 10 received a rainfall loading greater than the minimum SDF amount, but less than the maximum SDF amount.

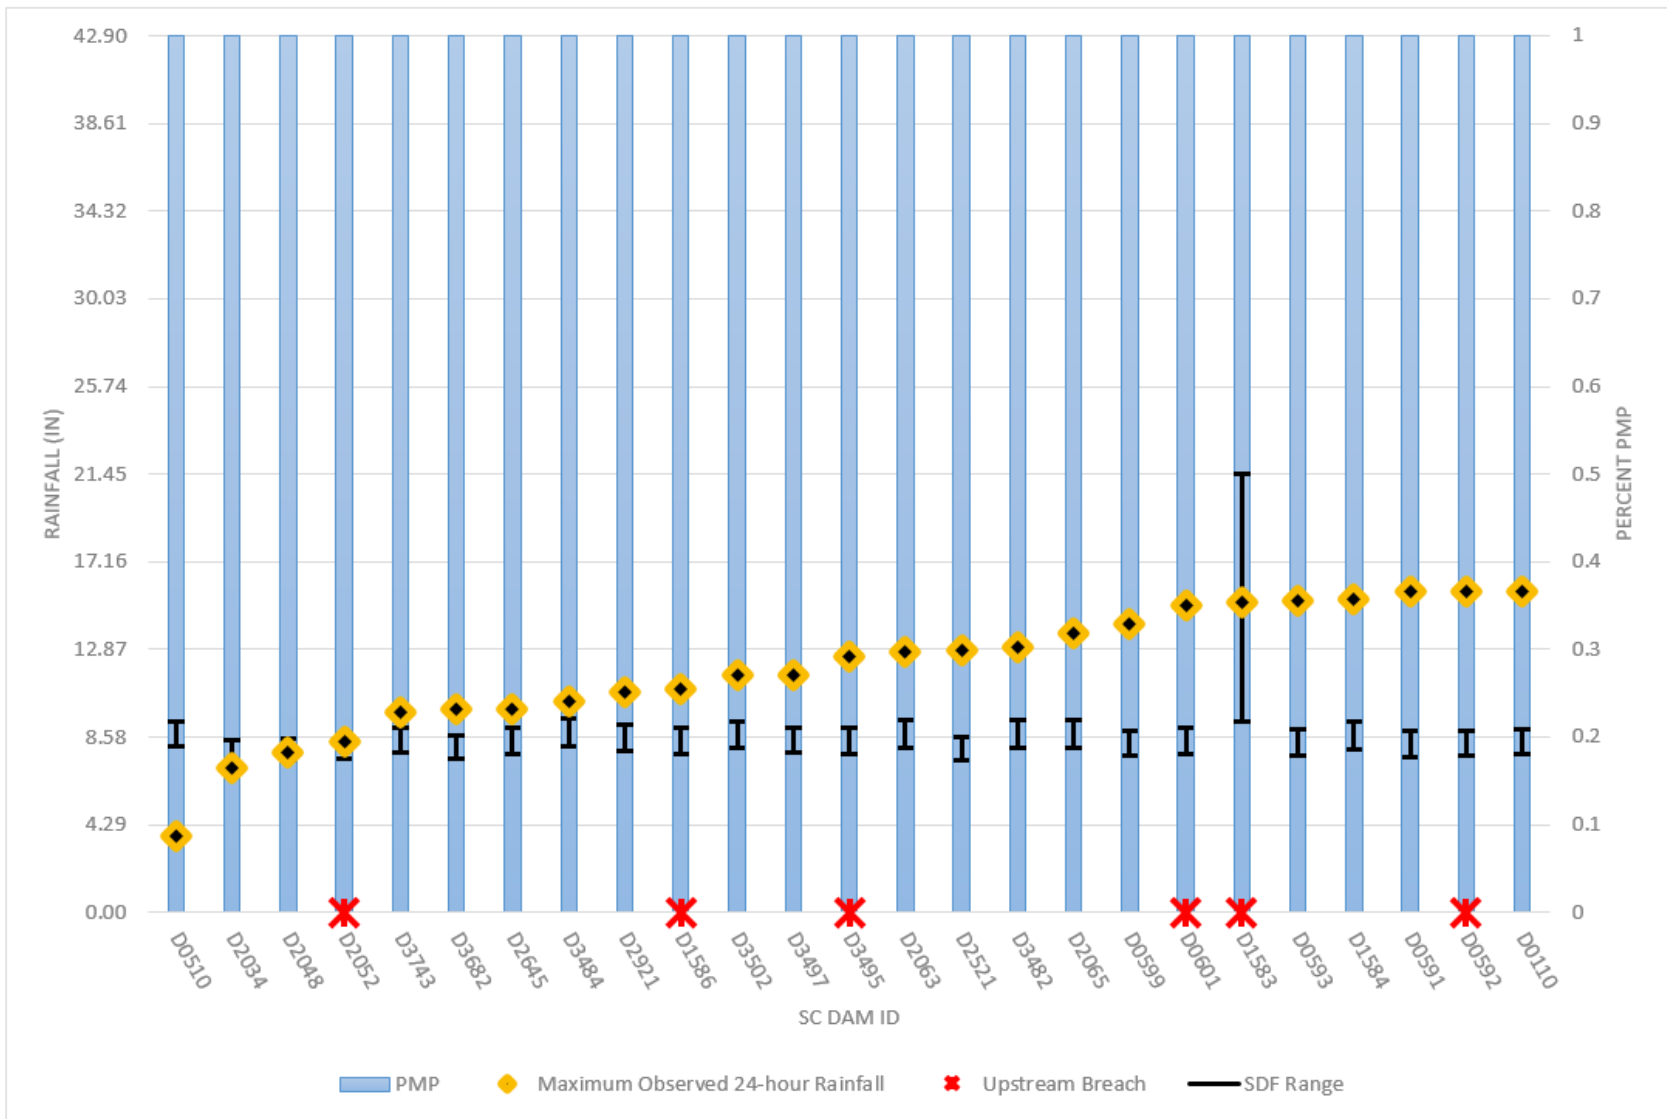
Figure 11: Rainfall Analysis for Low Hazard Potential Dams Compared to SC DHEC SDF Design Criteria (Assumes that a 24-hour PMP results in a PMF)

- The majority of Low Hazard potential dams in Figure 11 received a rainfall loading greater than the minimum SDF and the maximum SDF amount.
  - Six dams that experienced an upstream breach which may have potentially contributed to their failure. These failed dams’ potentially experienced volumes more than what was required by regulations. All dams were constructed prior to the enactment of the Dams and Reservoirs Safety Act.

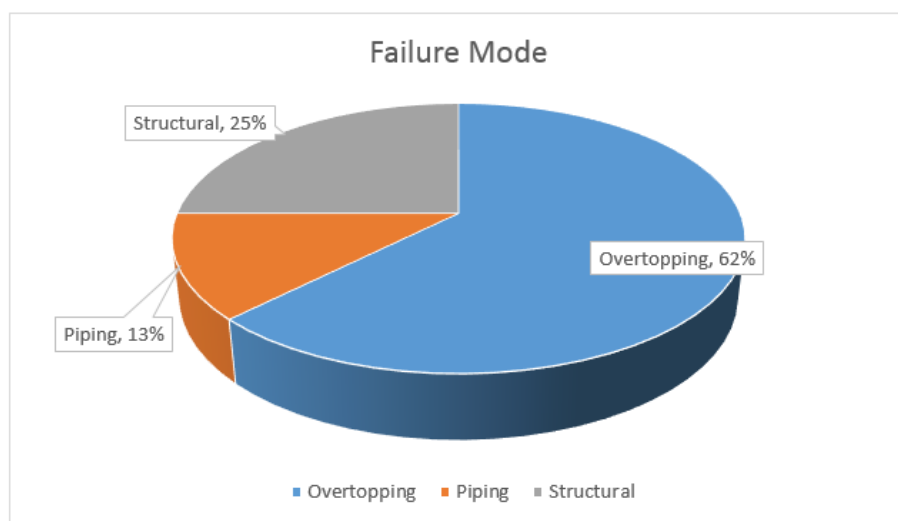
Figure 17. This included 30 overtopping, 6 piping, and 12 embankment failures.

Figure 17: Probable Dam Failure Modes

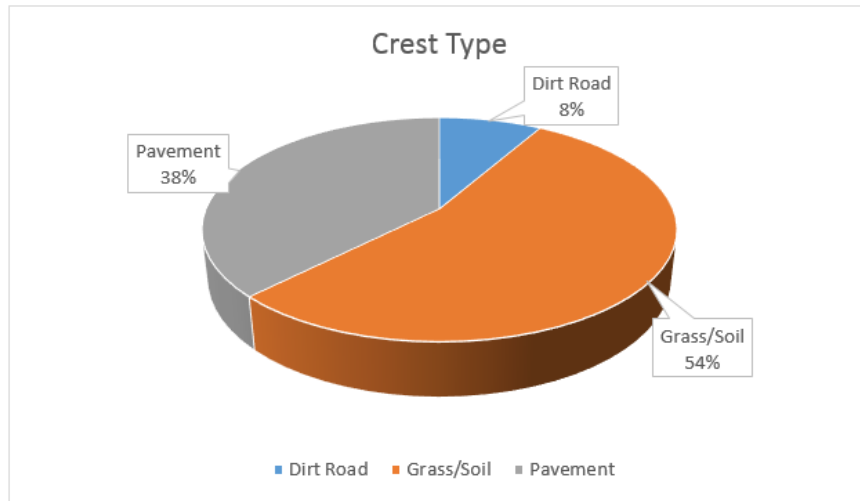
The dam crest types observed during the assessments are summarized in Figure 18. This includes: 4 dirt road, 26 grass or soil, and 18 pavement (roadway acts as the crest).

Figure 18: Failed Dams Crest Type

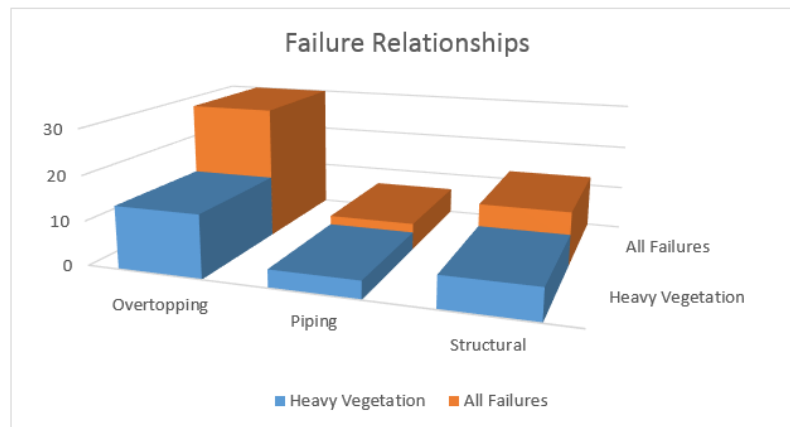
This data was broken down further to determine the number of dams exhibiting heavy woody vegetation which can potentially contribute to failure as illustrated in Figure 19. Woody vegetation penetrations of earthen dams is all too often believed to be a routine maintenance situation, but penetrations of earthen dams and their appurtenances have been demonstrated to be causes of serious structural deterioration and distress that can result in failure of earthen dams. This data was further broken down by failure modes to illustrate the frequency of heavy vegetation on dams. Heavy vegetation was observed at 14 of 30 dams with a probable failure mode determined to be by overtopping, 4 of 6 dams with a probable failure mode determined to be by piping, and 7 of 12 dams with a probable failure mode determined to be structural failures.

Figure 19: Failed Dams Having Heavy Woody Vegetation

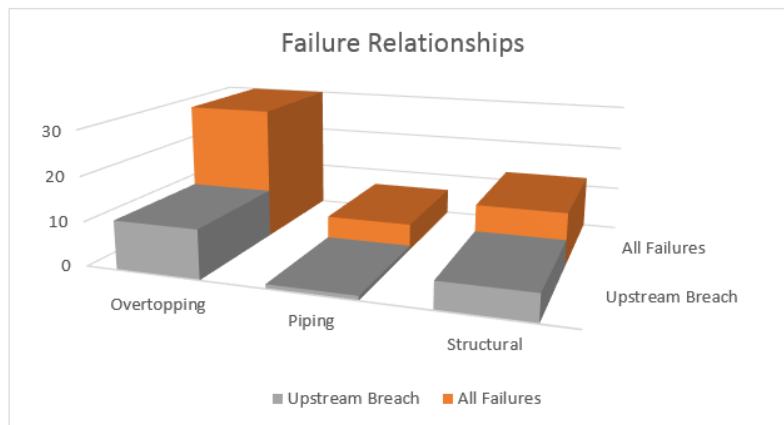
satellites. It is important to note that this data should not be used to say whether or not an upstream breach contributed to the downstream dam failure. In many cases, this is quite possible. However, in other cases the upstream dam may have breached after the downstream dam, thus not contributing to the downstream dam’s failure. This indicated that a large number of dams that most likely failed due to overtopping and structural failures were located downstream of another breached dam (Figure 20).

Figure 20: Failed Dams Where Upstream Breach Occurred
