**ANALYSIS OF
COAL REFUSE DAM FAILURE**

**MIDDLE FORK BUFFALO CREEK
SAUNDERS, WEST VIRGINIA**

**UNITED STATES
DEPARTMENT OF THE INTERIOR
BUREAU OF MINES
WASHINGTON, D.C.**

VOLUME 1 OF 2 - TEXT

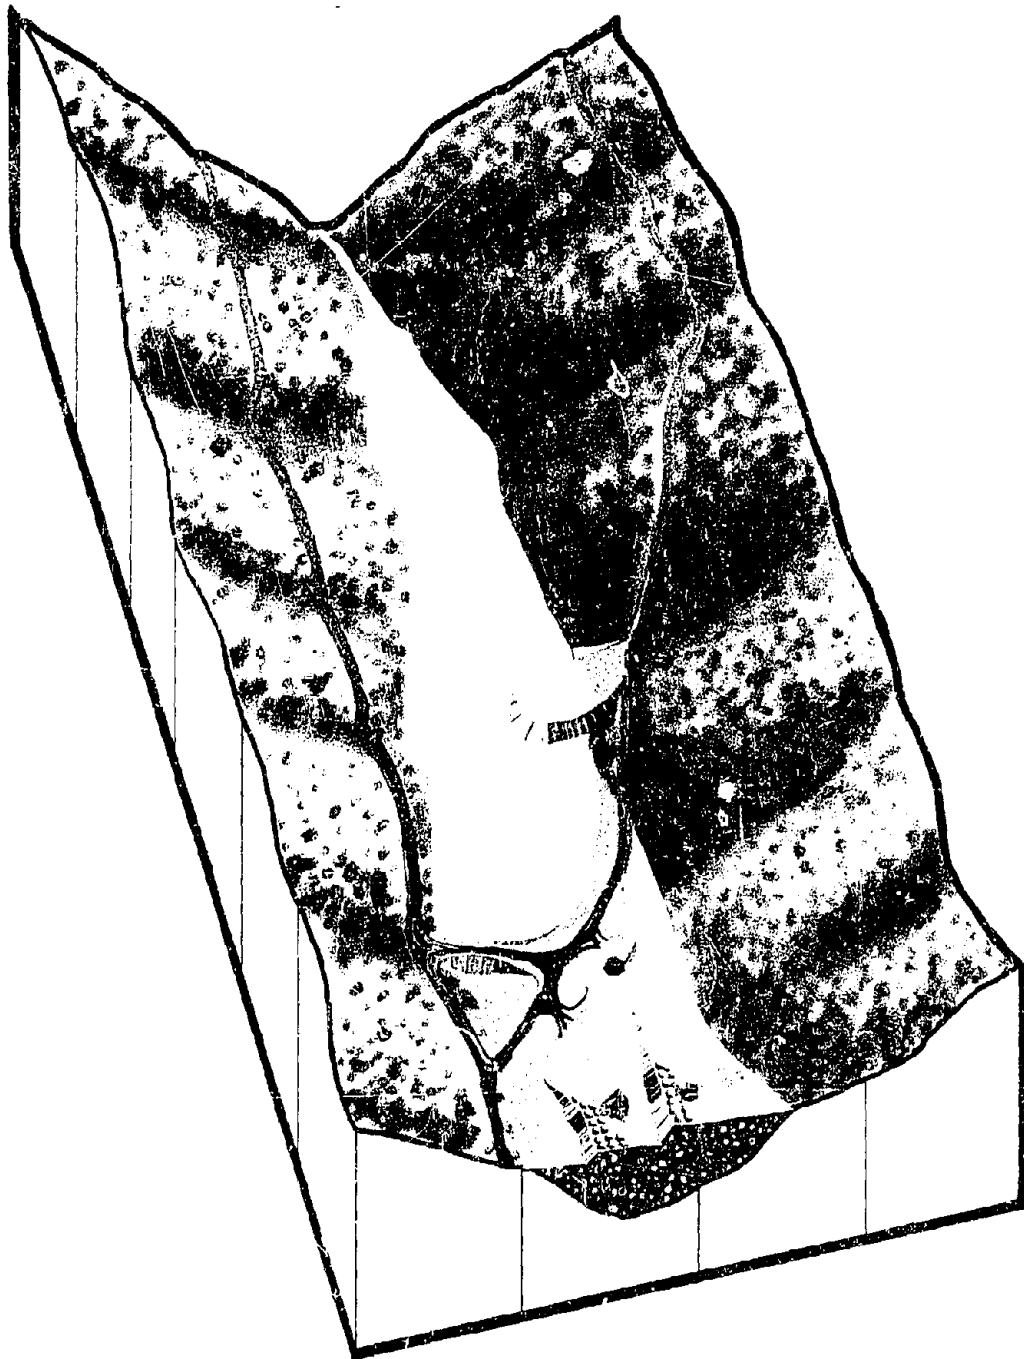
MIDDLE FORK VALLEY, DECEMBER 1966, LOOKING UPSTREAM. DAM NO 2 HAS BEEN STARTED AND EXTENDS INTO POOL 1.

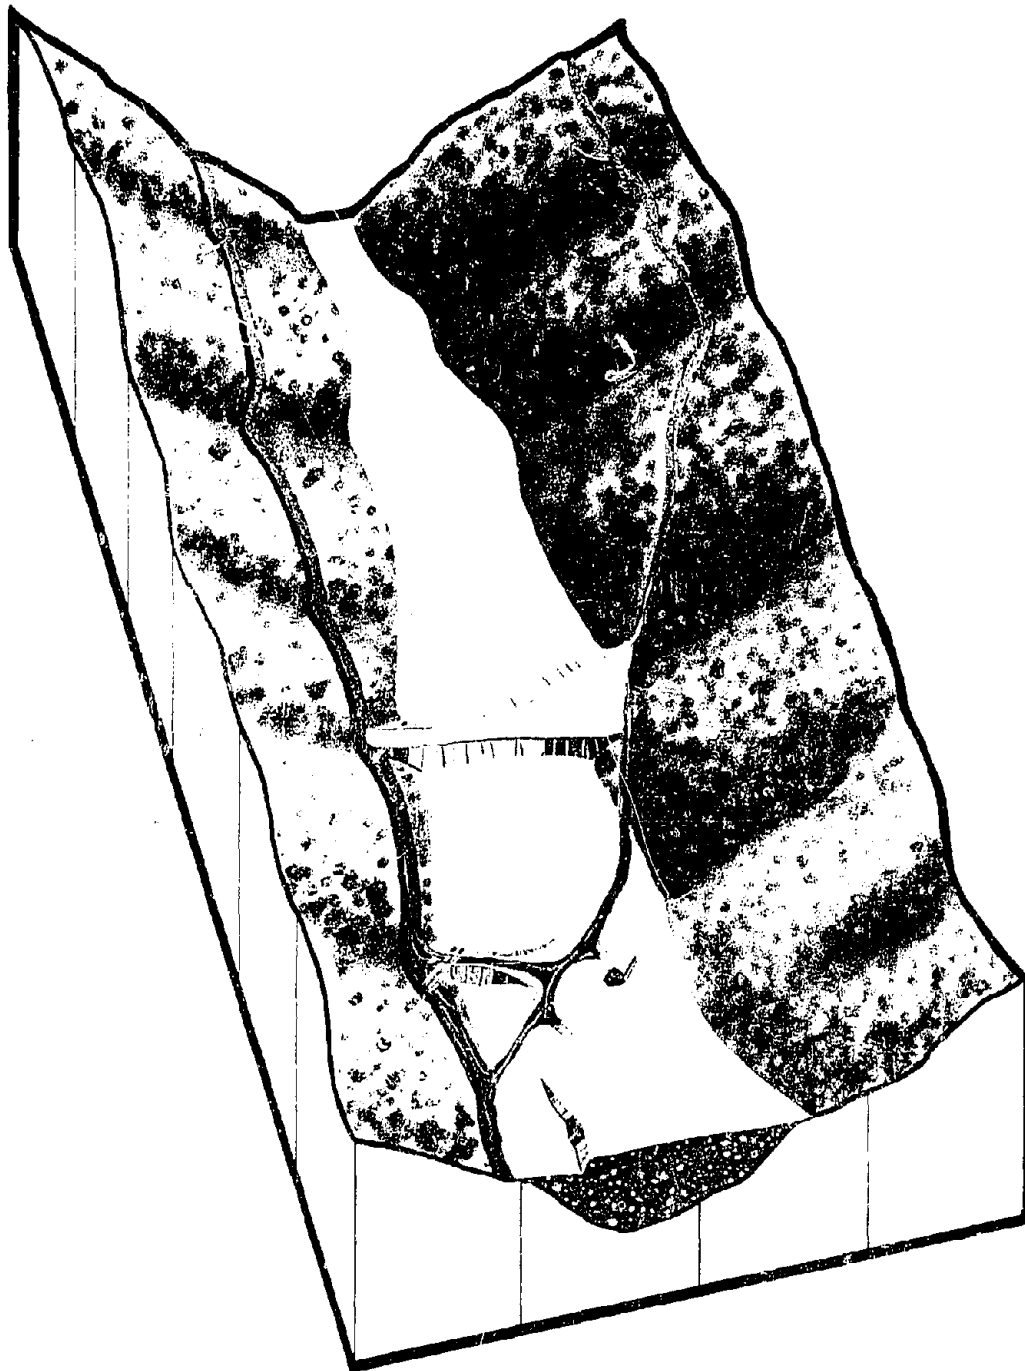
FIGURE V-11C

MIDDLE FORK VALLEY IN LATE 1967, LOOKING UPSTREAM. THE REFUSE BANK IS BEING EXTENDED UPSTREAM OVER PART OF POOL I.

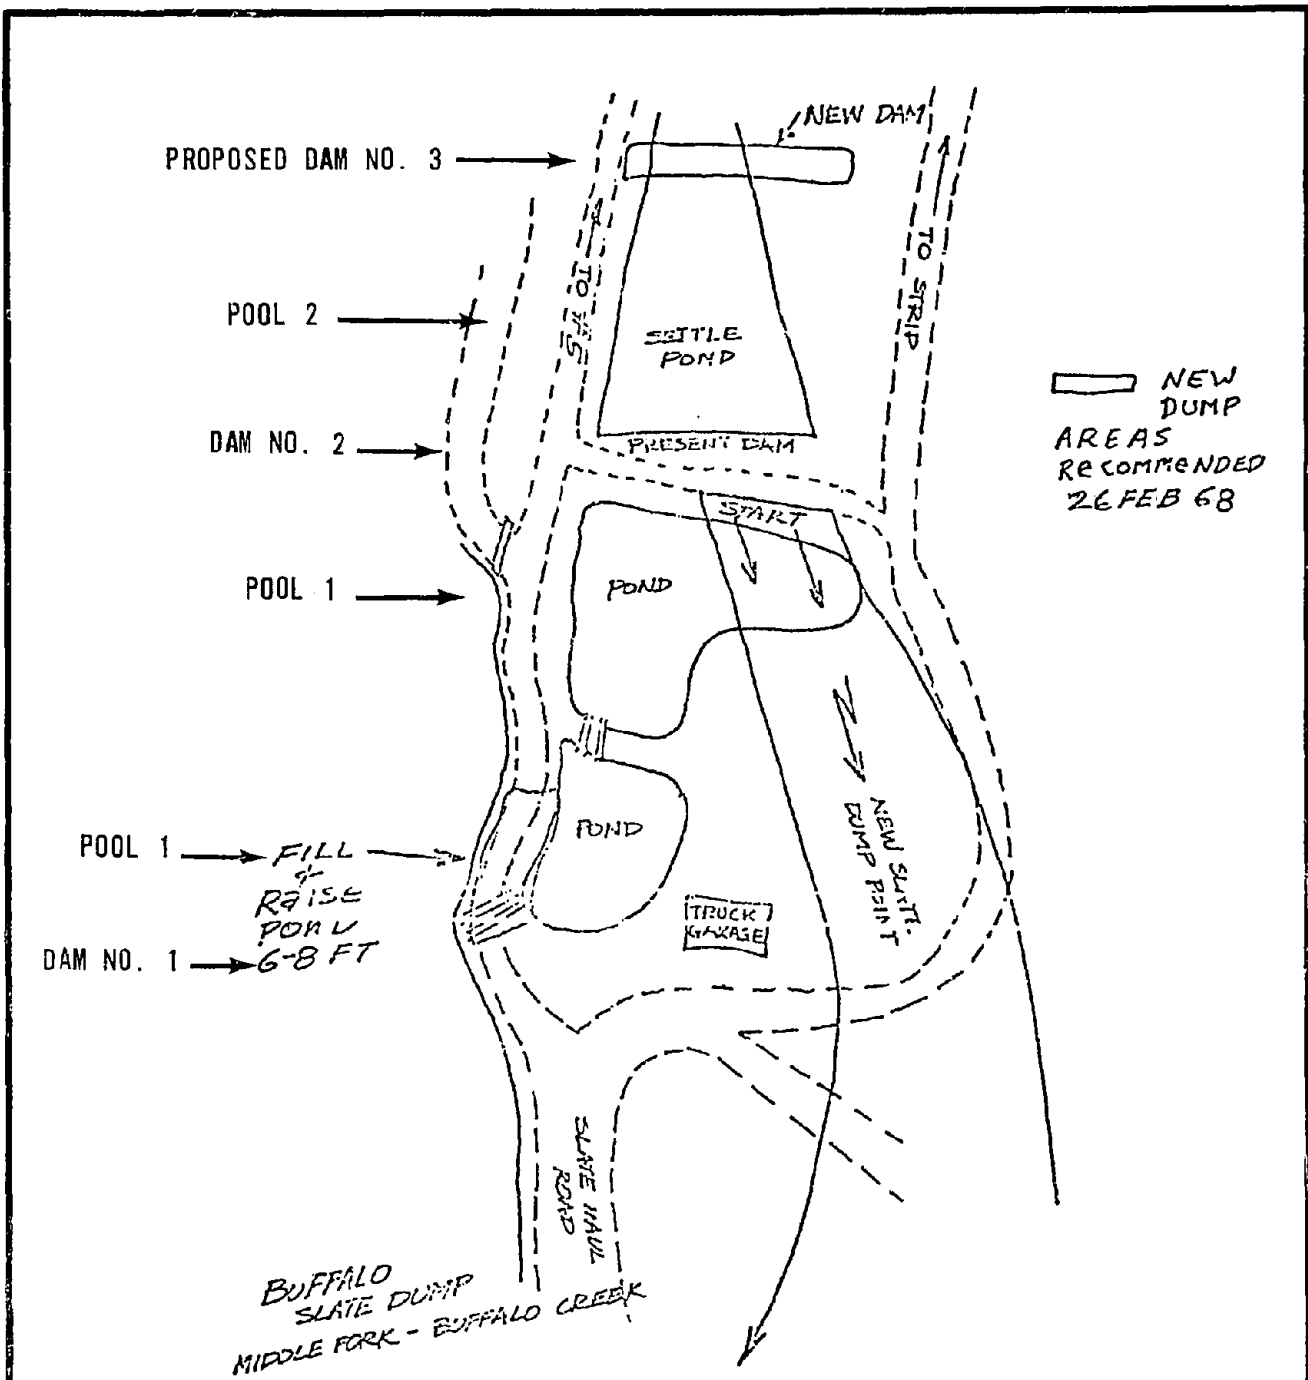
W.A. WAHLER & ASSOCIATES	COAL REFUSE DAM FAILURE SAUNDERS, WEST VIRGINIA	DASOVICH'S SKETCH		
		PROJECT NO 0700	DATE NOVEMBER 1972	FIGURE NO. V-13

With the completion of Dam No. 2 in late 1967, the stage was set for construction of Dam No. 3, which would continue the progressive upstream damming of Middle Fork Valley. On February 26, 1968, D. S. Dasovich, Vice President of Buffalo Mining Company, sketched out Dam No. 3 during a field inspection with representatives from the West Virginia Public Service Commission (Mr. Harold Snyder) and the West Virginia Department of Natural Resources (Mr. Joseph C. Holly). His sketch, reproduced from the Commission Report, is included here as Figure V-13. During this

THIS SKETCH WAS MADE BY D. S. DASOVICH, VICE-PRESIDENT OF BUFFALO MINING COMPANY, ON FEBRUARY 26, 1968. IT SHOWS THE PROPOSED "NEW DAM" (DAM NO. 3). POOL 1 IS INDICATED AS TWO SEPARATE PONDS AT THAT TIME.

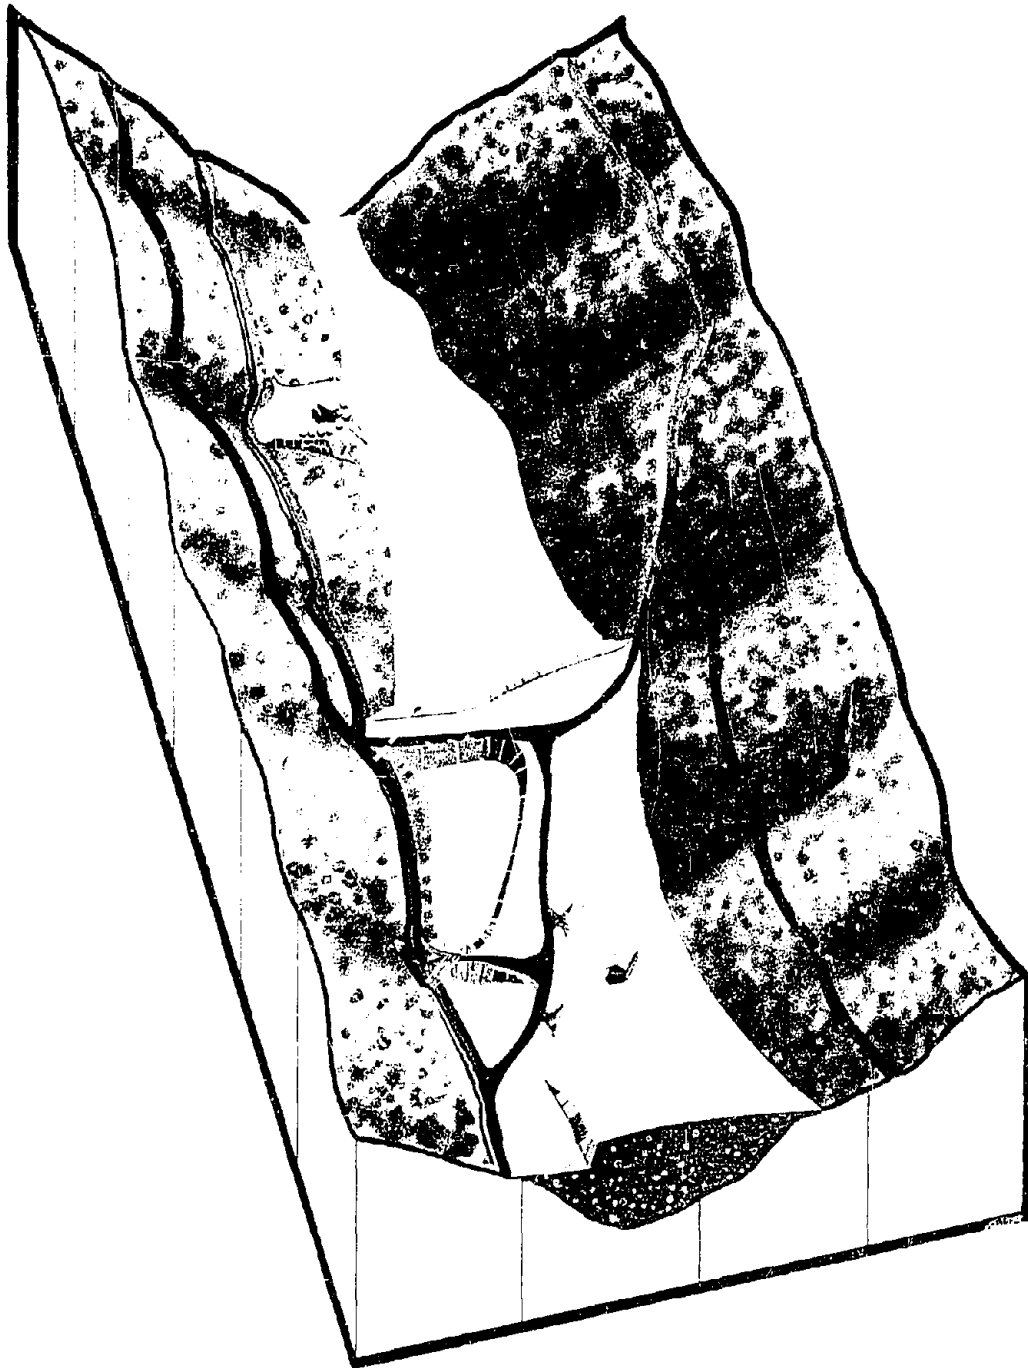
FIGURE V-14A

Diagrammatic sketches (Figures V-14A through H) are used to trace the history of Dam No. 3 from its start in May 1968. Trucks dumped coal refuse from a wide area in the No. 5 Mine Road on the right side of the valley, and a platform was made (Figure V-14A) from which trucks could dump either down the face or into individual piles for later leveling by a bulldozer. This platform became the right end of Dam No. 3. The embankment was carried across Middle Fork Valley from right to left (as viewed looking downstream) at approximately Elevation 1,740-1,750 (Figure V-14B).

MIDDLE FORK VALLEY IN MID-1969, LOOKING UPSTREAM
A PLATFORM OF COAL WASTE AT ITS RIGHT ABUTMENT.
MAXIMUM EXTENT AND COVERS ONE-HALF OF POOL 1.

DAM NO. 3 IS STARTED BY BUILDING
THE REFUSE BANK HAS REACHED ITS

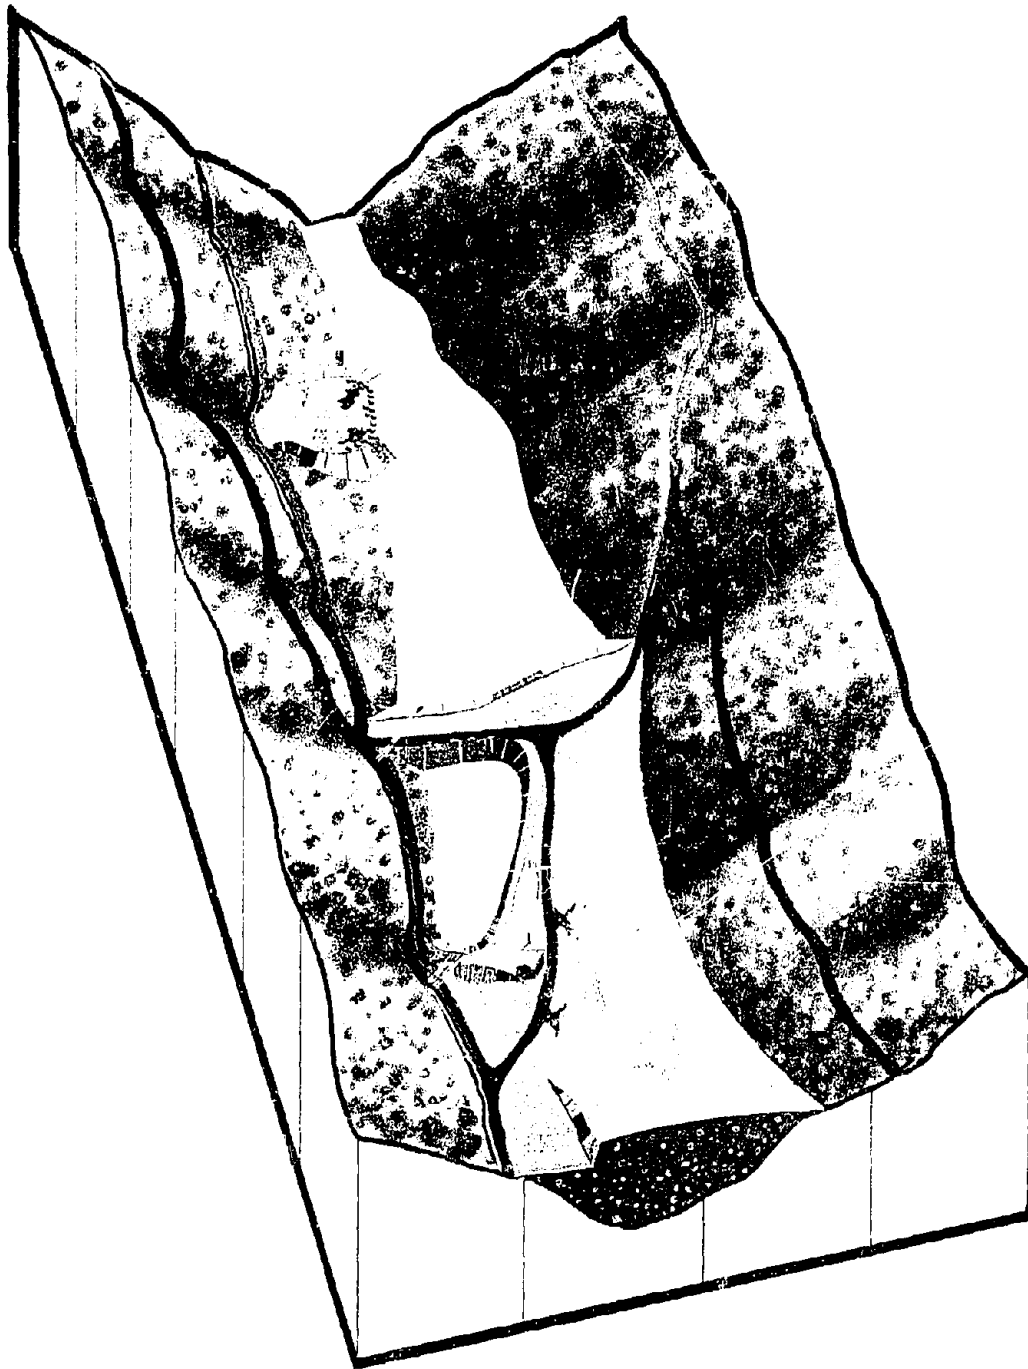
MIDDLE FORK VALLEY IN LATE 1968, LOOKING UPSTREAM. THE DAM NO. 3 EMBANKMENT HAS PROCEEDED OVER POOL 2 SLUDGE.

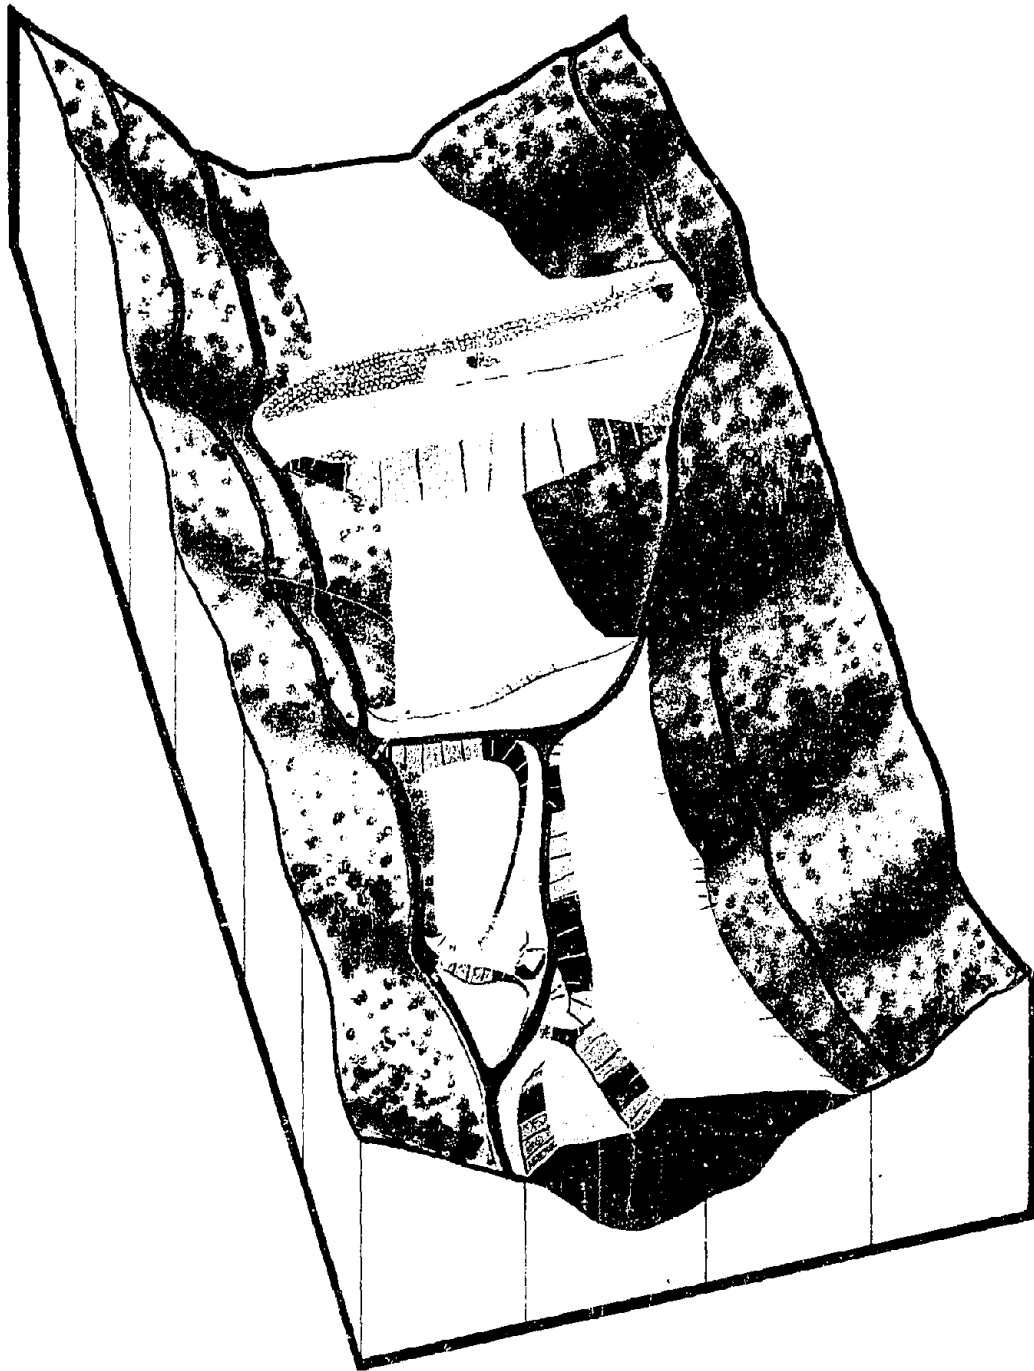
FIGURE V-14E

MIDDLE FORK VALLEY IN EARLY 1970, LOOKING UPSTREAM. DAM NO. 3 IS COMPLETED ACROSS THE VALLEY, BUT NOT TO ITS FULL WIDTH OR HEIGHT. BULLDOZERS RAISE THE DAM BY LEVELING DUMPED PILES OF COAL REFUSE.

By early 1970, Dam No. 3 was a true dam, extending completely across Middle Fork Valley (Figure V-14E). Prior to this closure, some refuse dumping may have occurred from the left abutment side; after closure, refuse trucks could approach the dam from either abutment. Which road the trucks travelled depended on traffic or road conditions, but they generally travelled up the No. 5 Mine Road, crossed the dam after dumping their loads, and came down the other side of the valley. Bulldozers both raised the embankment by leveling groups of piles and advanced it downstream and upstream by pushing edge-dumped piles down the face.

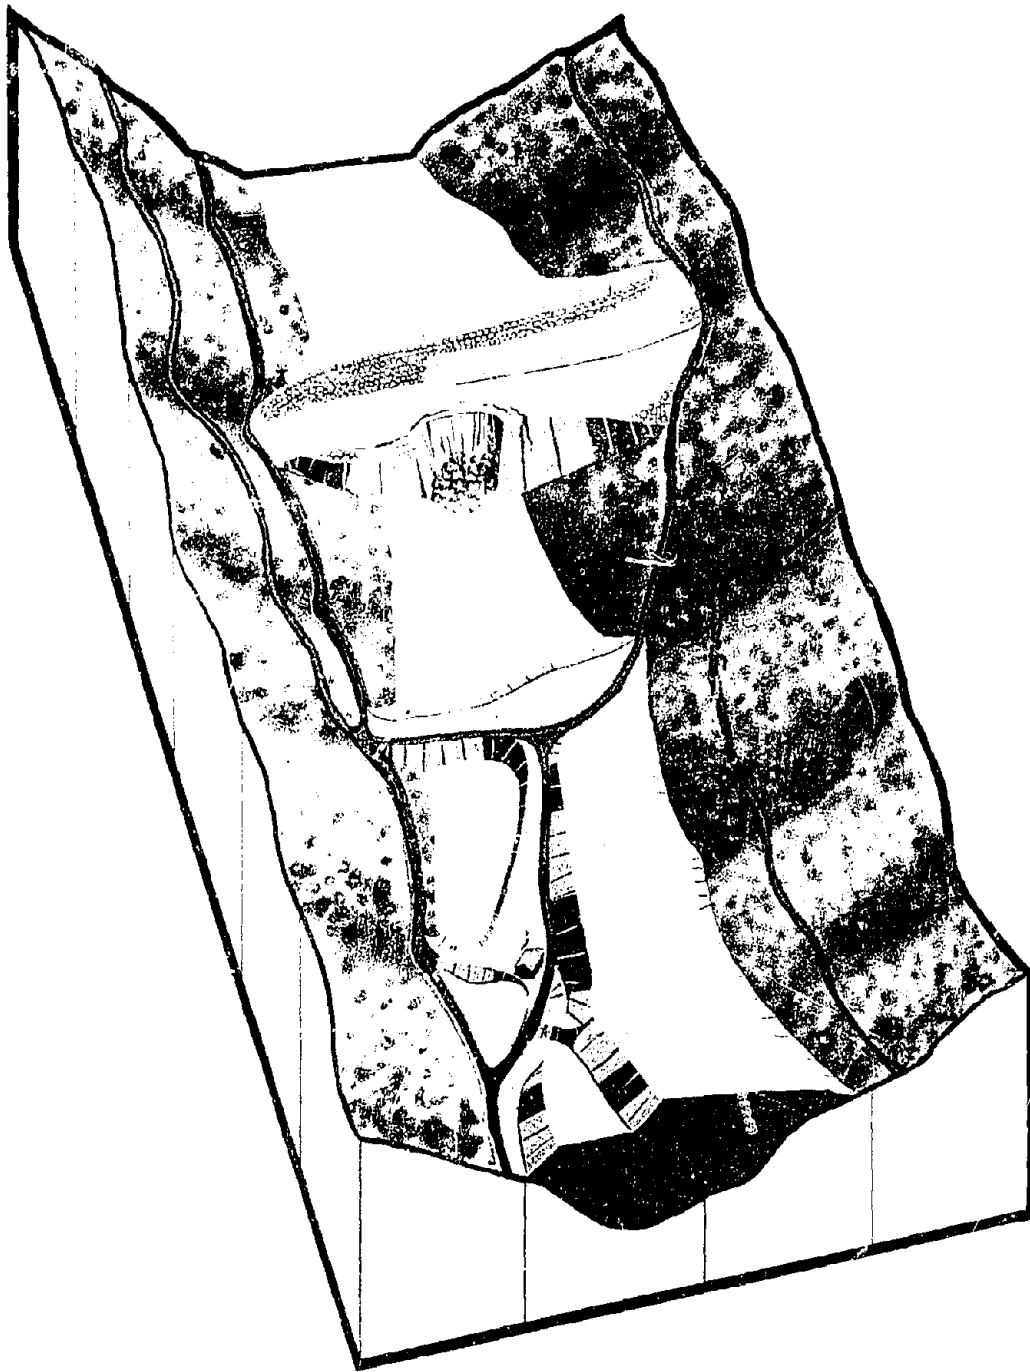
MIDDLE FORK VALLEY IN FEBRUARY-MARCH, 1971, LOOKING UPSTREAM. DAM NO. 3 EXPERIENCES SLUMPING ON THE DOWNSTREAM FACE.

Dam No. 3 reportedly reached its final height by February 1971. After this juncture, further dumping widened the dam by adding refuse to the upstream and downstream faces. In February or March 1971, a relatively shallow failure occurred on the downstream face of Dam No. 3 (Figure V-14F). This slide is described as being "150 to 200 feet wide across the face of the dam and 20 to 30 feet from the face back" (Commission Report). Again the slide was repaired by dumping more refuse down the scarp and refilling the void left by the slide (Figure V-14G).

1971	FEB. OR MAR.	DOWNSTREAM SIDE OF LEFT ABUTMENT OF DAM NO. 3 SLUMPED. SLUMP SIZE ESTIMATED TO BE "150 TO 200 FEET WIDE ACROSS THE FACE OF THE DAM AND 20 TO 30 FEET FROM FACE BACK." BLACK WATER OBSERVED BOILING INTO POOL 2 FROM THE DOWNSTREAM SIDE OF DAM NO. 3 AFTER FAILURE (COMMISSION REPORT). FROM PARK AND OTHERS (1972): "IN 1971 . . . A PORTION OF THE . . . DAM FAILED AT THE LOCATION JUST OFF CENTER TOWARD THE NORTHEAST SIDE OF THE DAM."
1971	APR. - JUNE	"24-INCH EMERGENCY SPILLWAY" PLACED IN DAM NO. 3. PIPE WAS "PLACED DIAGONALLY ACROSS THE RIGHT SIDE OF DAM NO. 3 AND ABOUT 7 OR 8 FEET BELOW THE GRADED CREST." (COMMISSION REPORT).
1972	FEB. 26 8:00 A.M.	DAM NO. 3 FAILS CATASTROPHICALLY.

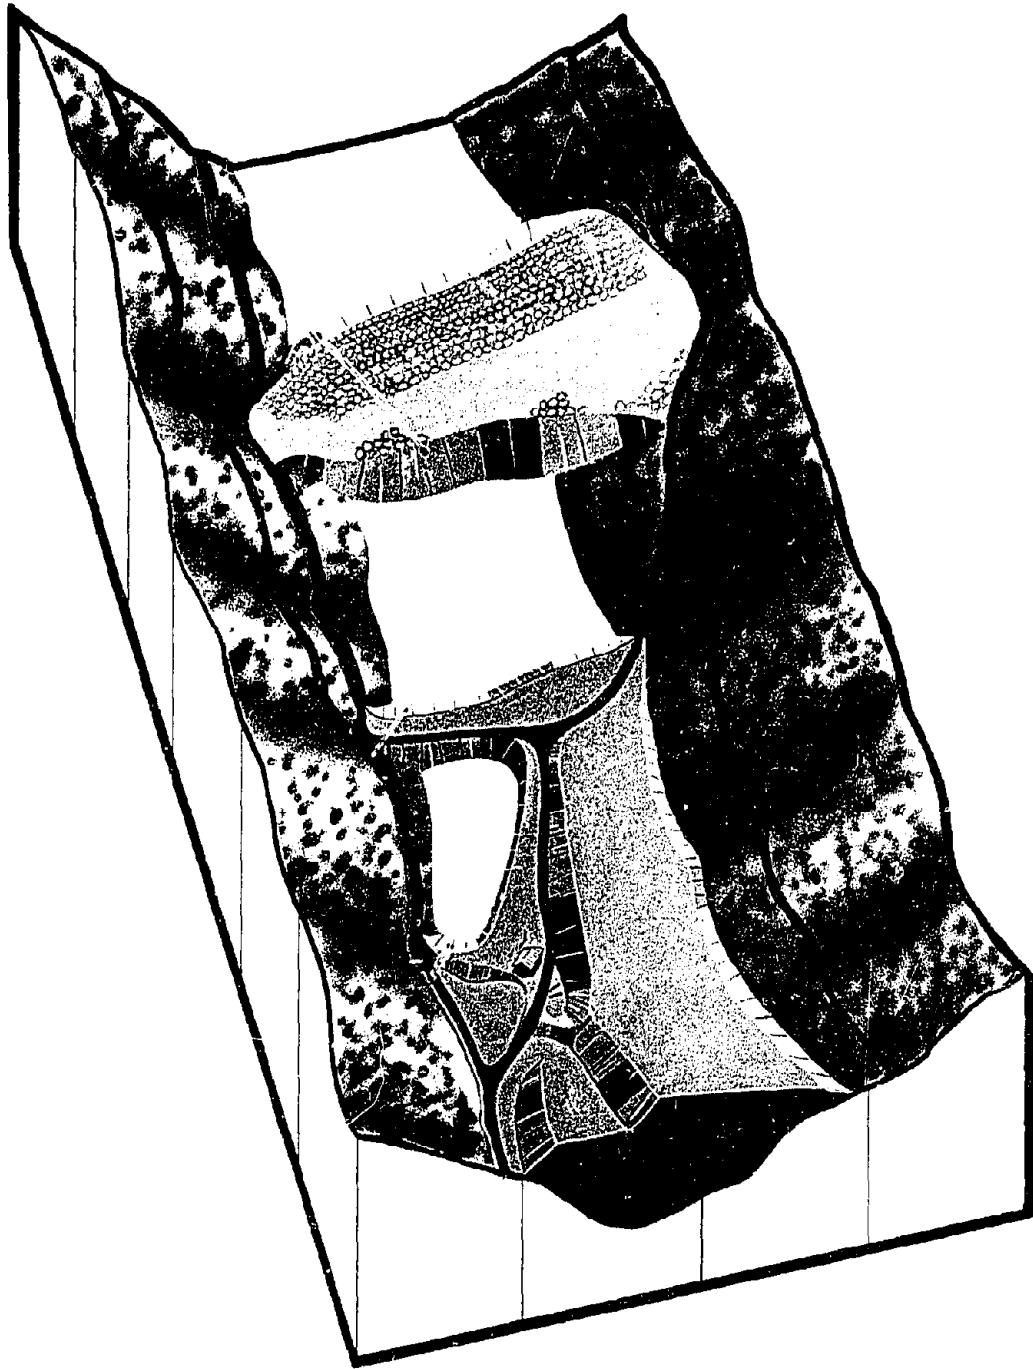
MIDDLE FORK VALLEY IN EARLY FEBRUARY 1972, LOOKING UPSTREAM. POOL 3 HAS A SURFACE ELEVATION OF ABOUT 1740-1745 FEET.

Figure V-14H shows the dam as it probably appeared a few days before the failure. As shown on this figure, the water level in Pool 3 is at about 1,740-1,745 feet. Due to the winter rains, this is a few feet higher than the long-term pool level. Piles of dumped refuse line the entire back portion of the crest "10 deep" as reported, and a few piles are scattered along the front face at the left.

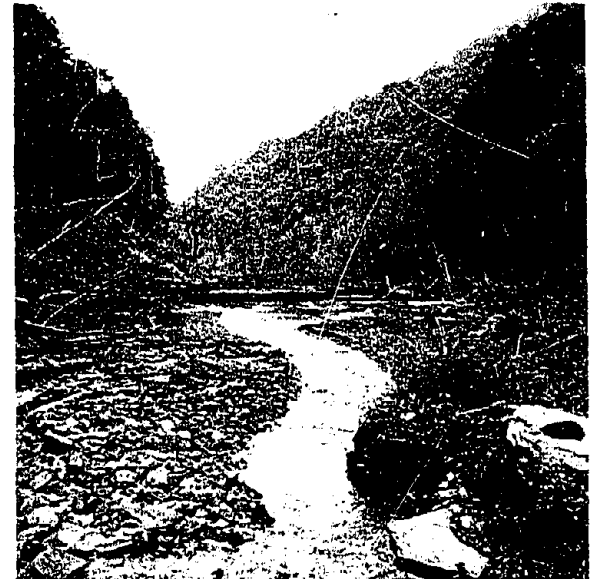
PHOTO D. UPPER END OF POOL 3, LOOKING
DOWNSTREAM. THE BASES OF THE LOWER-
MOST LIVE TREES ARE AT ELEVATION 1735;
THE SLUDGE IN THE MIDDLEGROUND IS AT
ELEVATION 1714.
