**ANALYSIS OF
COAL REFUSE DAM FAILURE**

**MIDDLE FORK BUFFALO CREEK
SAUNDERS, WEST VIRGINIA**

**UNITED STATES
DEPARTMENT OF THE INTERIOR
BUREAU OF MINES
WASHINGTON, D.C.**

VOLUME 1 OF 2 - TEXT

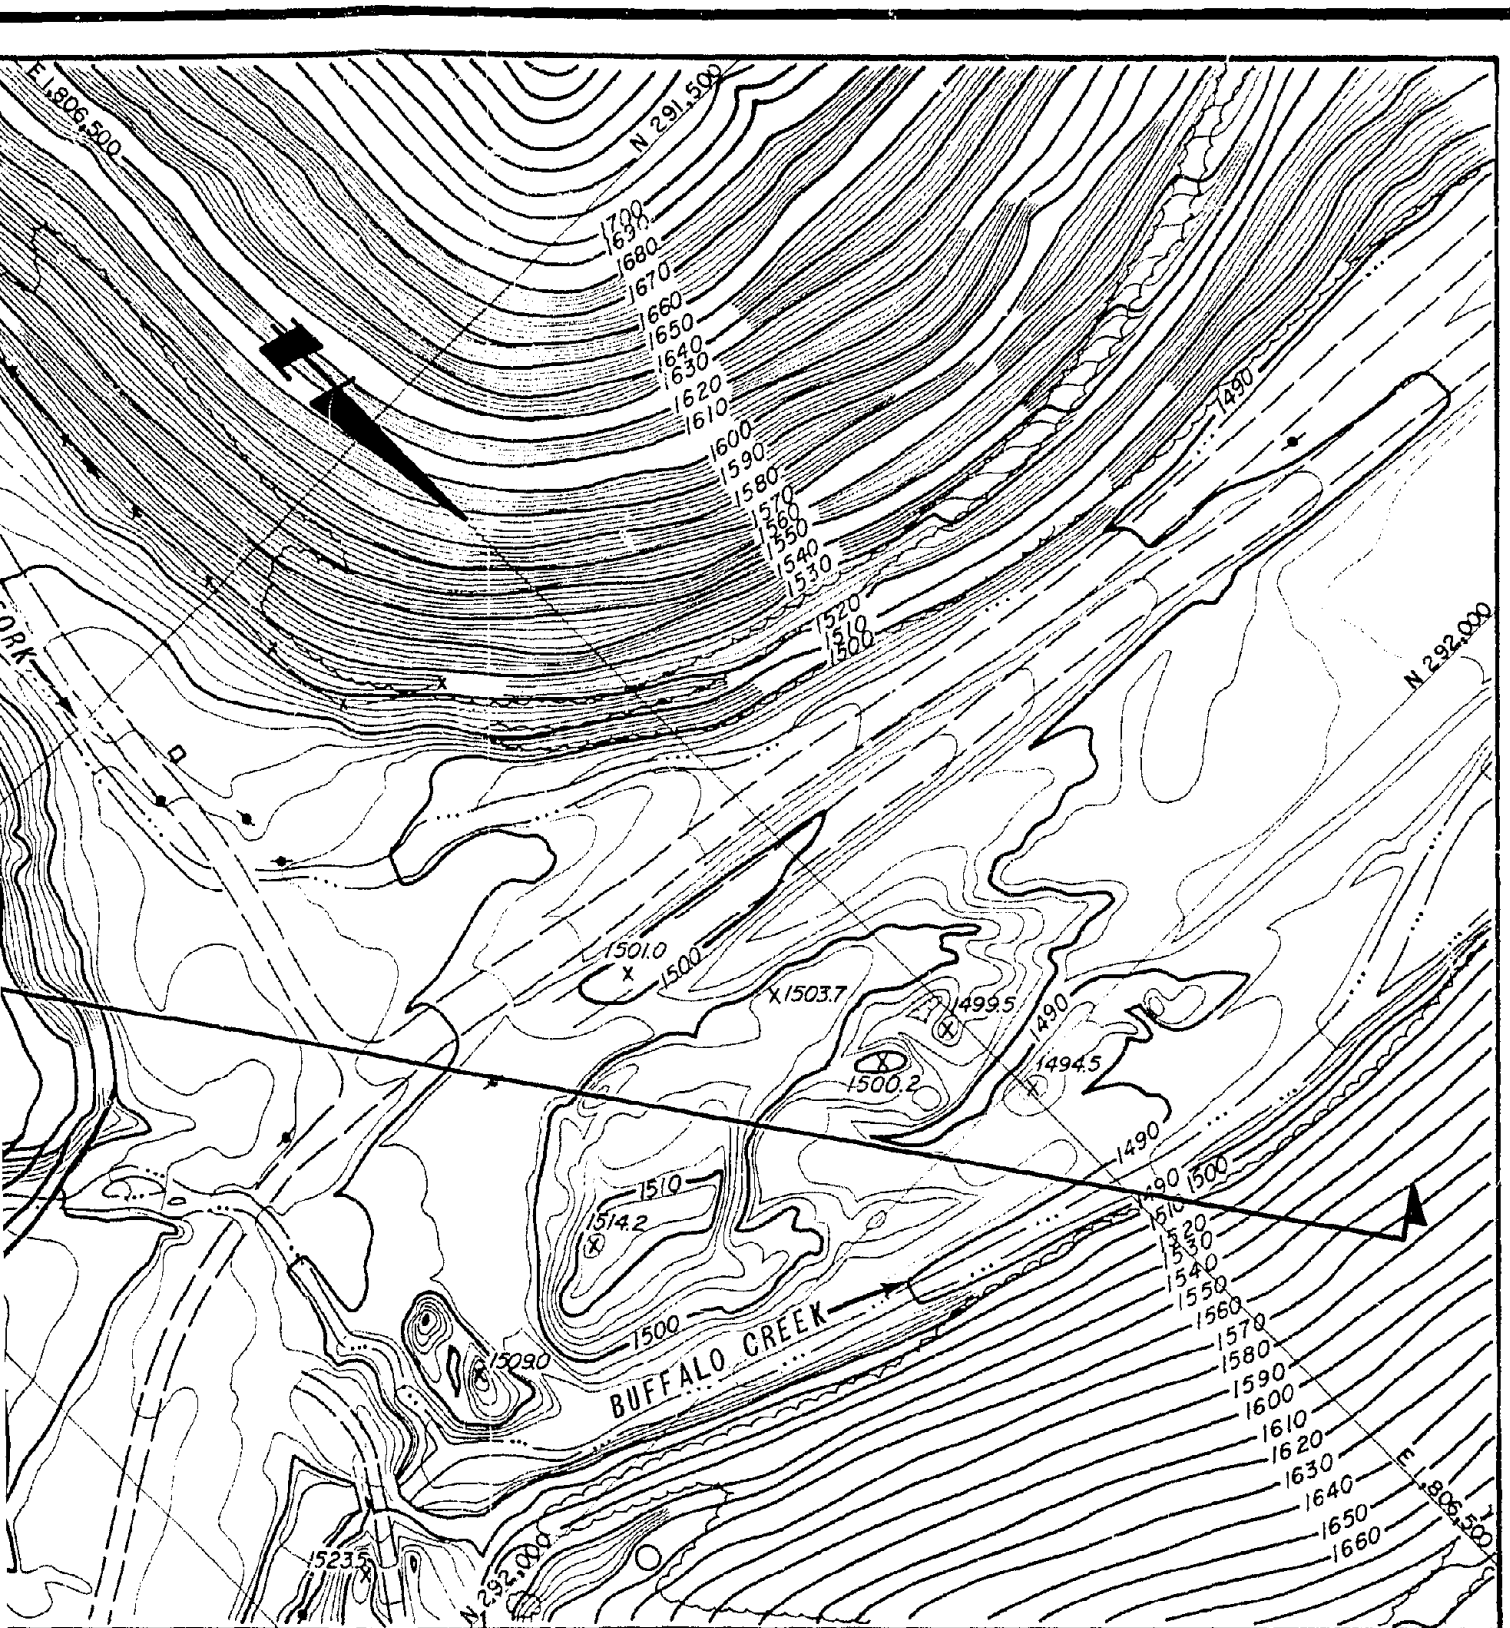
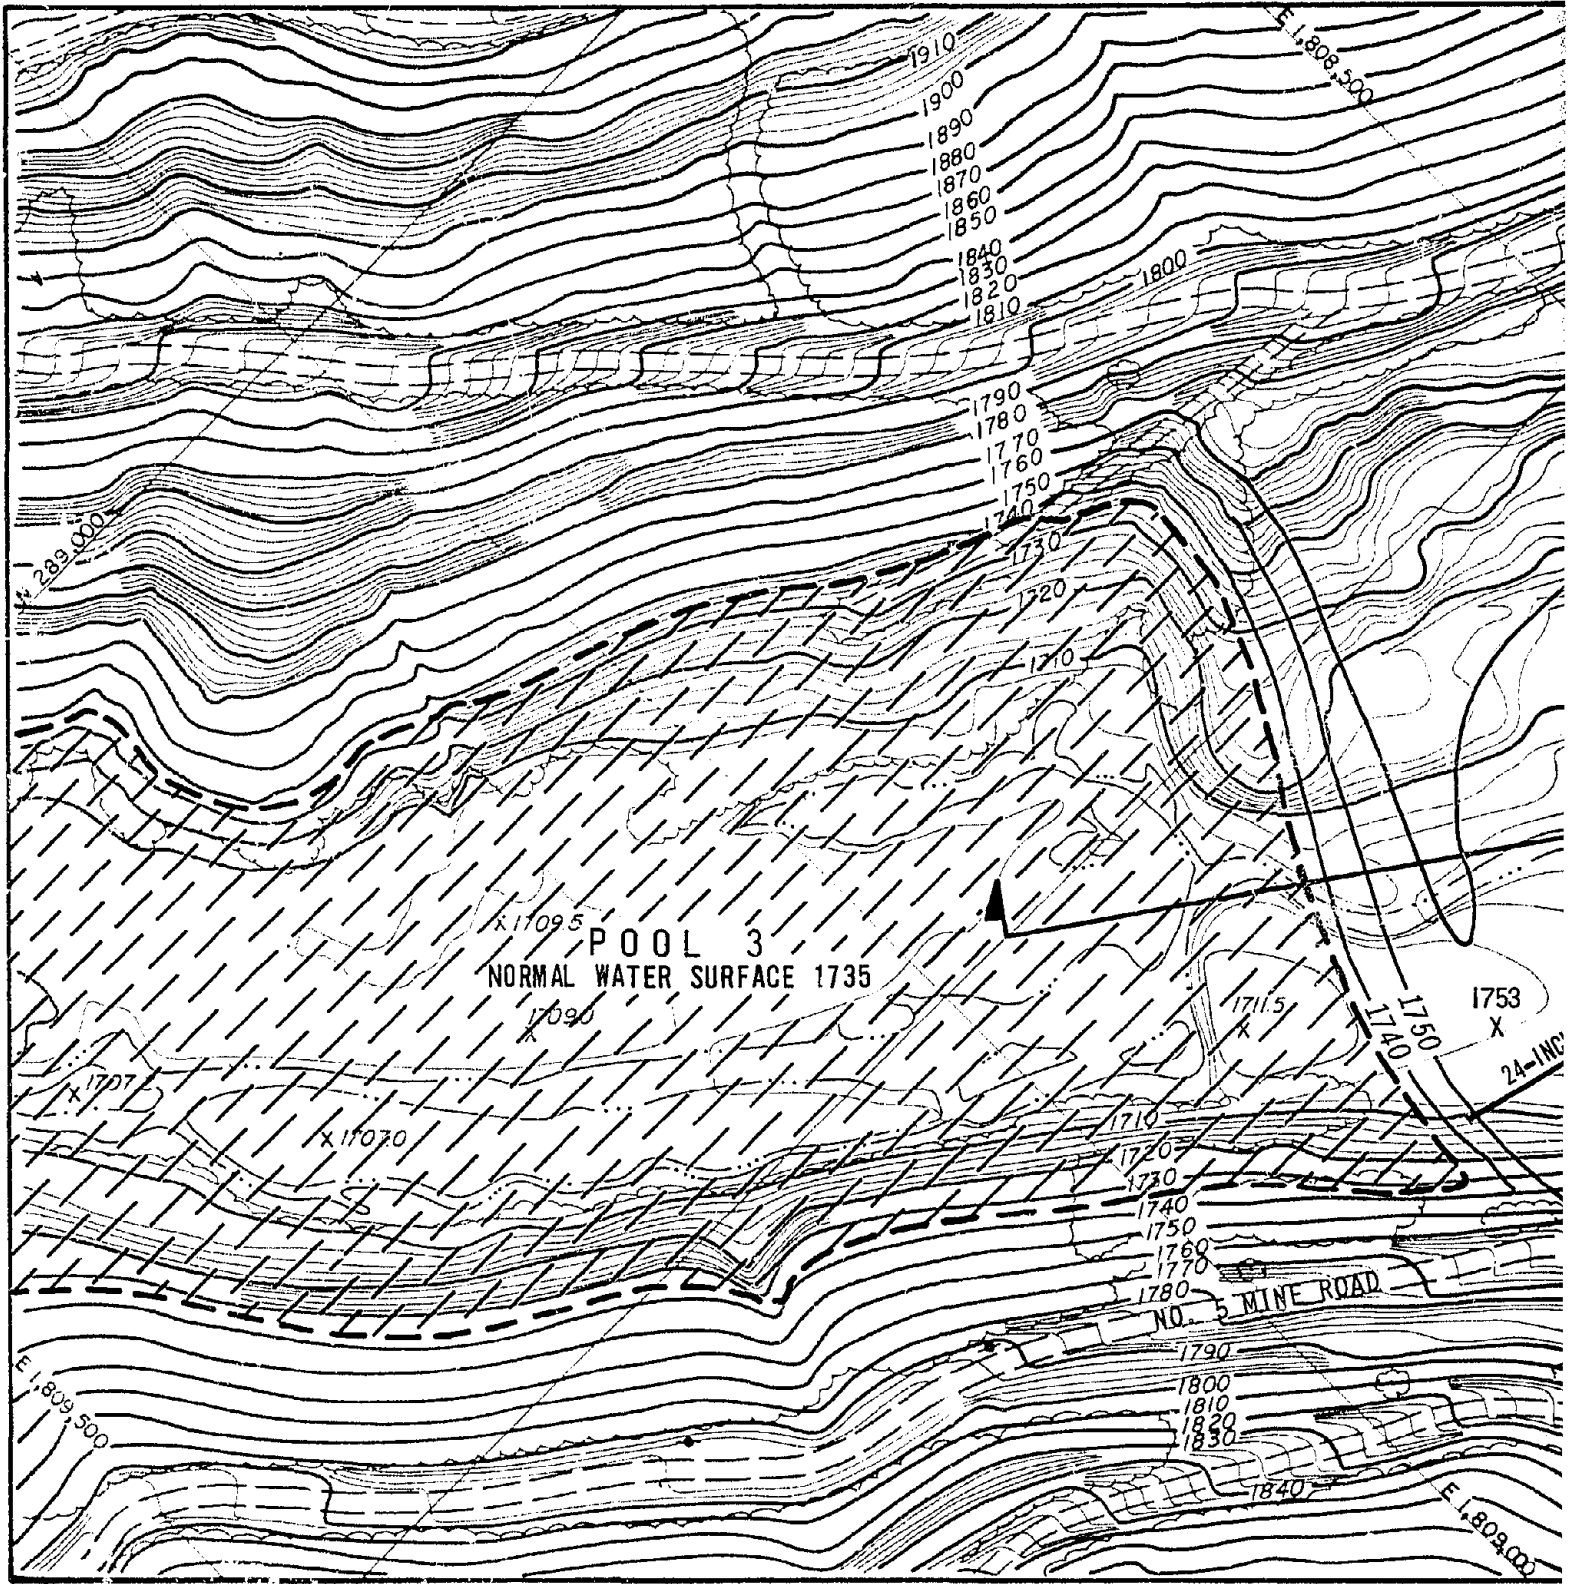
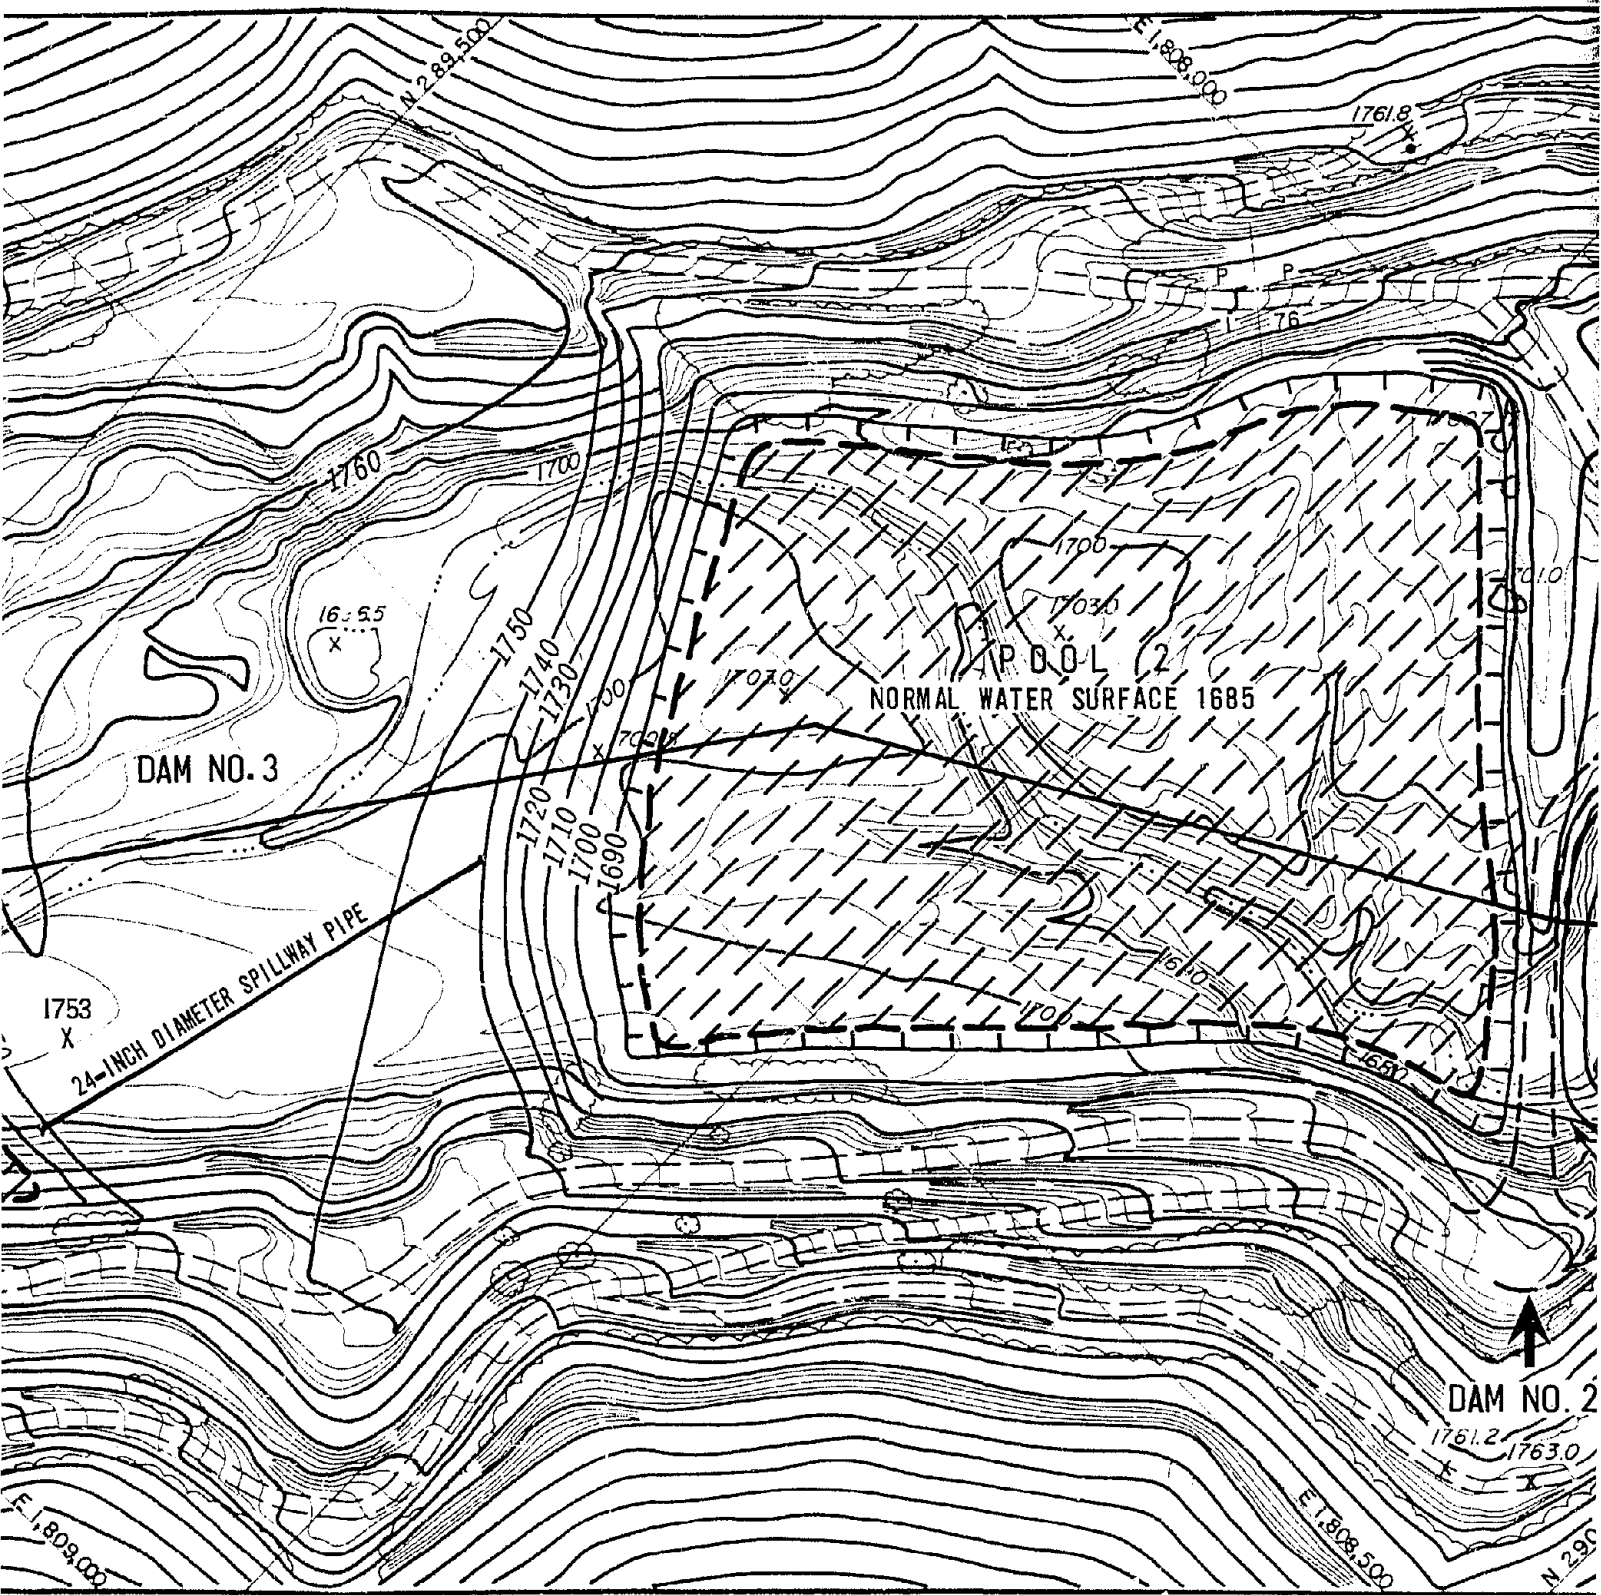
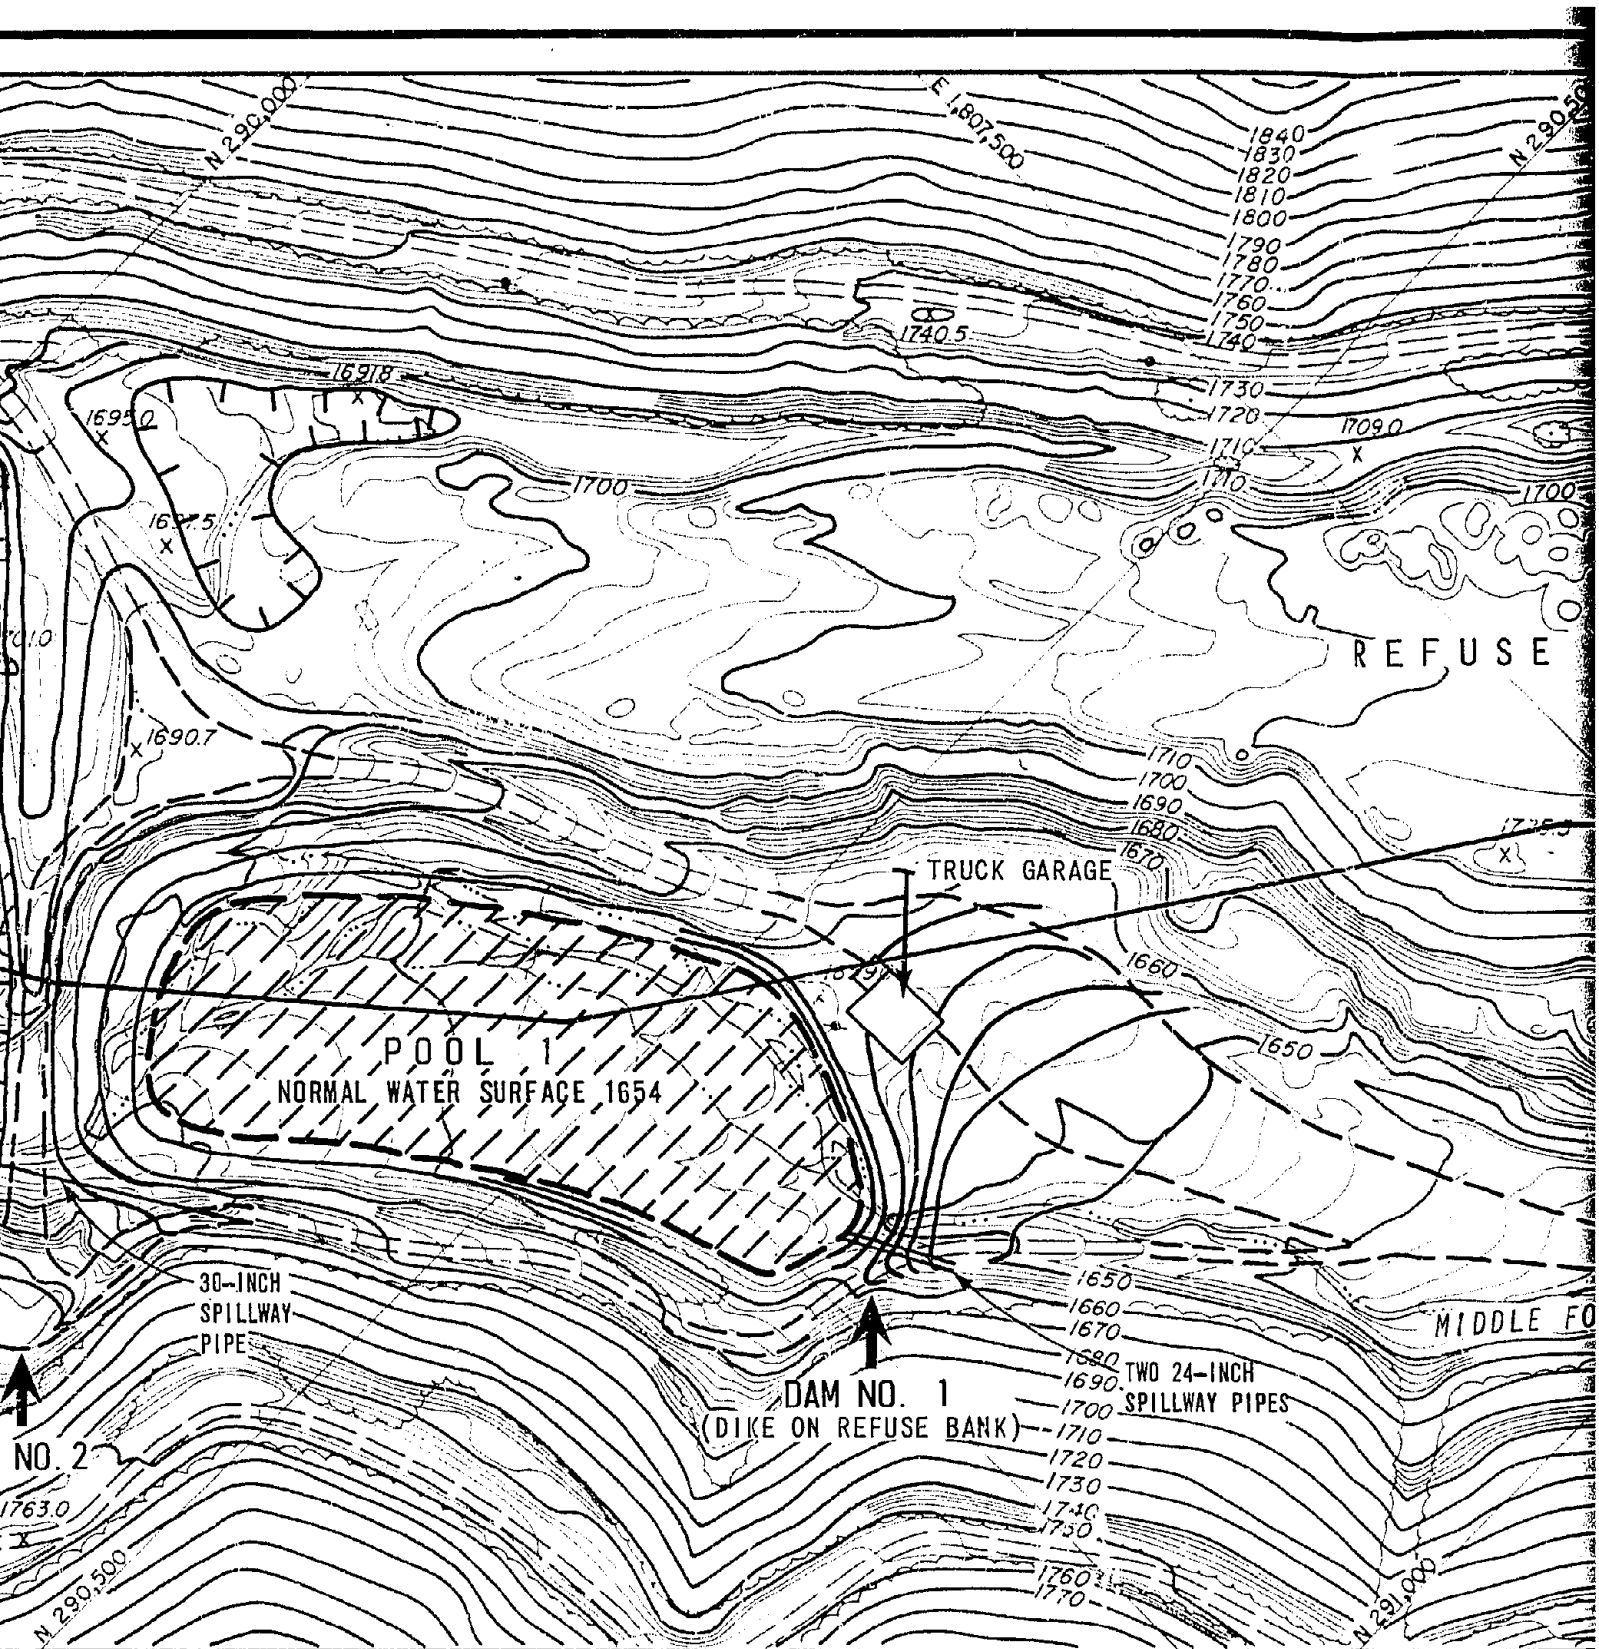
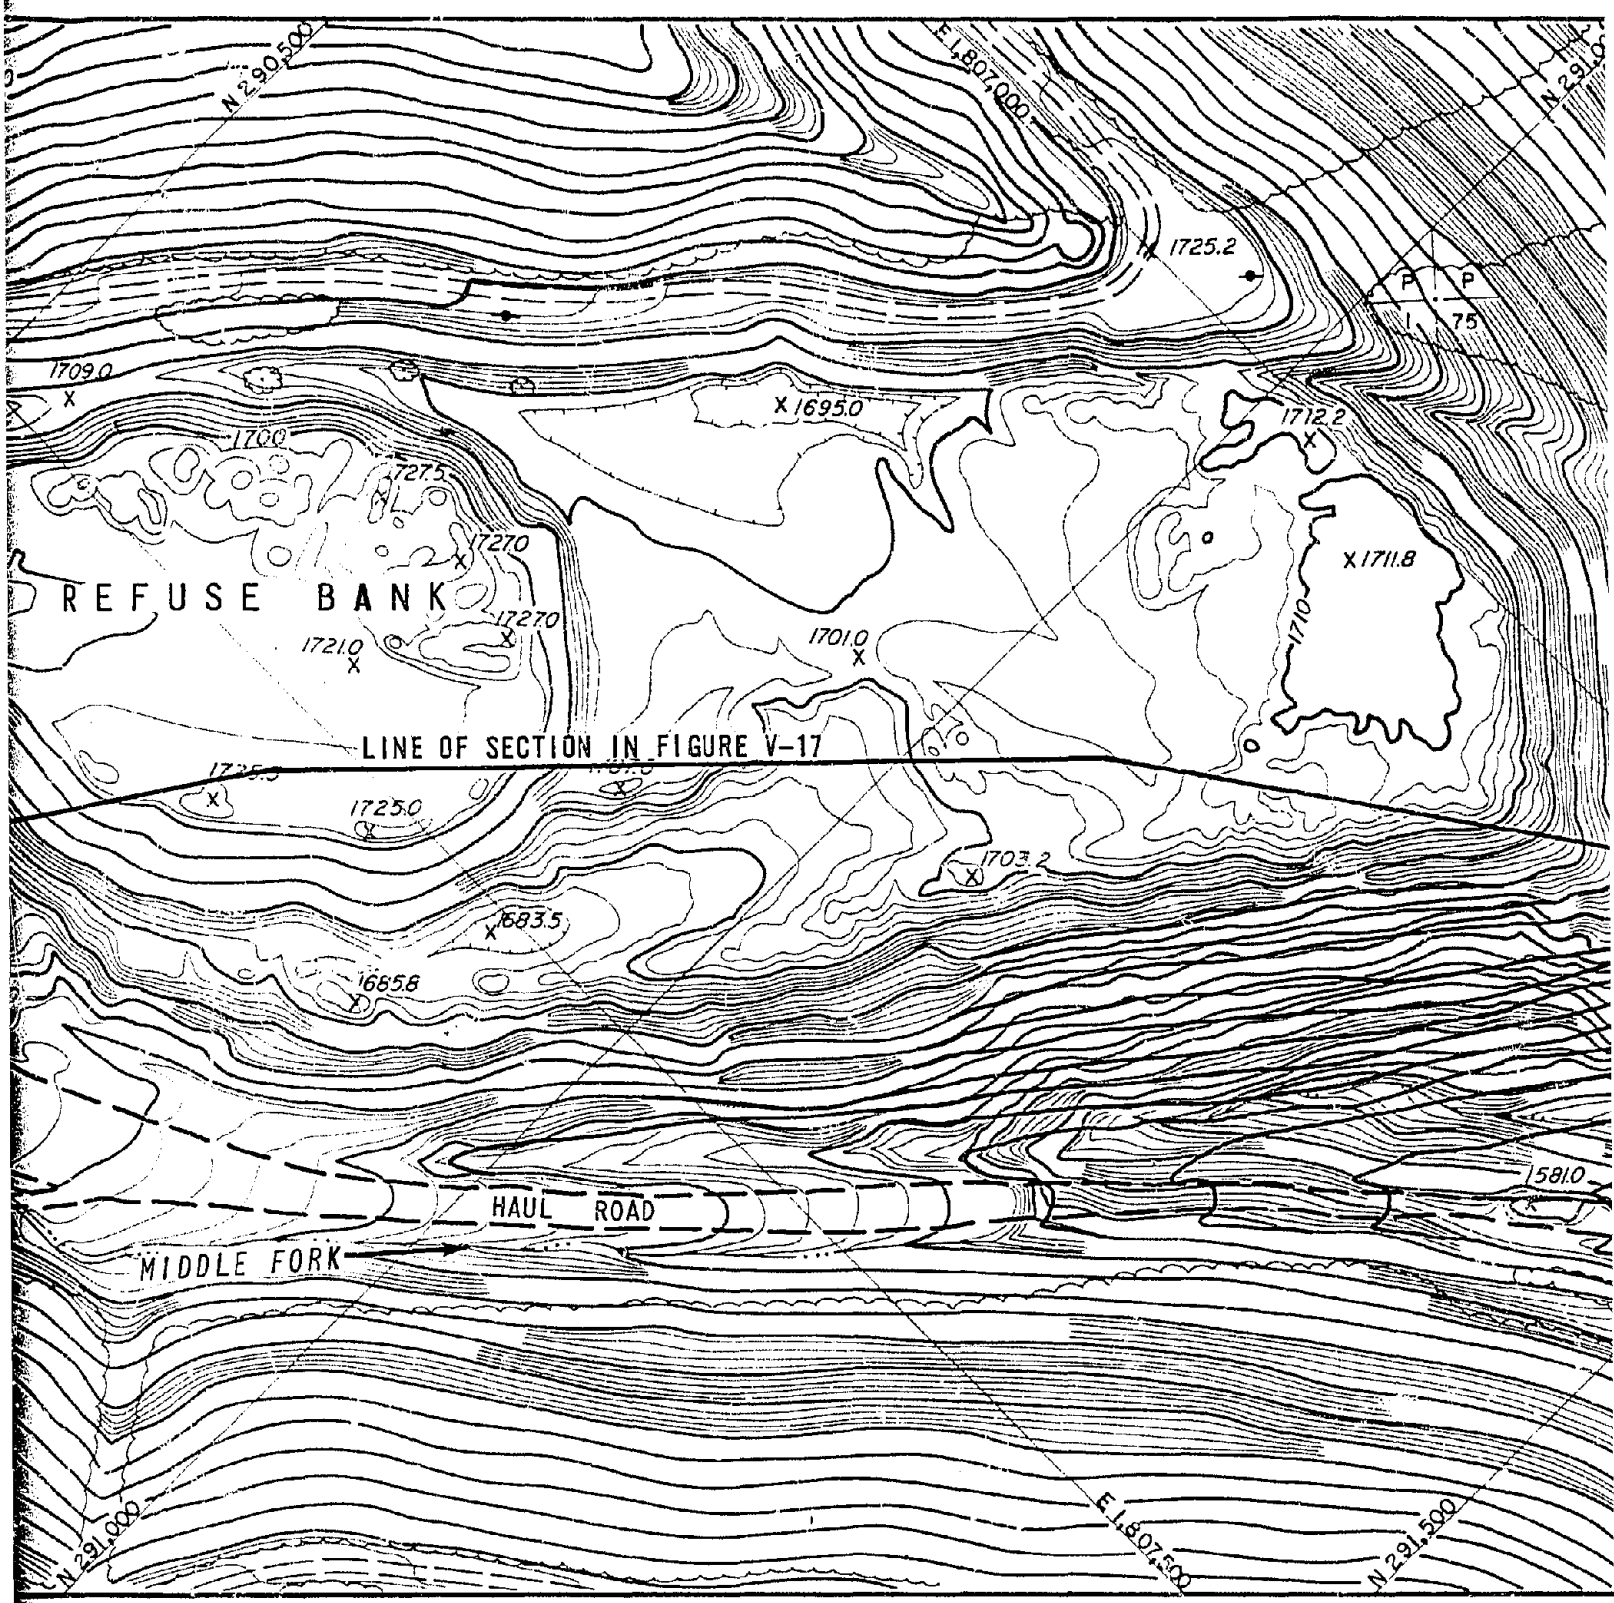
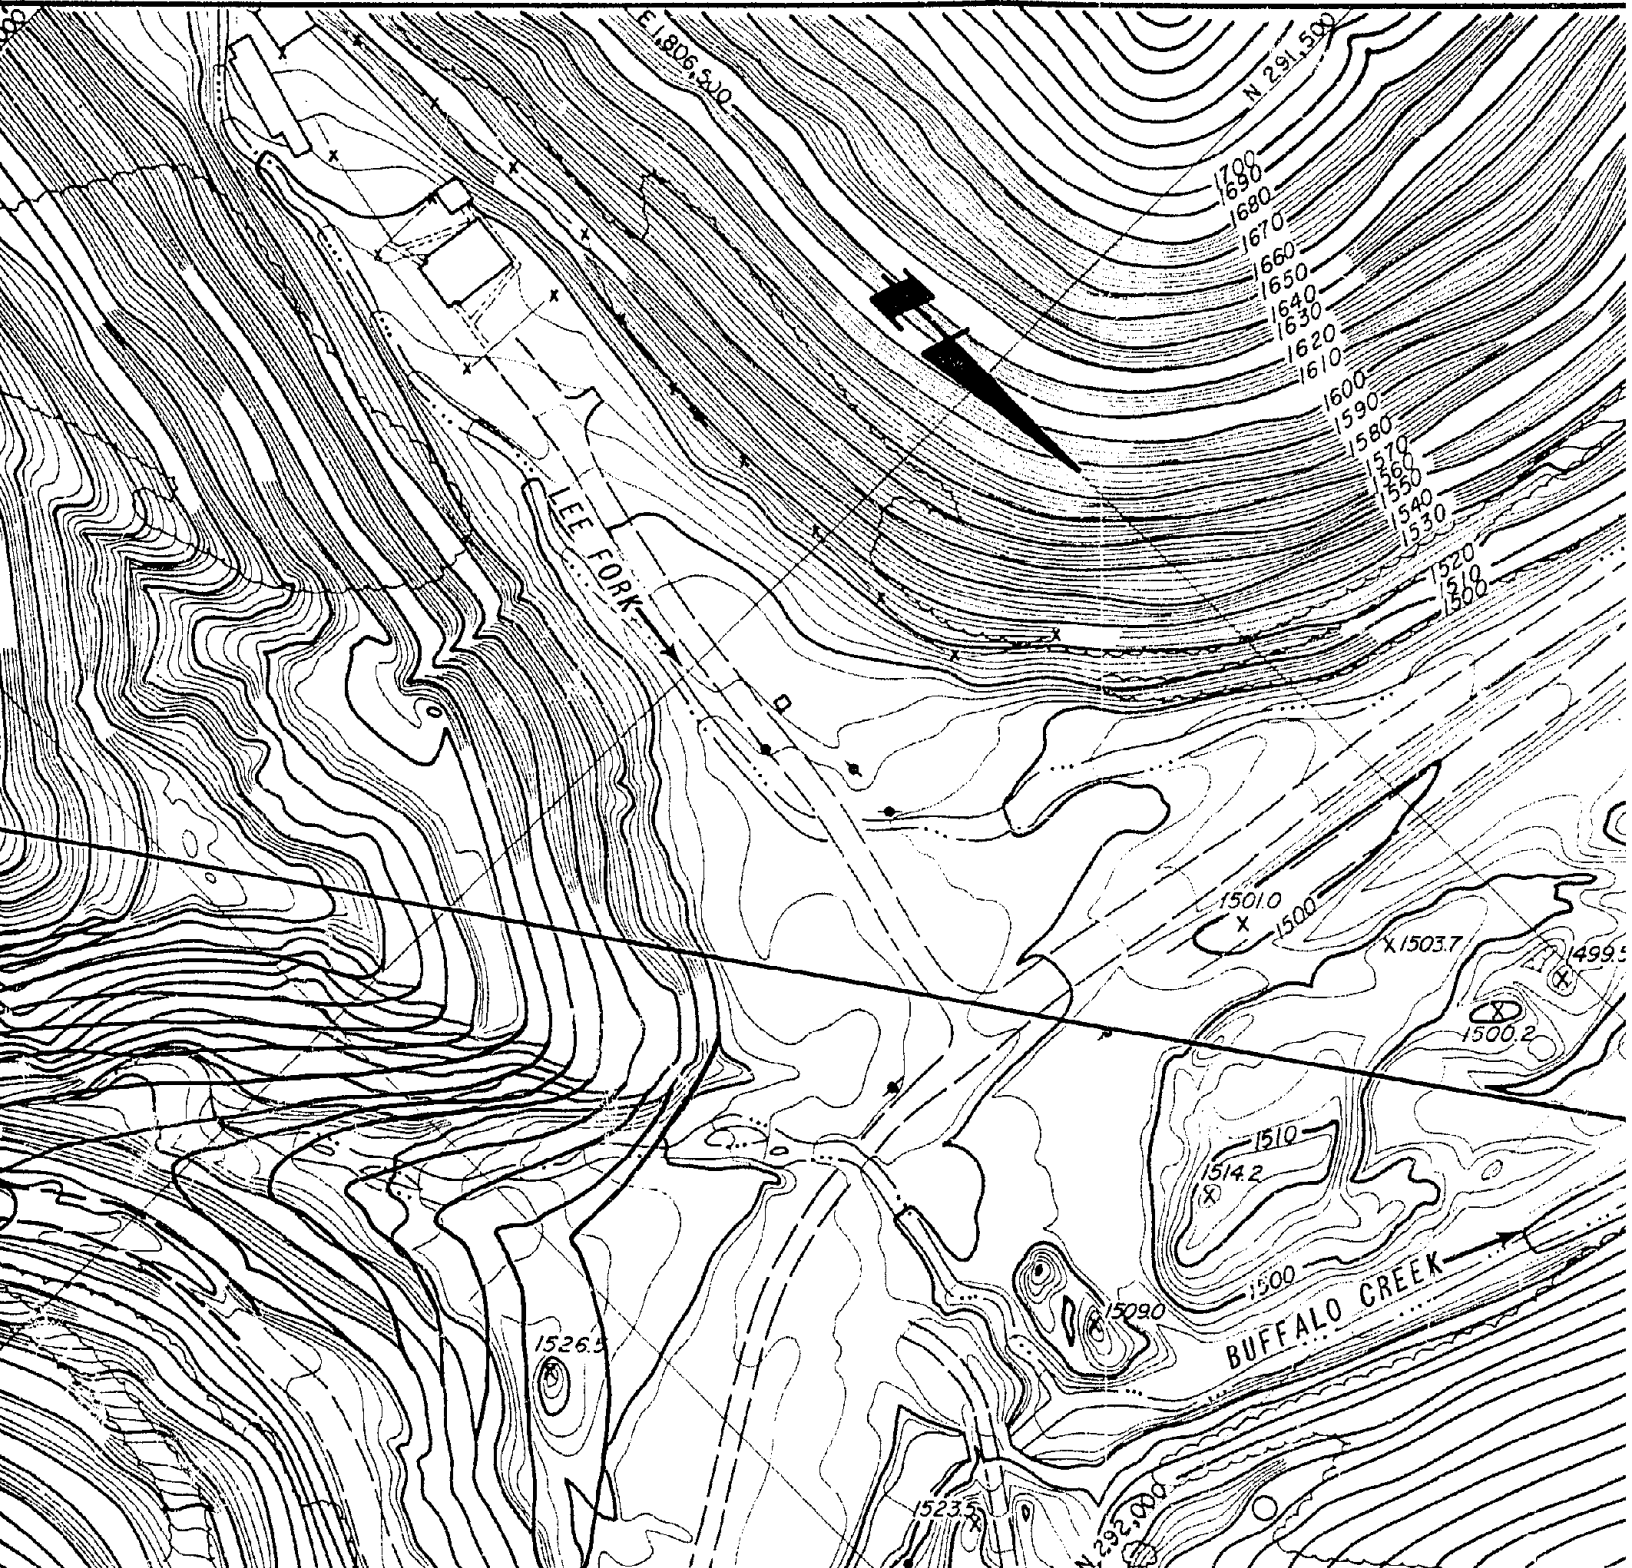
W.A. WAHLER & ASSOCIATES	COAL REFUSE DAM FAILURE SAUNDERS, WEST VIRGINIA		GENERALIZED PREFAILURE TOPOGRAPHY MIDDLE FORK VALLEY, EARLY 1972	
	PALO ALTO • NEWPORT BEACH • CALIF.	PROJECT NO 0700	DATE NOVEMBER 1972	FIGURE NO. V-16

The appearance of the refuse bank and Dams 1, 2, and 3 in early 1972 is seen on Figure V-16, in which postfailure topographic mapping was modified to show generalized prefailure topography, according to the available descriptions of the dams. Figure V-17 is a section generally along the center of Middle Fork Valley, and shows the profile of the dams and refuse bank before failure. Large-scale, more detailed versions of these drawings were used in our engineering analysis. Another interpretation of the prefailure appearance of the valley is shown on Figure V-18, where the prefailure outlines of the dams and pools have been sketched on a postfailure aerial photograph. Figure V-19 is a diagrammatic sketch of Middle Fork Valley before the failure.

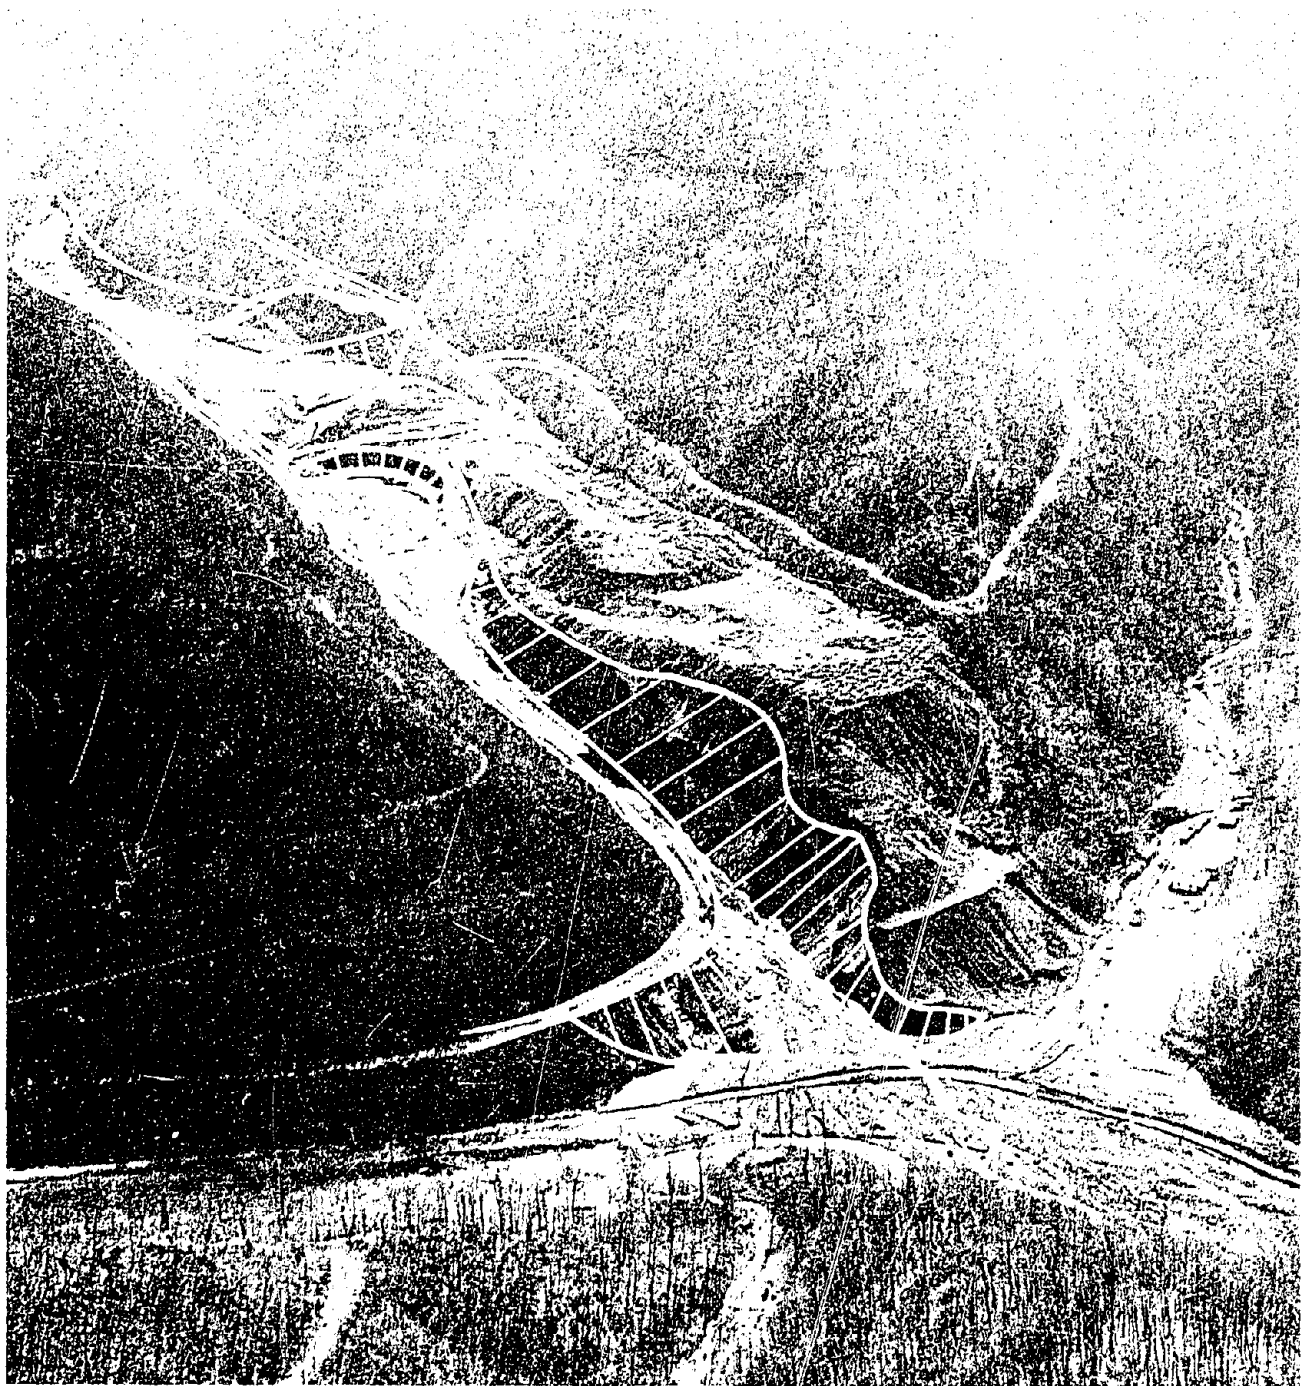
AERIAL VIEW OF MIDDLE FORK VALLEY, FEBRUARY 28, 1972, LOOKING UPSTREAM. THE PREFAILURE CONFIGURATION OF REFUSE BANK AND DAMS 1, 2, AND 3, HAS BEEN ADDED. PHOTO COURTESY, WEST VIRGINIA DEPARTMENT OF HIGHWAYS.

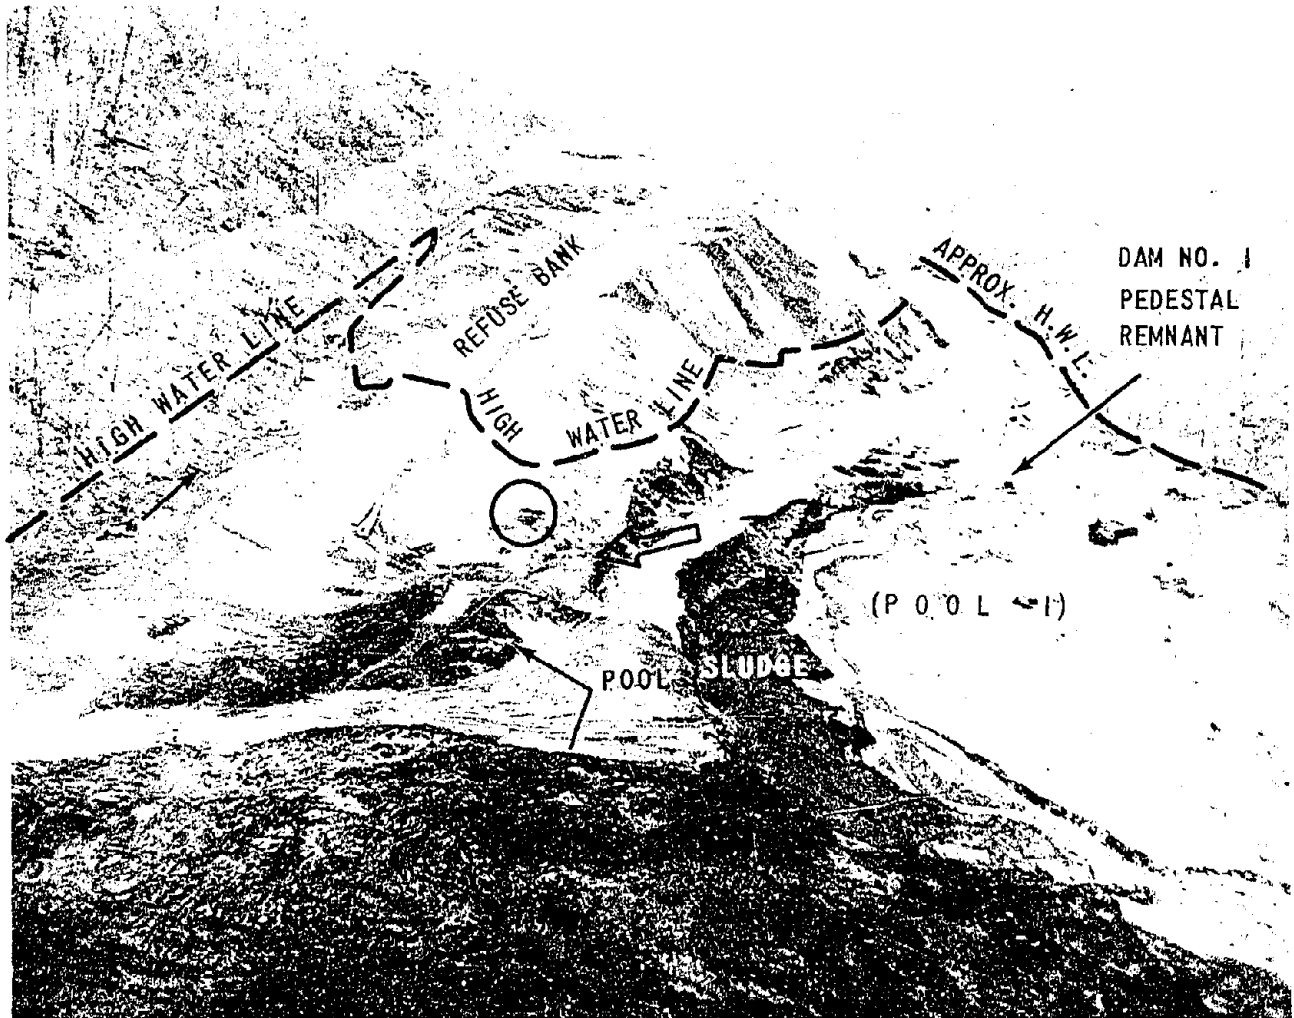
AERIAL VIEW OF MIDDLE FORK VALLEY, LOOKING DOWNSTREAM FROM ABOVE DAM NO. 2. THE TWO LENGTHS OF 24-INCH DIAMETER PIPE (LEFT OF THE STATION WAGON BODY) ARE THE ONES BUFFALO MINING COMPANY INTENDED TO INSTALL IN DAM NO. 3 AS A SUPPLEMENTAL SPILLWAY. THE DAM FAILED BEFORE THE PIPES COULD BE INSTALLED. THE APPROXIMATE HIGH WATER LINE FROM THE FLOOD IS SHOWN ON THE REFUSE BANK. PATCHES OF SLUDGE BELIEVED TO REPRESENT THE HIGHEST POOL 2 SLUDGE, AT ELEVATION 1702, ARE CIRCLED NEAR THE CENTER. THE MAIN MASS OF POOL 2 SLUDGE (BOTTOM OF PHOTO) WAS EMPLACED BY BEING PUSHED BY A MASSIVE SLIDE OF DAM NO. 3 EMBANKMENT INTO POOL 2. THE PATCHES PROBABLY WERE DETACHED FROM THE MAIN BODY OF SLUDGE AND EMPLACED BY THE FLOOD WATERS. FOR A CLOSE-UP VIEW OF THE HIGH WATER LINE, INDICATED BY THE SOLID ARROW, SEE FIGURE VI-6. THE ROAD HAS BEEN CLEARED OF SLUDGE; COMPARE THIS VIEW (TAKEN MARCH 15, 1972) WITH THE SOMEWHAT MORE EXTENSIVE SLUDGE DEPOSITS SHOWN IN FIGURE VI-19, TAKEN FEBRUARY 28, 1972. THE OPEN ARROW POINTS TO THE SMALL STREAM TERRACE SHOWN CLOSE-UP IN FIGURE VI-27C.

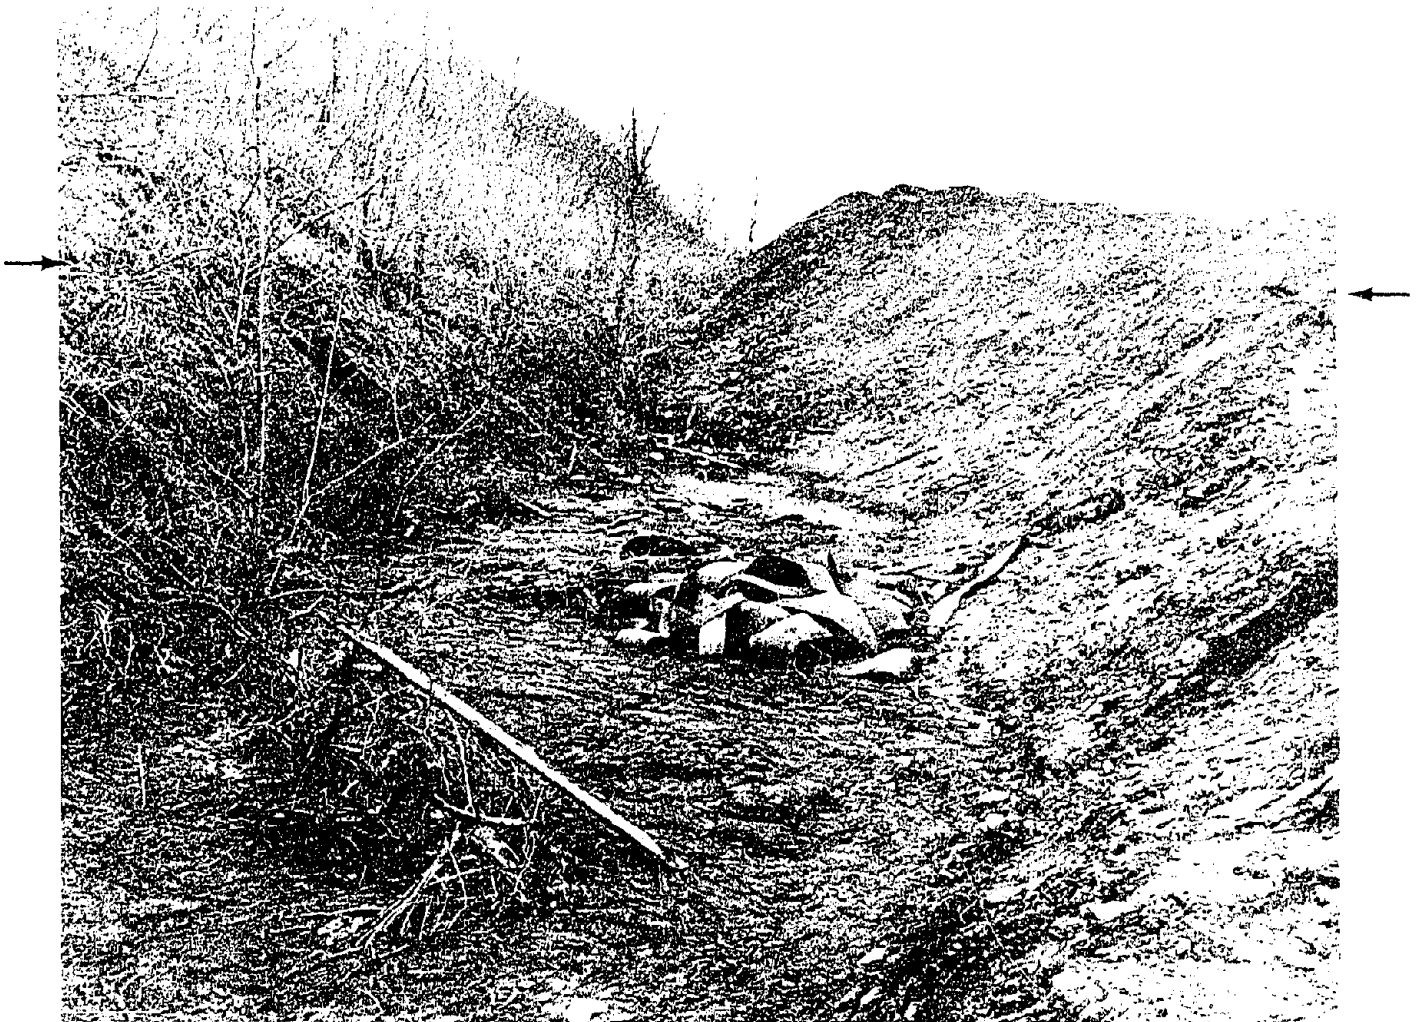
HIGH WATER LINE (ARROWS) AT APPROXIMATELY ELEVATION 1709 AT LEFT SIDE OF REFUSE BANK PHOTO
TAKEN ON FEBRUARY 29, 1973

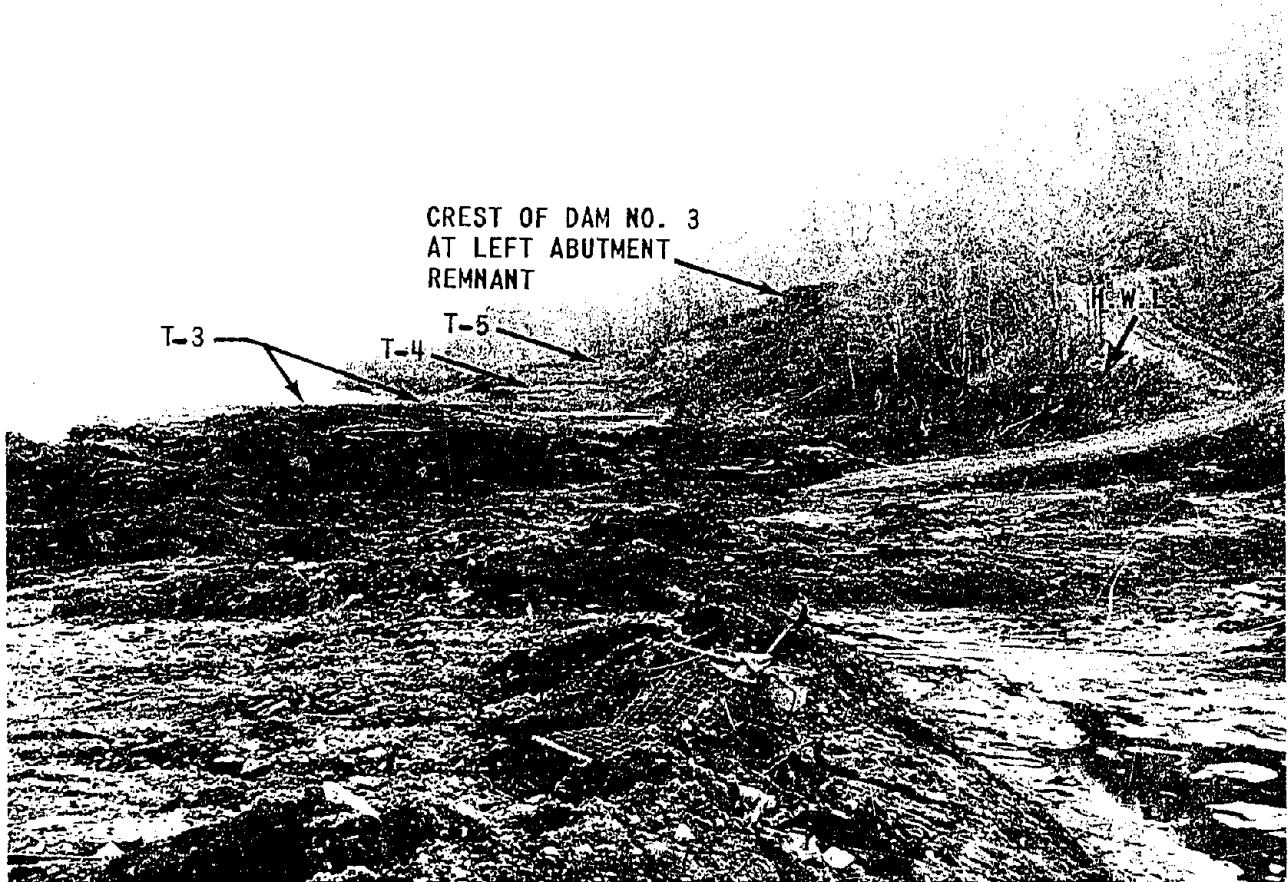
LEFT SIDE OF MIDDLE FORK VALLEY, LOOKING UPSTREAM FROM THE UPPER END OF THE REFUSE BANK. NOTE POOL 2 SLUDGE COVERING THE ROAD TO DAM NO. 3. PHOTO TAKEN FEBRUARY 29, 1972. THE THREE HIGHEST STREAM TERRACES CARVED IN DAM NO. 3 BY THE FLOODWATERS ARE INDICATED BY T-3, T-4, AND T-5. H.W.L. = HIGH WATER LINE FROM FLOOD

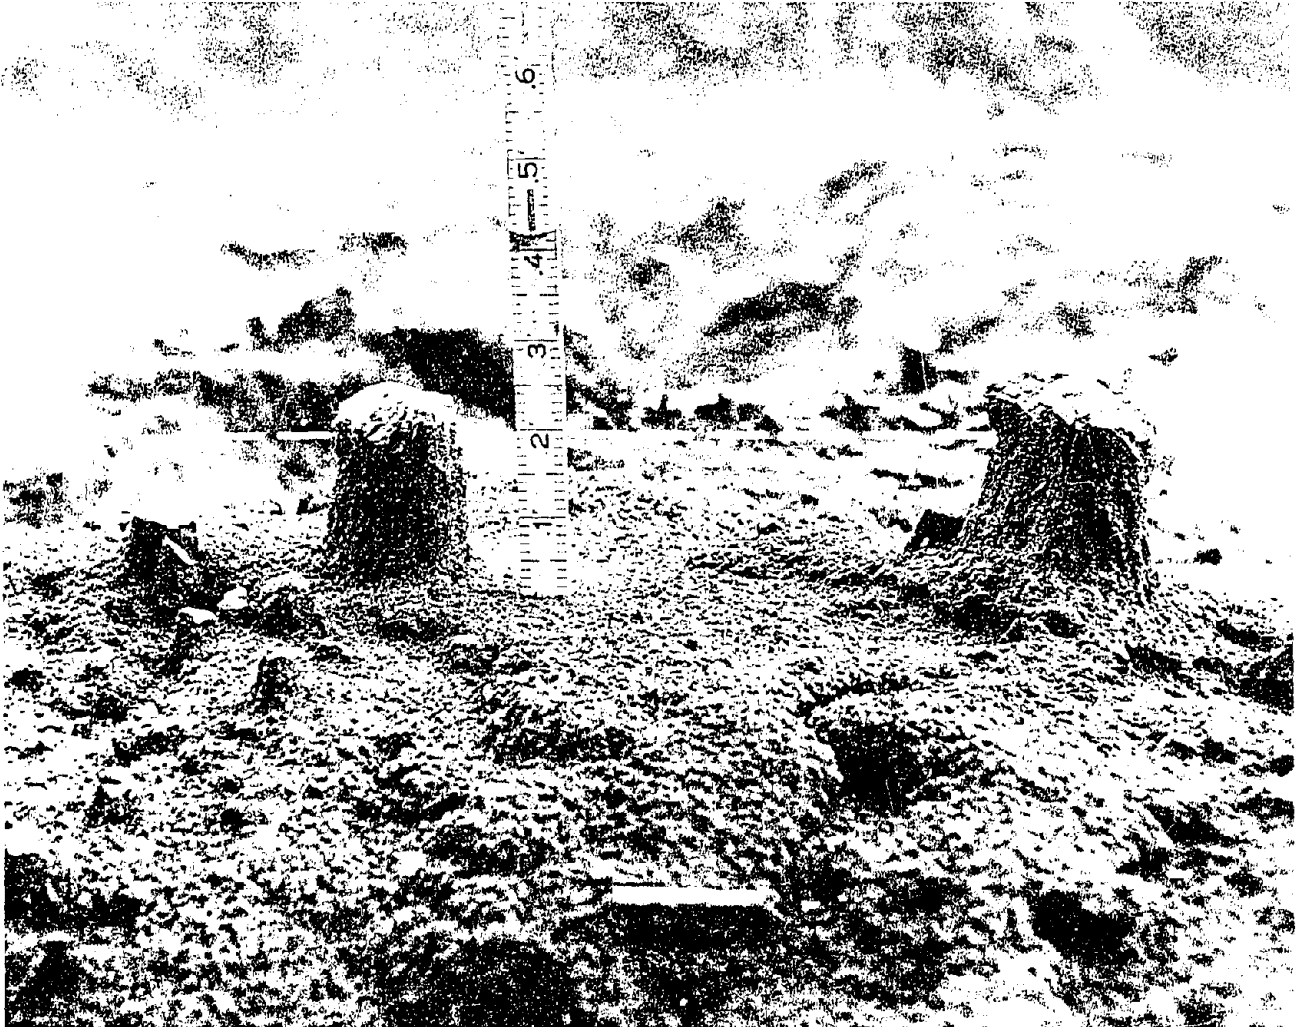
SMALL PEDESTALS IN THE POOL 2 SLUDGE. PHOTO TAKEN AUGUST 2, 1972. THE SURFACE OF THE SLUDGE WAS ORIGINALLY NEAR THE BOTTOM OF THE ROCK CAPS ON THE PEDESTALS. RAIN SINCE THE FLOOD HAS ERRODED ABOUT 0.2 FOOT OF SLUDGE.
