**ANALYSIS OF
COAL REFUSE DAM FAILURE**

**MIDDLE FORK BUFFALO CREEK
SAUNDERS, WEST VIRGINIA**

**UNITED STATES
DEPARTMENT OF THE INTERIOR
BUREAU OF MINES
WASHINGTON, D.C.**

VOLUME 1 OF 2 - TEXT

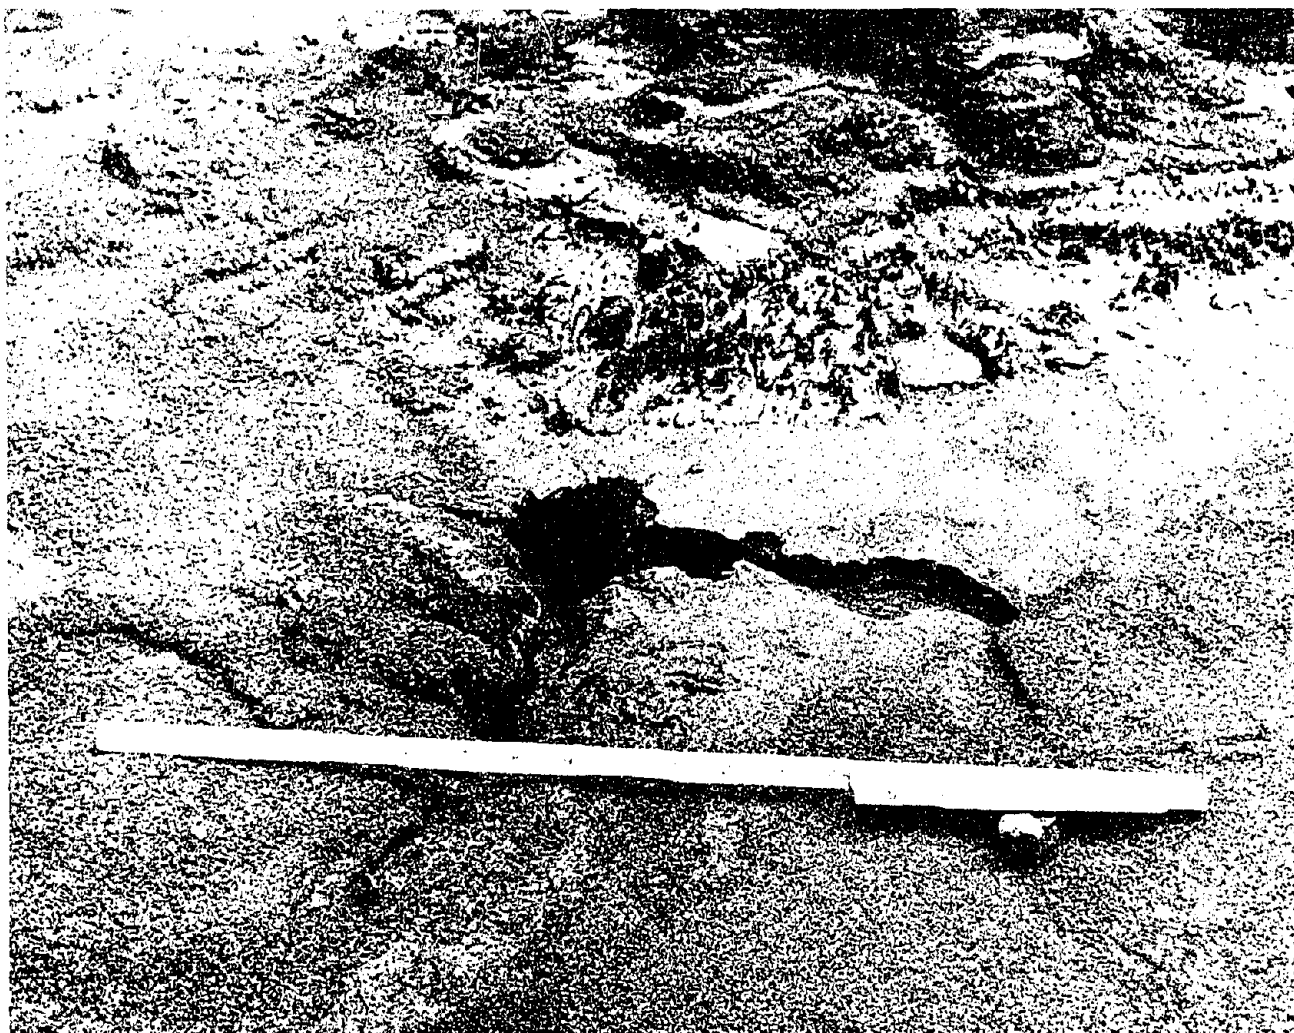
ENTRANCE TO SUBSURFACE CHANNEL IN POOL 2 SLUDGE

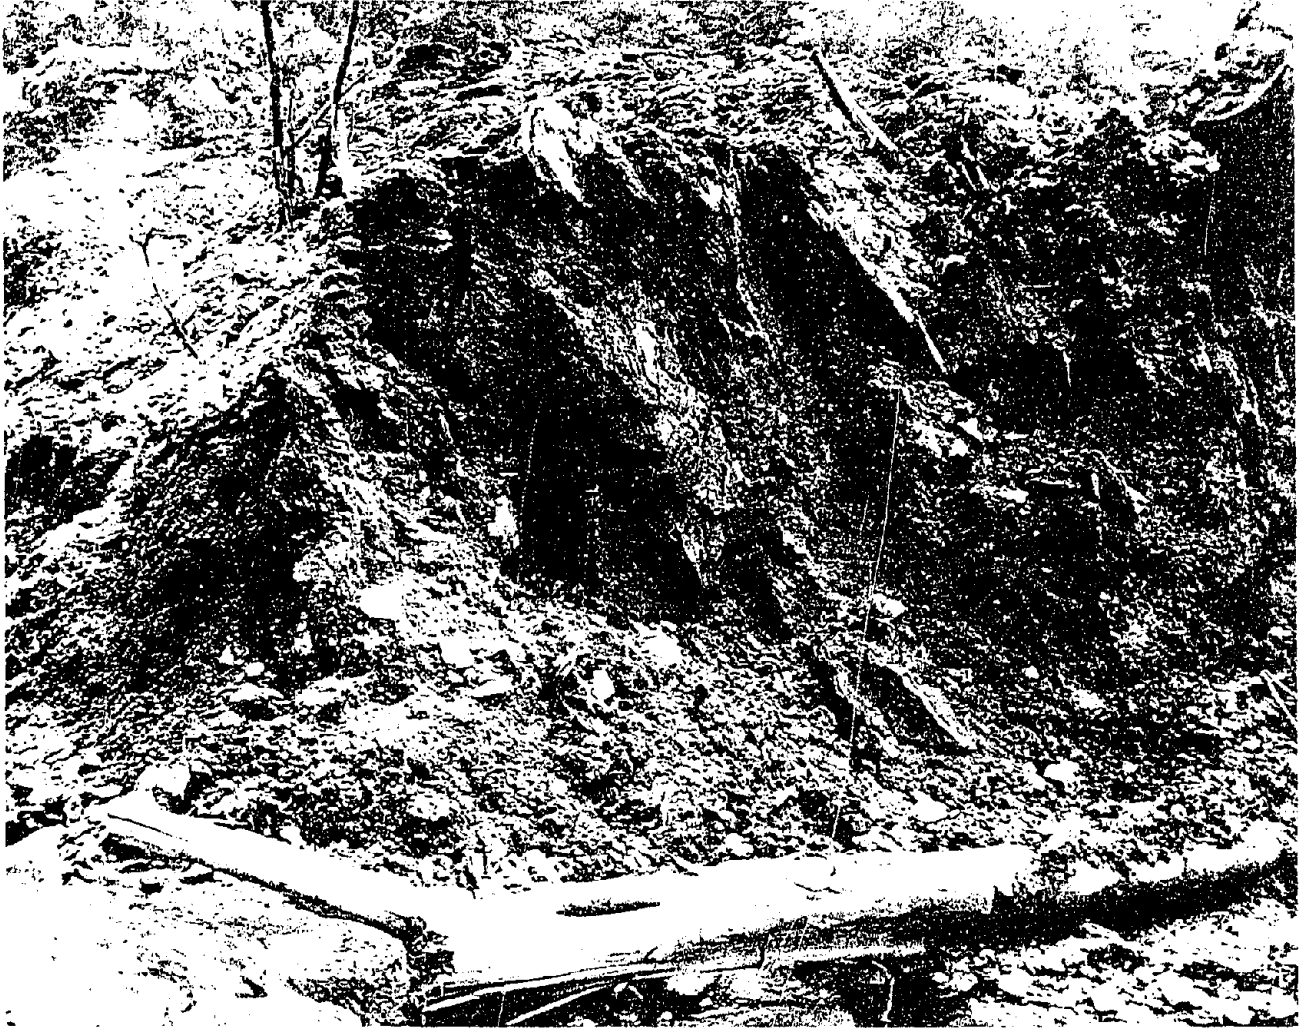
STEEPLY DIPPING CONTACT OF POOL 2 SLUDGE AND DAM NO. 3 EMBANKMENT GRAVELS AREA IS AT THE 82° DIP SYMBOL UPSTREAM FROM THE DAM NO. 2 BREACH ON FIGURE VI-20.

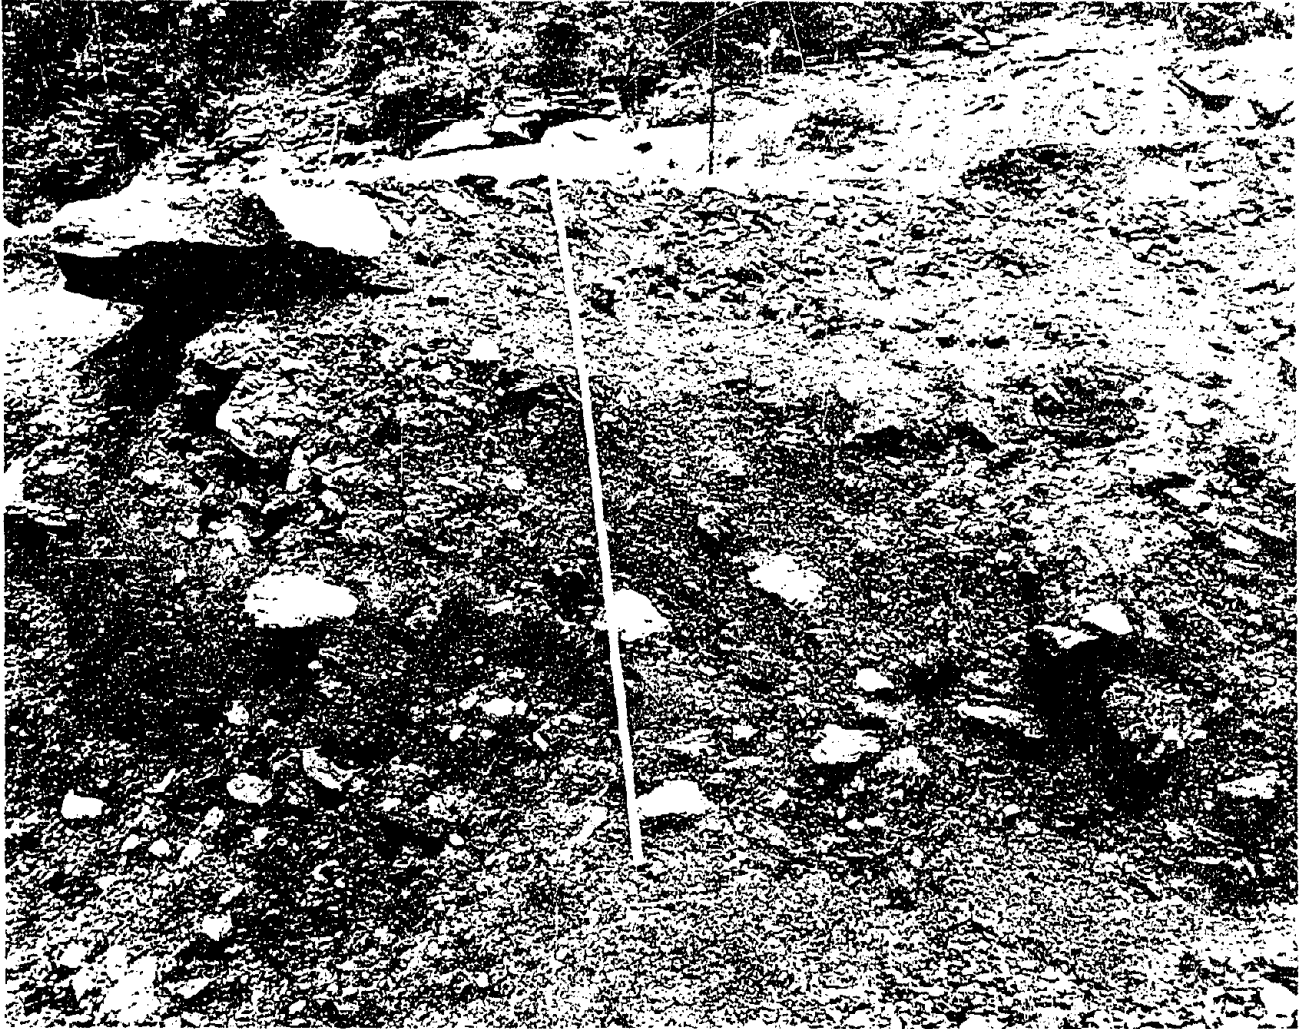
PHOTO OF STREAM BANK 40 FEET SOUTH OF HOLE S-19. THE TOP 1-1 2 - 2 FEET ARE RELATIVELY CLEAN GRAVEL DEPOSITED BY THE FLOOD WATERS. BELOW THE SCOUR LINE IS A COHERENT (BUT TRANSLATED AND ROTATED) PORTION OF THE DAM NO. 3 EMBANKMENT. THE MIDDLE OF THE PHOTO IS AT APPROXIMATELY ELEVATION 1690, PUTTING IT 5 FEET ABOVE THE WATER SURFACE OF POOL 2 WHICH FORMERLY EXISTED HERE

In places, the clean coarse material was several feet thick and, where this thick, it probably represents fill in local channels cut by the flood.

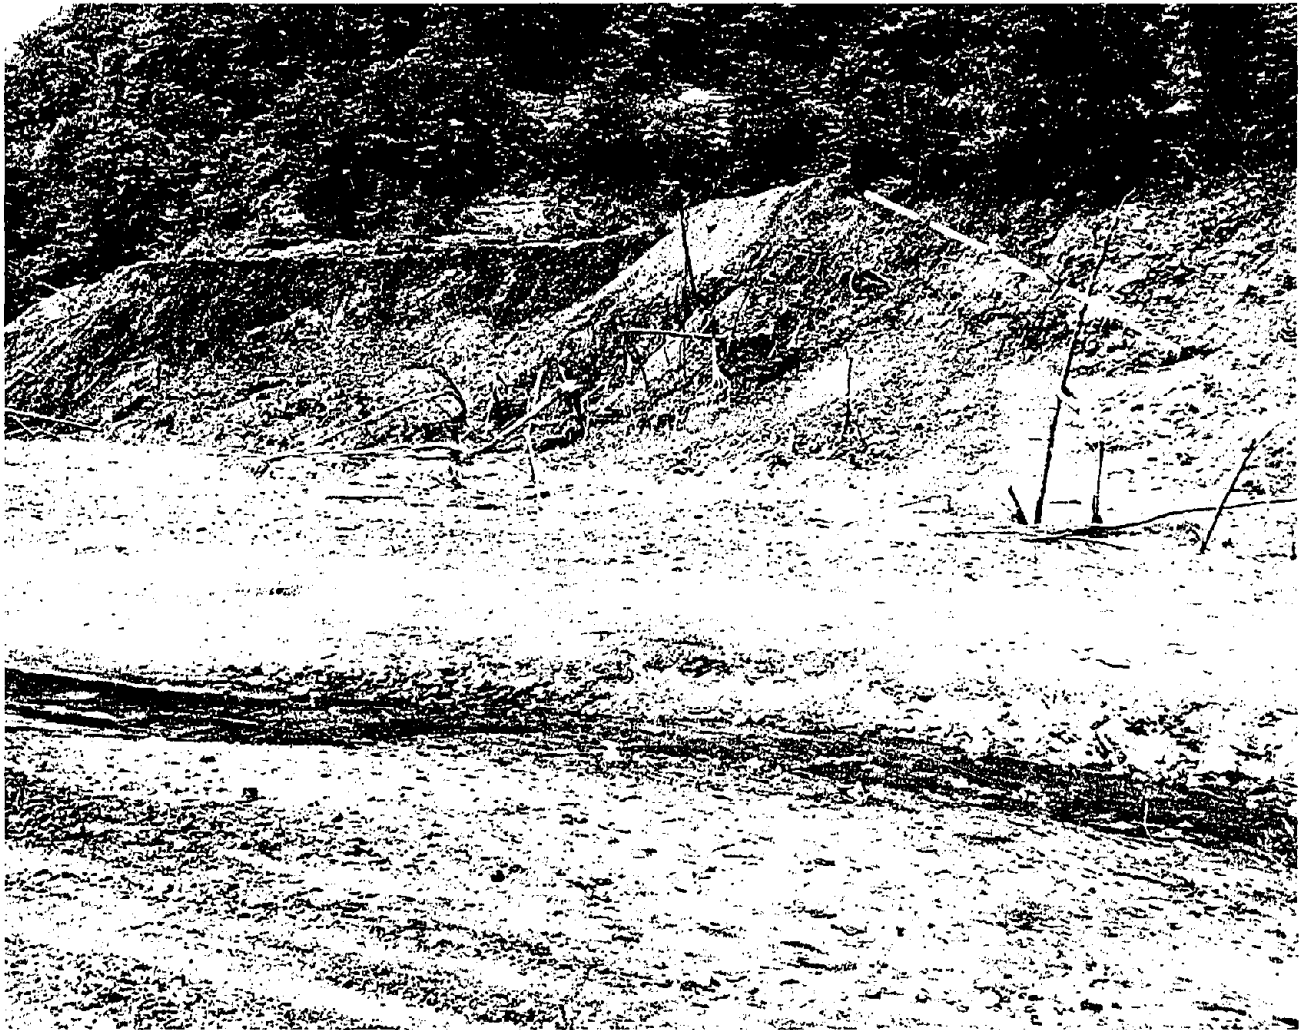
RIGHT ABUTMENT OF DAM NO. 3. THE DASHED LINE INDICATES THE PROBABLE LOCATION OF THE
UPSTREAM EMBANKMENT CONTACT WITH THE VALLEY WALL.

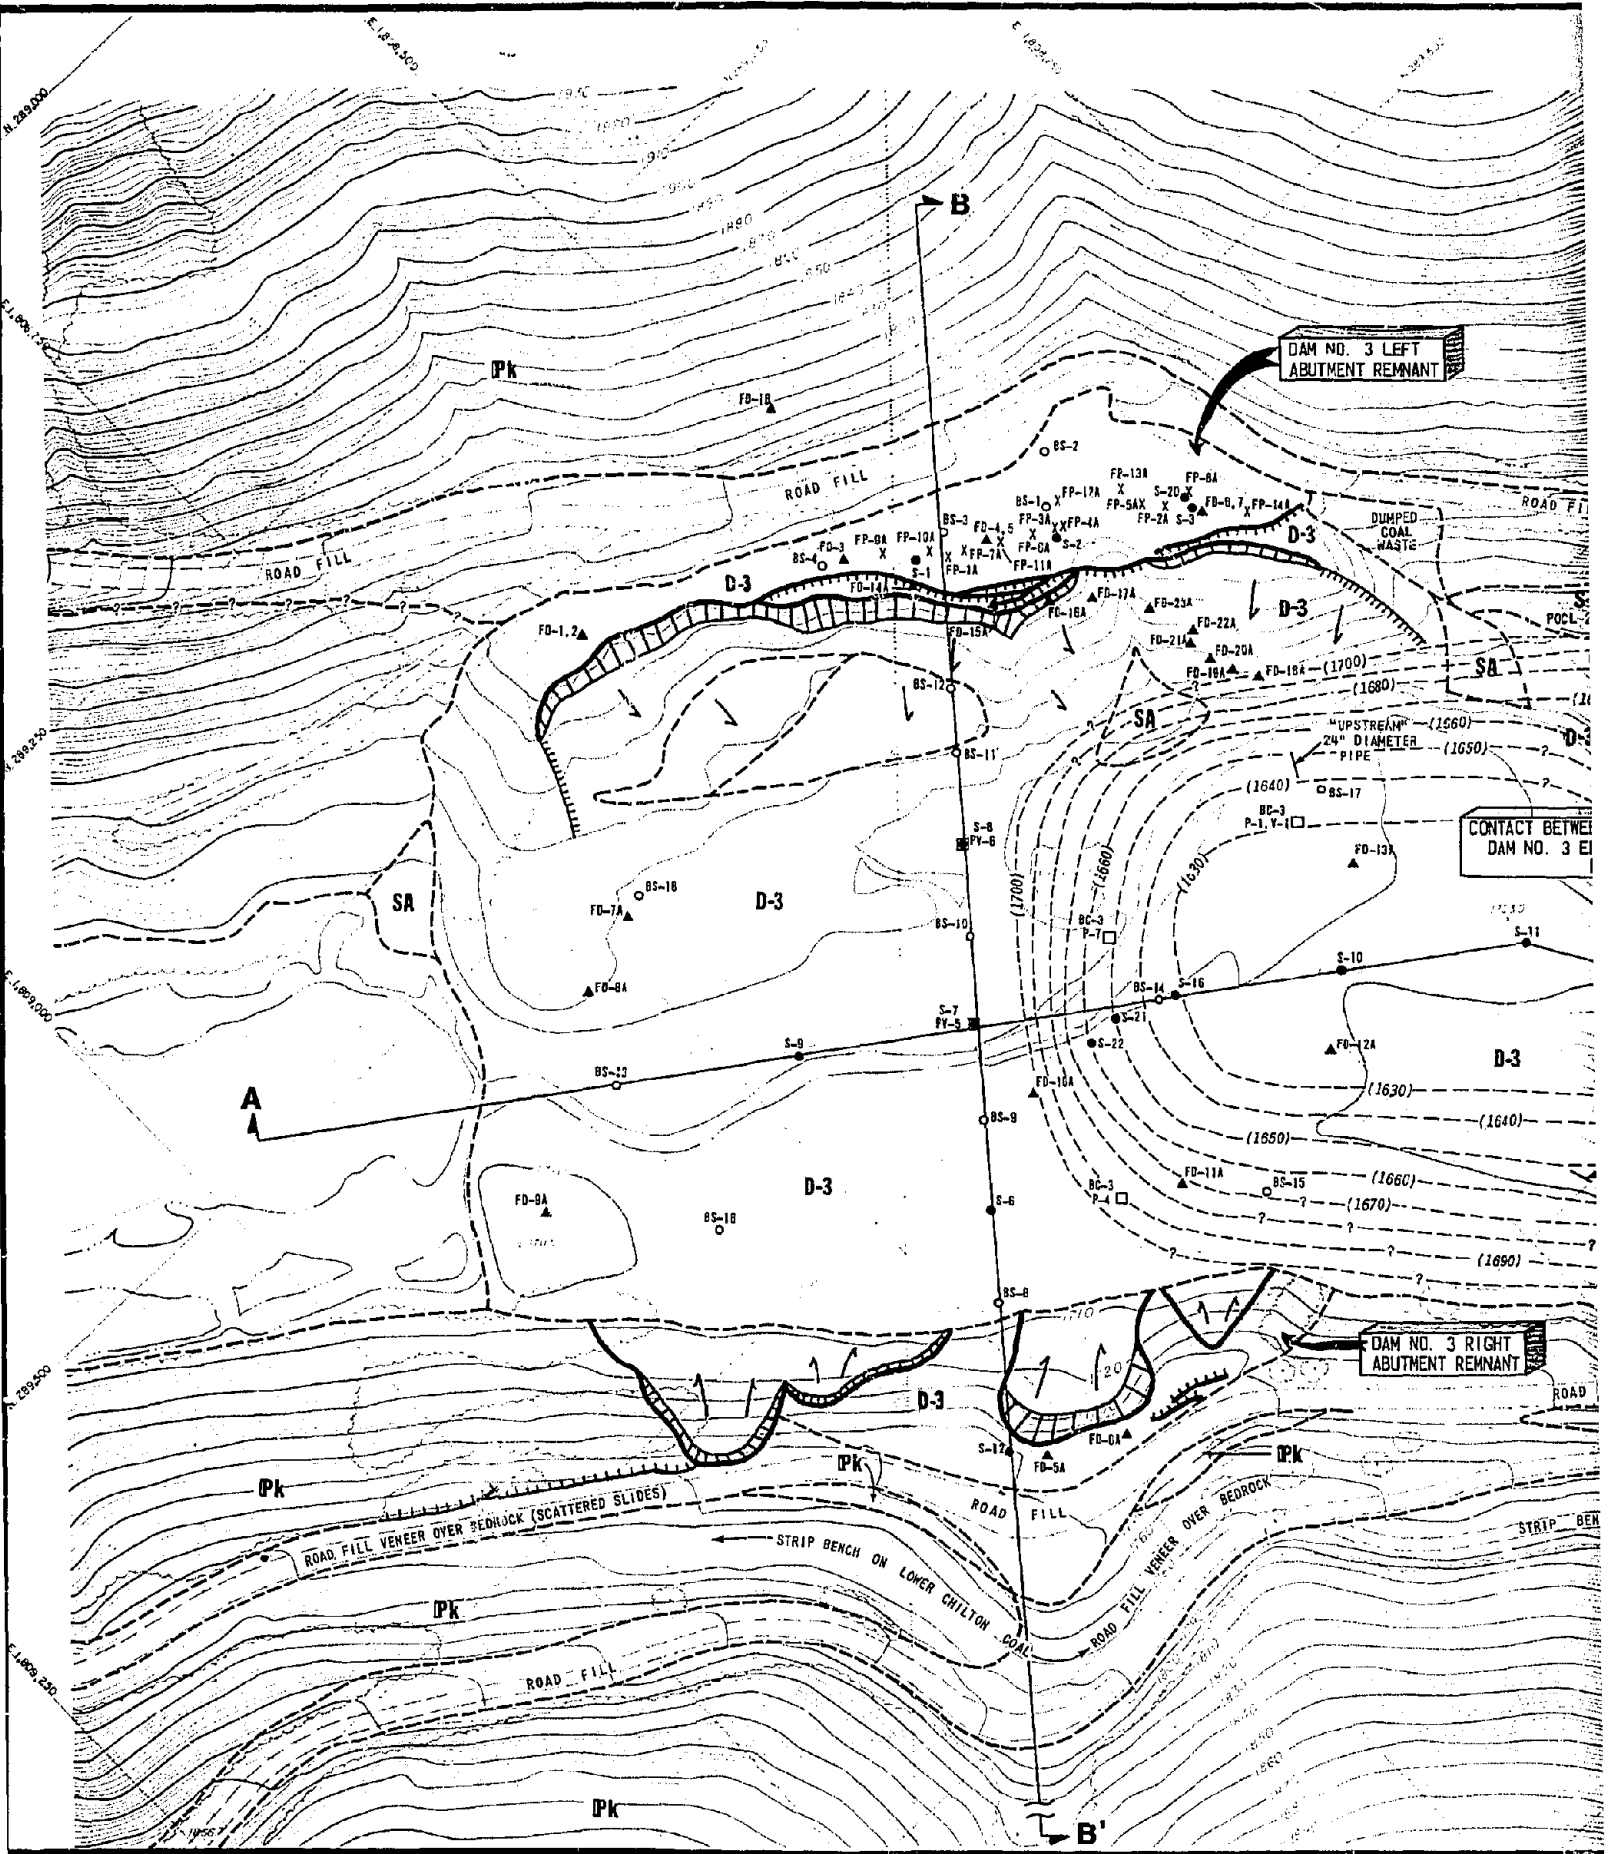
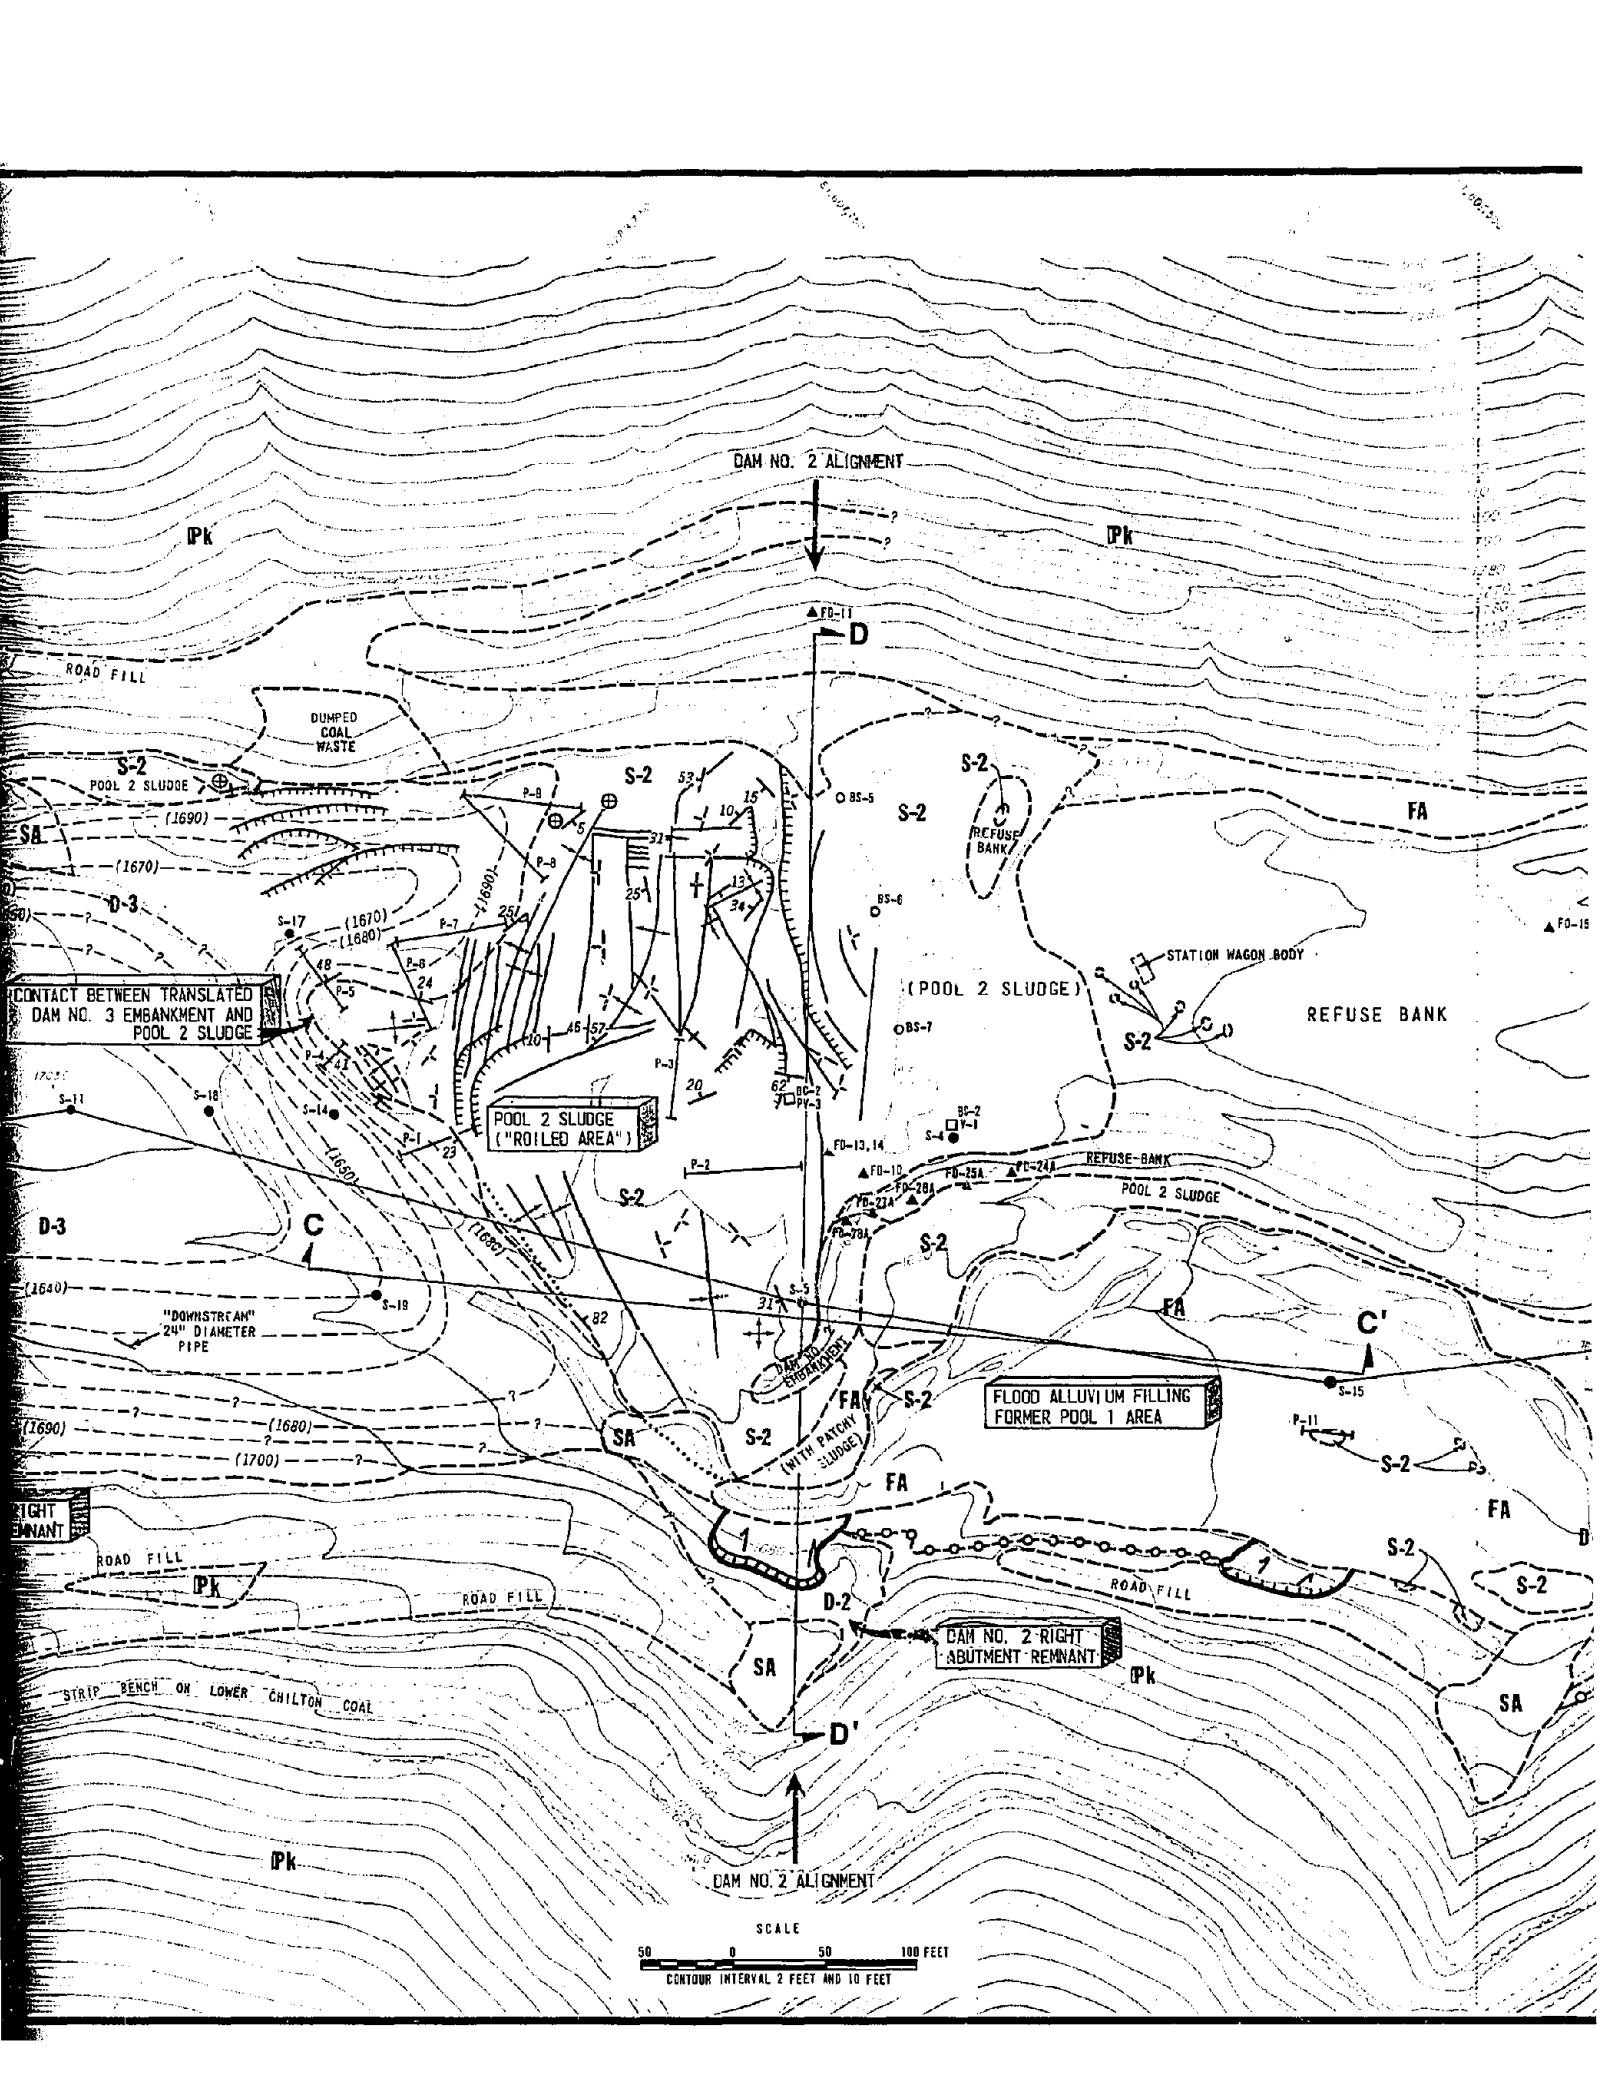
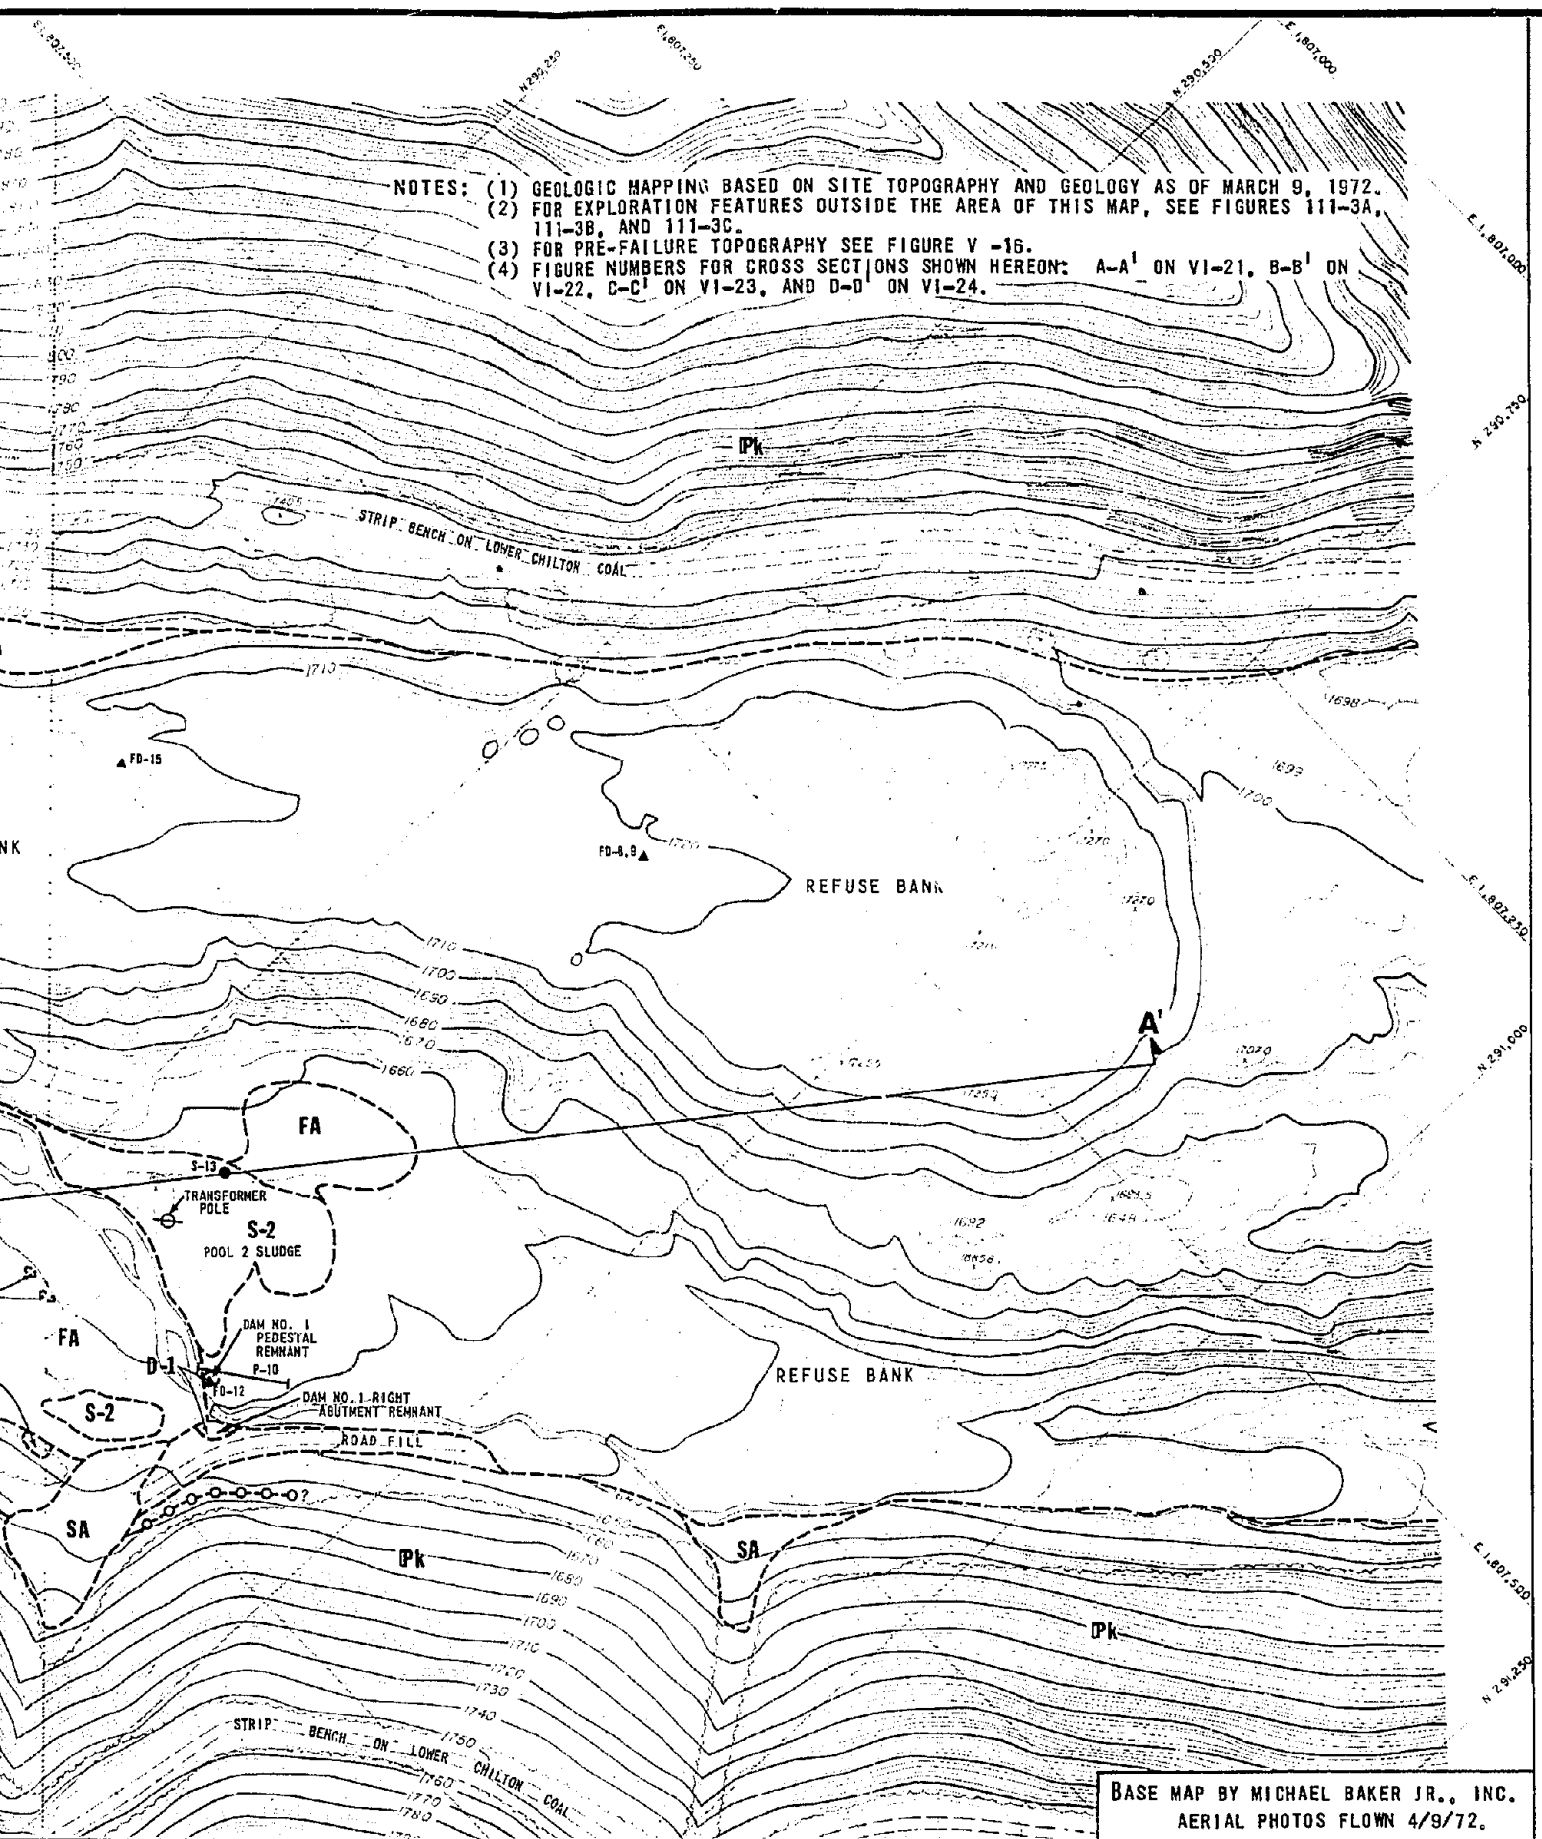
W. A. WAHLER & ASSOCIATES	COAL REFUSE DAM FAILURE SAUNDERS, WEST VIRGINIA	GEOLOGIC AND EXPLORATION MAP DAM NO. 1-DAM NO. 3 AREA	
	PALO ALTO • NEWPORT BEACH • CALIF.	PROJECT NO. 0700	DATE NOVEMBER 1972
		FIGURE NO. VI-20

Features of principal interest on Figure VI-20 are the roiled area of Pool 2 sludge and the contact between it and the translated mass of Dam No. 3 embankment. Map symbols show the structure of the roiled area, and it is also shown on many photographs herein (especially Figures VI-9 through VI-12). The contact between the Pool 2 sludge and the translated Dam No. 3 embankment was explored with backhoe pits, the locations of which are indicated on Figure VI-20. Logs of the pit walls are included in Appendix A (Figure A-6); typical photographs of pit walls are presented on Figure A-4. The roiled area consisted of elongated blocks of Pool 2 sludge which were formed during and after the downstream translation of the slide mass from Dam No. 3. This slide mass pushed the Pool 2 sludge ahead of it, shoving some of it over Dam No. 2. As a result of this movement, the Pool 2 sludge was folded into a series of anticlines (upwarps) and synclines (downwarps), and at the same time broken into a group of steep-sided blocks which jostled about and slid past one another. Some of the sludge later moved through the Dam No. 2 breach (Figure V-2) into the Pool 1 area, and other portions entered Pool 1 by overtopping Dam No. 2. Just left of the former location of the downstream

toe of Dam No. 3, a sliver of Pool 2 sludge was displaced laterally and upward to the left as the slide mass moved downstream. This area is shown on Figure VI-25, Photo C, and represents an important piece of evidence indicating a massive slide failure of Dam No. 3.

The mapped contact between translated Dam No. 3 embankment and Pool 2 sludge (Figure VI-20) has a sinuous shape. This unusual configuration results chiefly from two factors: 1) the contact is irregular because it incorporates earlier Dam No. 3 failures, and 2) the contact was warped near the breach of Dam No. 2 as a result of the forces carrying both sludge and gravel through the breach. The contact and sludge beds on Figure VI-13 may, in fact, have been rotated slightly beyond the vertical. While the outcrop pattern of the embankment-sludge contact is defined by both the surficial exposures and the shallow backhoe pits, its subsurface location was defined best by drill holes. The bottom surface of the translated mass of Dam No. 3 embankment is defined by structure contours on Figure VI-20. These contours are based on drill hole data, slide geometry, depth to bedrock, and the thickness of the sludge below the dam; they are, therefore, interpretive.
