**ANALYSIS OF
COAL REFUSE DAM FAILURE**

**MIDDLE FORK BUFFALO CREEK
SAUNDERS, WEST VIRGINIA**

**UNITED STATES
DEPARTMENT OF THE INTERIOR
BUREAU OF MINES
WASHINGTON, D.C.**

VOLUME 1 OF 2 - TEXT

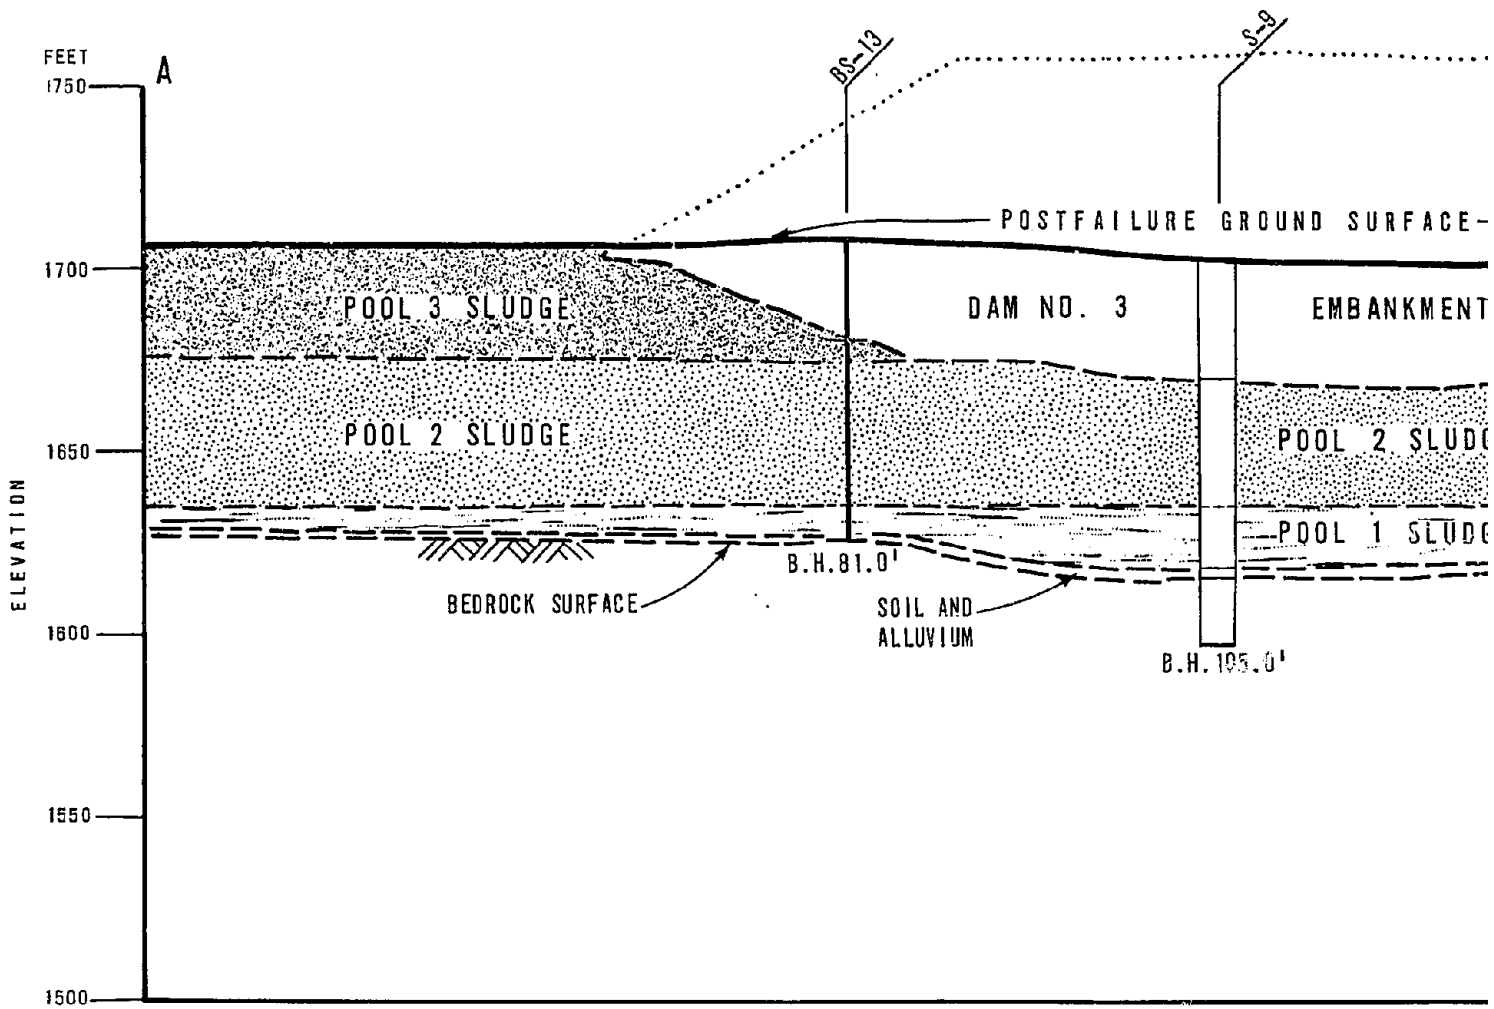
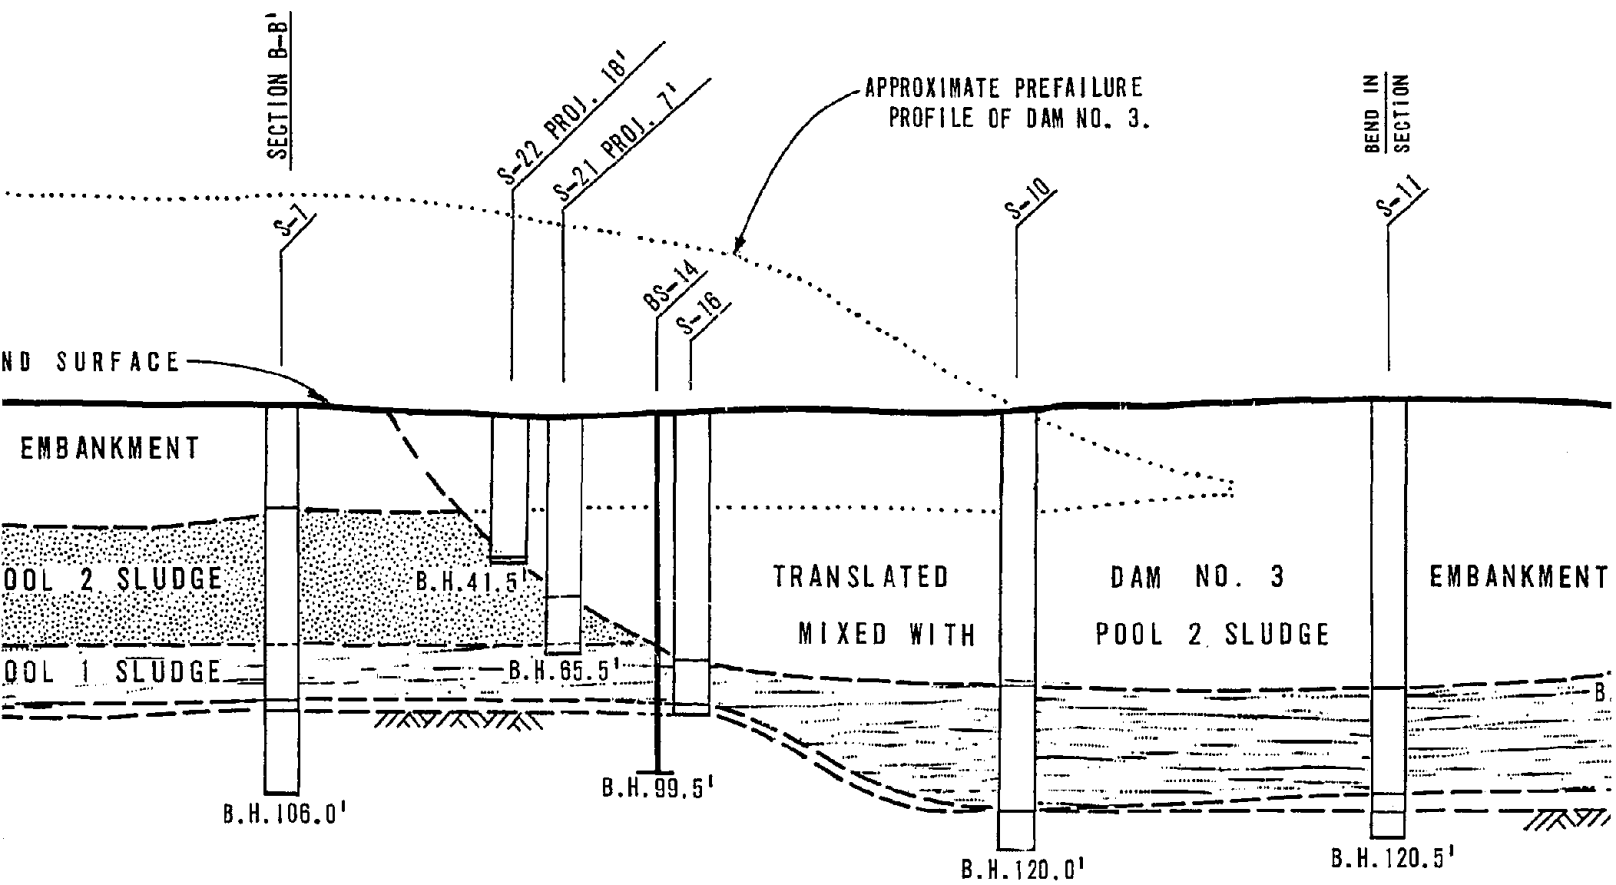
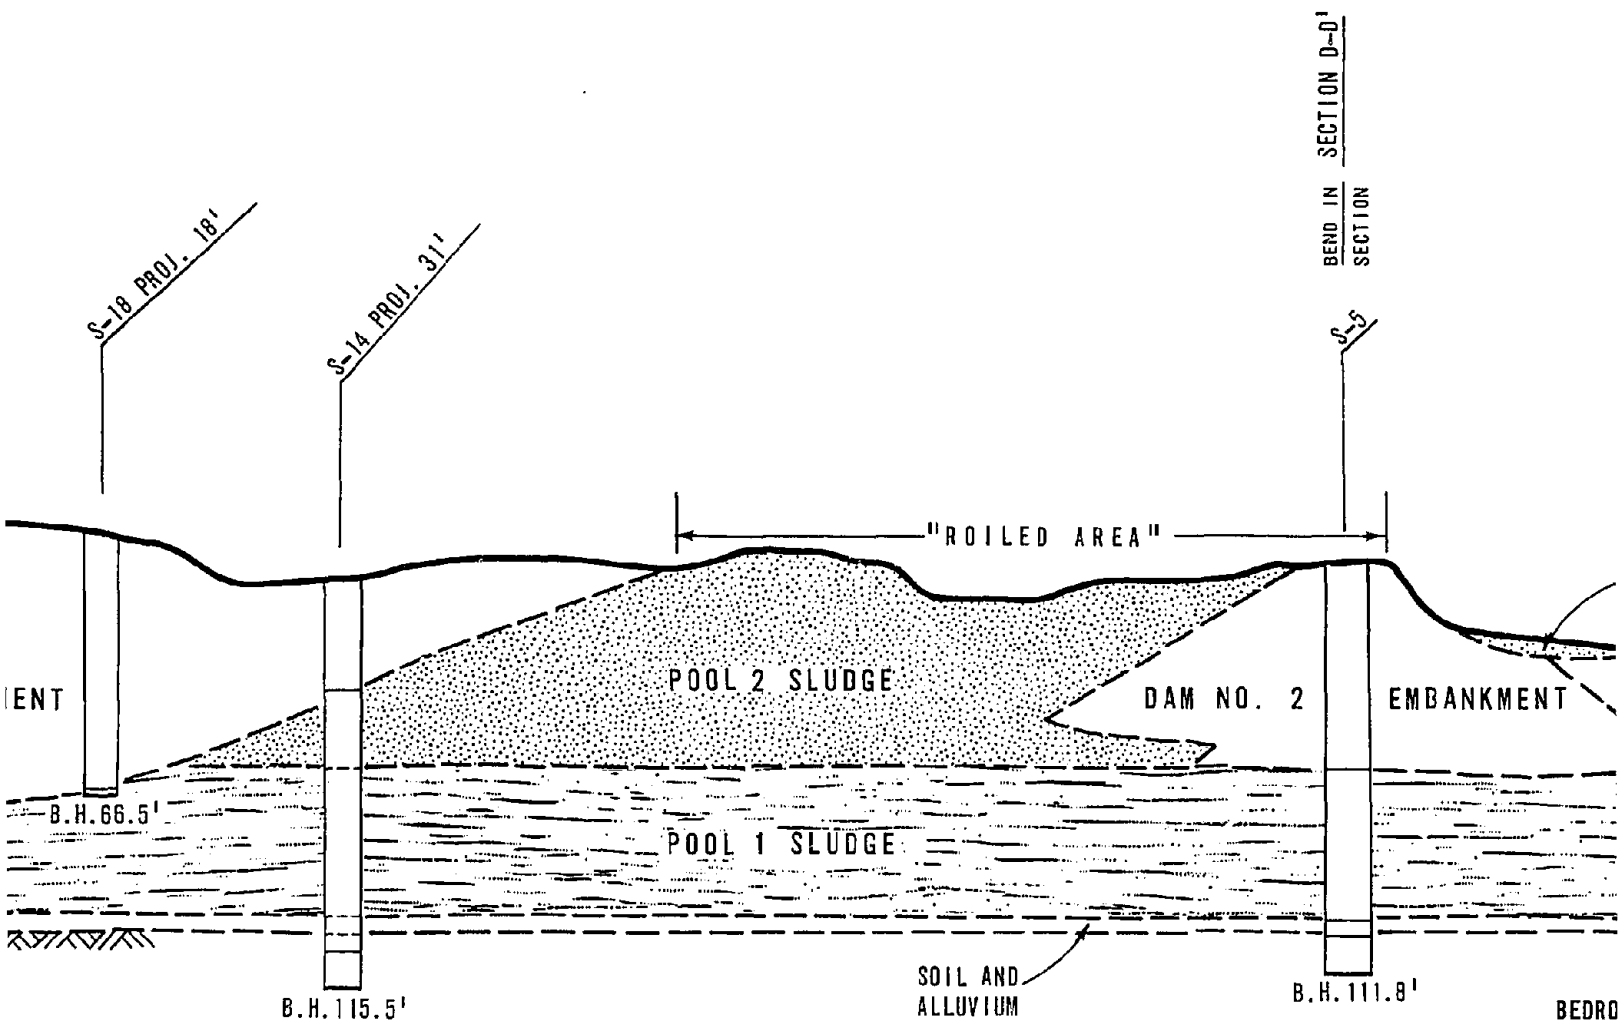
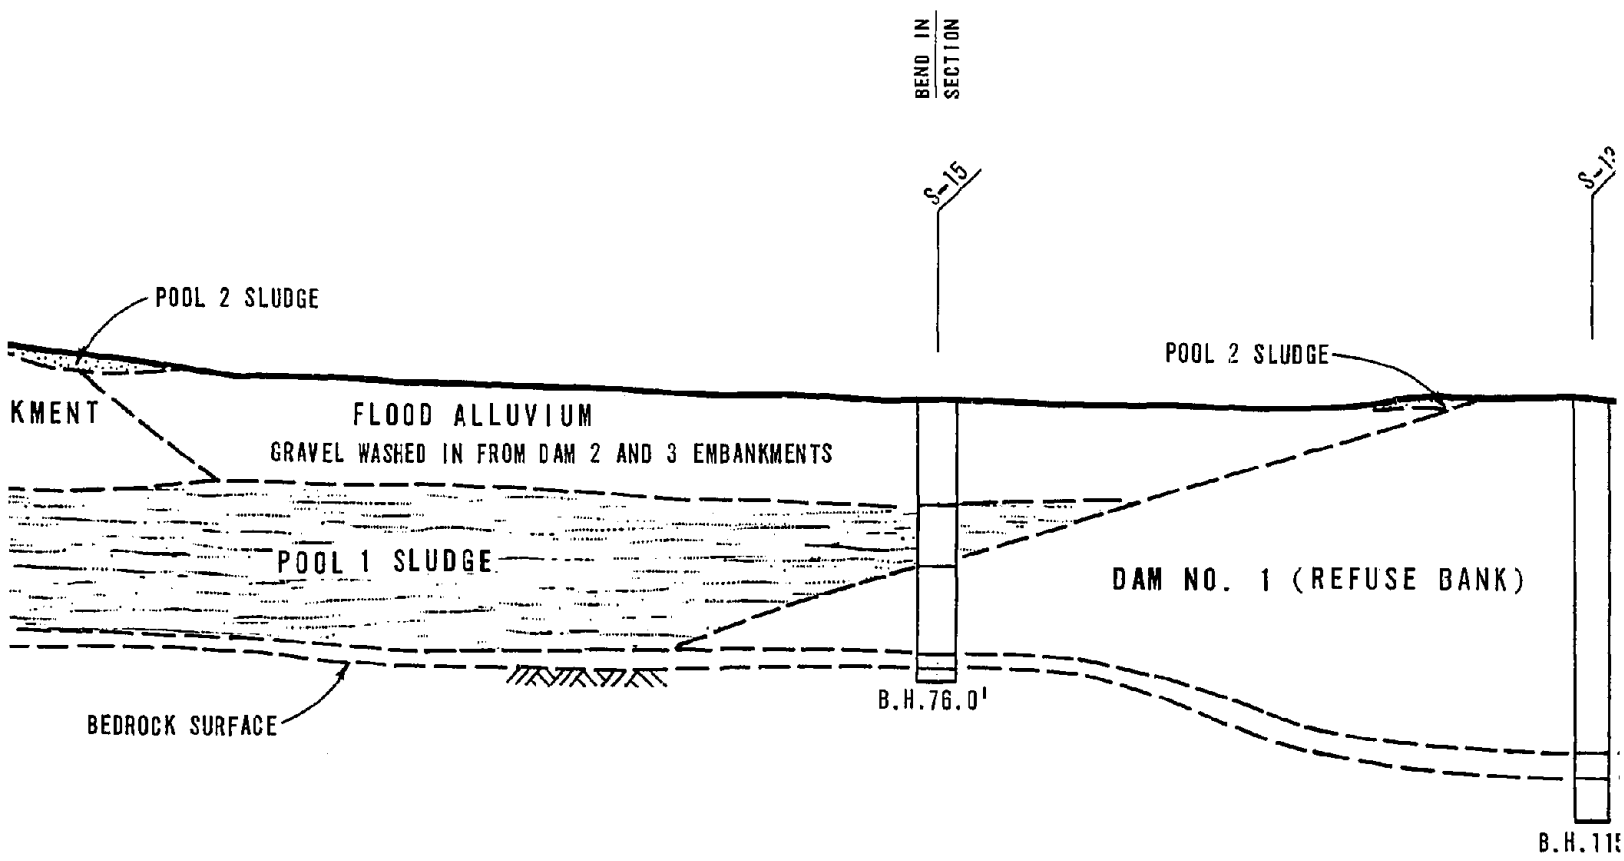
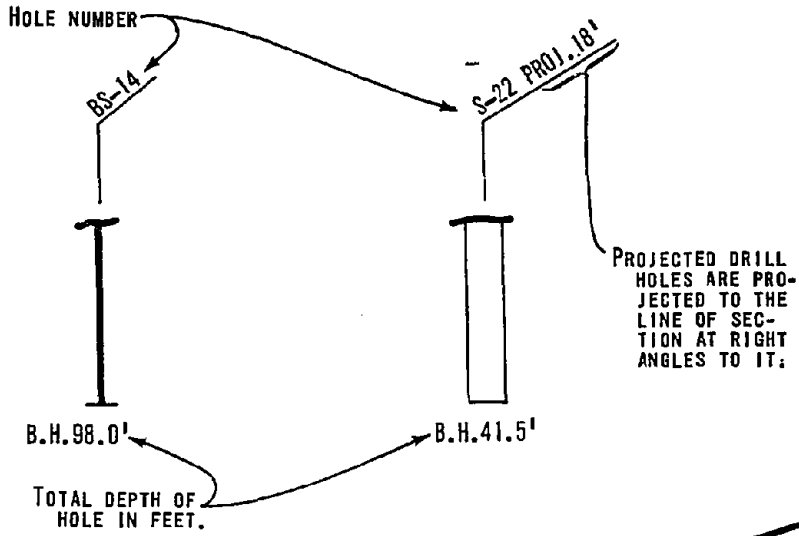
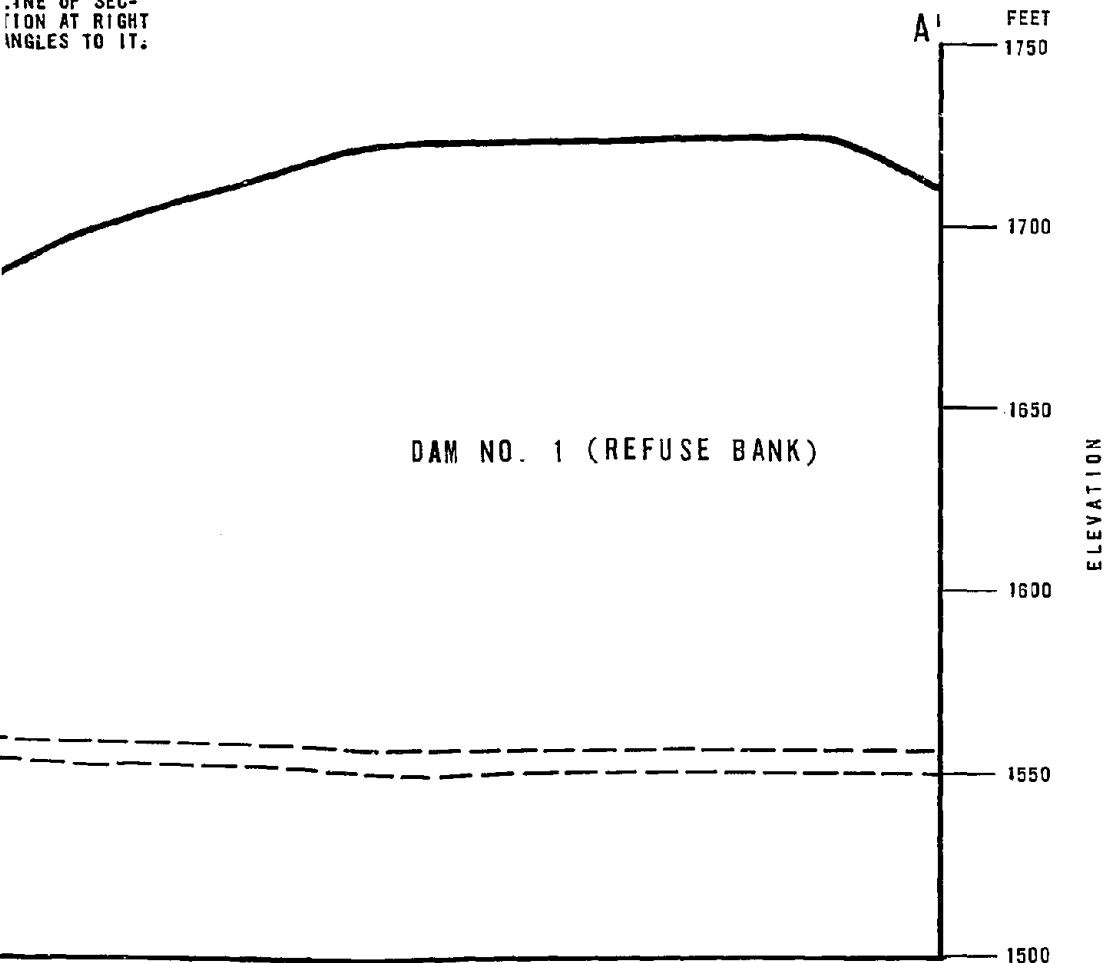
W.A. WAHLER & ASSOCIATES	COAL REFUSE DAM FAILURE SAUNDERS, WEST VIRGINIA PALO ALTO • NEWPORT BEACH • CALIF.	GEOLOGIC CROSS SECTION A-A' (POSTFAILURE)		
		PROJECT NO. 0700	DATE NOVEMBER 1972	DRAWING NO. Y1-21

In cross section A-A' on Figure VI-21, the embankment-sludge contact is defined by drill hole evidence. The approximate prefailure outline of Dam No. 3 embankment is also shown. It is tempting to think of the embankment-sludge contact line on section A-A' as a single or unique slide plane, purely on the basis of observation. Indeed, interpretation of the contact shown on that section as the main failure surface is generally supported by the engineering analyses presented in Chapter VII. However, the structure contours on Figure VI-20 represent conditions after all sliding had ceased, and the surface they define is the final failure surface; that is, the main failure surface as modified by subsequent failures. A determination of the failure sequence of Dam No. 3 must rely on field observation and engineering analyses and also take into account salient points of eyewitness reports. Our step-by-step account of the failure of Dam No. 3 is presented in Chapter VII.

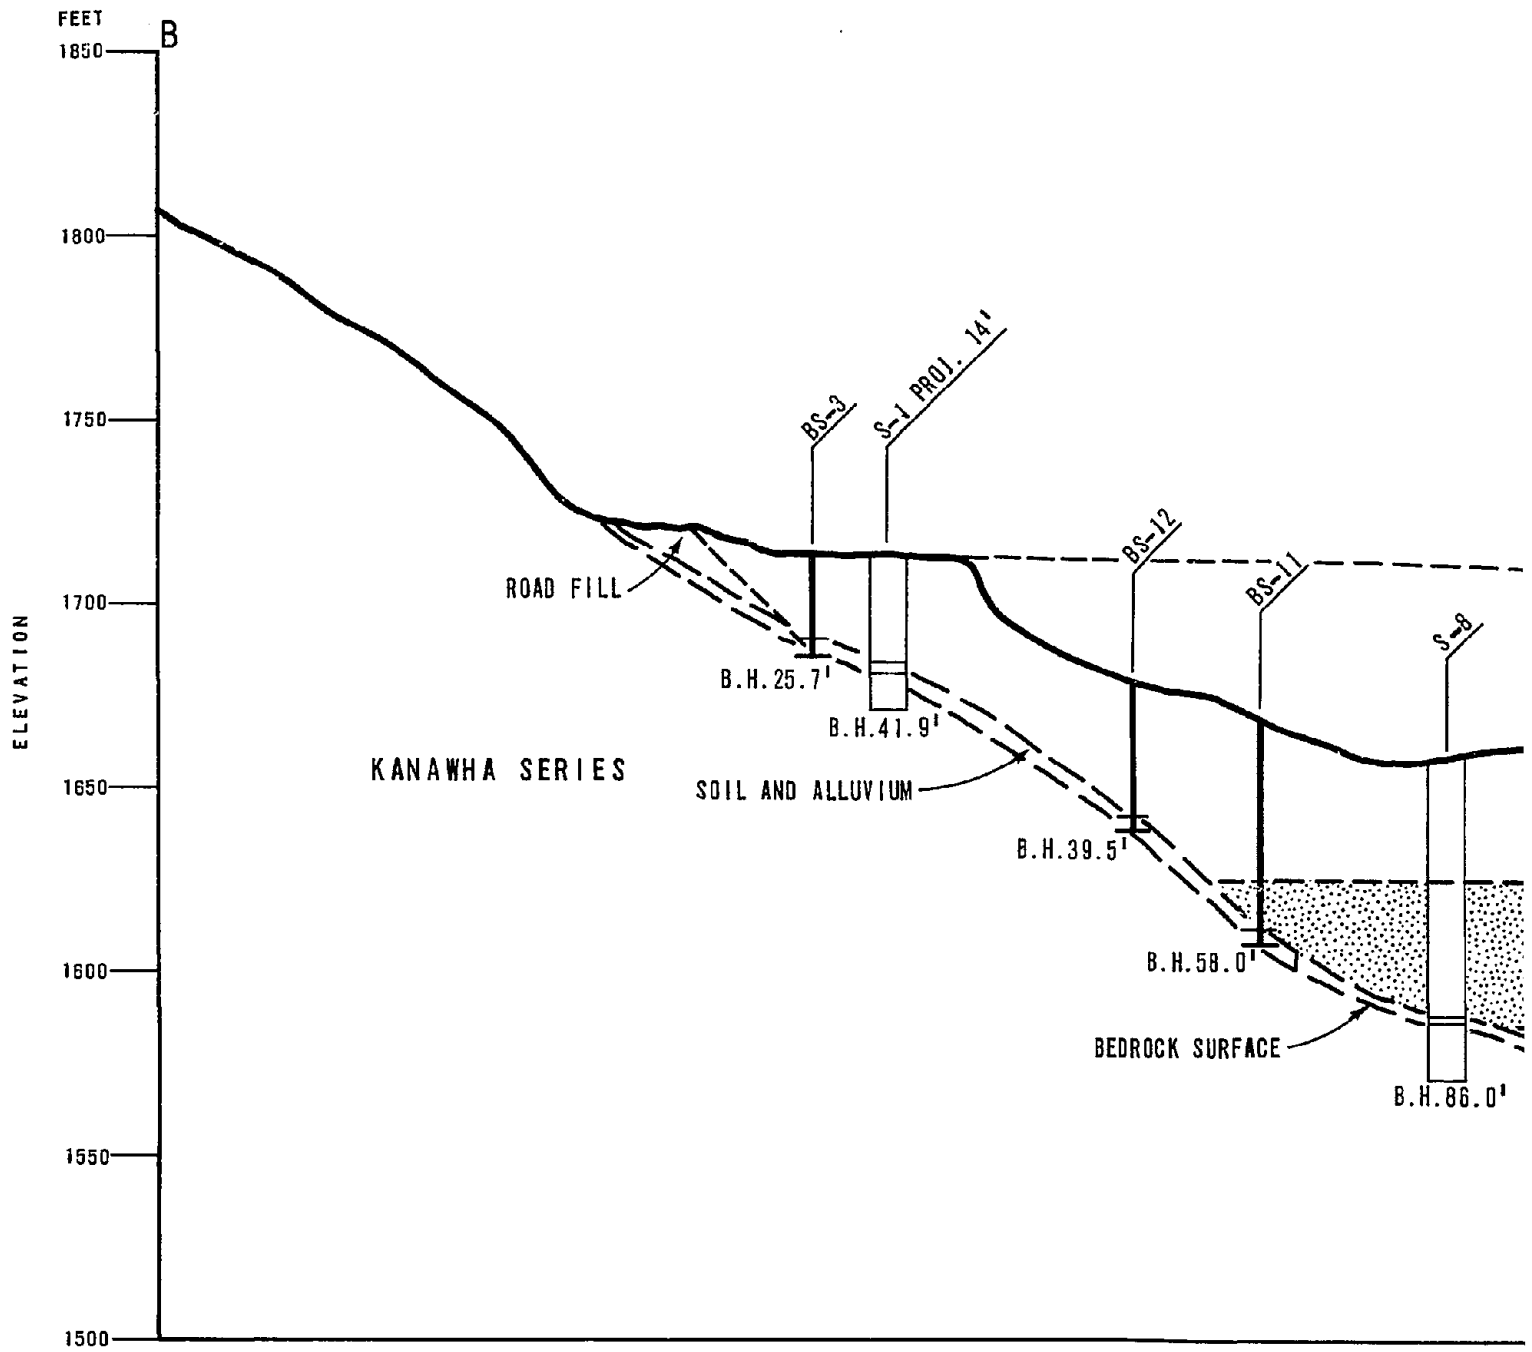
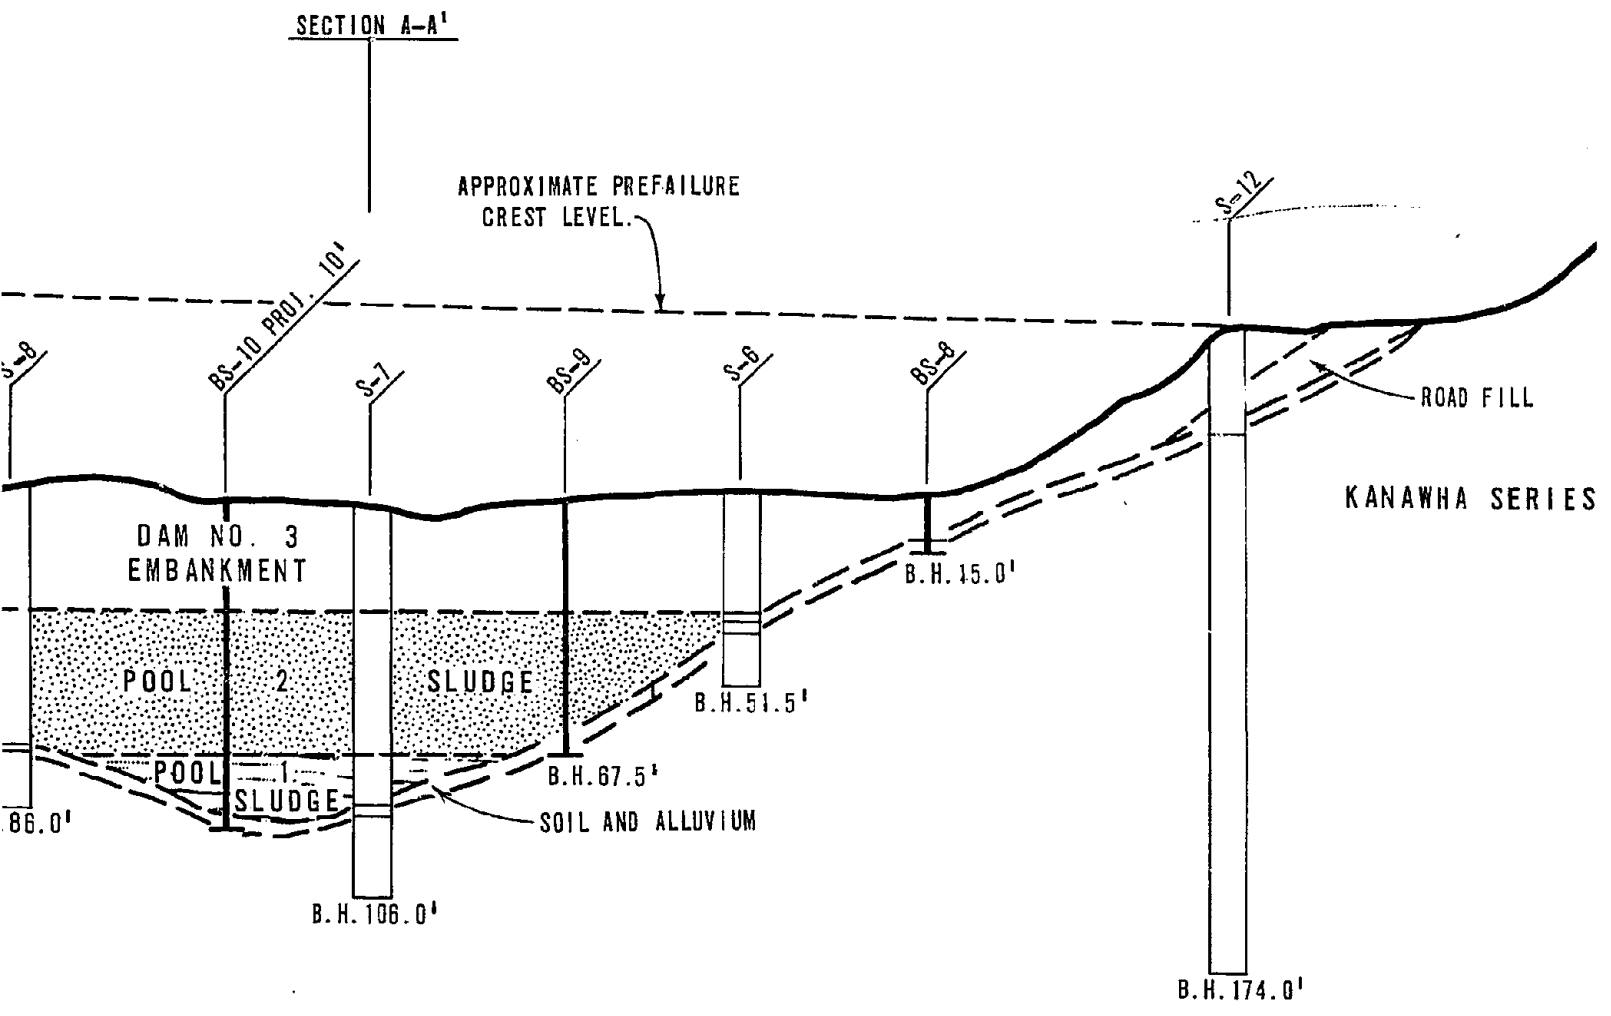
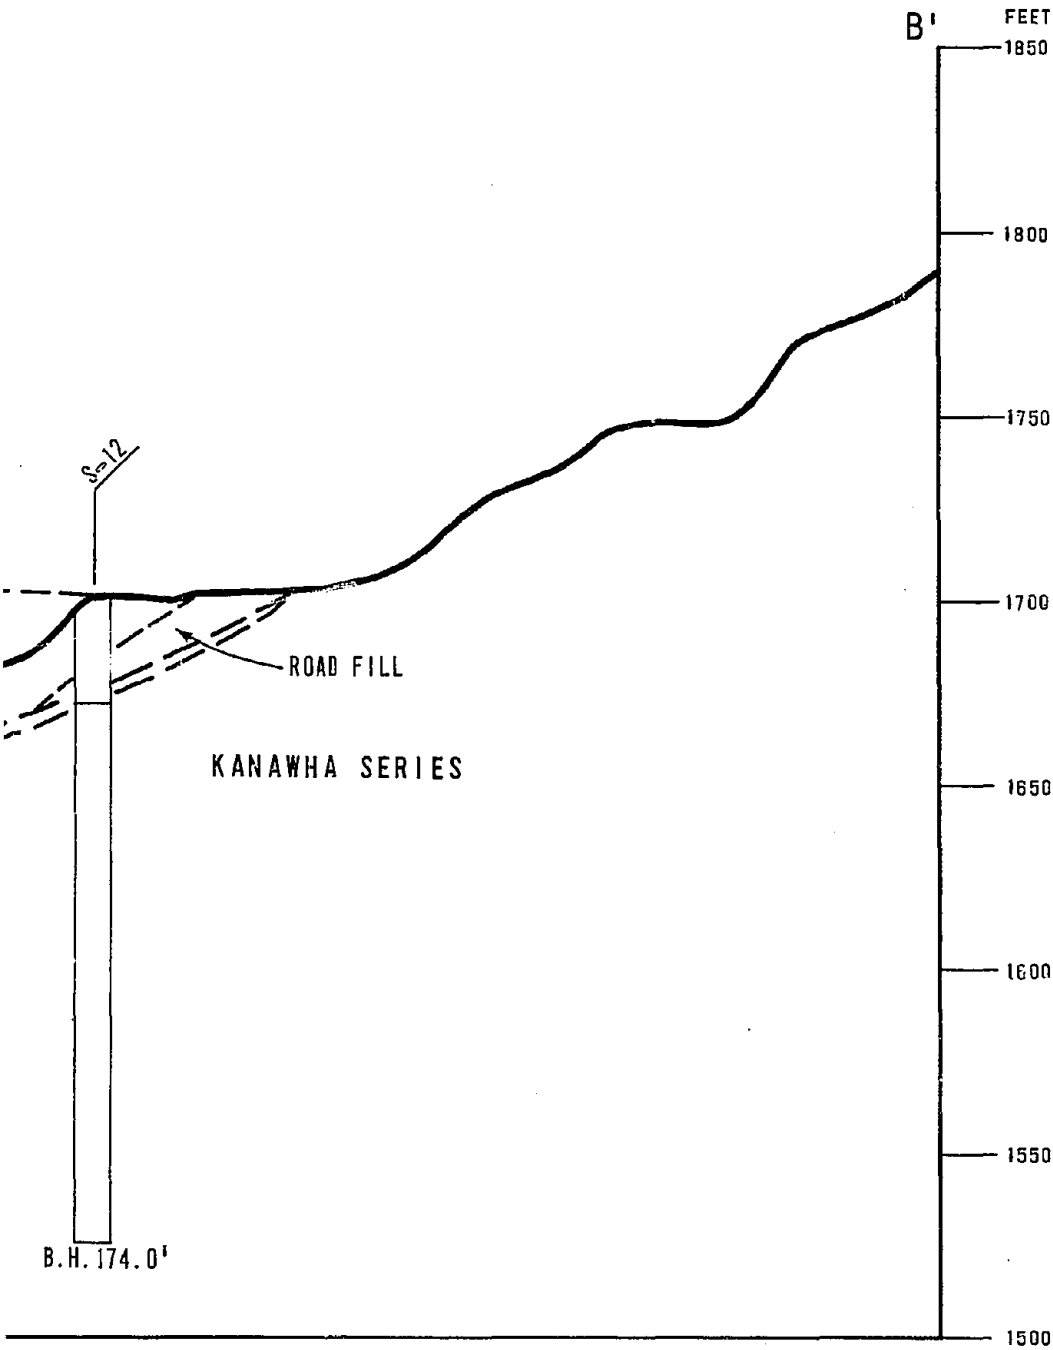
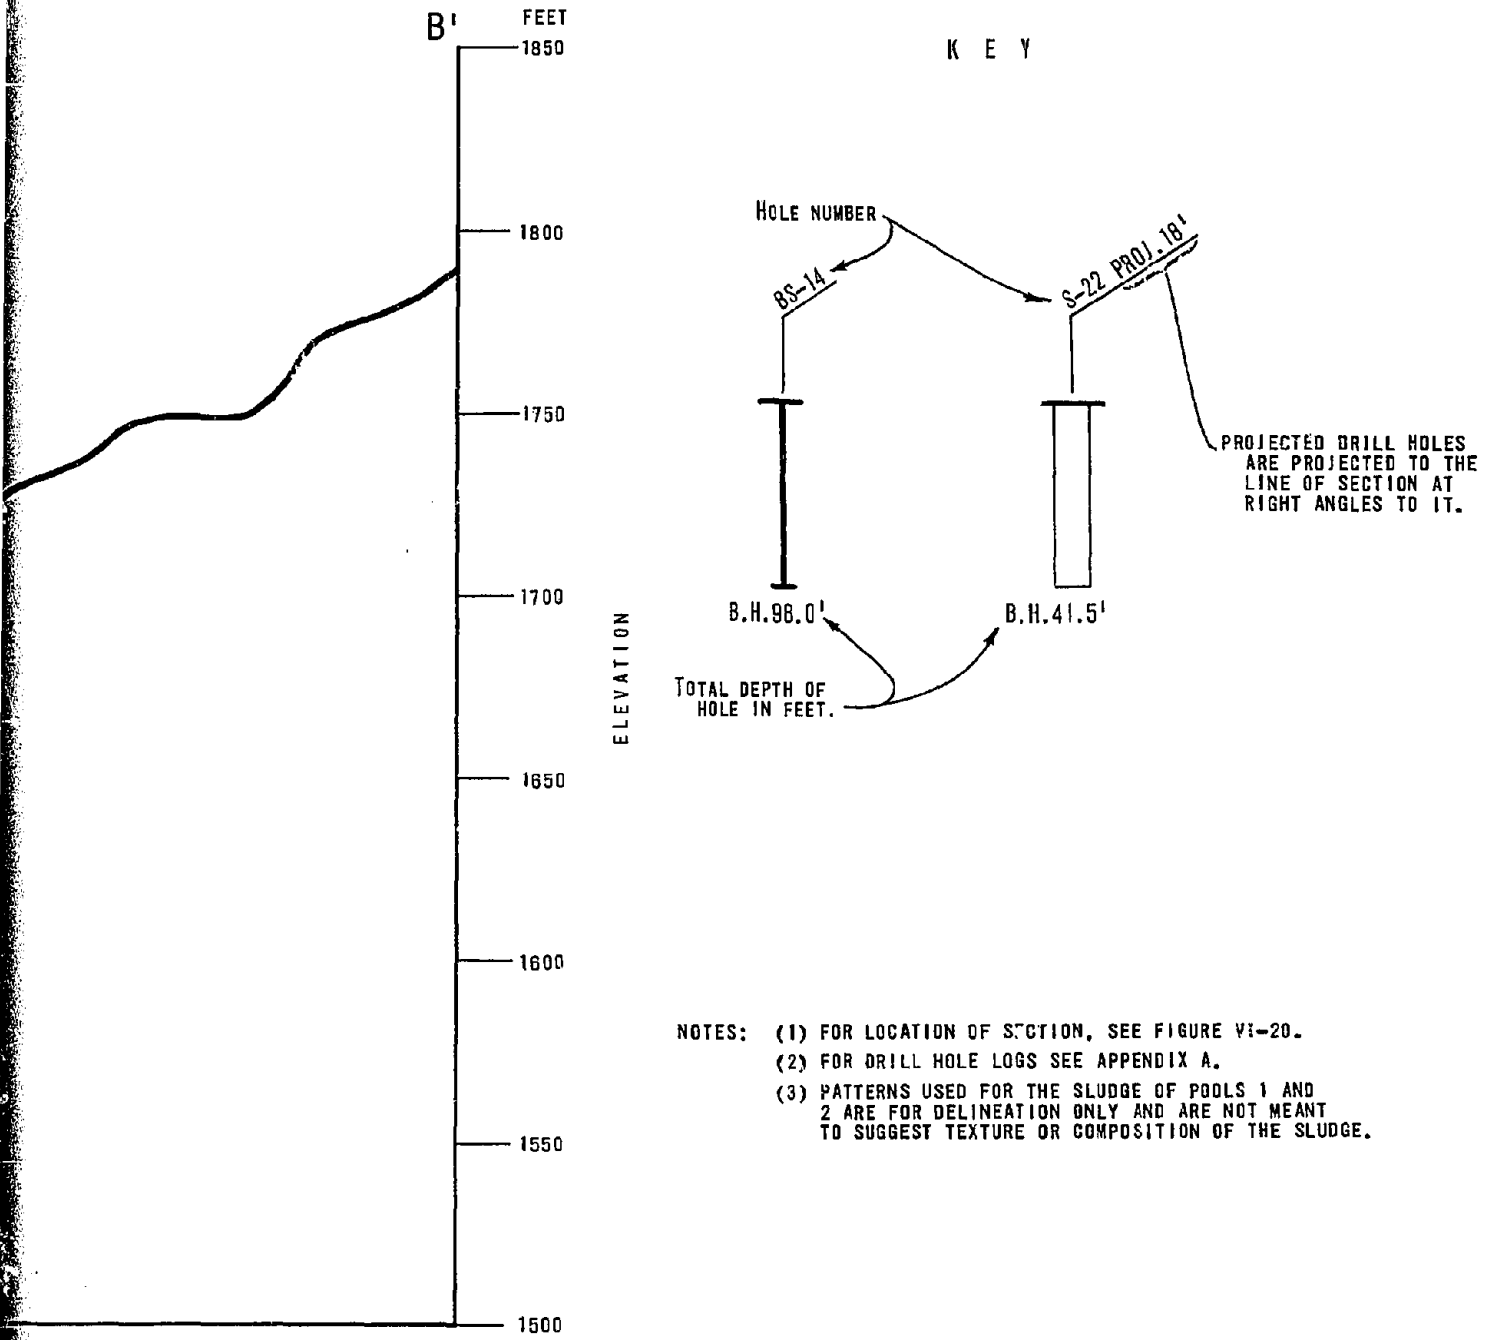
W. A. WAHLER & ASSOCIATES	COAL REFUSE DAM FAILURE SAUNDERS, WEST VIRGINIA PALO ALTO • NEWPORT BEACH • CALIF.	GEOLOGIC CROSS SECTION B-B' (POSTFAILURE)		
		PROJECT NO. 0700	DATE NOVEMBER 1972	FIGURE NO. VI-22

Cross section B-B' (Figure VI-22) is drawn along the crest of Dam No. 3. It defines the valley walls of Middle Fork Valley below the dam, and also shows how the dam was constructed over layers of sludge in pre-existing pools. The prefailure profile of the dam crest is also shown. Sections C-C' and D-D' on Figures VI-23 and VI-24, respectively, illustrate Dam No. 2. Figure VI-26 is a diagrammatic sketch of Middle Fork Valley, postfailure.

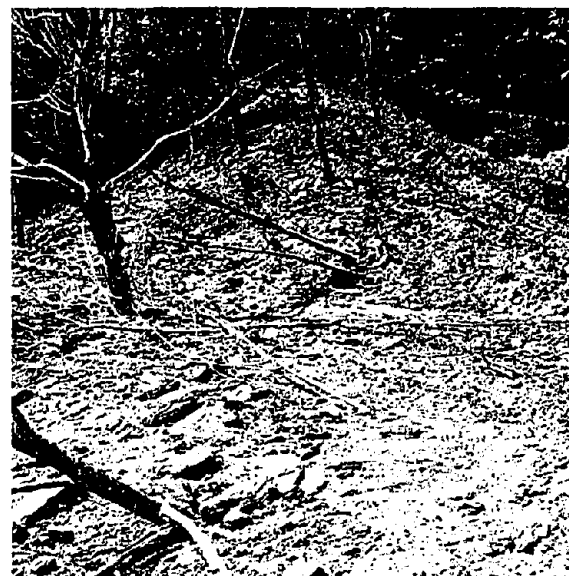
PHOTO D. TERRACE 5 AT EXTREME UPSTREAM END OF DAM NO. 3 LEFT ABUTMENT REMNANT. FOR MAP OF TERRACES, SEE FIGURE 111-3B.

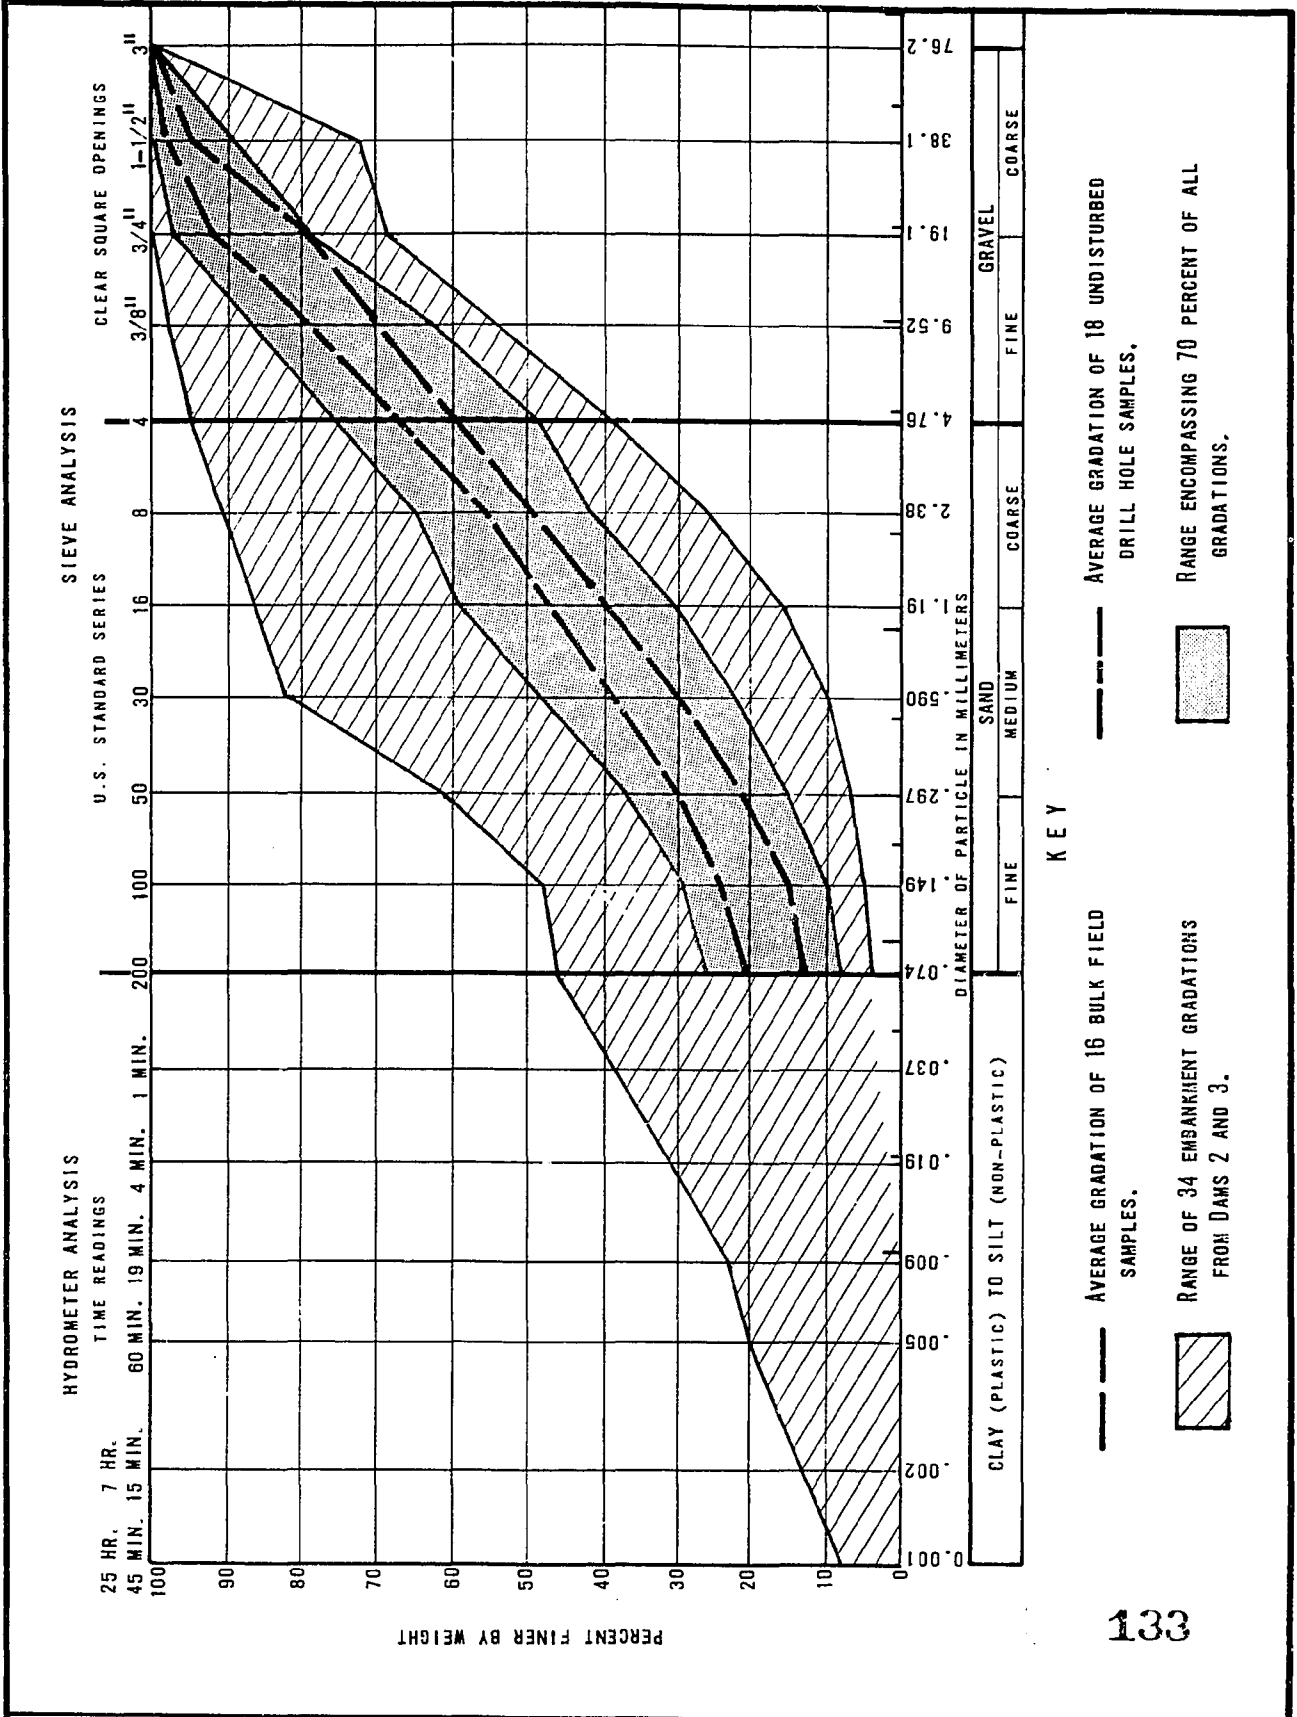
W. A. WAHLER & ASSOCIATES PALO ALTO • NEWPORT BEACH • CALIF	COAL REFUSE DAM FAILURE SAUNDERS, WEST VIRGINIA		GRADATION SUMMARY COARSE COAL WASTE (EMBANKMENT) MATERIAL		
	PROJECT NO	DATE	DRAWING NO		
	0700	NOVEMBER 1972	VII-1

The average gradation characteristics of the embankment materials for Dams 2 and 3 were determined from a total of 34 gradation tests, of which 18 were performed on undisturbed tube samples, and 16 were performed on disturbed samples such as those obtained from field density tests. The results of the gradation tests are presented on Figure VII-1 in the form of the total range of all tests and the average gradation as determined from undisturbed and disturbed samples. As noted on Figure VII-1, the average gradations for the coarse-grained coal waste embankment material, as determined by the two sampling methods, are remarkably similar.

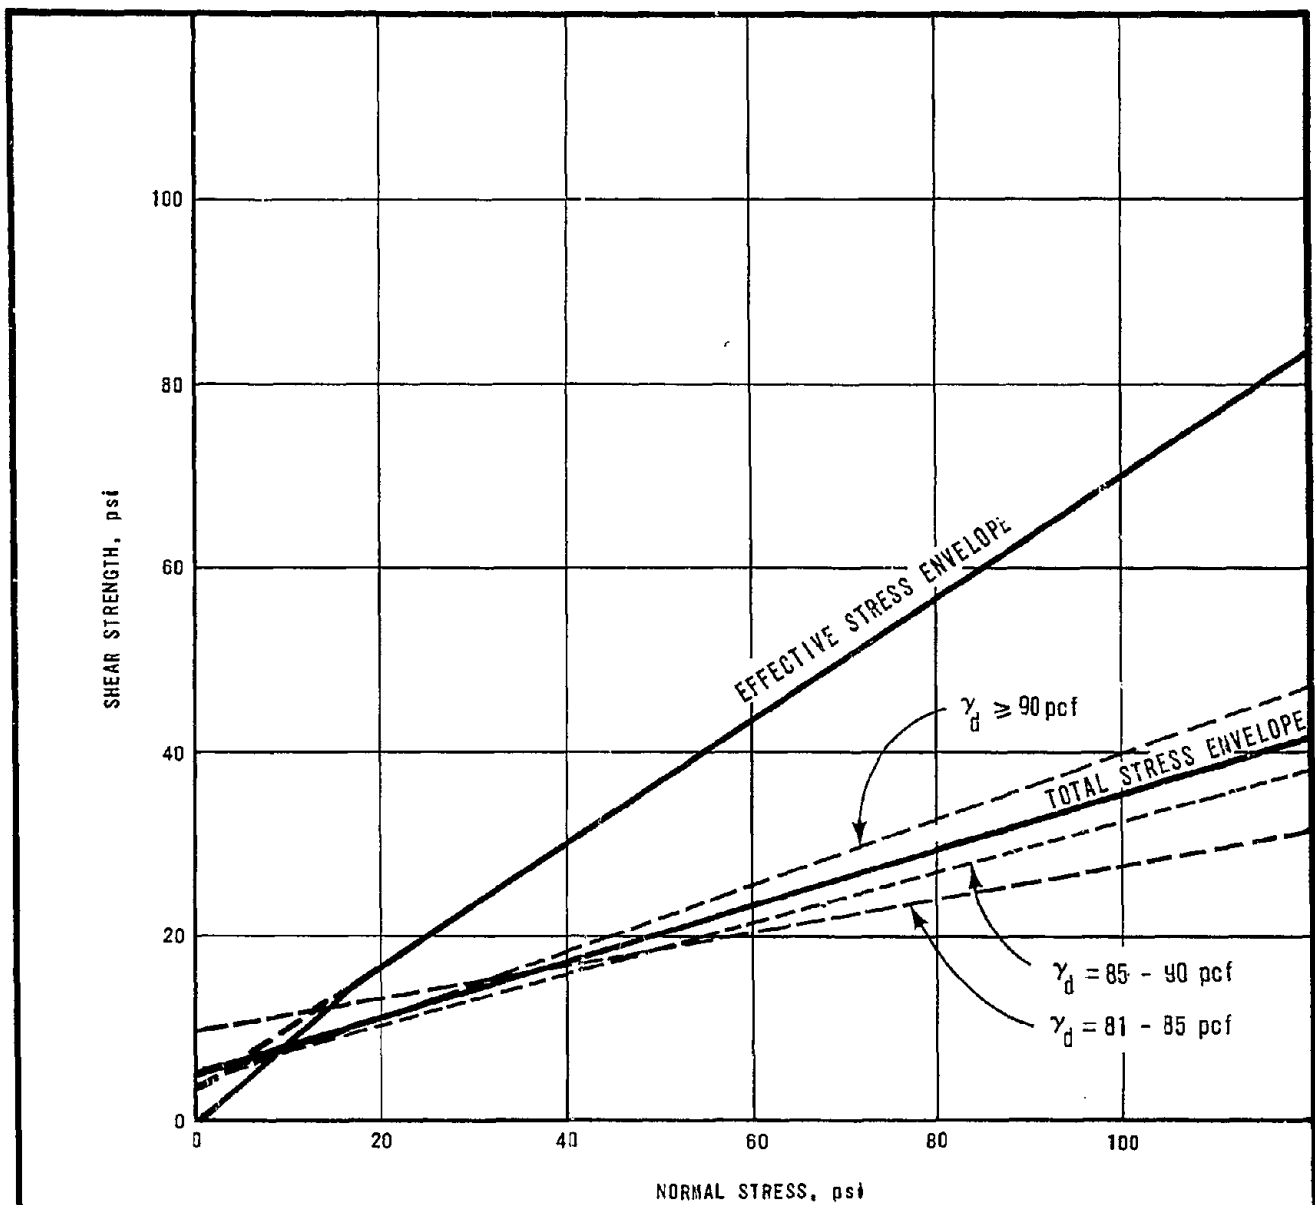
W.A. WAHLER & ASSOCIATES	COAL REFUSE DAM FAILURE SAUNDERS, WEST VIRGINIA	EMBANKMENT MATERIALS SHEAR STRENGTH PARAMETERS		
		PROJECT NO. 0700	DATE NOVEMBER 1972	FIGURE NO. VII-5
PALO ALTO • NEWPORT BEACH • CALIF.

Two strength envelopes were developed based on consolidated undrained triaxial tests on fabricated samples and six additional envelopes were developed based on triaxial testing of undisturbed drill hole samples. Figure VII-5 represents the total and effective shear strength envelopes resulting from a comparison of all eight individual envelopes. A distinct trend was defined in the variation of the total stress envelope with respect to initial dry density. This approximate variation is indicated by the dashed envelopes on Figure VII-5.

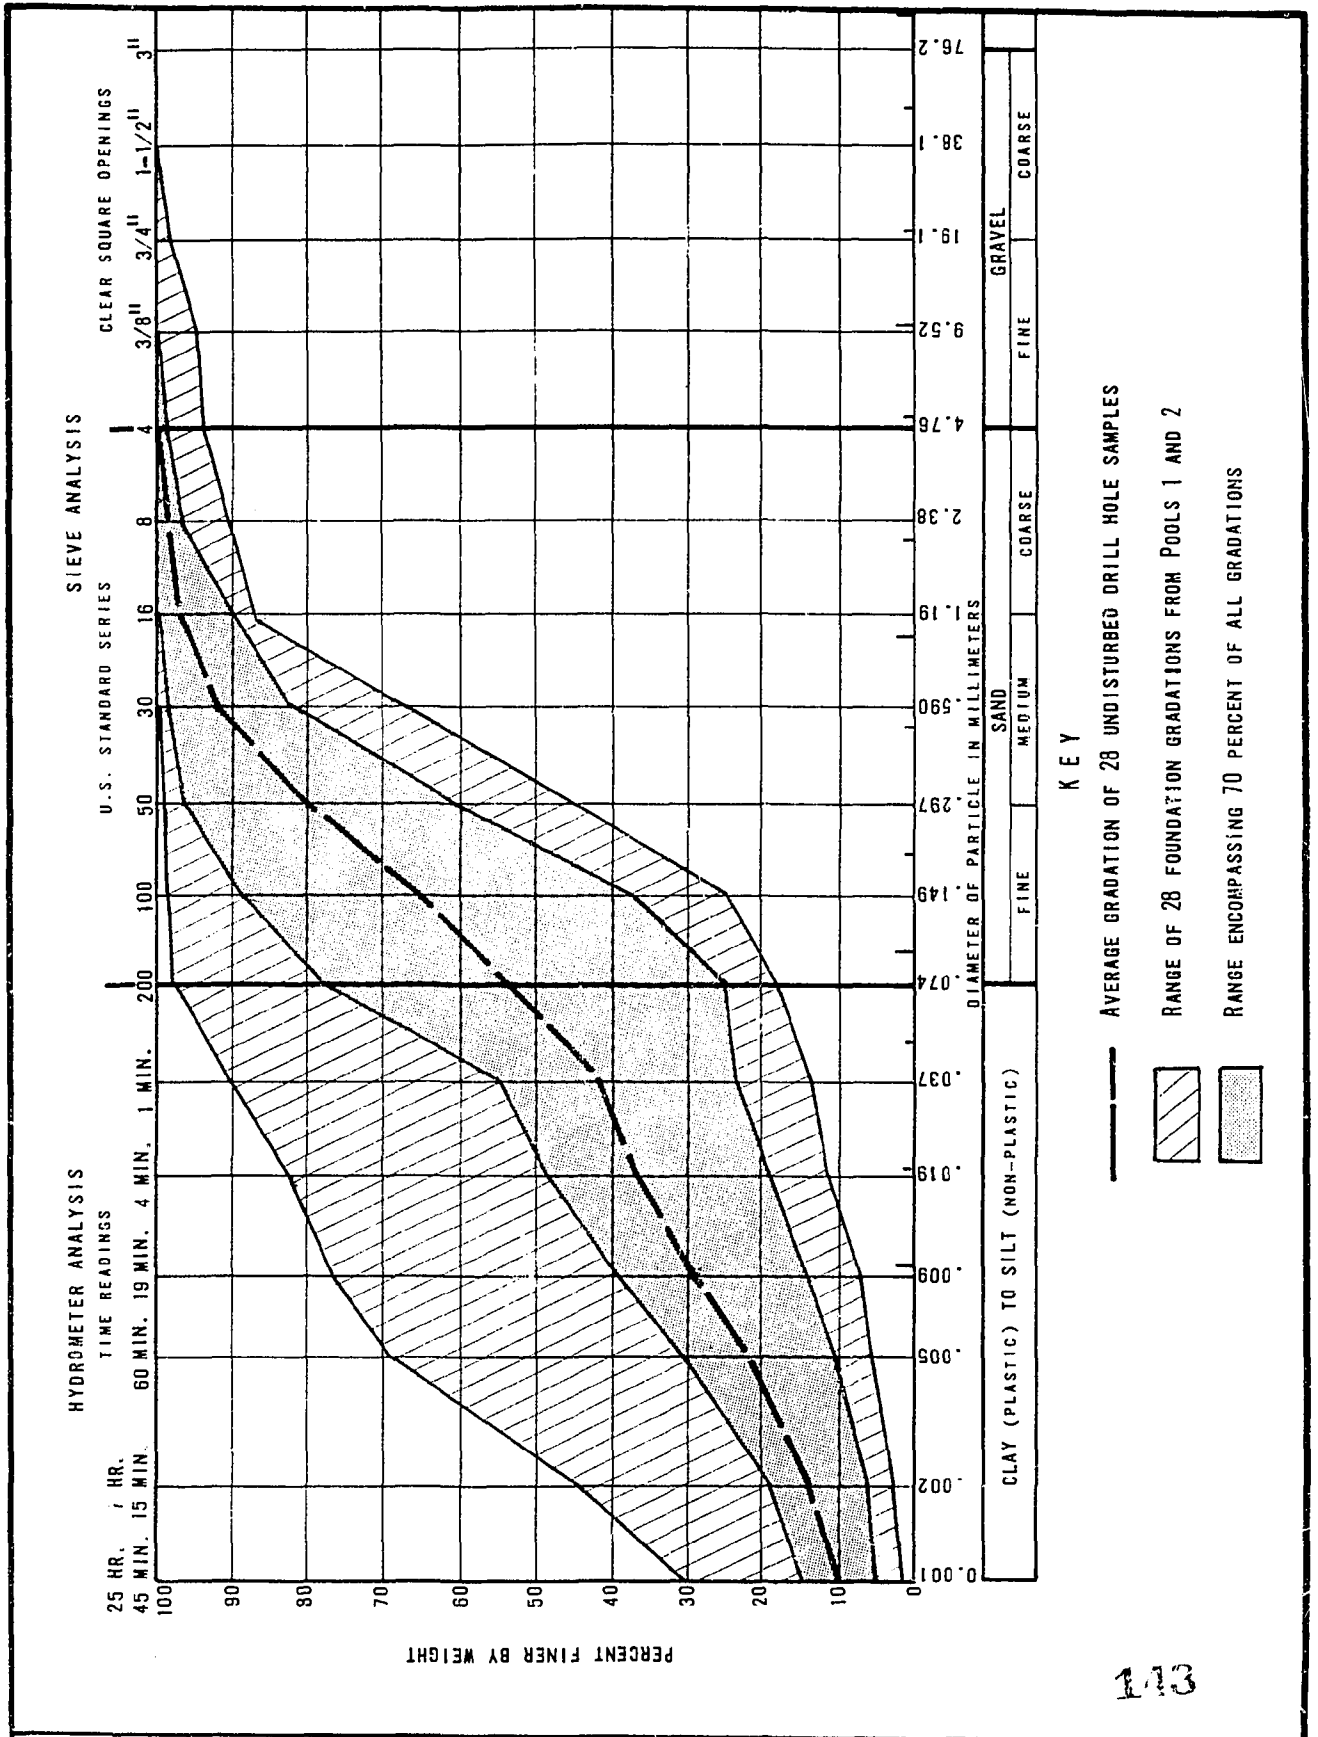
W. A. WAHLER & ASSOCIATES PALO ALTO • NEWPORT BEACH • CALIF	COAL REFUSE DAM FAILURE SAUNDERS, WEST VIRGINIA			GRADATION SUMMARY FOUNDATION (SLUDGE) MATERIAL		
	PROJECT NO	DATE	DRAWING NO	PROJECT NO	DATE	DRAWING NO
	0700	NOVEMBER 1972	VII-6	0700	NOVEMBER 1972	VII-6

Composite gradation curves for representative foundation sludge materials are presented on Figure VII-6. These materials are described as sandy silt to silty sand under the Unified Soil Classification System. For the solid portion of the coal waste sludge pumped from the No. 5 Preparation Plant, and typically the material providing foundation support for Dams 2 and 3, an average specific gravity of 1.43 was obtained, with a range of 1.34 to 1.66. The higher values represent materials having less coal content and higher proportions of the Kanawha shales and sandstones.
