**ANALYSIS OF
COAL REFUSE DAM FAILURE**

**MIDDLE FORK BUFFALO CREEK
SAUNDERS, WEST VIRGINIA**

**UNITED STATES
DEPARTMENT OF THE INTERIOR
BUREAU OF MINES
WASHINGTON, D.C.**

VOLUME 1 OF 2 - TEXT

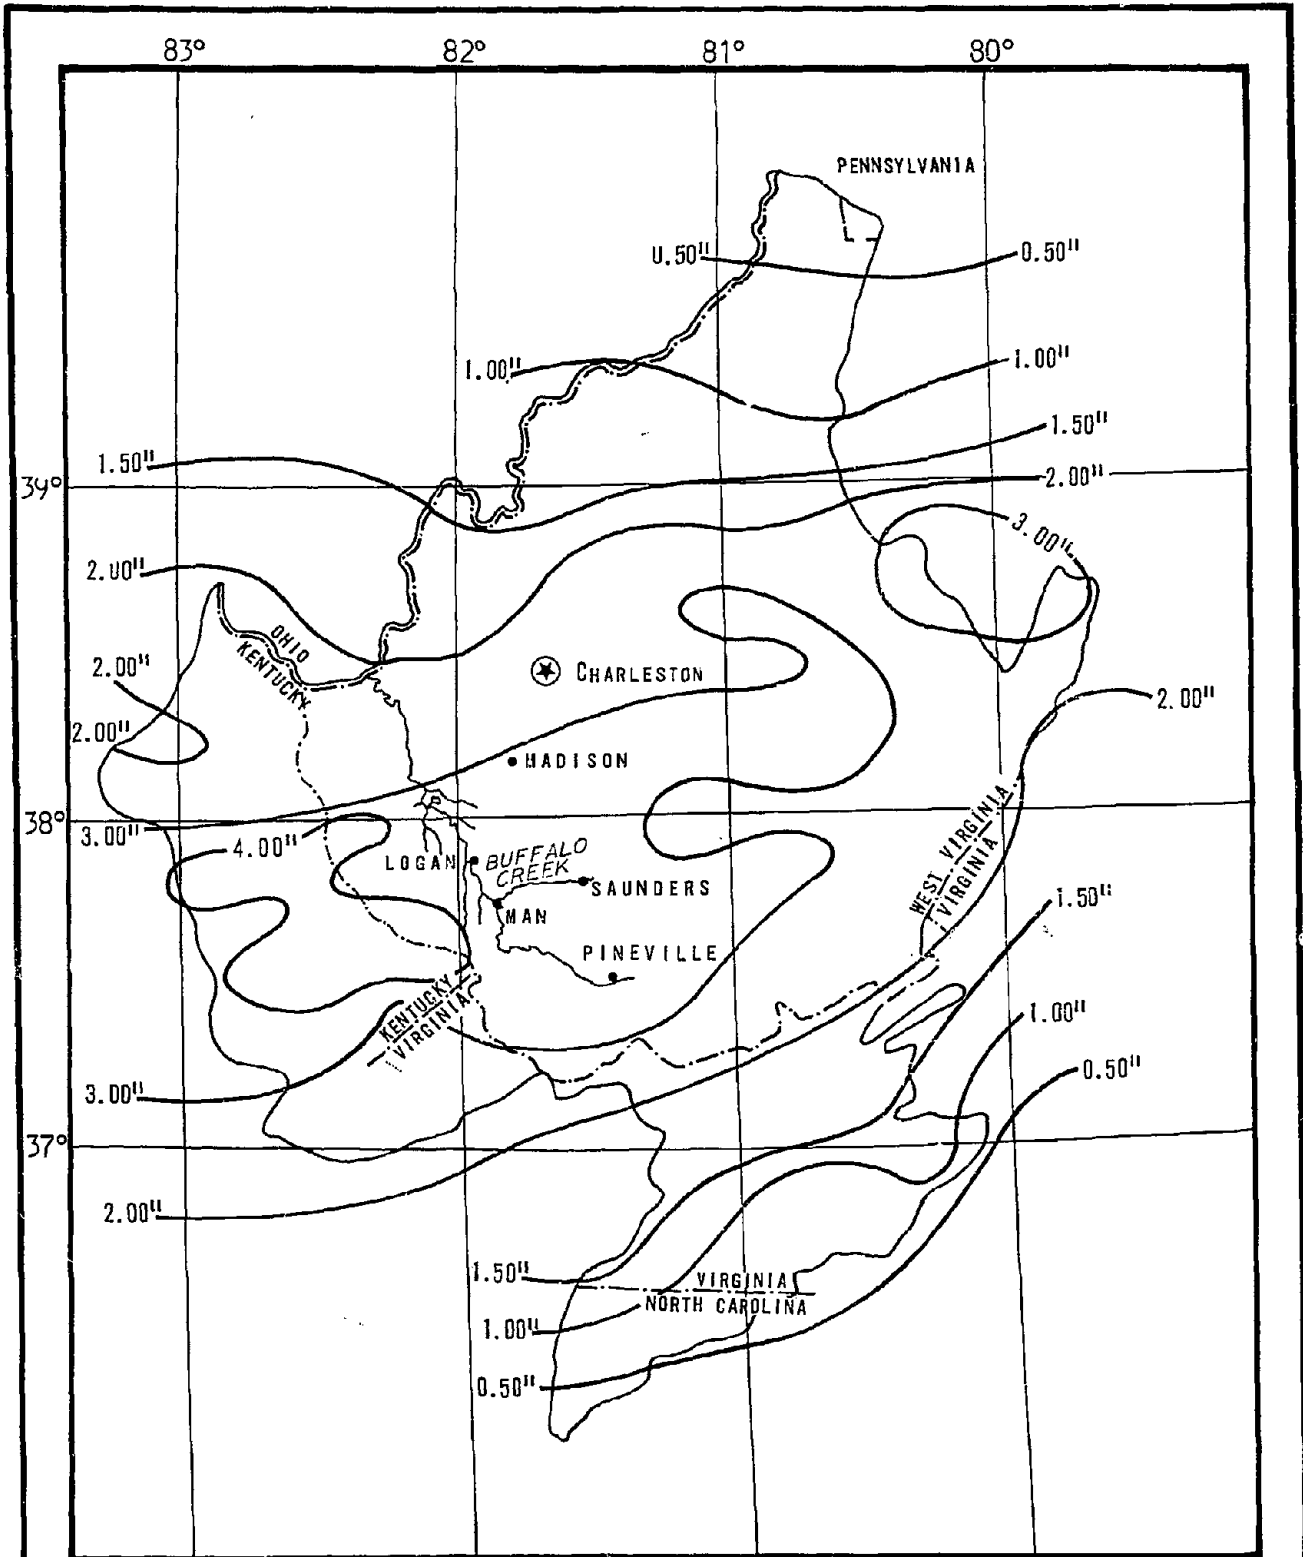
The rainfall for February, while above normal, was not of an unusual amount for this area. As shown on Figure VII-9, the rainfall at Saunders in the 48 hours preceding the flood probably amounted to 3½ inches. A field survey of open containers by the U.S. Geological Survey in the week following the flood found no open containers which contained more than the 3.7 inches of rain recorded at Logan, West Virginia (Davies and others, 1972b). In addition, indirect measurements by USGS personnel of Buffalo Creek tributaries indicate that there were no high flows in these streams such as would be produced by a local rainfall of extreme intensity.

1. The rainfall was widespread and rather evenly distributed within at least a 20-mile radius of the dam site during the two-day period preceding the dam failure.

6. In the absence of heavy snow cover or snow melt, and considering the not too unusual amount of local rainfall and the lack of flooding on other local streams, it is concluded that the magnitude of the Buffalo Creek Flood was due solely to the water released by the failure of Dam No. 3 on the Middle Fork near Saunders.

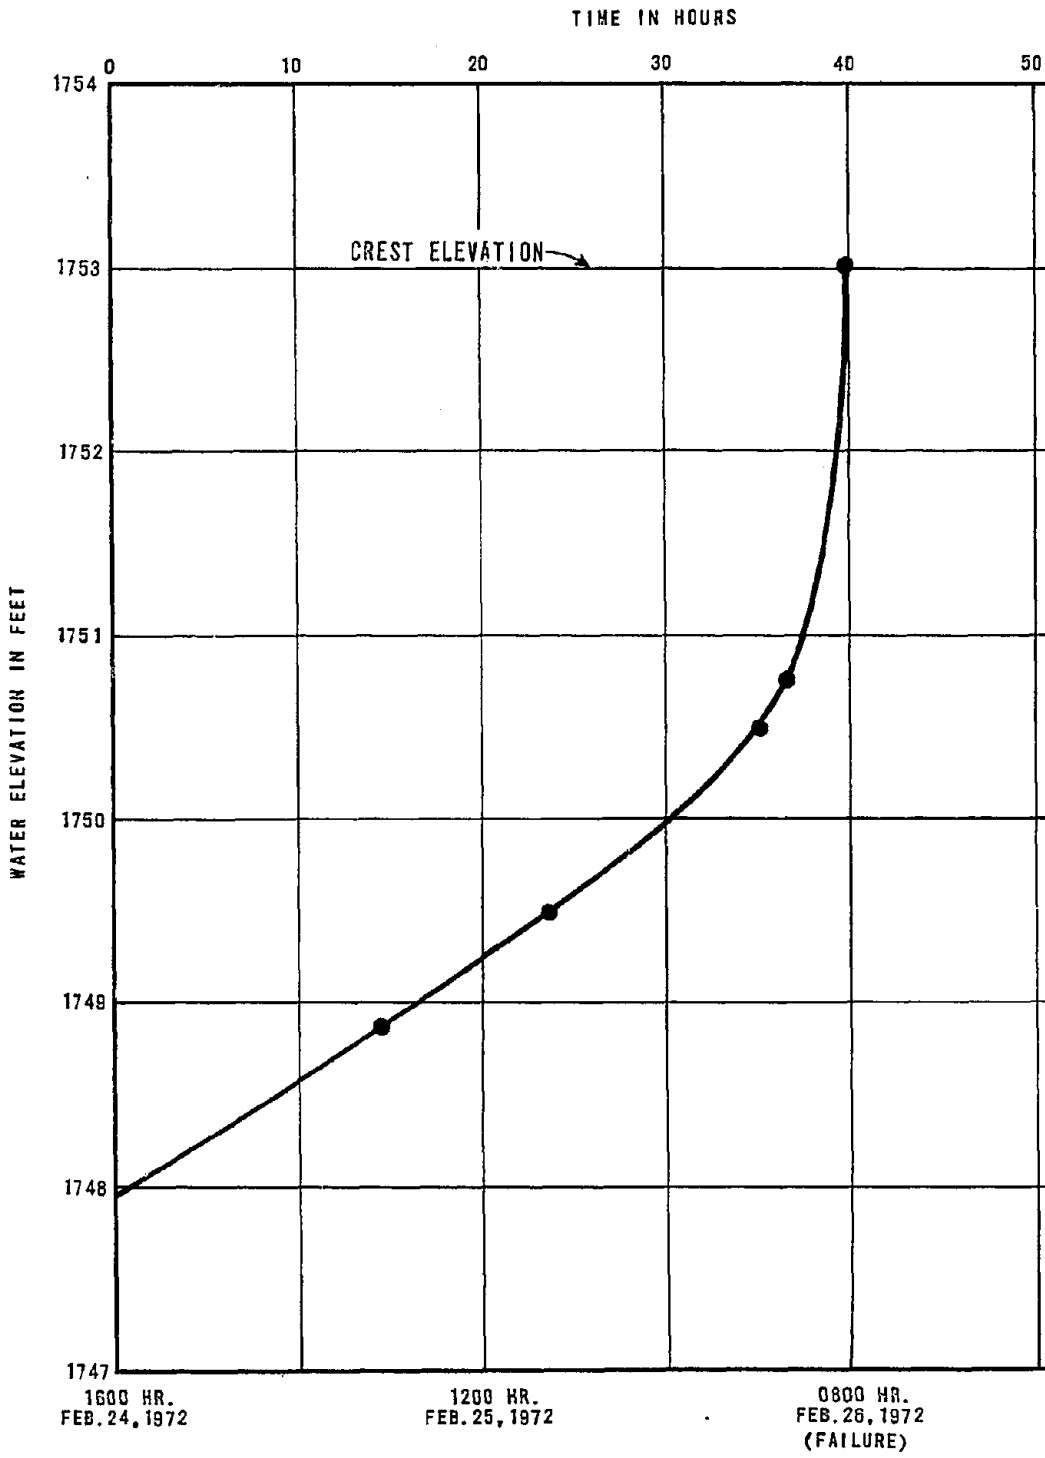
W. A. WAHLER & ASSOCIATES	COAL REFUSE DAM FAILURE SAUNDERS, WEST VIRGINIA	APPARENT WATER LEVEL RISE VS TIME POOL 3 (BASED ON MR. KENT'S TESTIMONY)		
		PROJECT NO. 0700.	DATE NOVEMBER 1972	FIGURE NO. VII-10

On Thursday, February 24, Mr. Dasovich observed water flowing from the downstream end of the 24-inch spillway pipe and that the water level in Pool 3 had risen two to three feet since his previous visit on February 22. On the same date, Mr. Jack Kent, Strip Mining Superintendent, Buffalo Mining Company, observed the water level rising behind Dam No. 3, and that at 1600 hours it was about five feet below the graded crest of the dam and above the spillway pipe. Based on these statements, it is estimated that the invert level of the pipe was at approximately Elevation 1,745. Thus, it is expected that the spillway pipe at Dam No. 3 carried a full flow for at least 40 hours prior to the failure.

At the time of Mr. Kent's observation, he placed a stick measuring 3 feet 9 inches long into the upstream face above the opening of the 24-inch overflow pipe. The top of the stick was reported to have been about one foot below the top (Elevation 1,752) of the graded crest. Table VII-1 summarizes our interpretation of the rise of the water level in Pool 3 during the 40-hour period preceding failure, based on testimonies by Messrs. Dasovich, Kent, Gibson and Goodman.

and most likely resulted in the water reaching its highest level of Elevation 1,753 just prior to failure at about 0800 hours on February 26, 1972. The significance of this reservoir rise and the probability of overtopping are discussed later in this Chapter.

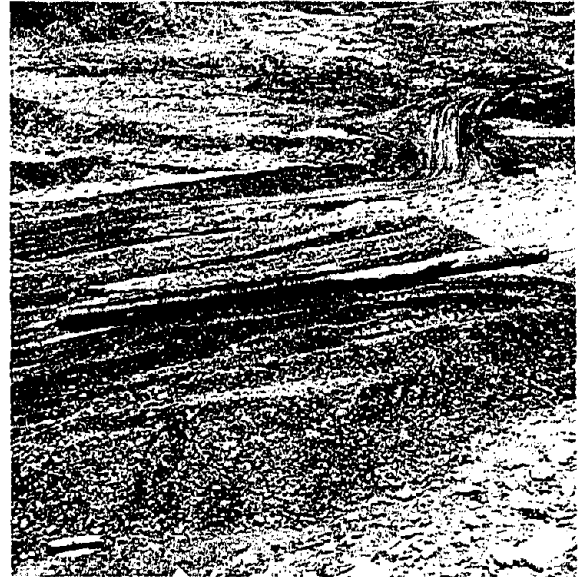
PHOTO B. DOWNSTREAM PIPE AFTER PULLING WITH WINCH.

trench walls was coal waste deposited by the flood, indicating that the pipe was carried in the bed load of the flood water after the failure. The downstream pipe was examined after extraction and found to be 44.5 feet long with both ends apparently torch-cut, unbroken by pulling, and unwelded. In the opinion of the bulldozer operator, the pipe pulled "very easily," as though unconnected to anything at its buried end.

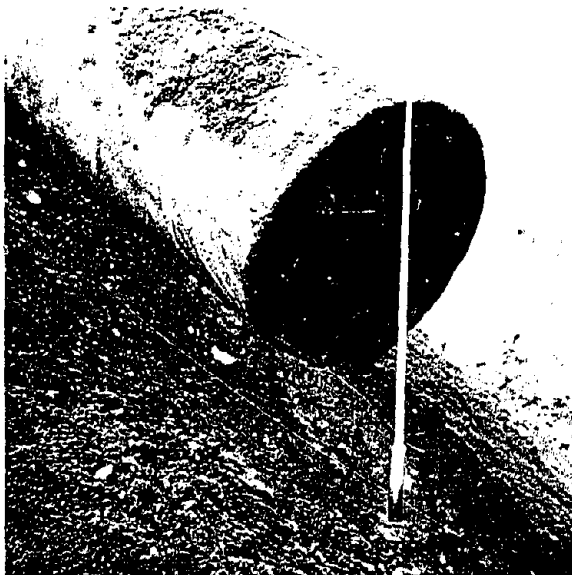
PHOTO C. DETAIL OF BURIED END OF UPSTREAM PIPE. NOTE ROUGH EDGES FROM TORCH CUTTING.

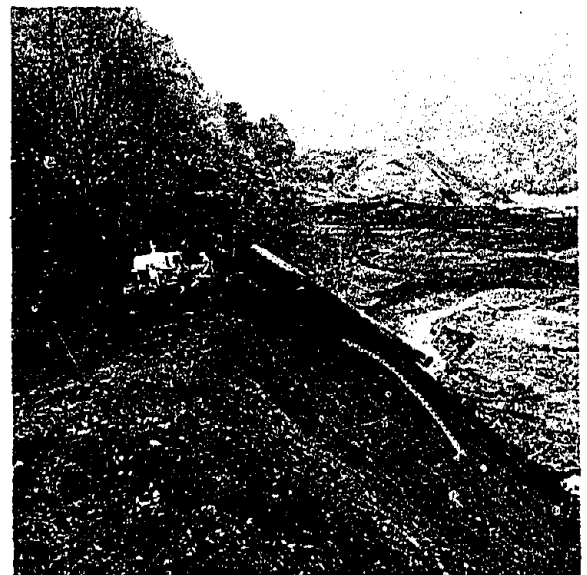
PHOTO D. UPSTREAM PIPE JUST AFTER PULLING IT TO THE EXPLORATORY BULLDOZER TRENCH ON THE LEFT ABUTMENT OF DAM NO. 3.

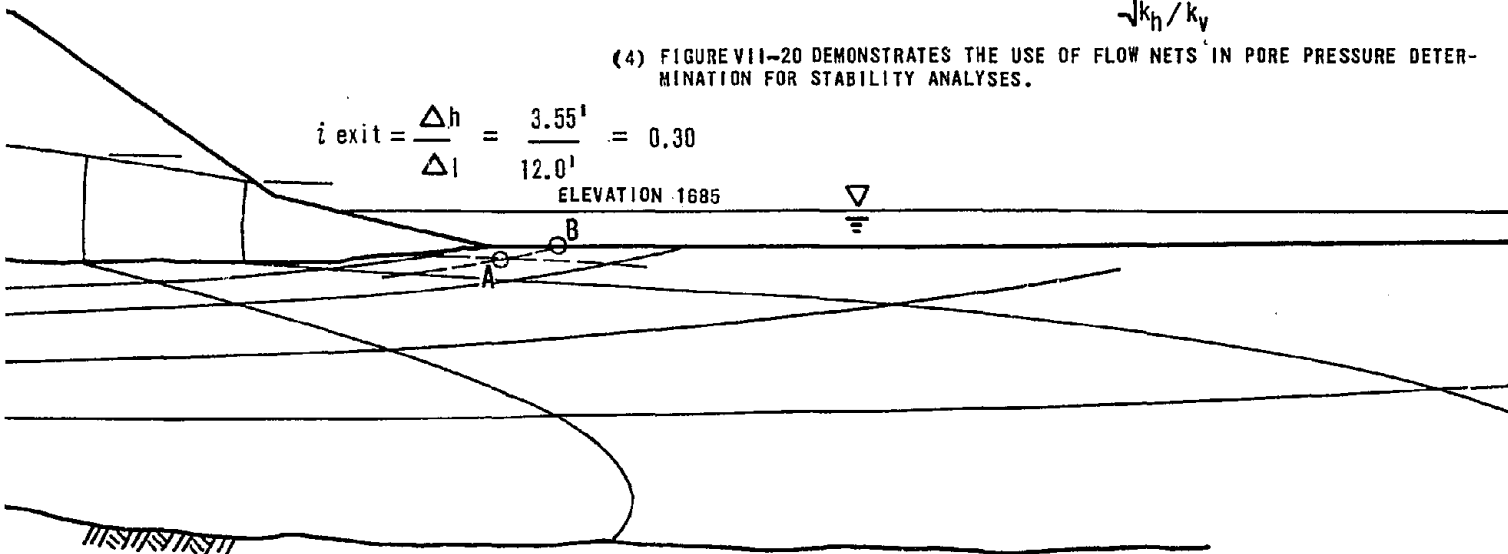
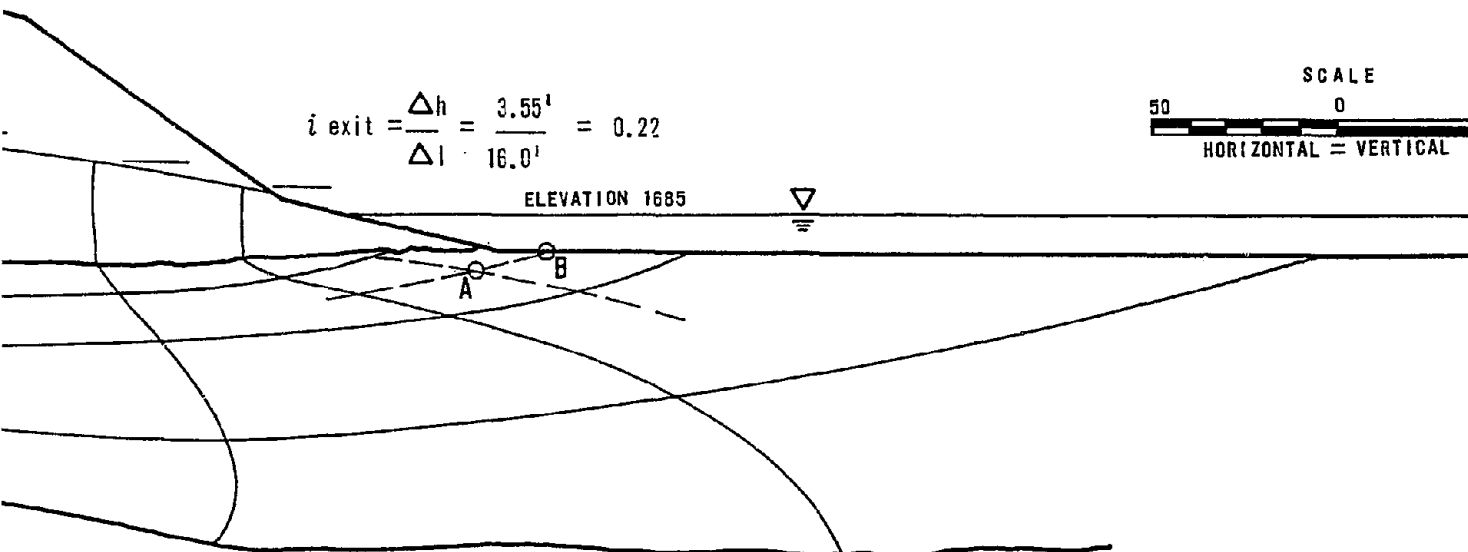
W. A. WAHLER & ASSOCIATES	COAL REFUSE DAM FAILURE SAUNDERS, WEST VIRGINIA PALO ALTO • NEWPORT BEACH • CALIF.	SECTION E-E' FLOW NETS - NORMAL POI COAL WASTE DAM NO. 3		
		PROJECT NO.	DATE	FIGURE
		0700	NOVEMBER 1972	VII-11

Appropriate flow nets for varying thicknesses of foundation sludge material appear on Figures VII-16, VII-17, VII-18 and VII-19. They represent differing flow patterns resulting from normal and maximum Pool 3 levels and variations in the hydraulic anisotropy of the sludge material. It may be noted that for both Pool 3 levels, the flow nets, for a given horizontal to vertical permeability ratio, are very nearly the same. This is primarily due to the configuration of the embankment and the use of the same number of equipotential lines in each case.

$$i_{\text{exit}} = \frac{\Delta h}{\Delta l} = \frac{3.55'}{12.0'} = 0.30$$

$$i_{\text{exit}} = \frac{\Delta h}{\Delta l} = \frac{3.55'}{16.0'} = 0.22$$

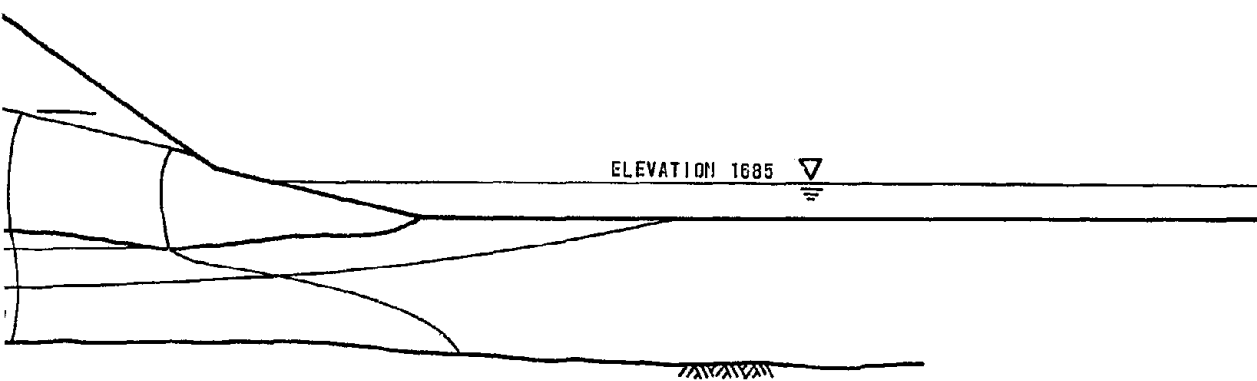
W. A. WAHLER & ASSOCIATES	COAL REFUSE DAM FAILURE SAUNDERS, WEST VIRGINIA	SECTION F-F' FLOW NETS - MAXIMUM POOL COAL WASTE DAM NO. 3		
		PROJECT NO.	DATE	FIGURE NO.
PALO ALTO • NEWPORT BEACH • CALIF.		0700	NOVEMBER 1972	VII-19

The ratio of embankment to foundation permeabilities (k_E / k_F) was taken to be 10 where $k_E = k_v = k_h = 2 \times 10^{-4}$ cm/sec, and $k_F = \sqrt{k_v k_h} = \sqrt{(4 \times 10^{-6}) (1 \times 10^{-4})} = 2 \times 10^{-5}$ cm/sec. For the above ratio, one flow line or stream line in the embankment is equal to ten flow lines in the foundation when considering quantity of seepage.

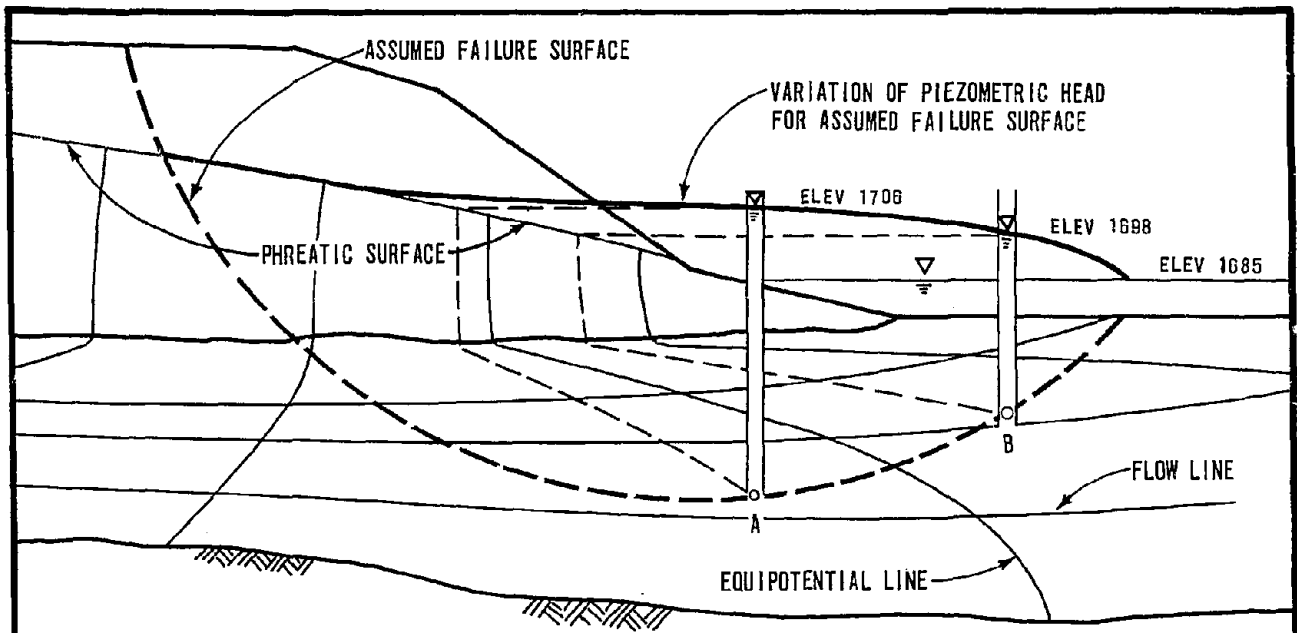
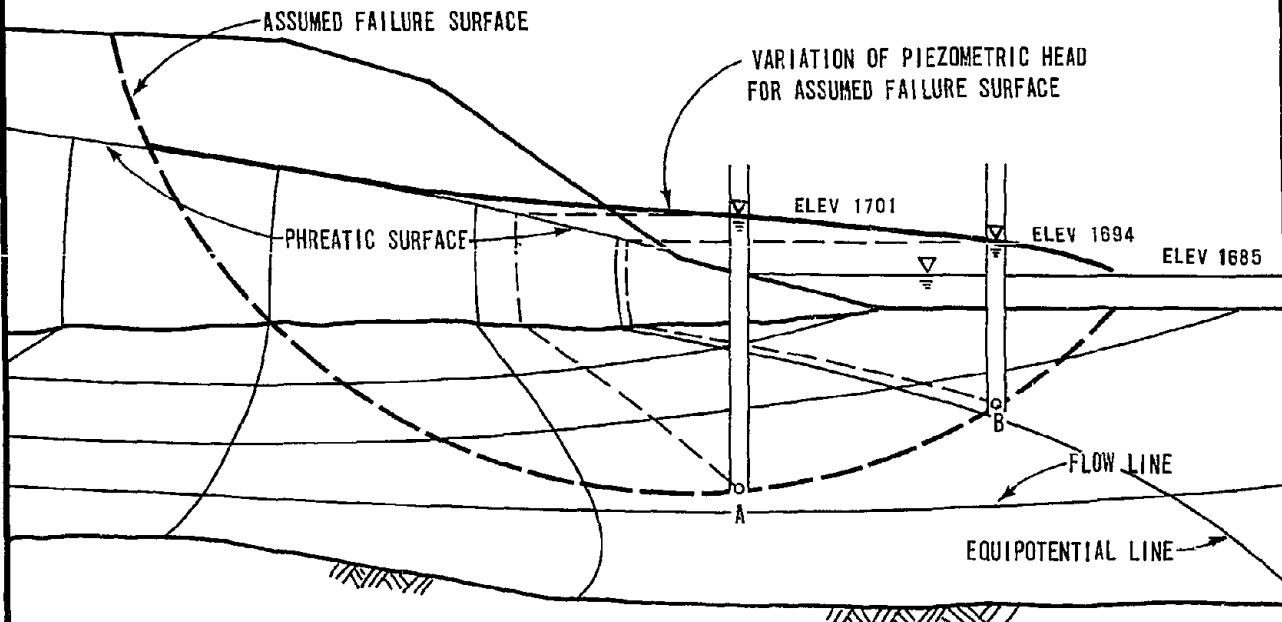
W. A. WAHLER & ASSOCIATES	COAL REFUSE DAM FAILURE SAUNDERS, WEST VIRGINIA	DETERMINATION OF PIEZOMETRIC HEAD MAXIMUM RESERVOIR LEVEL		
		PROJECT NO.	DATE	FIGURE NO.
		0700	NOVEMBER 1972	VII-20

The influence of the foundation permeability ratio on the developed pore pressures is readily seen by an examination of the flow nets for each case. Shown on Figure VII-20 is a quantitative comparison of piezometric head within the foundation for Pool 3 elevation of 1,753.

Following the dashed line from Point A, in a direction parallel to the adjacent equipotential line, to the intersection with the phreatic surface gives the correct piezometric head for that point. If this method is used for a number of points, the variation in the piezometric head for the assumed failure surface can be developed as shown on Figure VII-20. It is interesting to note that the actual piezometric head at a given point may be considerably different than that which would be determined solely by the difference in elevations of the point in question and the phreatic surface vertically above it. Also, the piezometric head at a given point varies with different assumed values of foundation anisotropic permeability ratio. The computer program developed by W. A. Wahler and Associates and utilized in these analyses, is capable of incorporating variations in piezometric head in both vertical and horizontal directions, thus permitting a rapid and efficient analysis of a large number of potential failure surfaces.

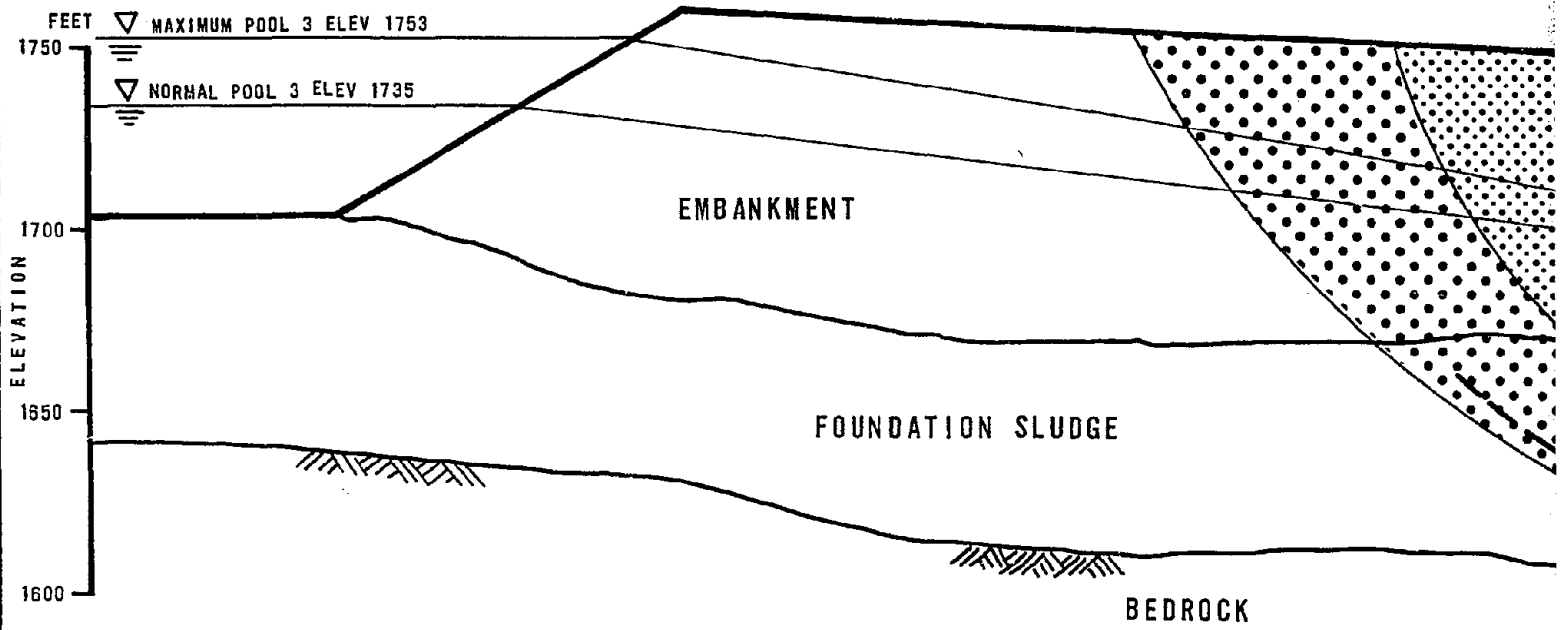
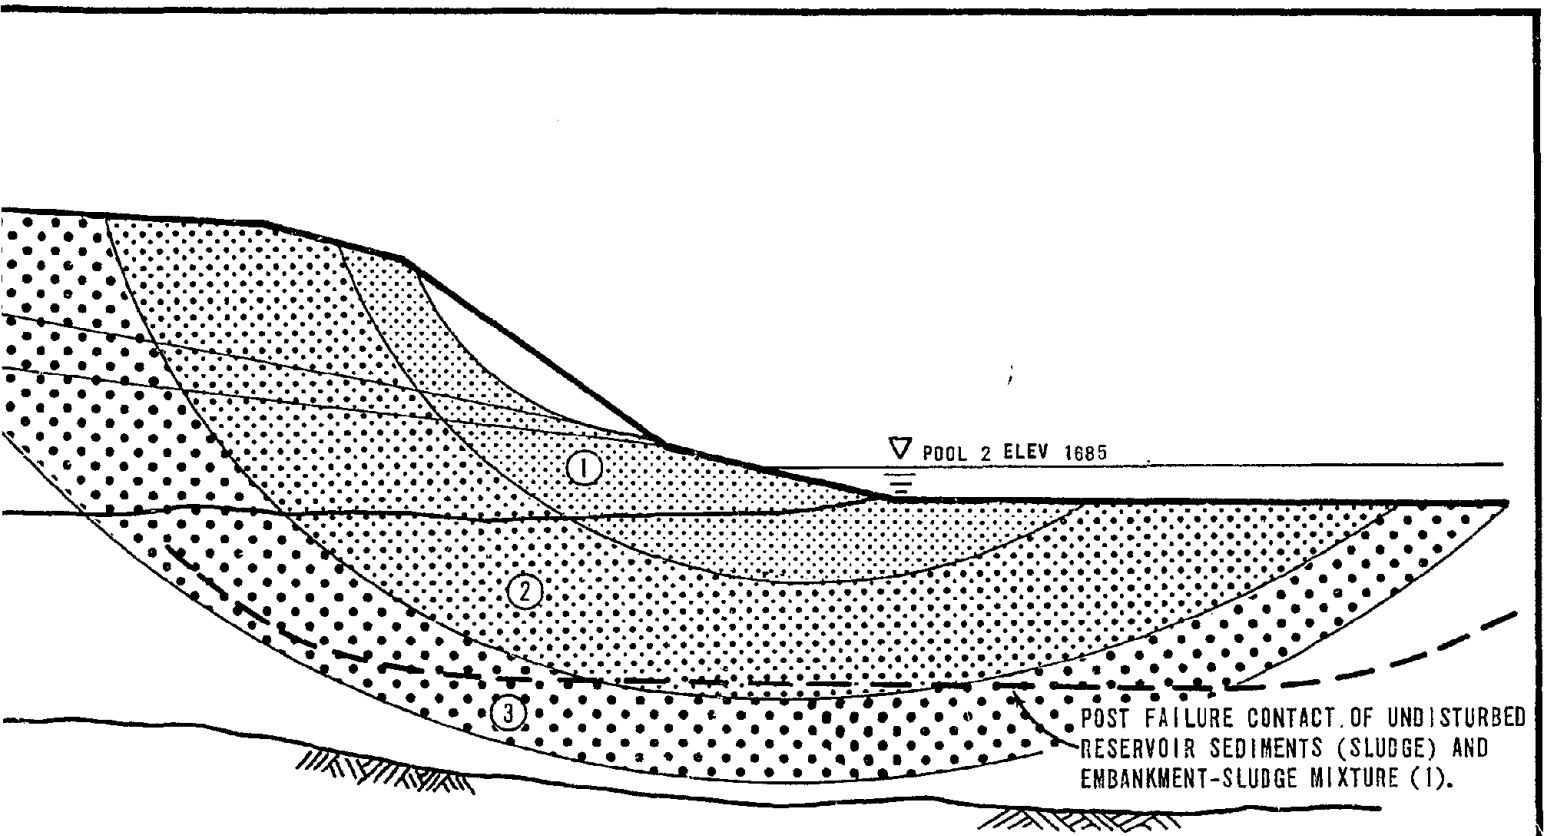
W. A. WAHLER & ASSOCIATES	COAL REFUSE DAM FAILURE SAUNDERS, WEST VIRGINIA PALO ALTO • NEWPORT BEACH • CALIF.	RESULTS OF STABILITY ANALYSIS SECTION E-E'		
		COAL WASTE DAM NO. 3		
		PROJECT NO.	DATE	FIGURE NO.
		0700	NOVEMBER 1972	VII-21

Normal Pool 3 Level - The results of the stability analyses for sections E-E' and F-F' of Dam No. 3 for normal Pool 3 elevation of 1,735, are presented on Figures VII-21 and VII-22, respectively. Although results are presented for two anisotropic permeability ratios, the following discussion will concentrate on the results obtained for the ratio of 25:1. As discussed earlier in this Chapter, the range of horizontal to vertical permeability of the foundation sludge varied from about 16:1 to 100:1 with an average value between 25:1 and 36:1. For this reason, the conclusions regarding the embankment stability

were based on the anisotropic foundation permeability ratio of 25:1. However, the results for the ratio of 100:1 are also presented to indicate the sensitivity of the stability results to the assumed permeability ratio.

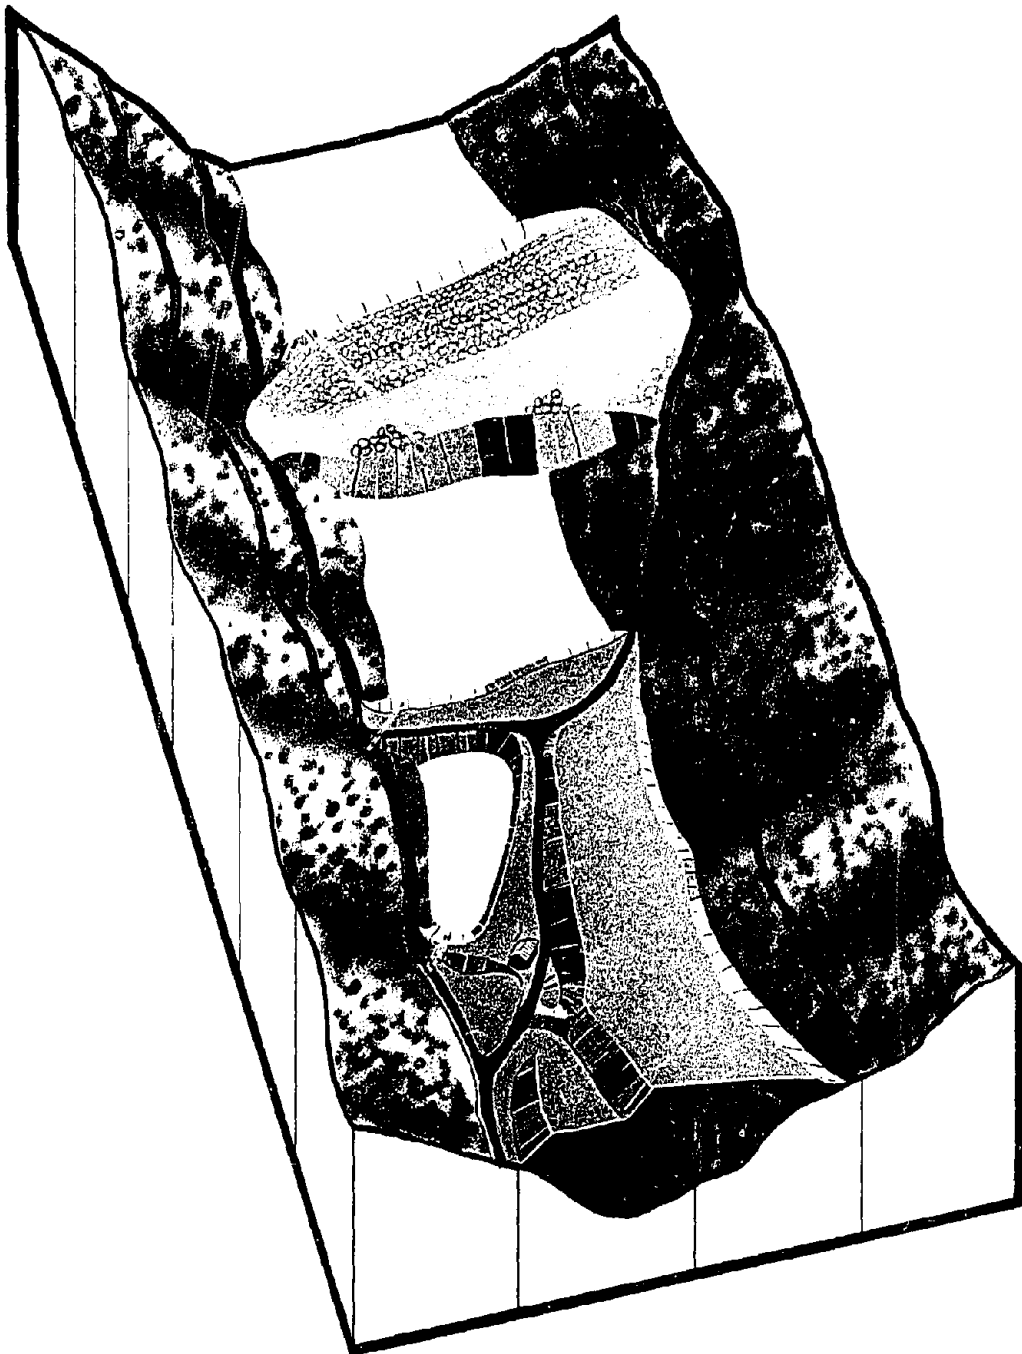
MIDDLE FORK VALLEY IN EARLY FEBRUARY 1972, LOOKING UPSTREAM. POOL 3 HAS A SURFACE ELEVATION OF ABOUT 1740-1745 FEET.

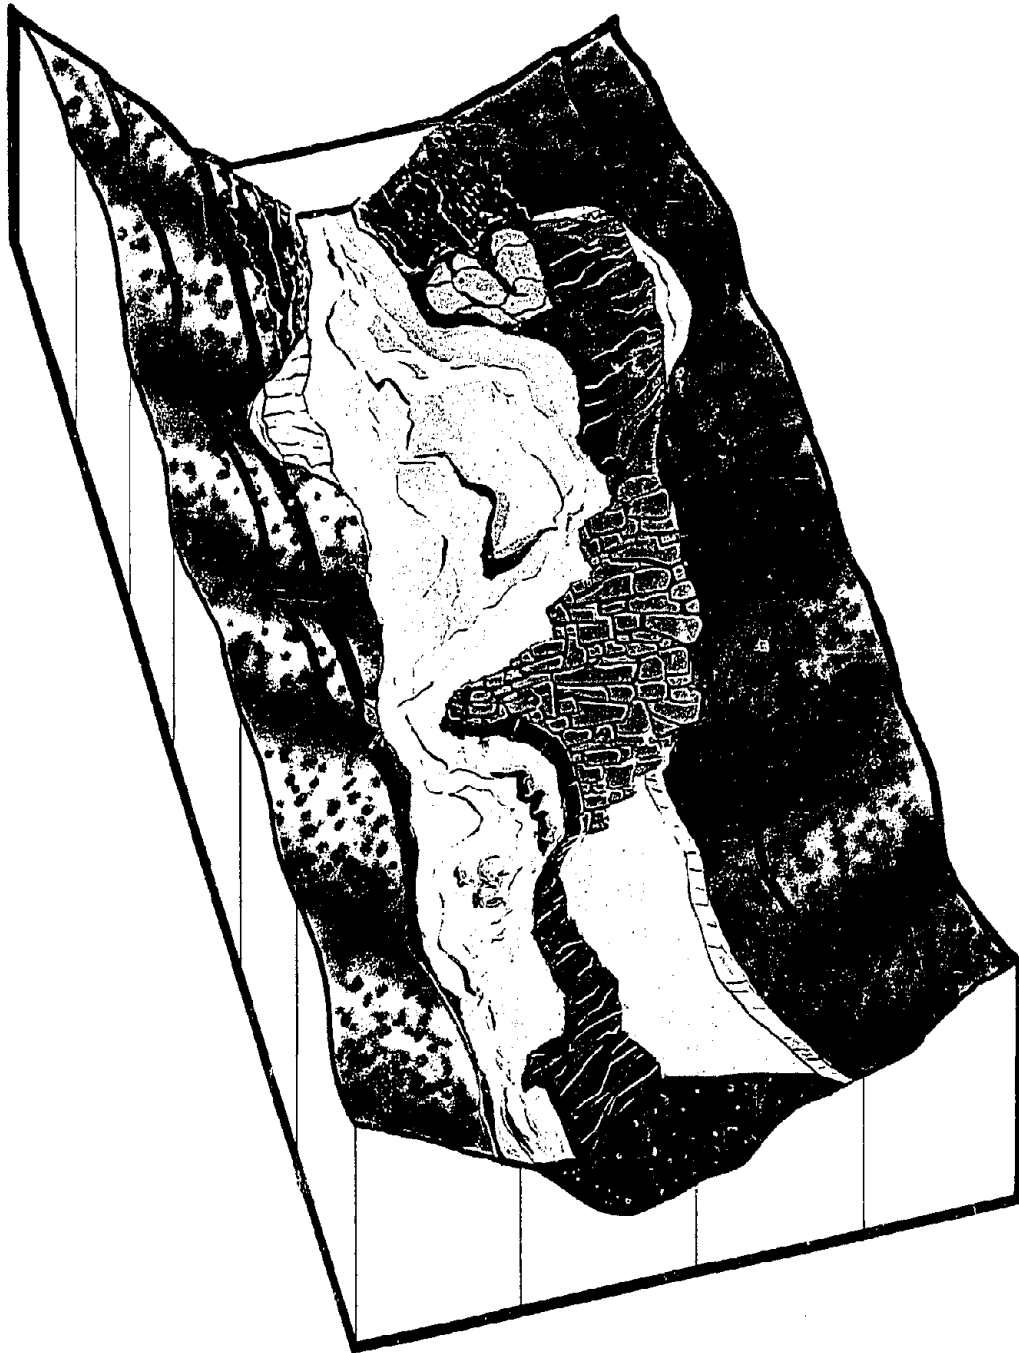
MIDDLE FORK VALLEY, FEBRUARY 26, 1972. FAILURE AFTERMATH

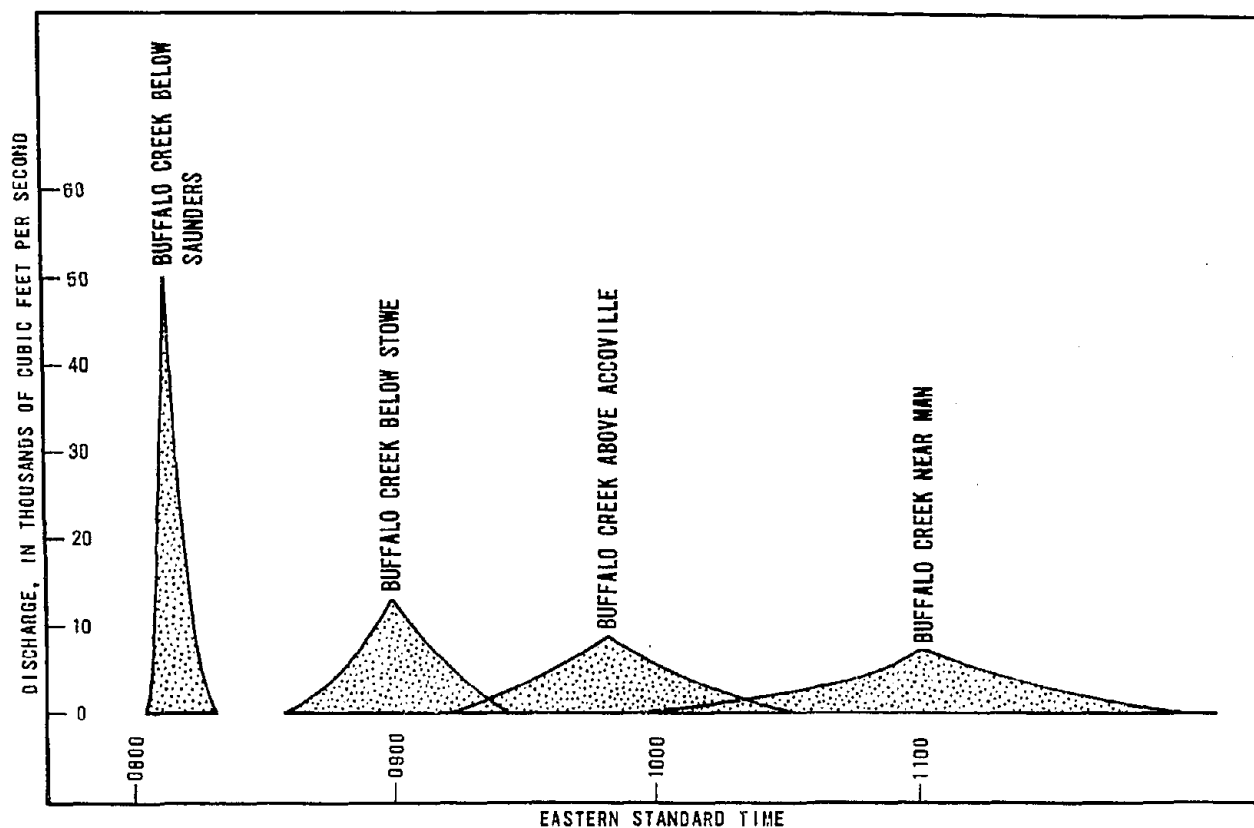
FIGURE VIII-1.—ESTIMATED FLOOD HYDROGRAPHS FOR BUFFALO CREEK BELOW SAUNDERS, BELOW STOWE, ABOVE ACCOVILLE, AND NEAR MAN ON FEBRUARY 26, 1972.

When Dam No. 3 failed, approximately 140 million gallons of water and coal wastes were discharged into Buffalo Creek. Since the time of total discharge from the impoundment was 15 minutes or less, as reported by eyewitnesses, the impact on the Buffalo Creek flood plain was dramatic. The USGS computed the peak discharge in Buffalo Creek below Saunders to have been 50,000 cfs (22 million gpm), resulting in a flash flood with a magnitude at least 40 times that of the 50-year flood for this area.
