TENNESSEE VALLEY AUTHORITY

SUBJECT: REPORT ON FAILURE OF WHEELER LOCK

REPORT ON FAILURE OF WHEELER LOCK

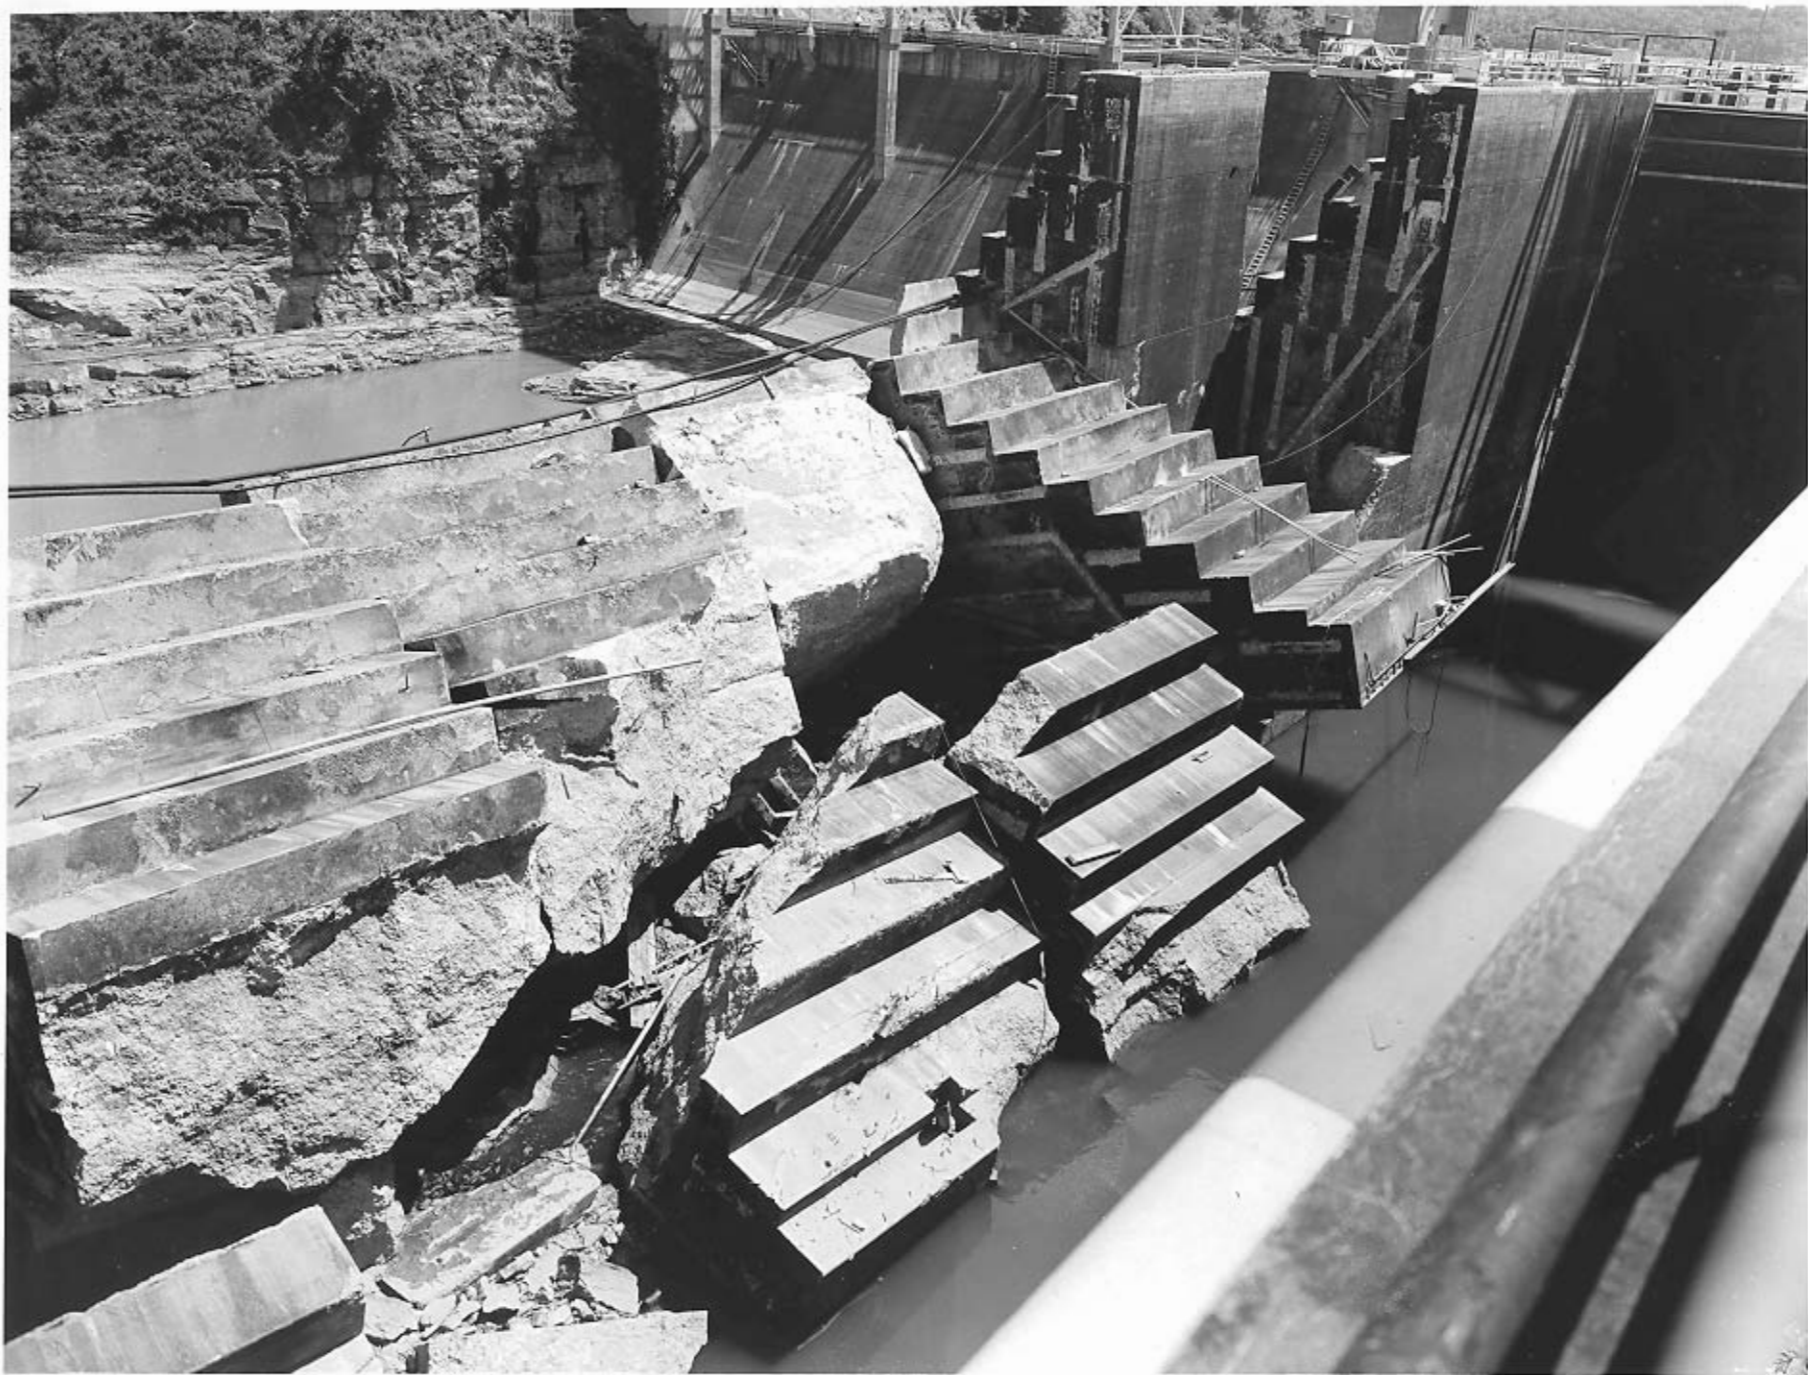
Auxiliary lock blocks 6 through 1.

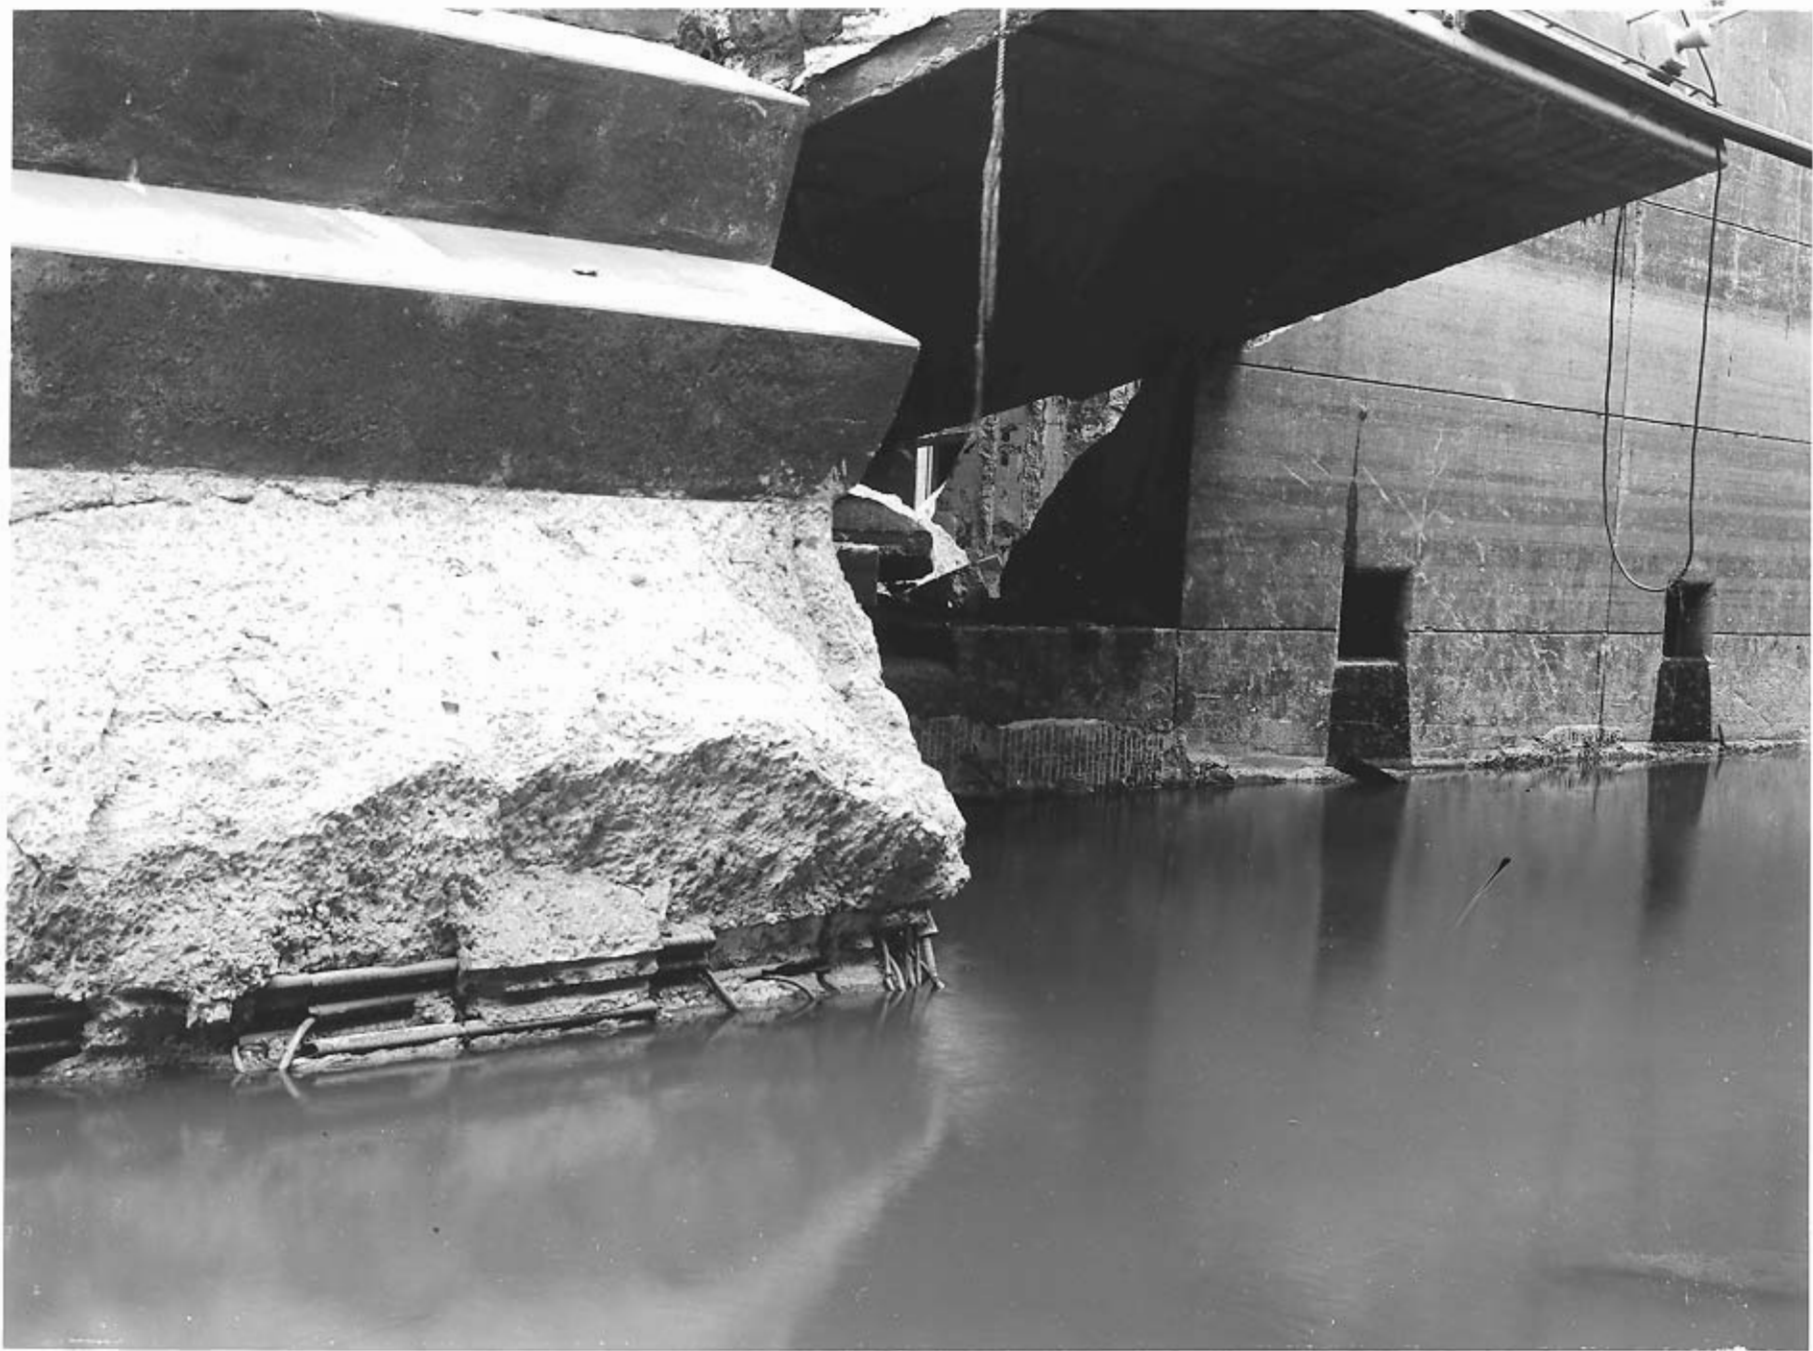
Auxiliary lock blocks 4, 3, 2, and 1.

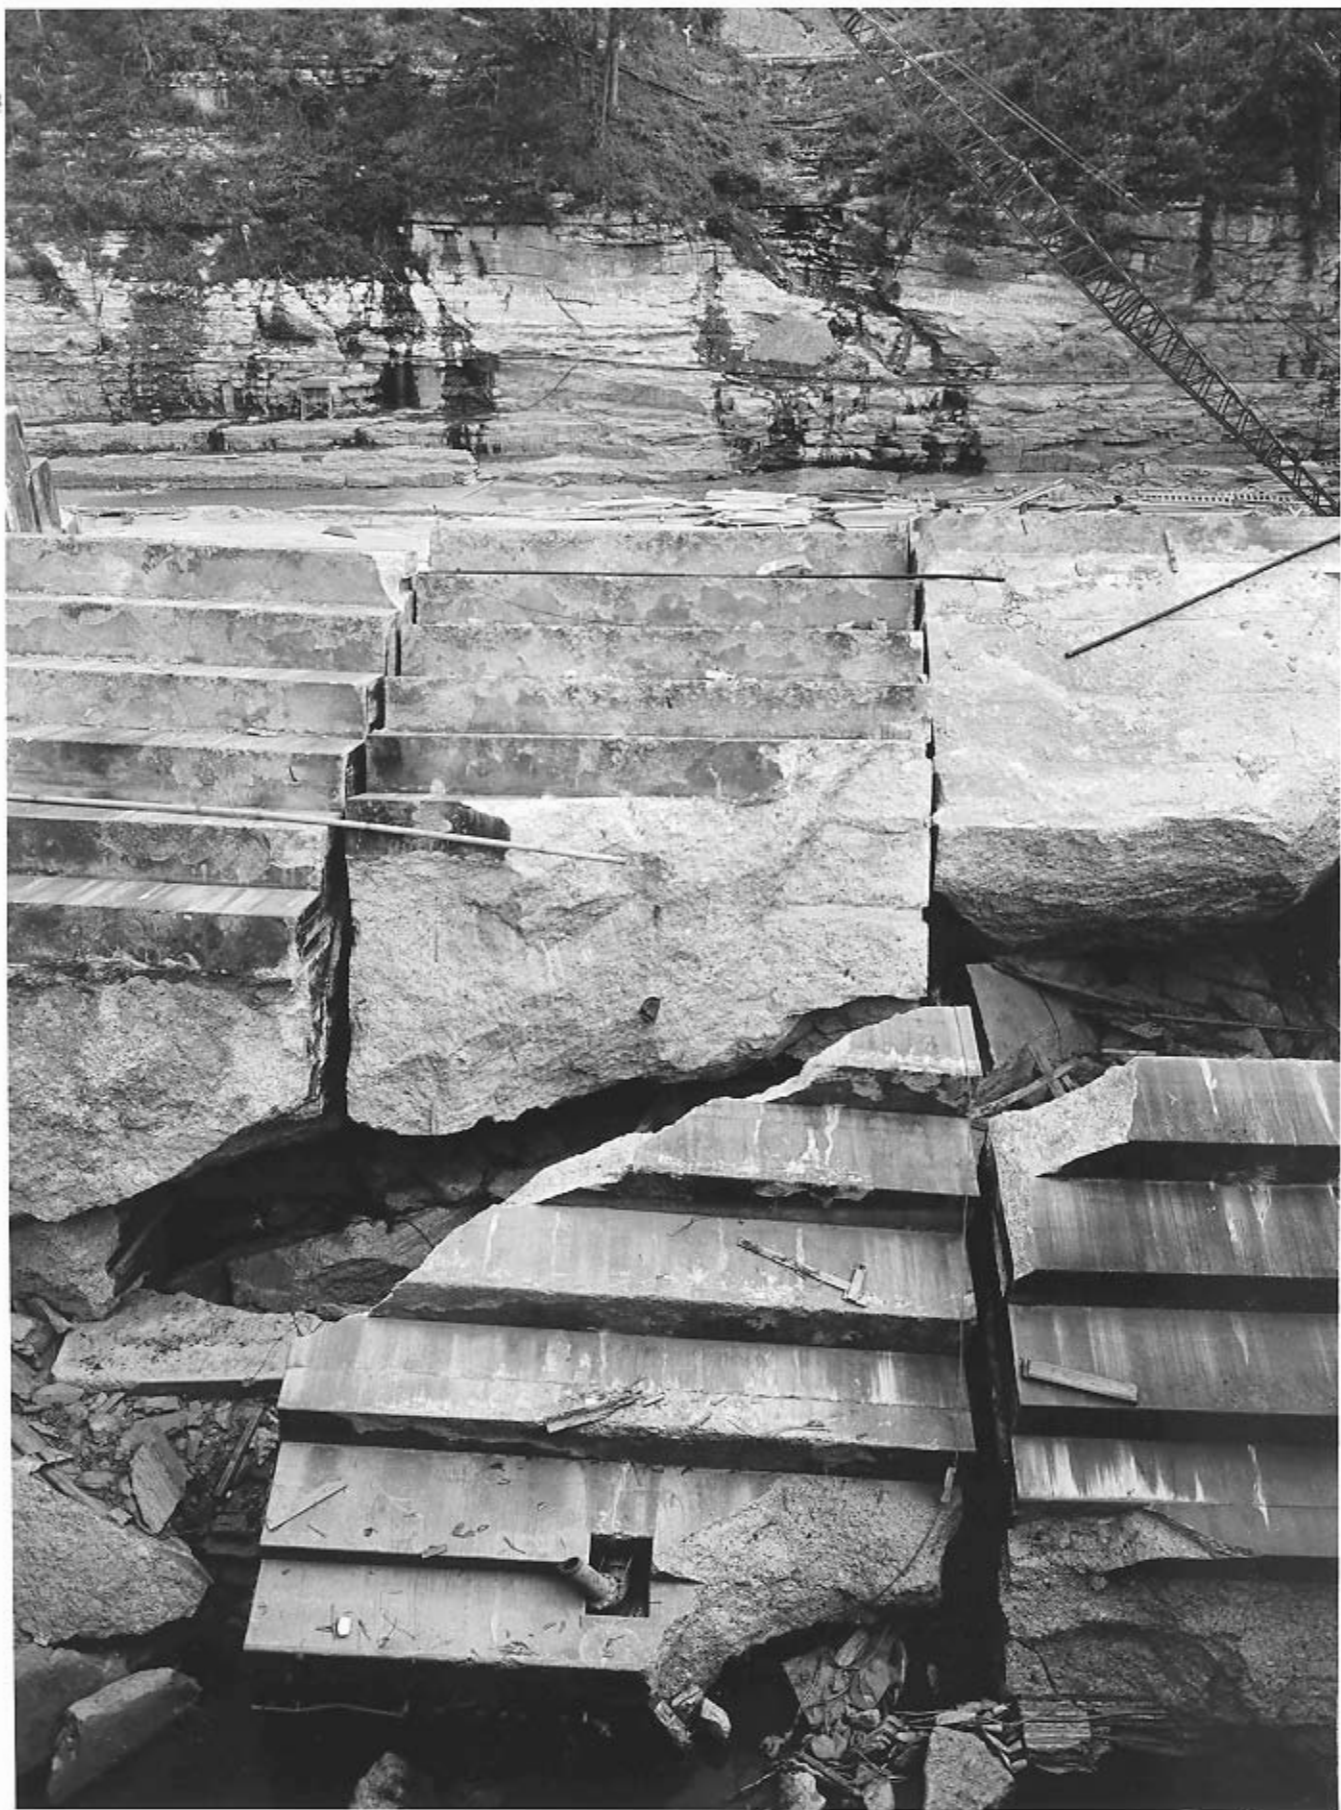
Auxiliary lock, blocks 6, 5, and 4.

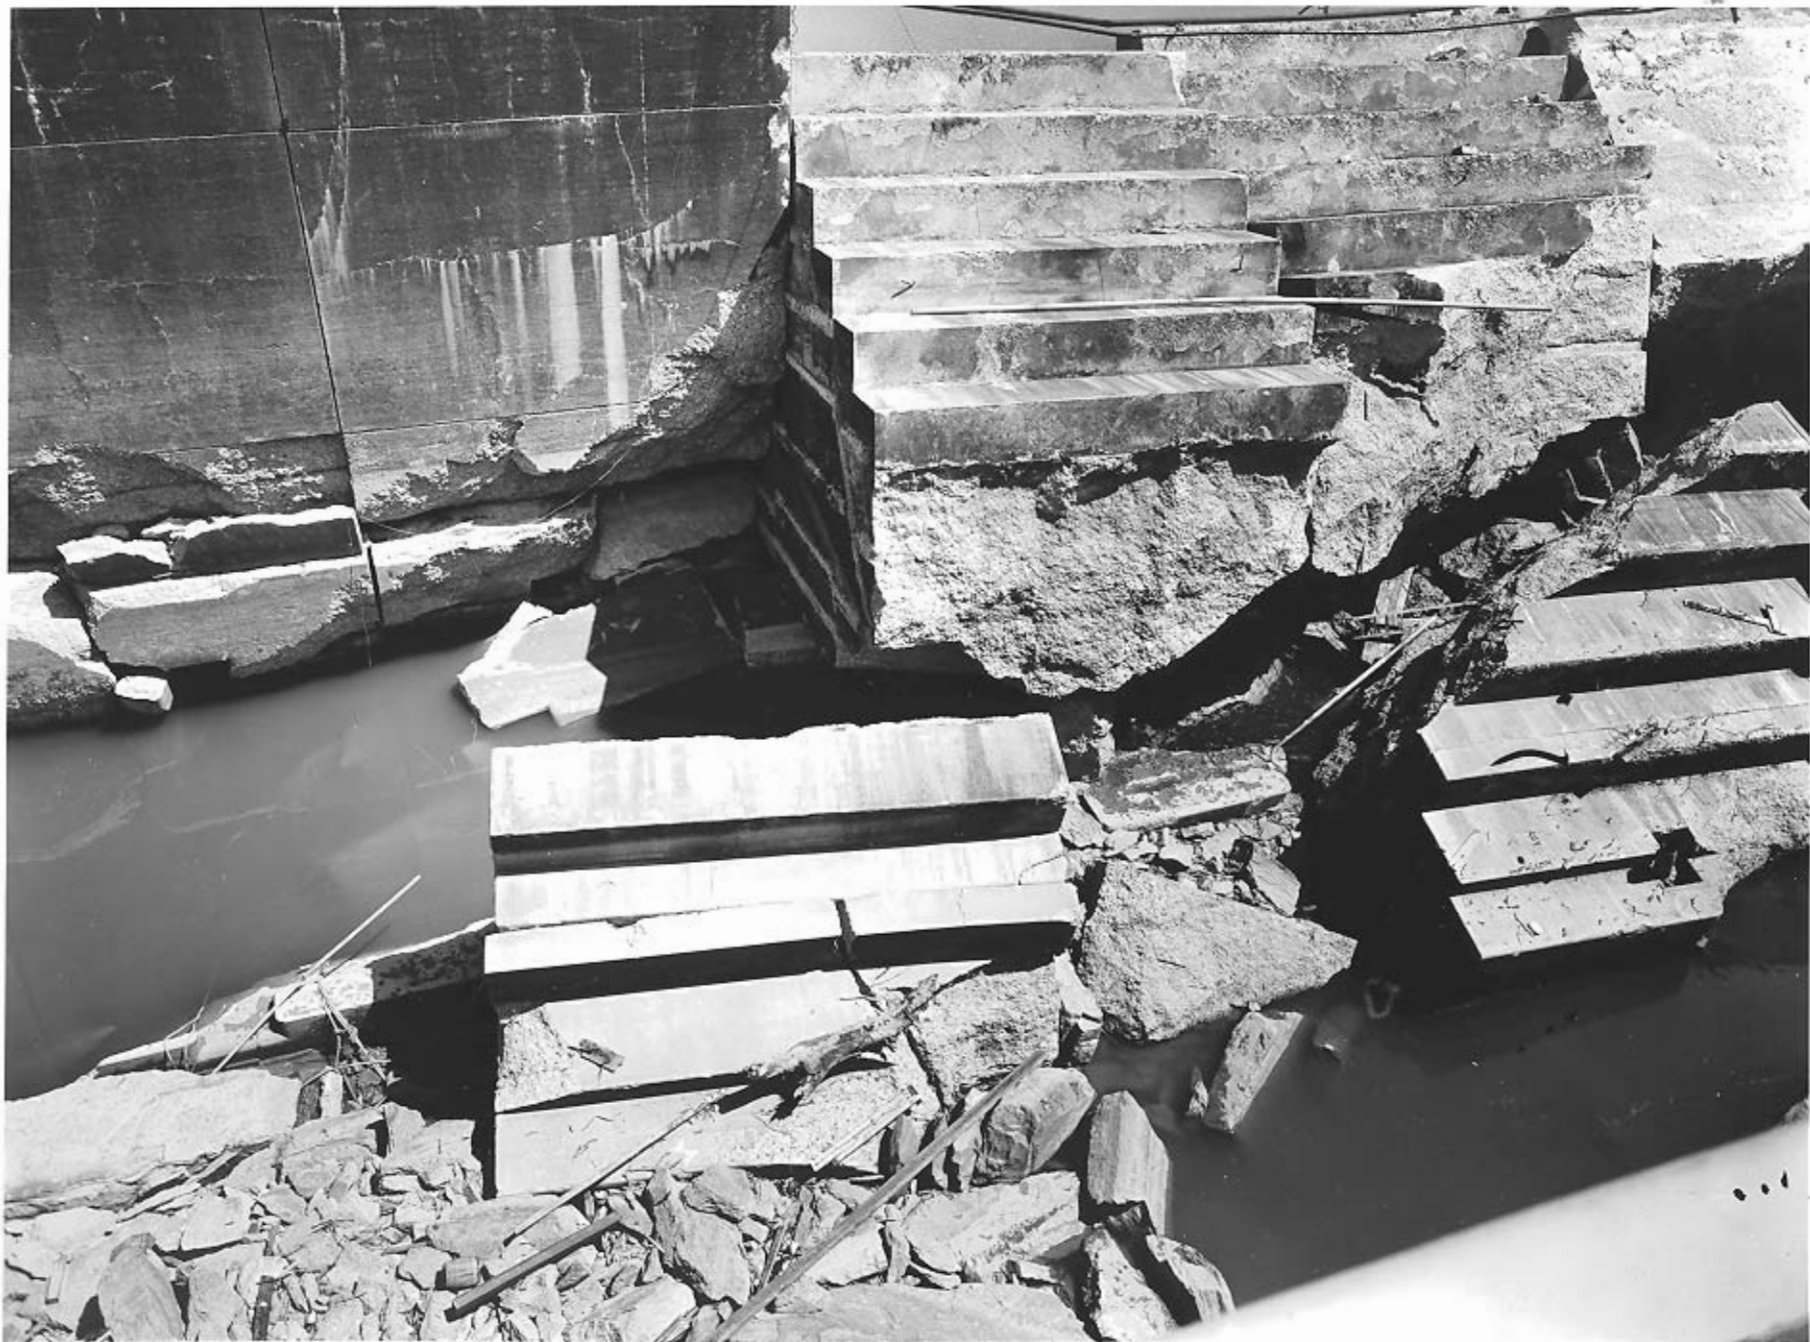
Auxiliary lock blocks 8 through 4.

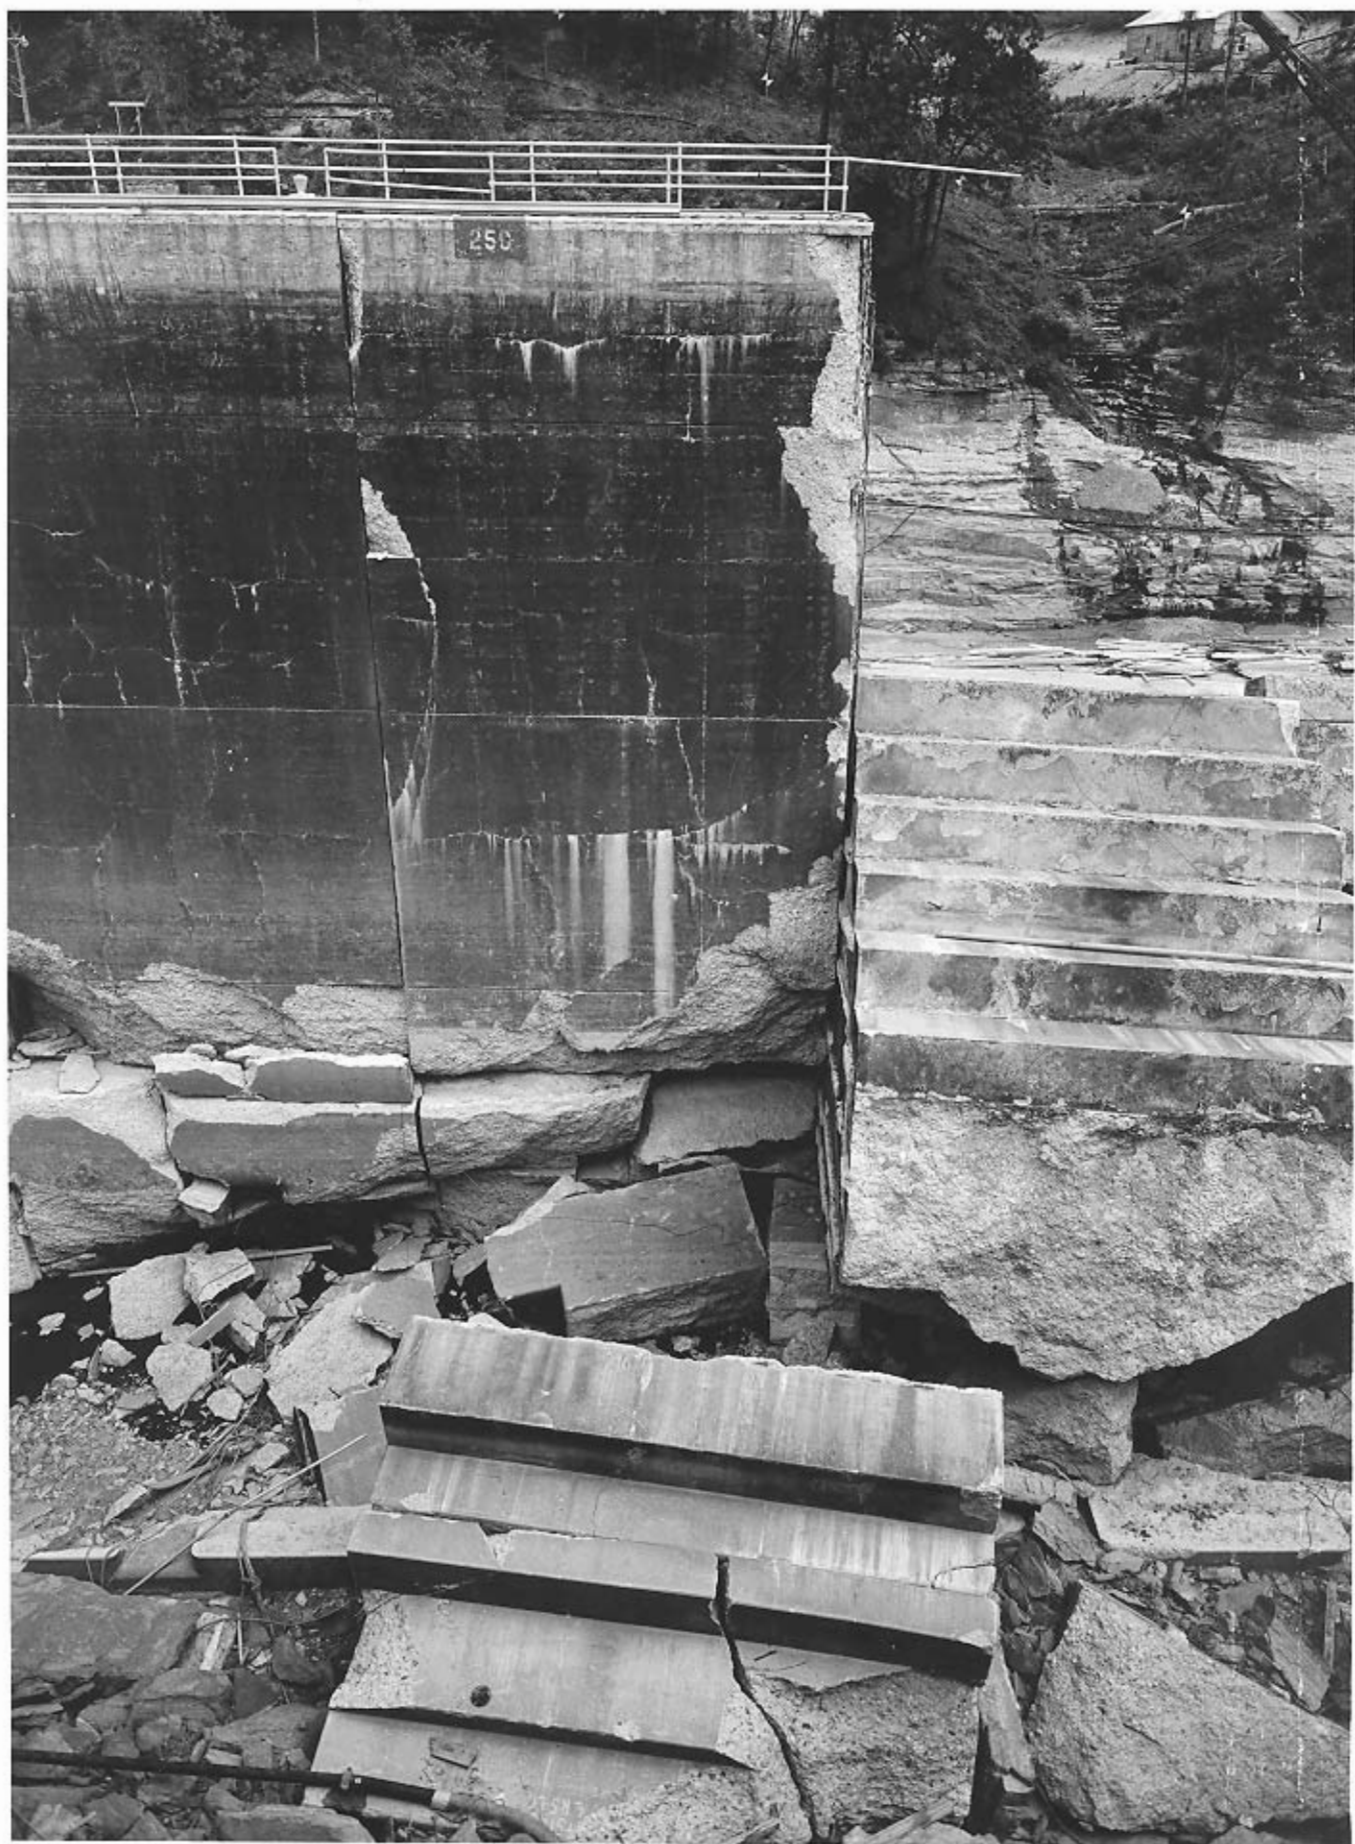
Auxiliary lock, blocks 8, 7, and 6.

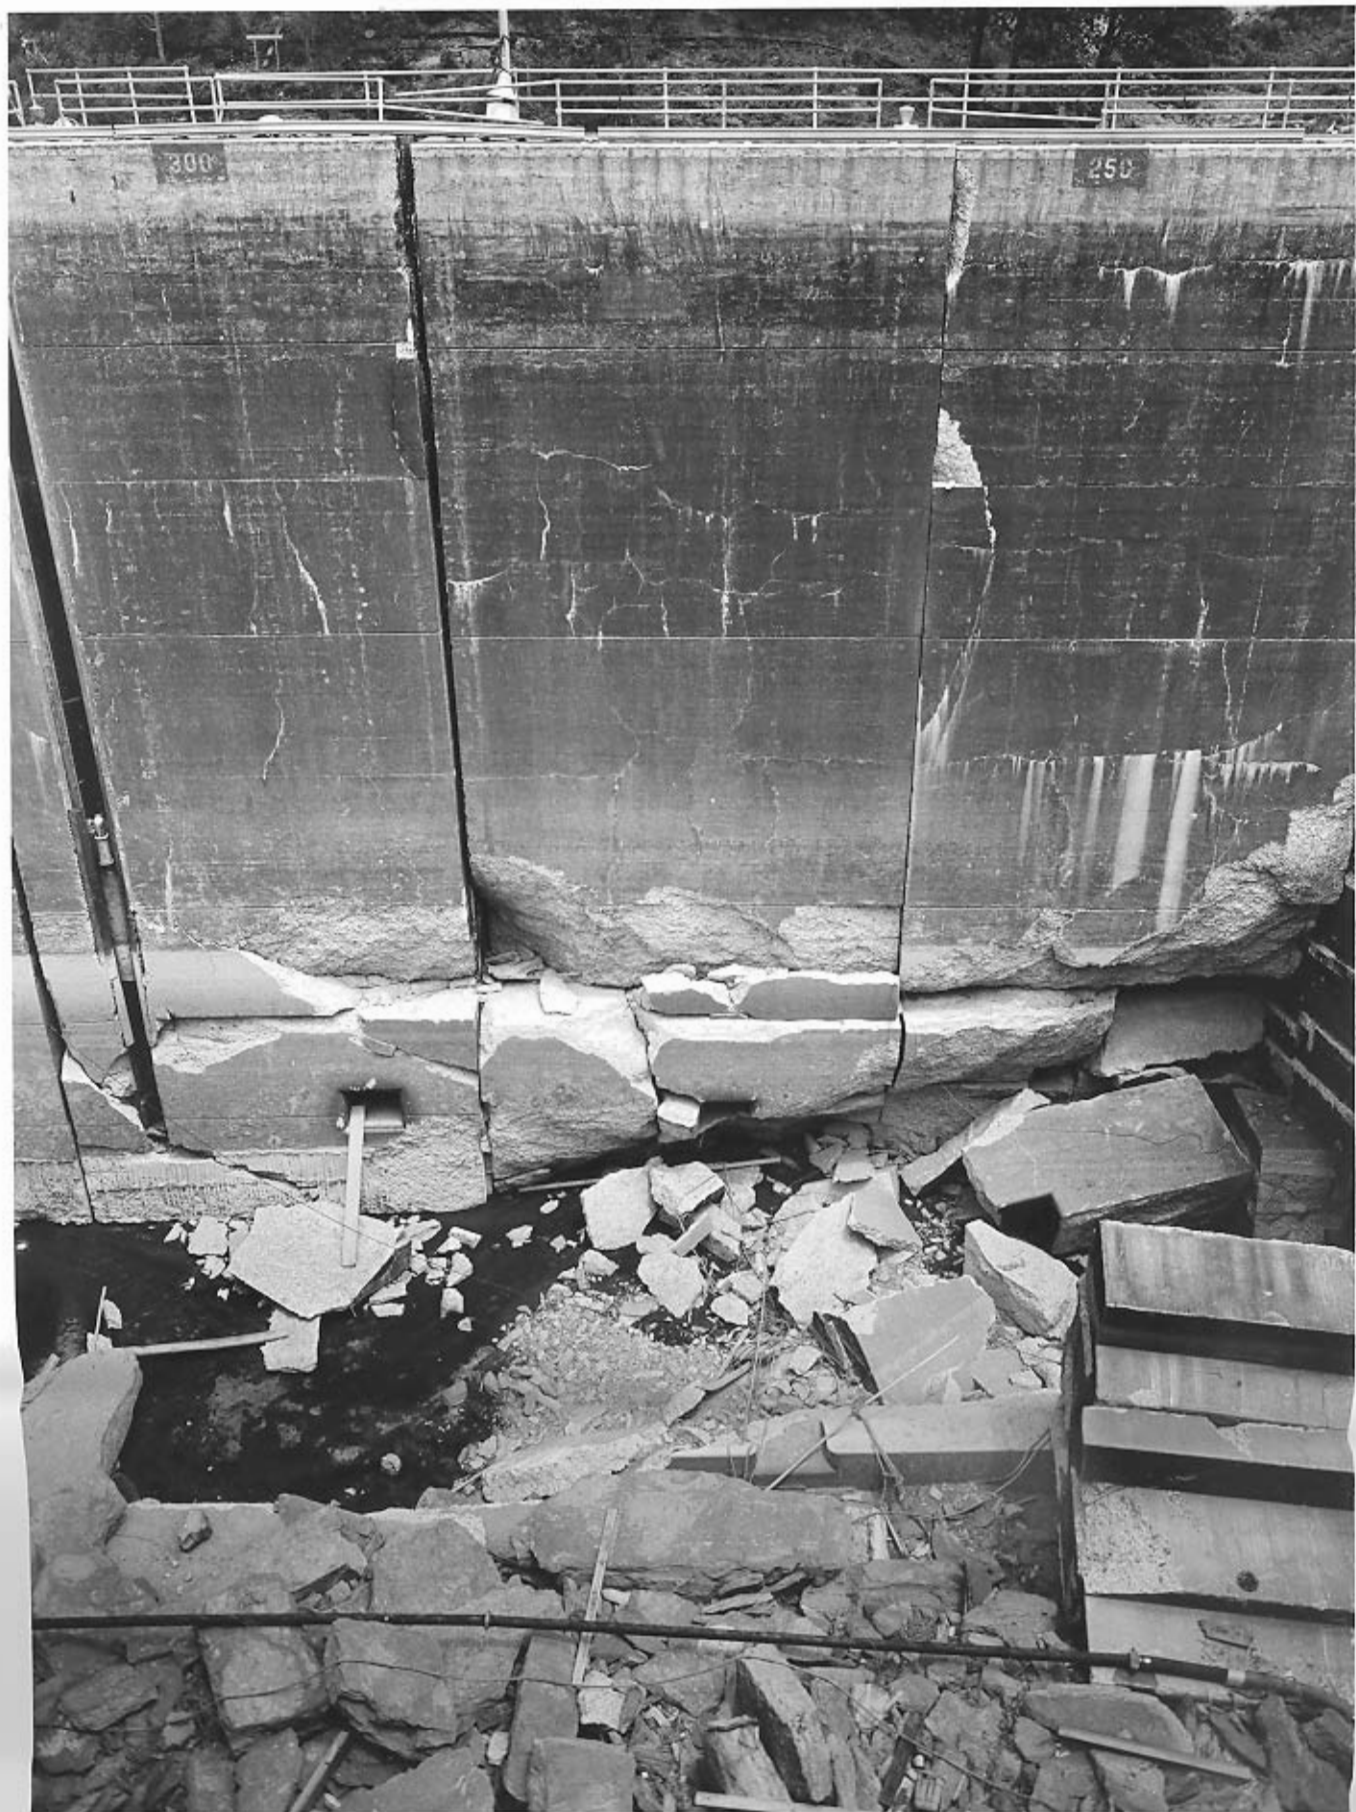
Auxiliary lock, blocks 9, 8, and 7.

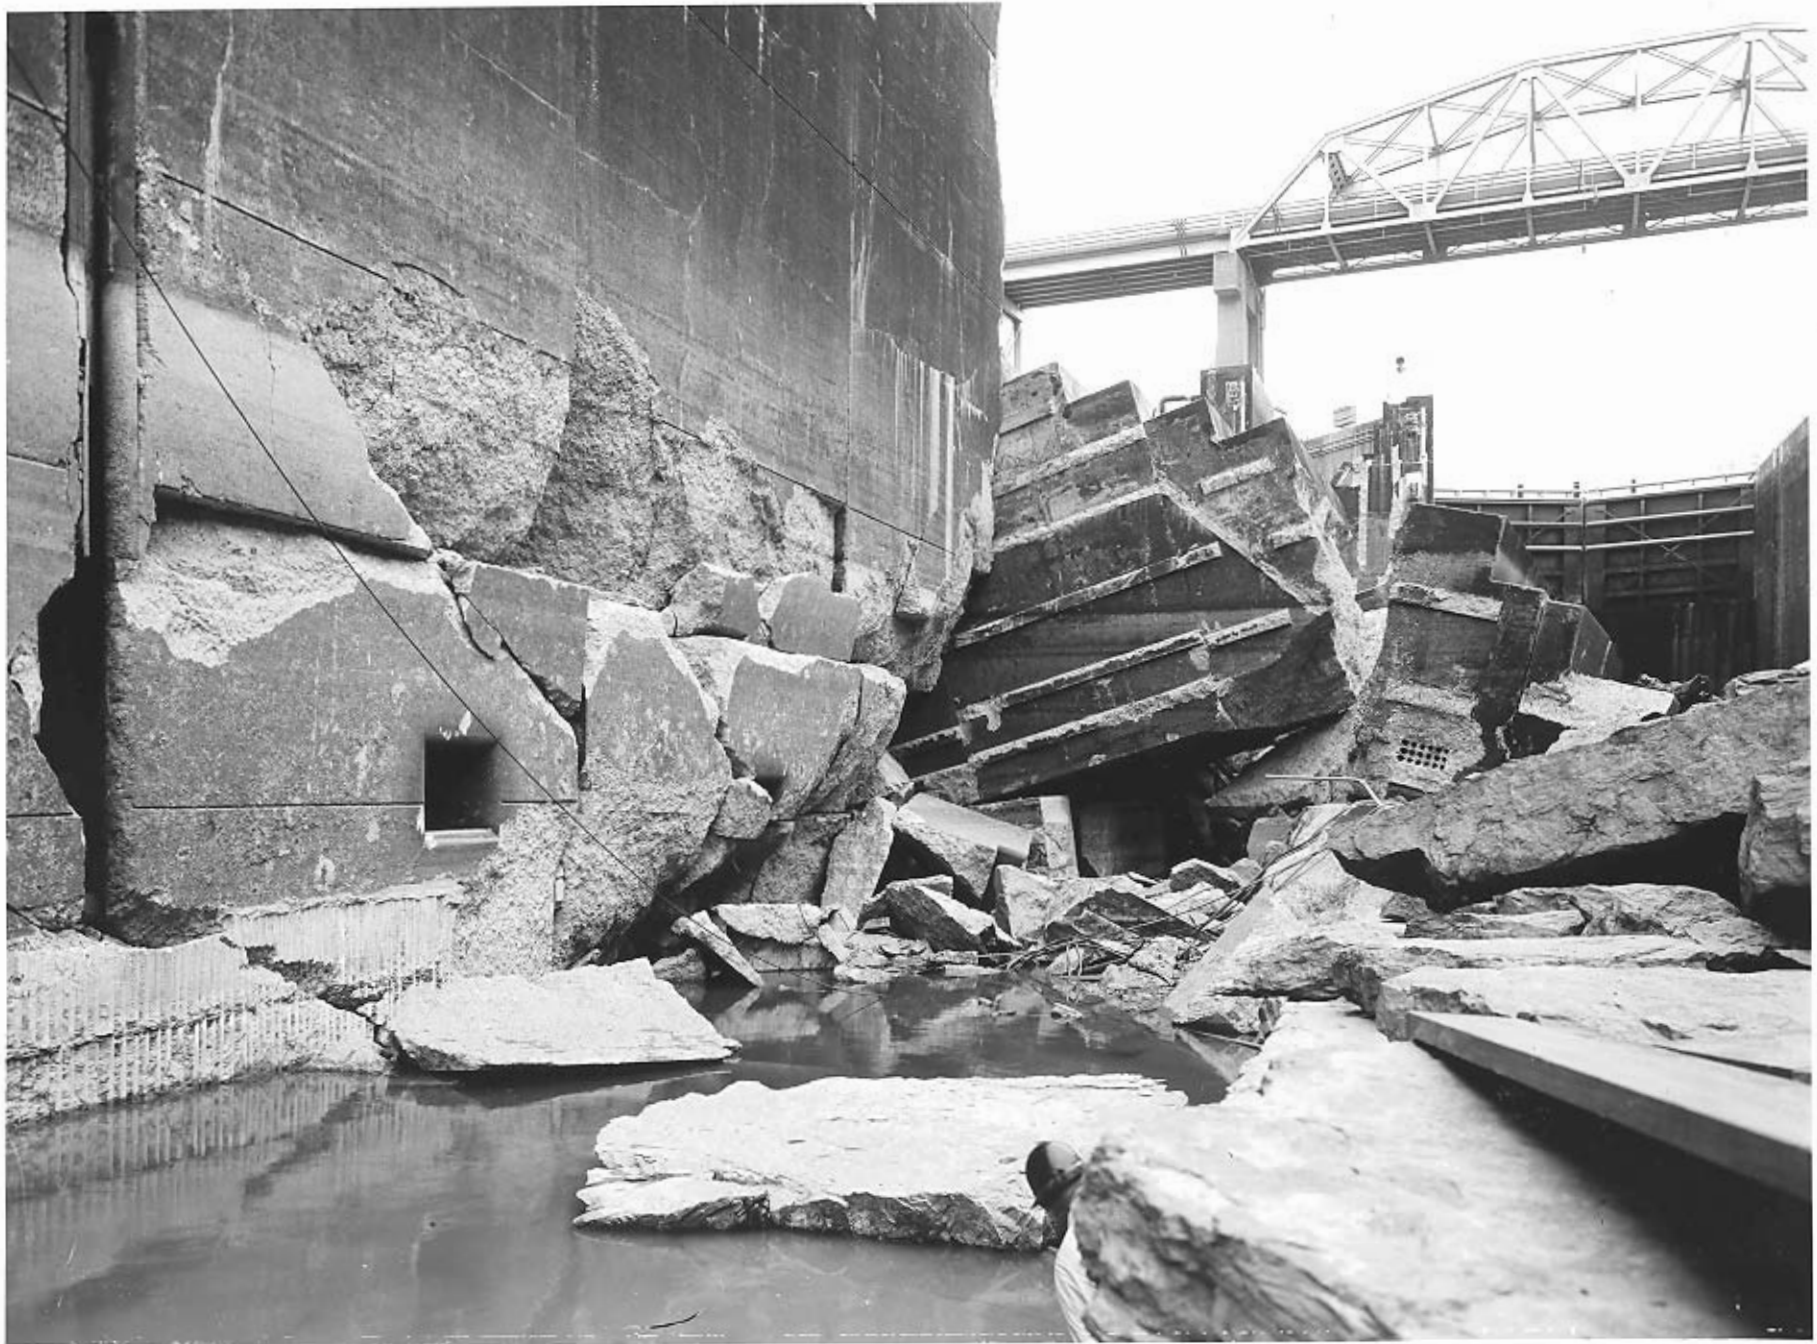
Auxiliary lock land wall from elevation 490 (block 9 at left).

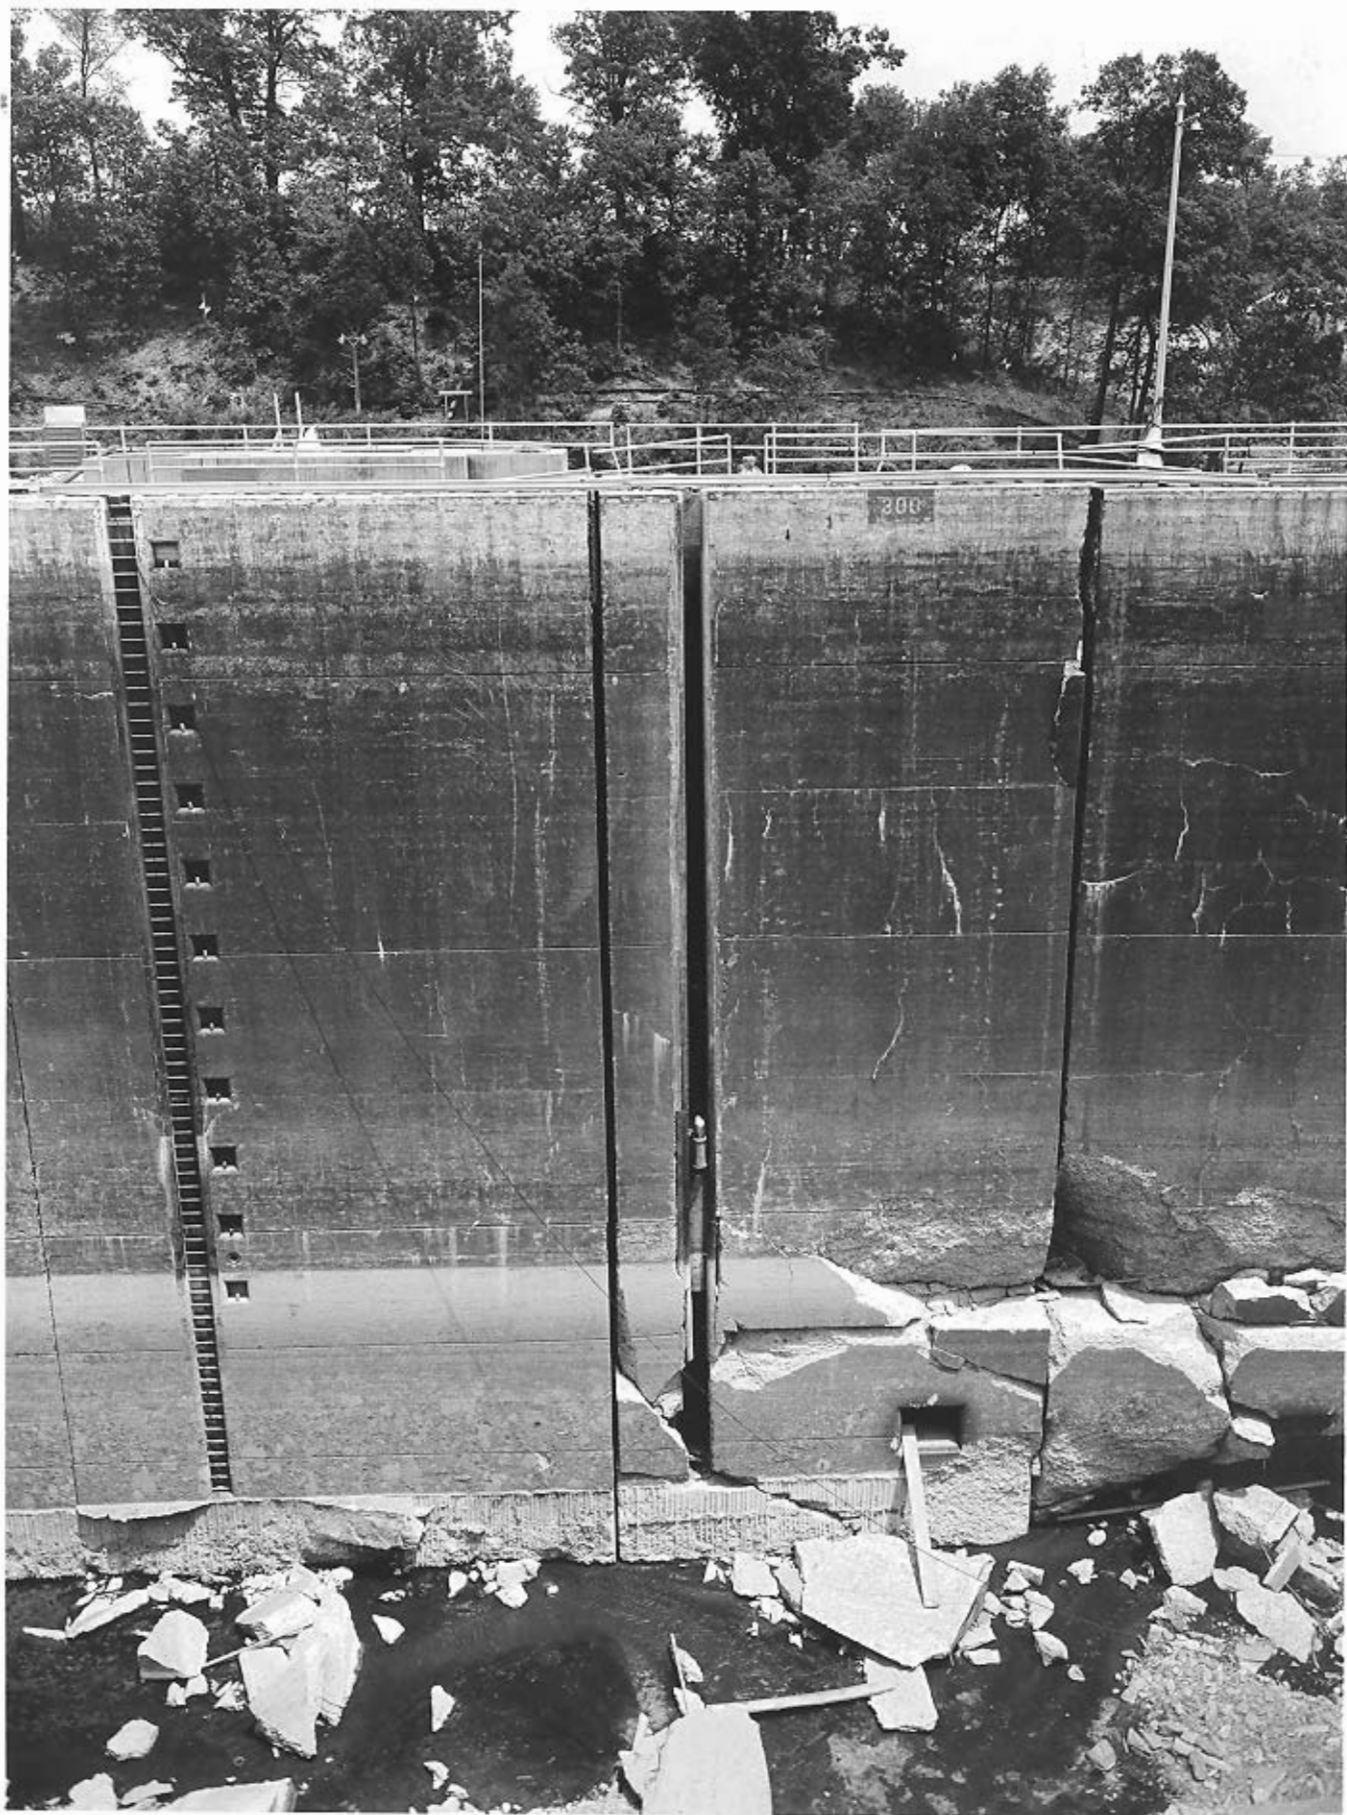
Auxiliary lock, blocks 10, 9, and 8.

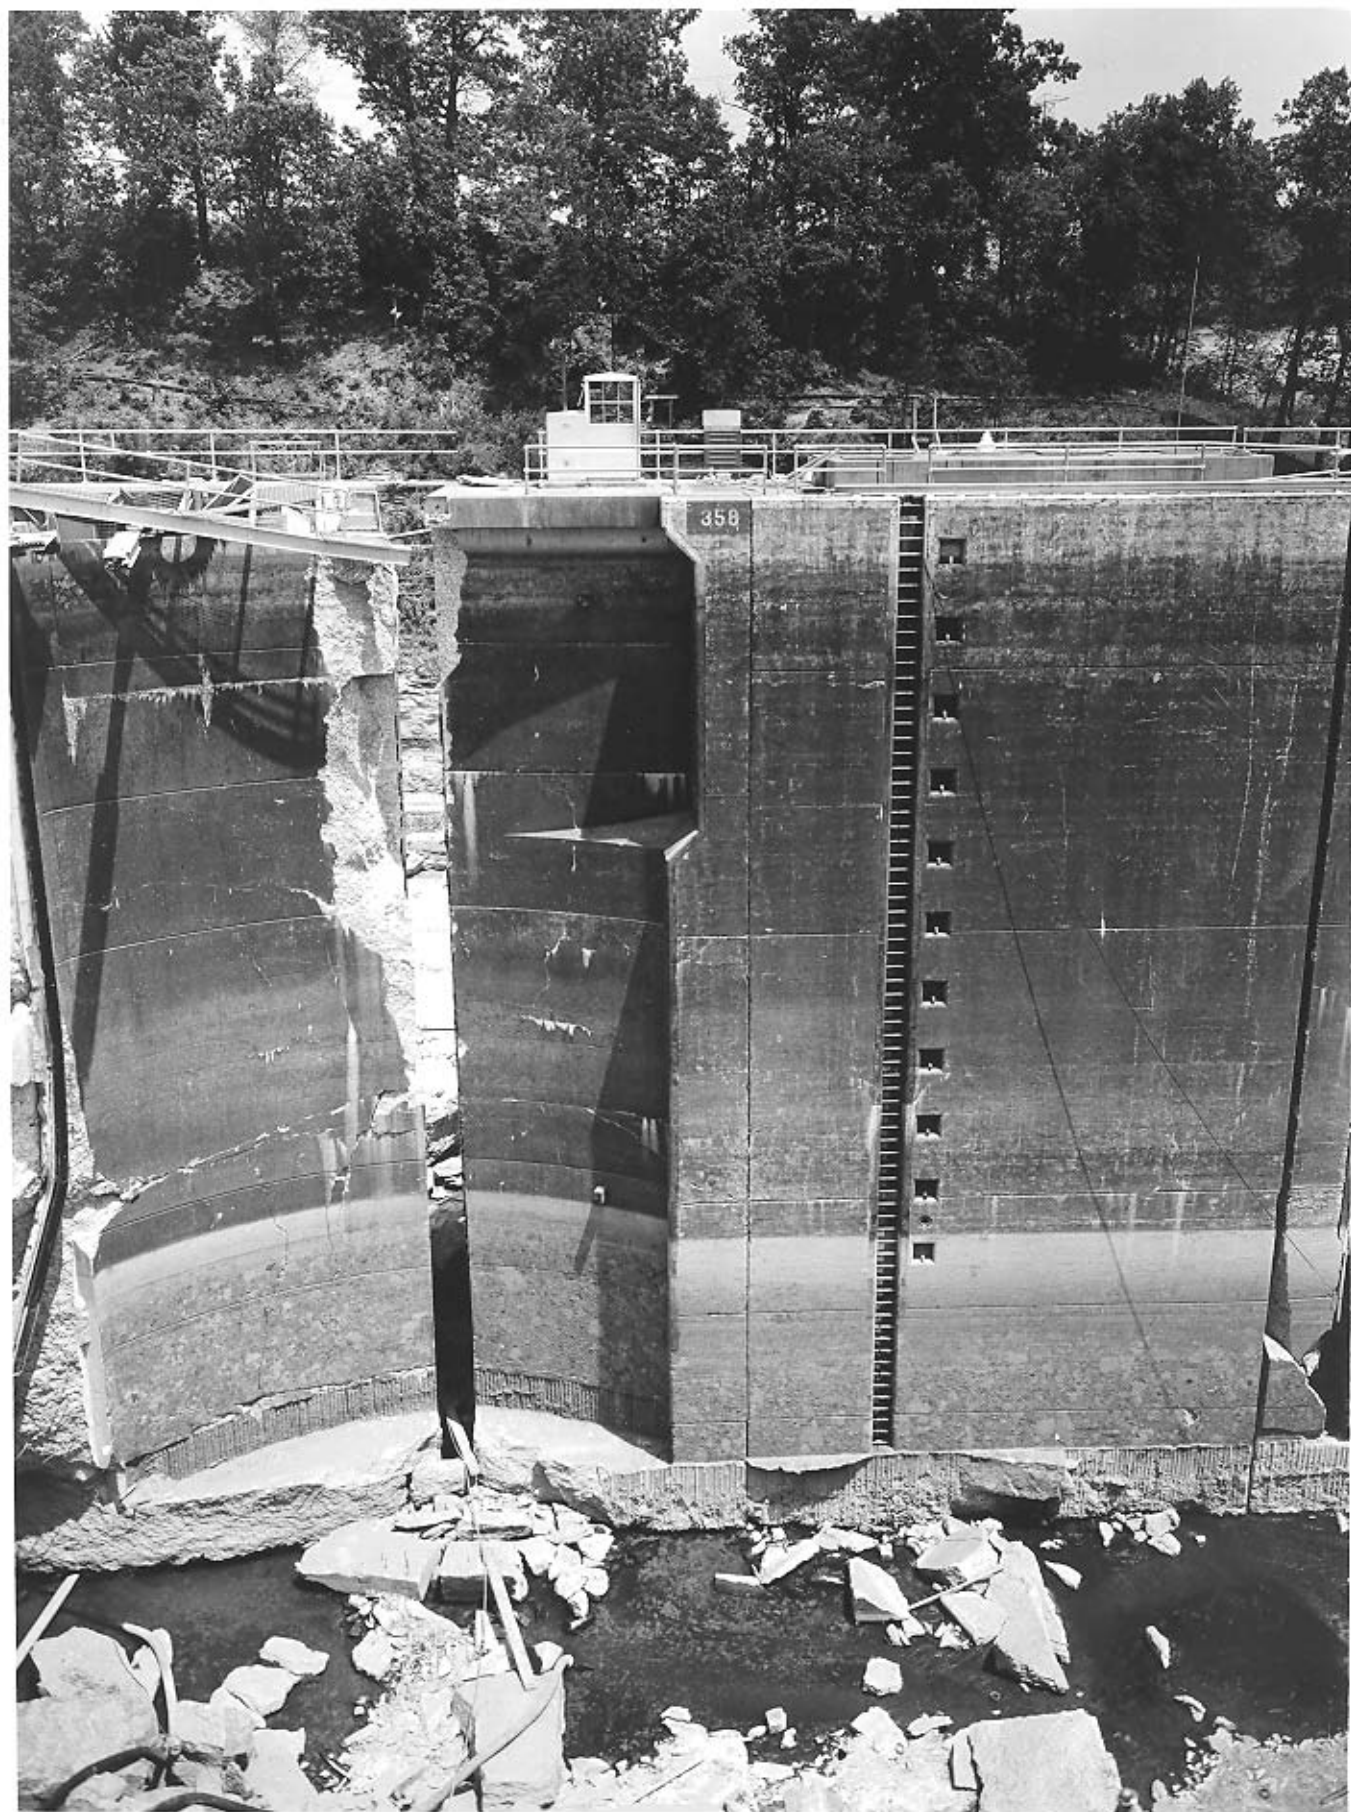
Auxiliary lock, blocks 12, 11, and 10.
