TENNESSEE VALLEY AUTHORITY

SUBJECT: REPORT ON FAILURE OF WHEELER LOCK

REPORT ON FAILURE OF WHEELER LOCK

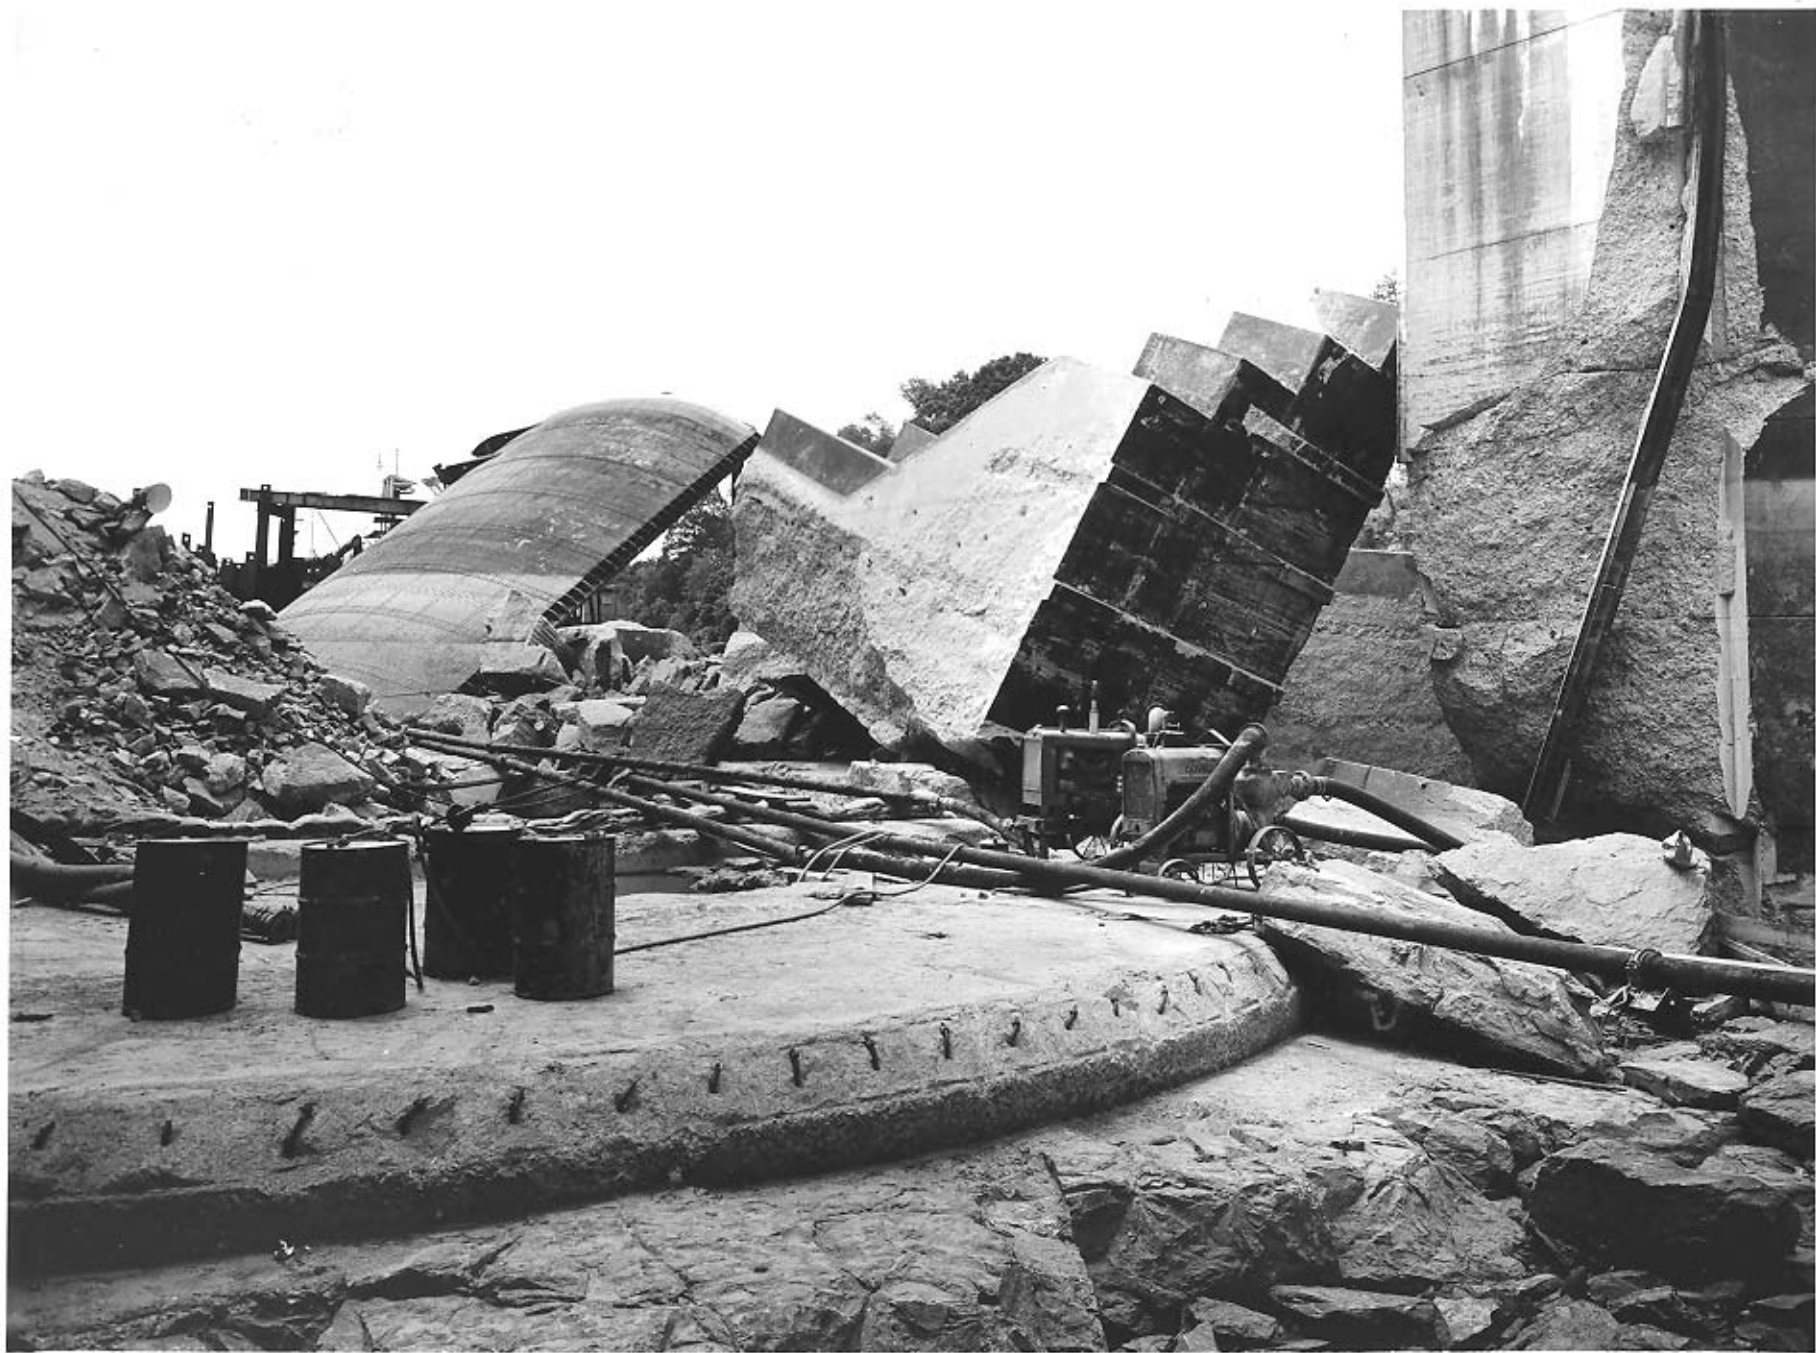
Auxiliary lock area, downstream from block 12 (looking northwest).

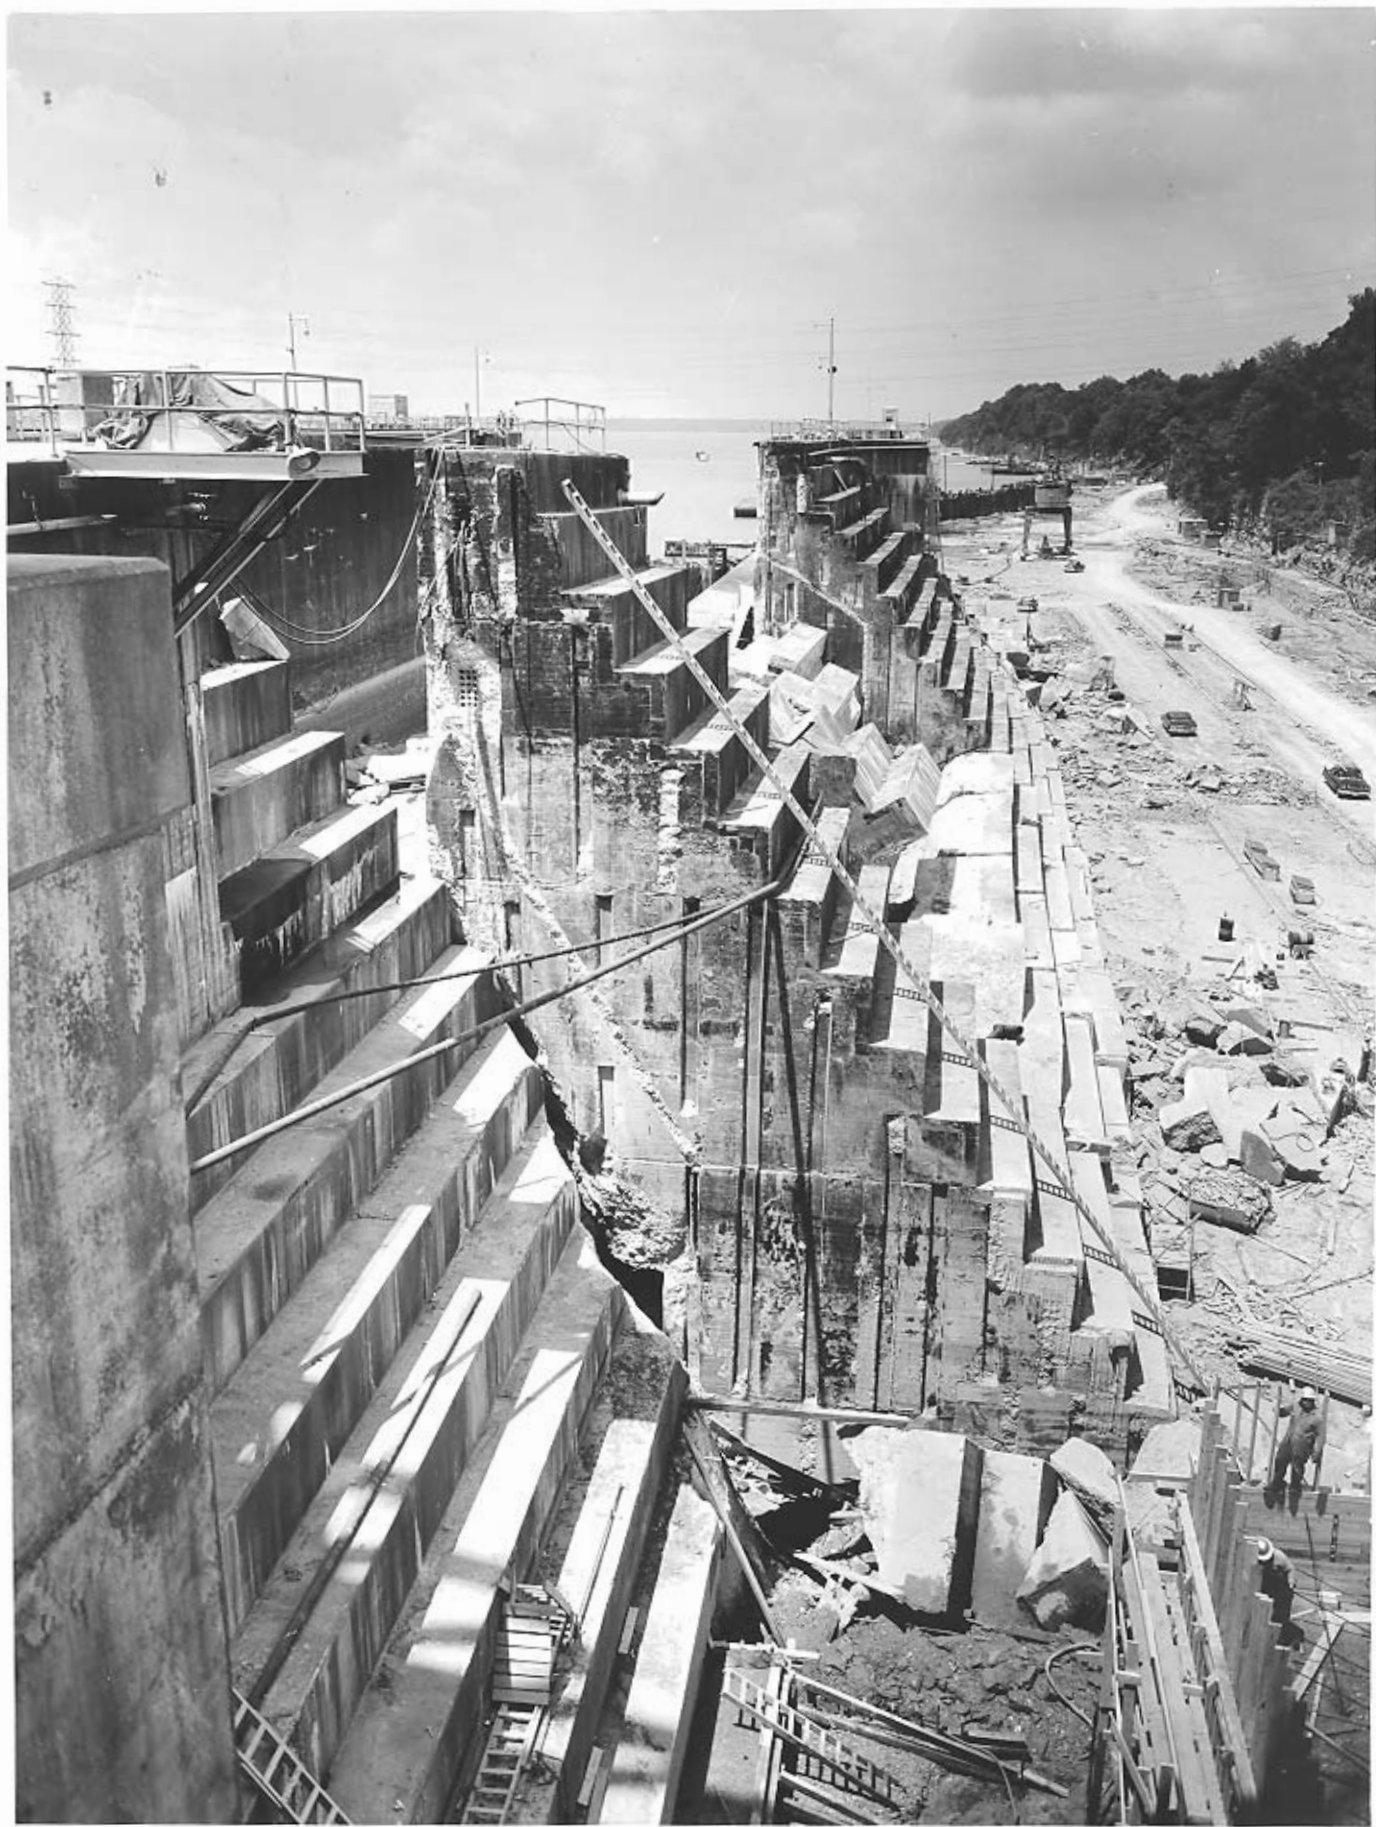
Auxiliary lock, looking downstream from dam non-overflow section.

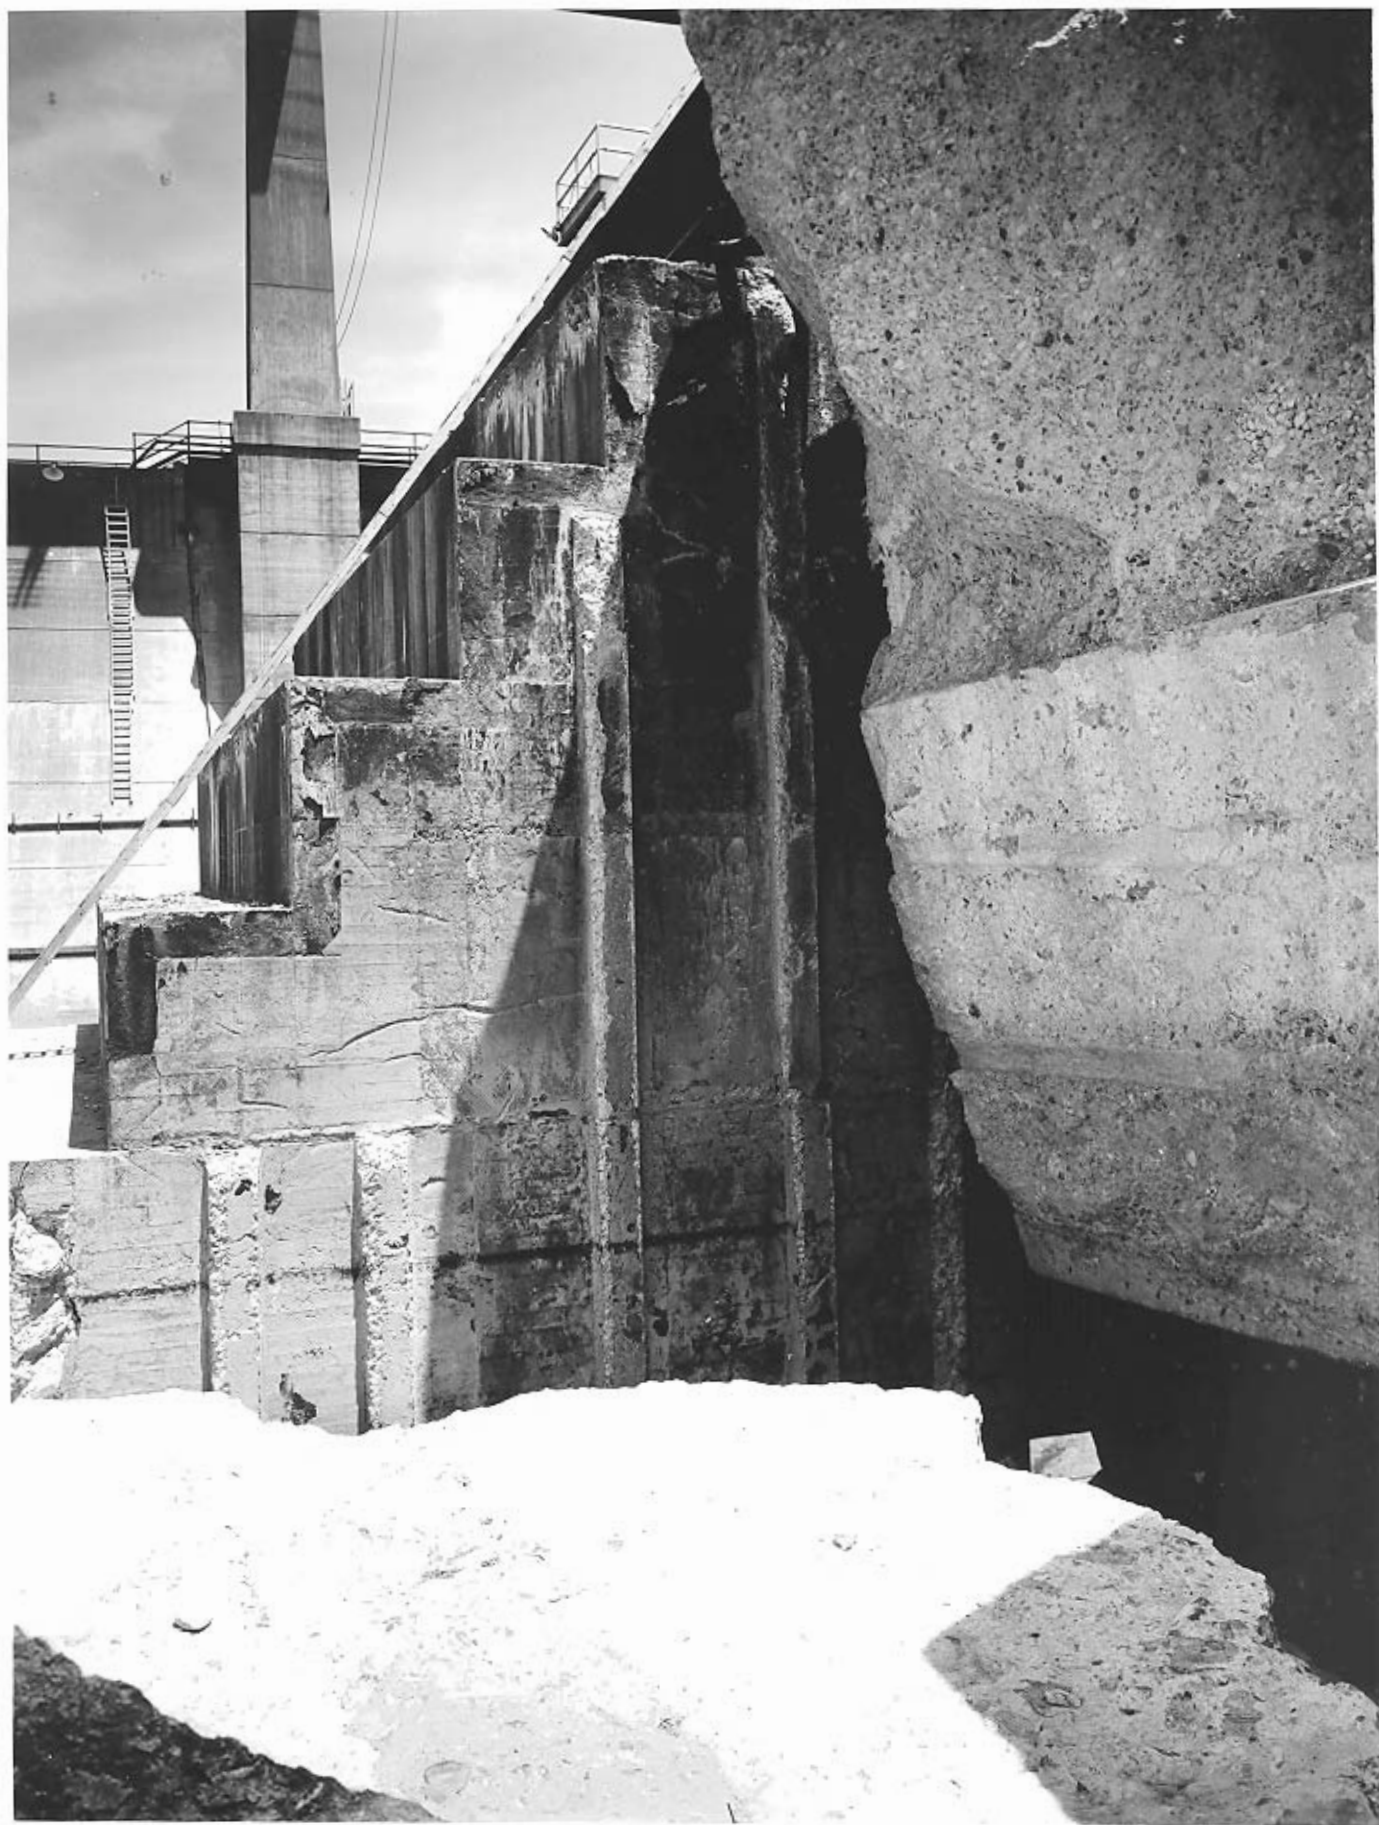
Auxiliary lock, portion of downstream face of block 2.

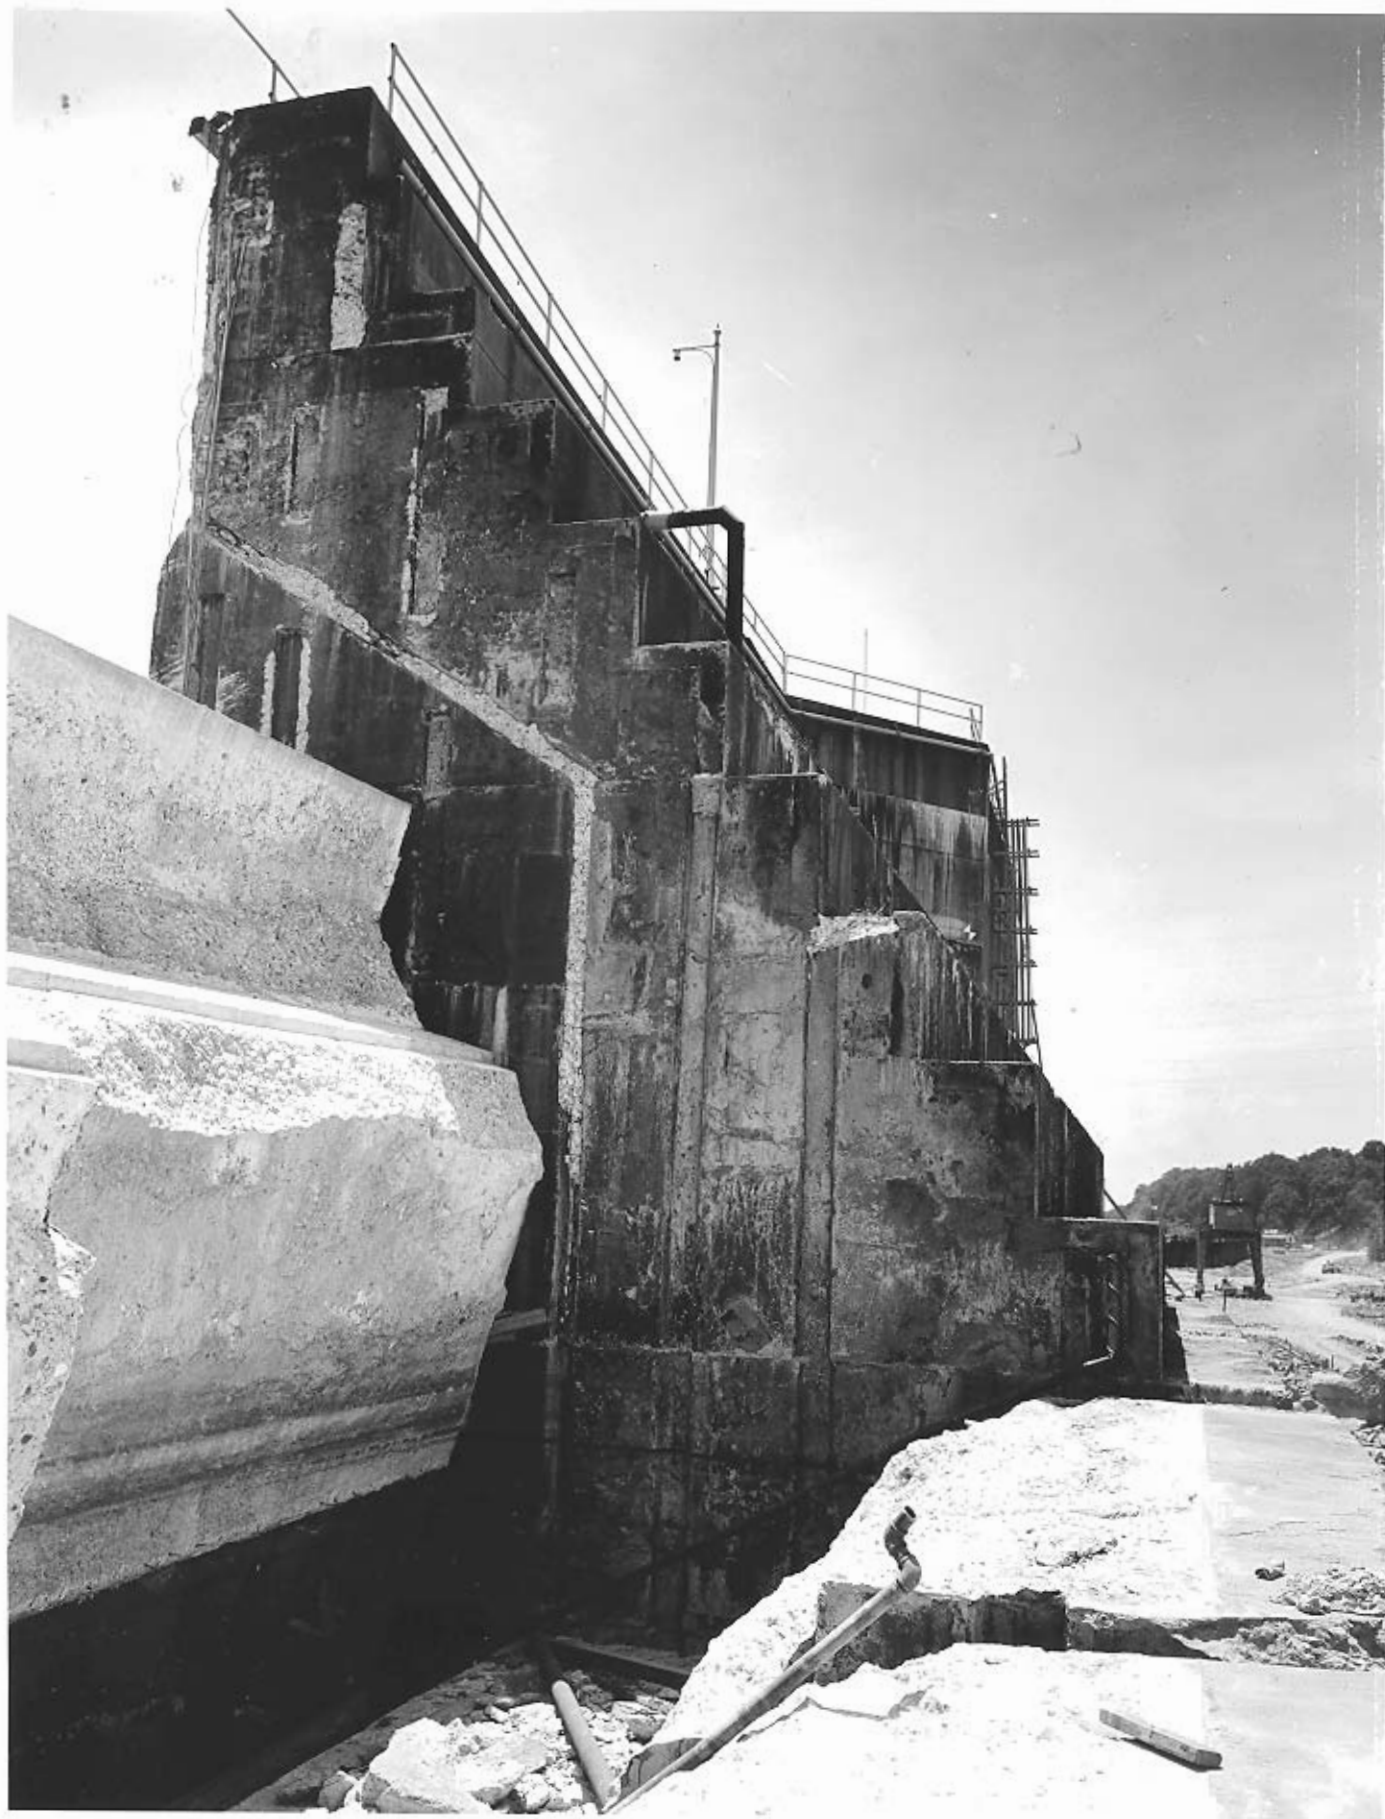
Auxiliary lock, upstream face of block 7.

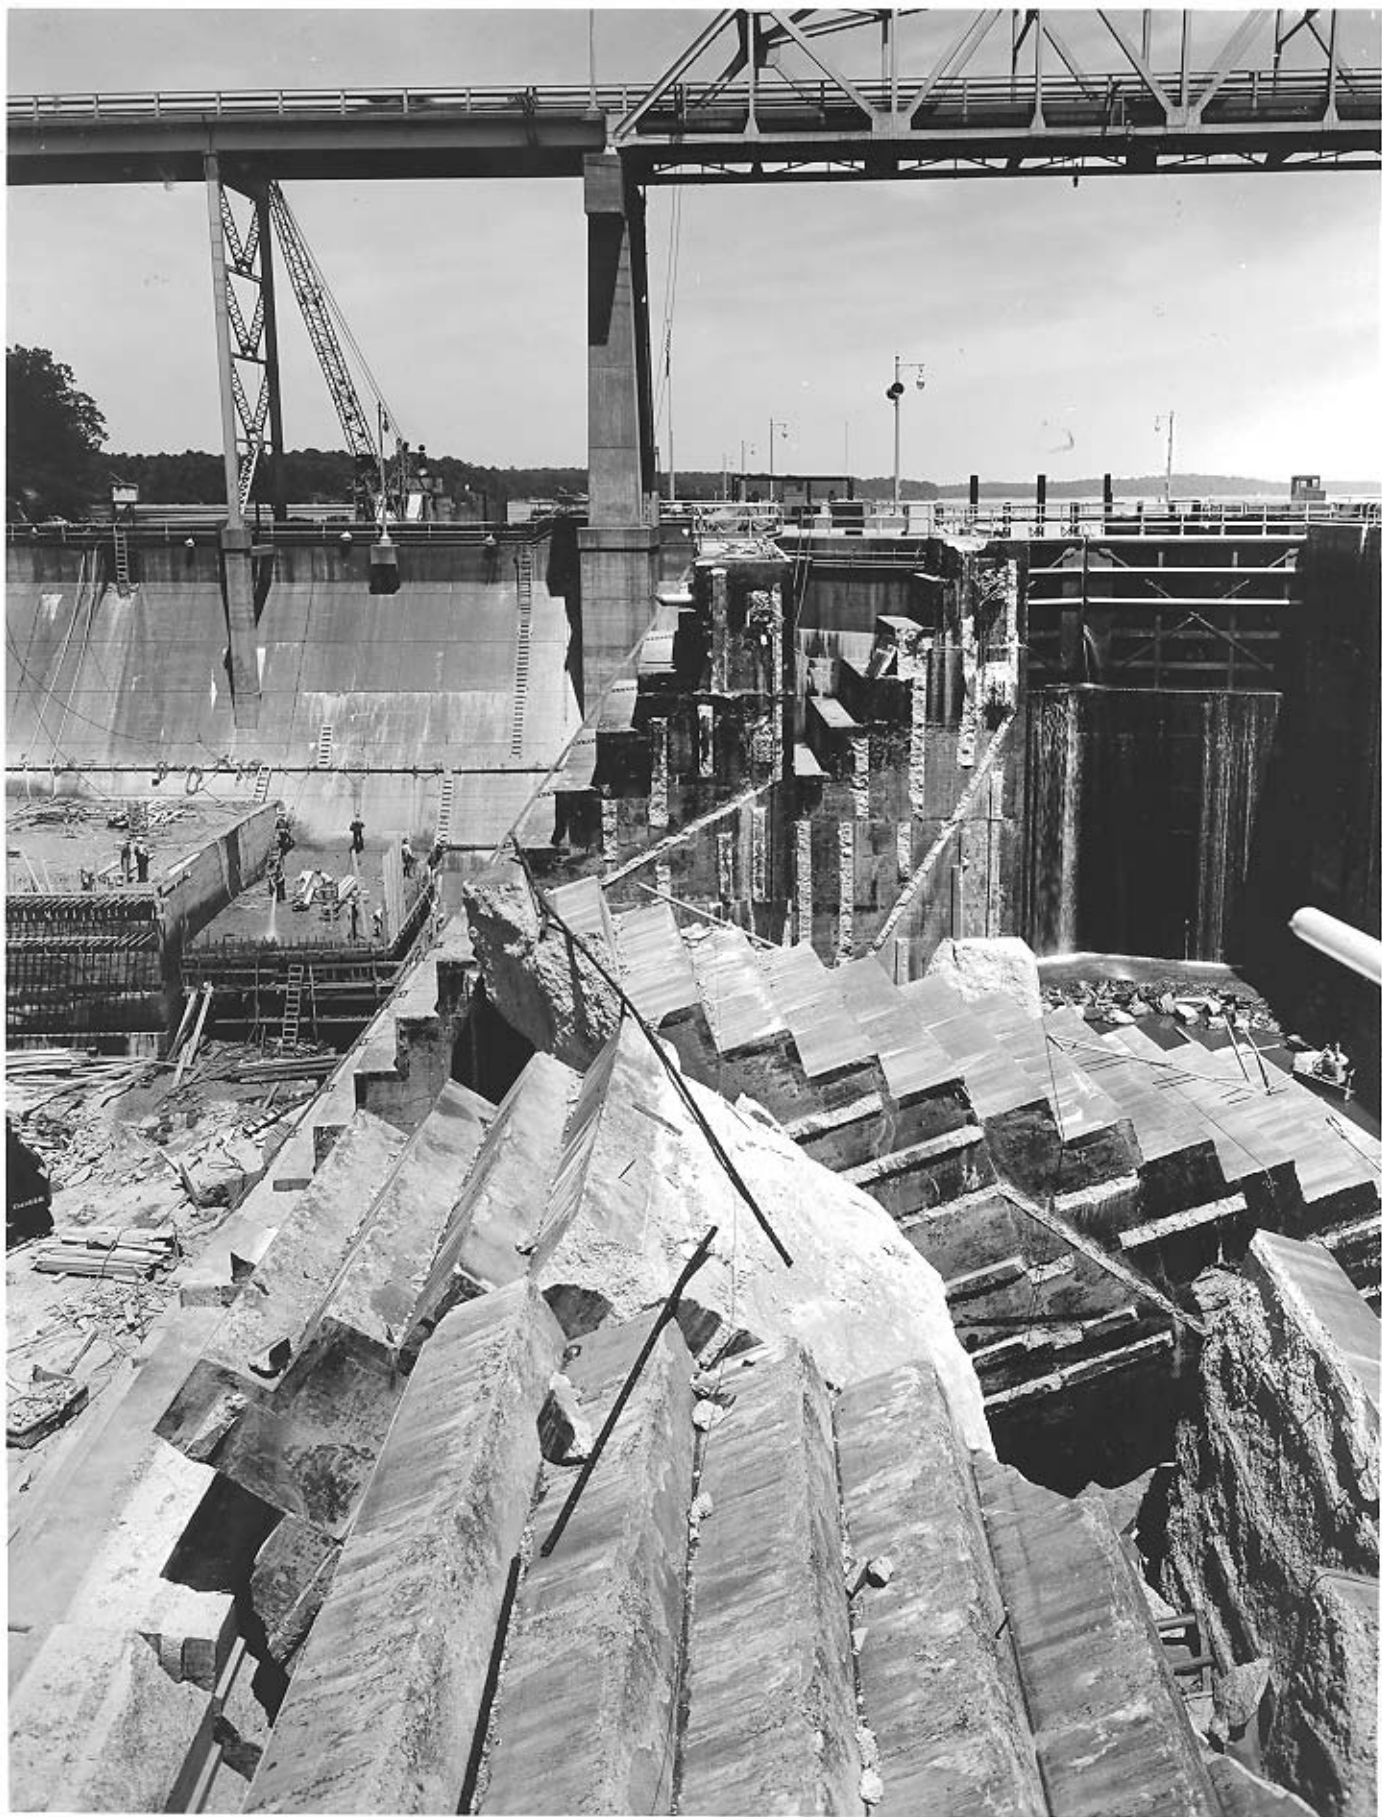
Auxiliary lock, looking upstream from top of block 7.

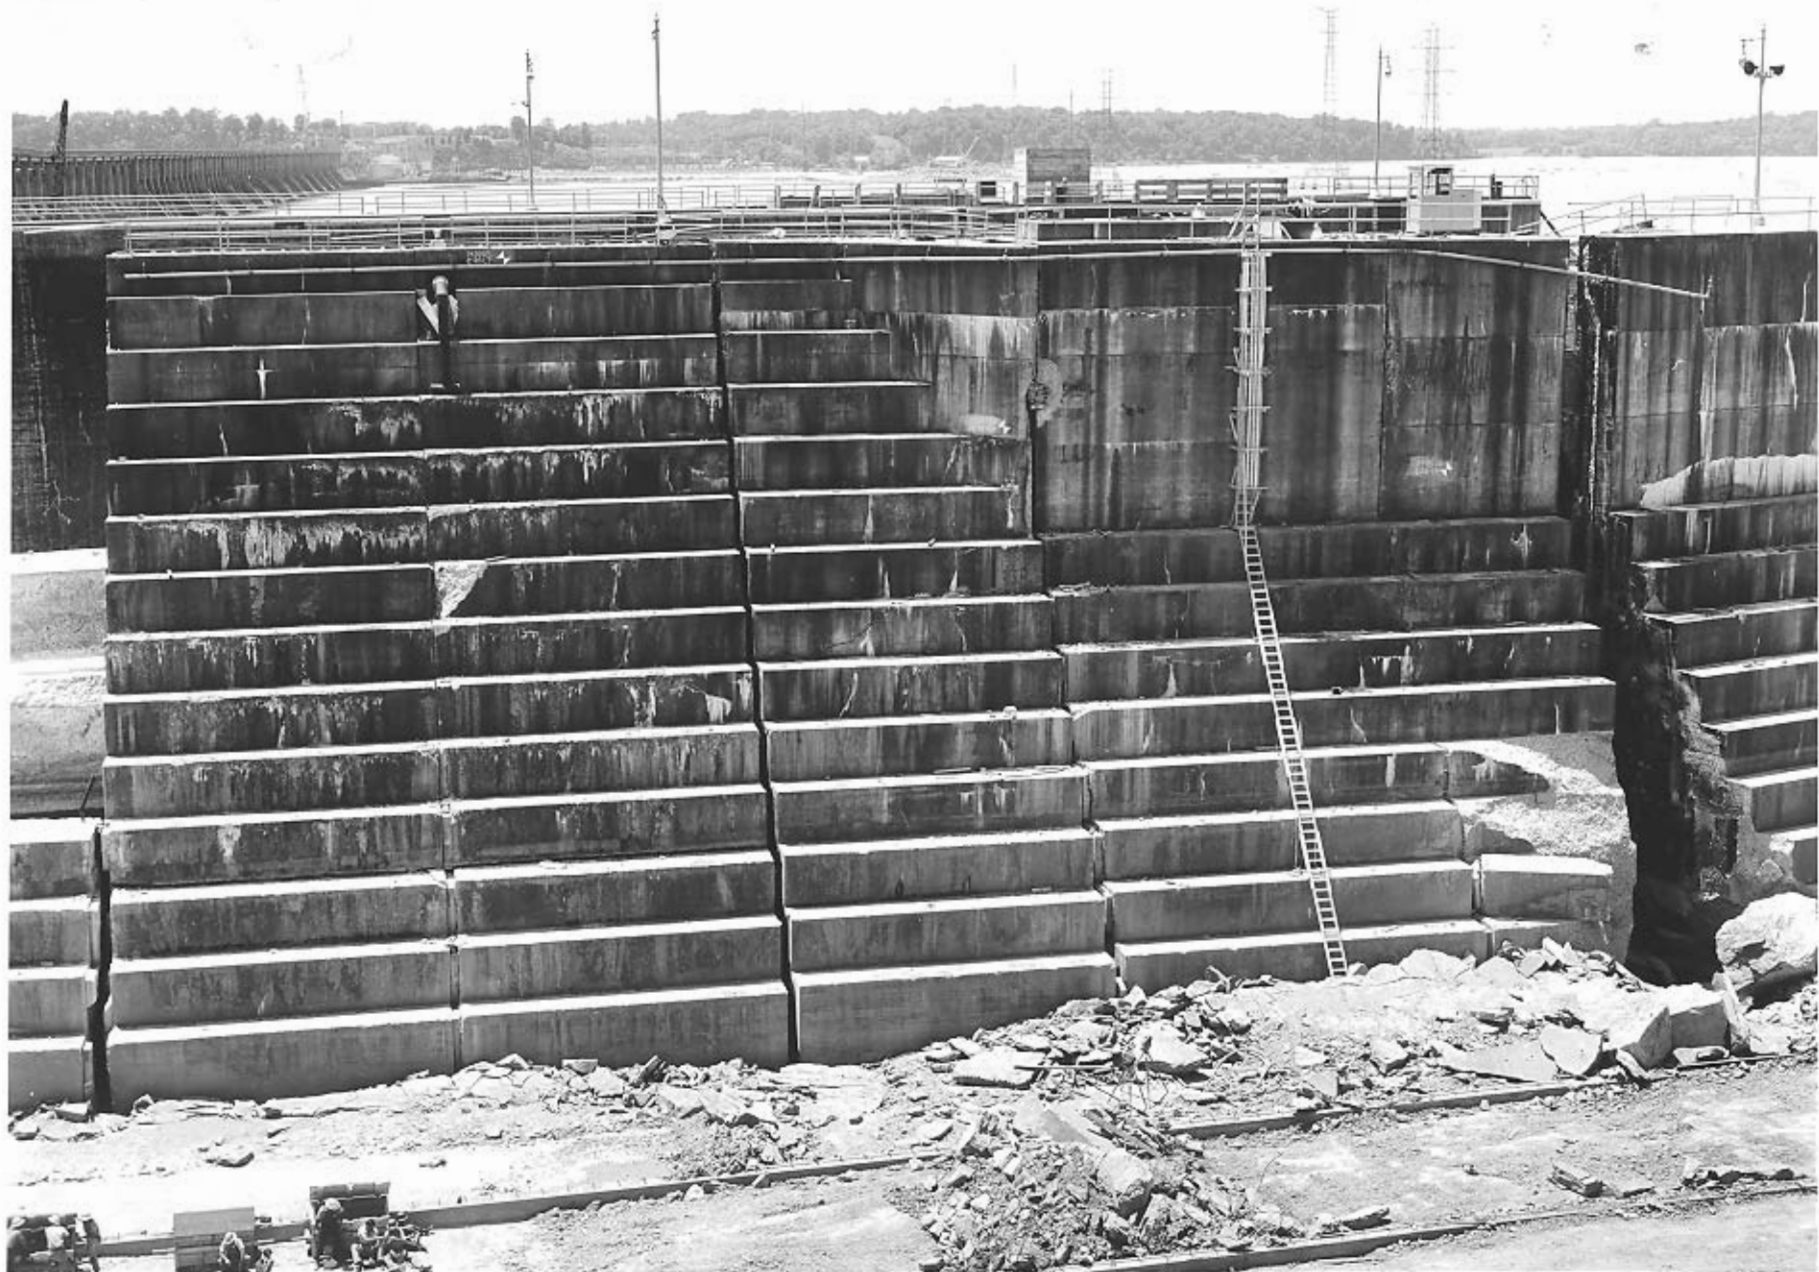
Auxiliary lock, blocks 7 through 12.

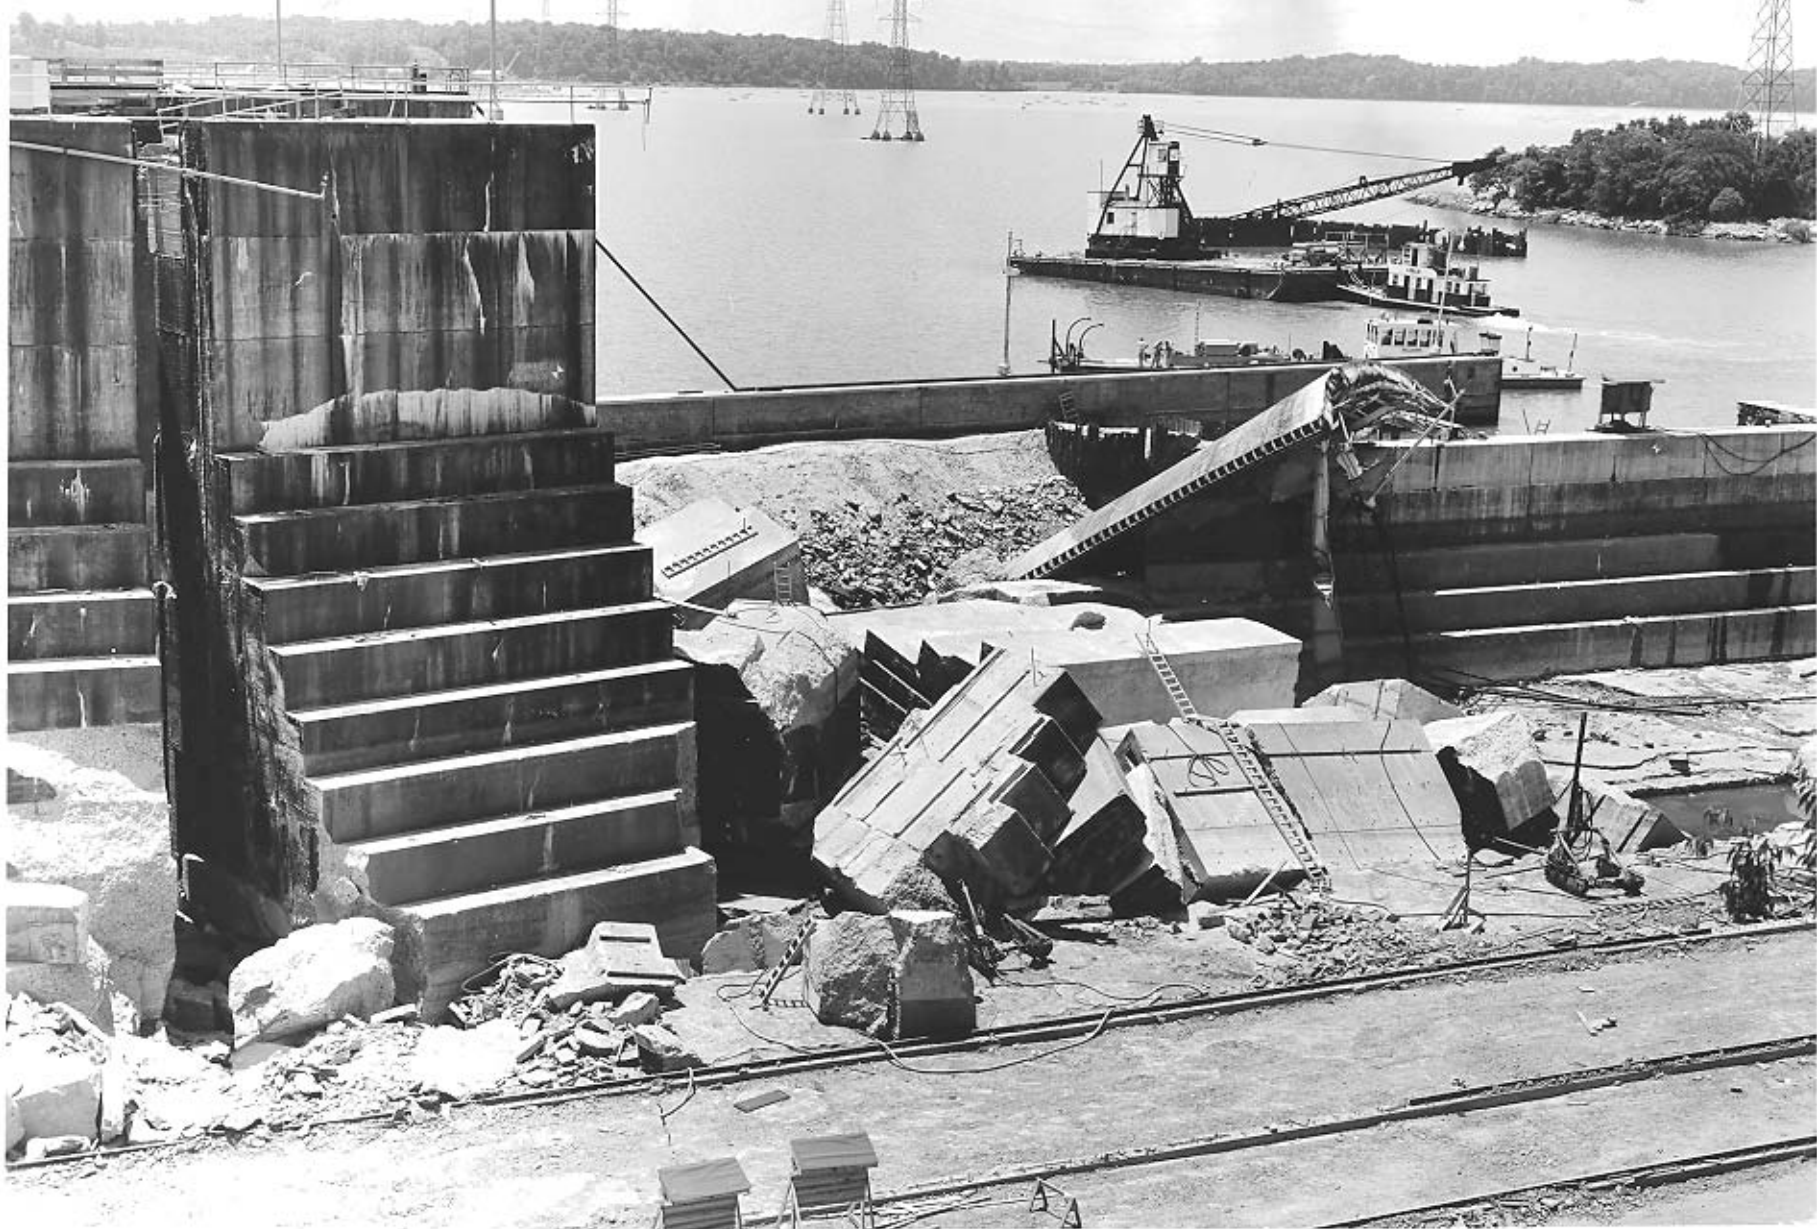
Auxiliary lock, block 12 and area downstream.

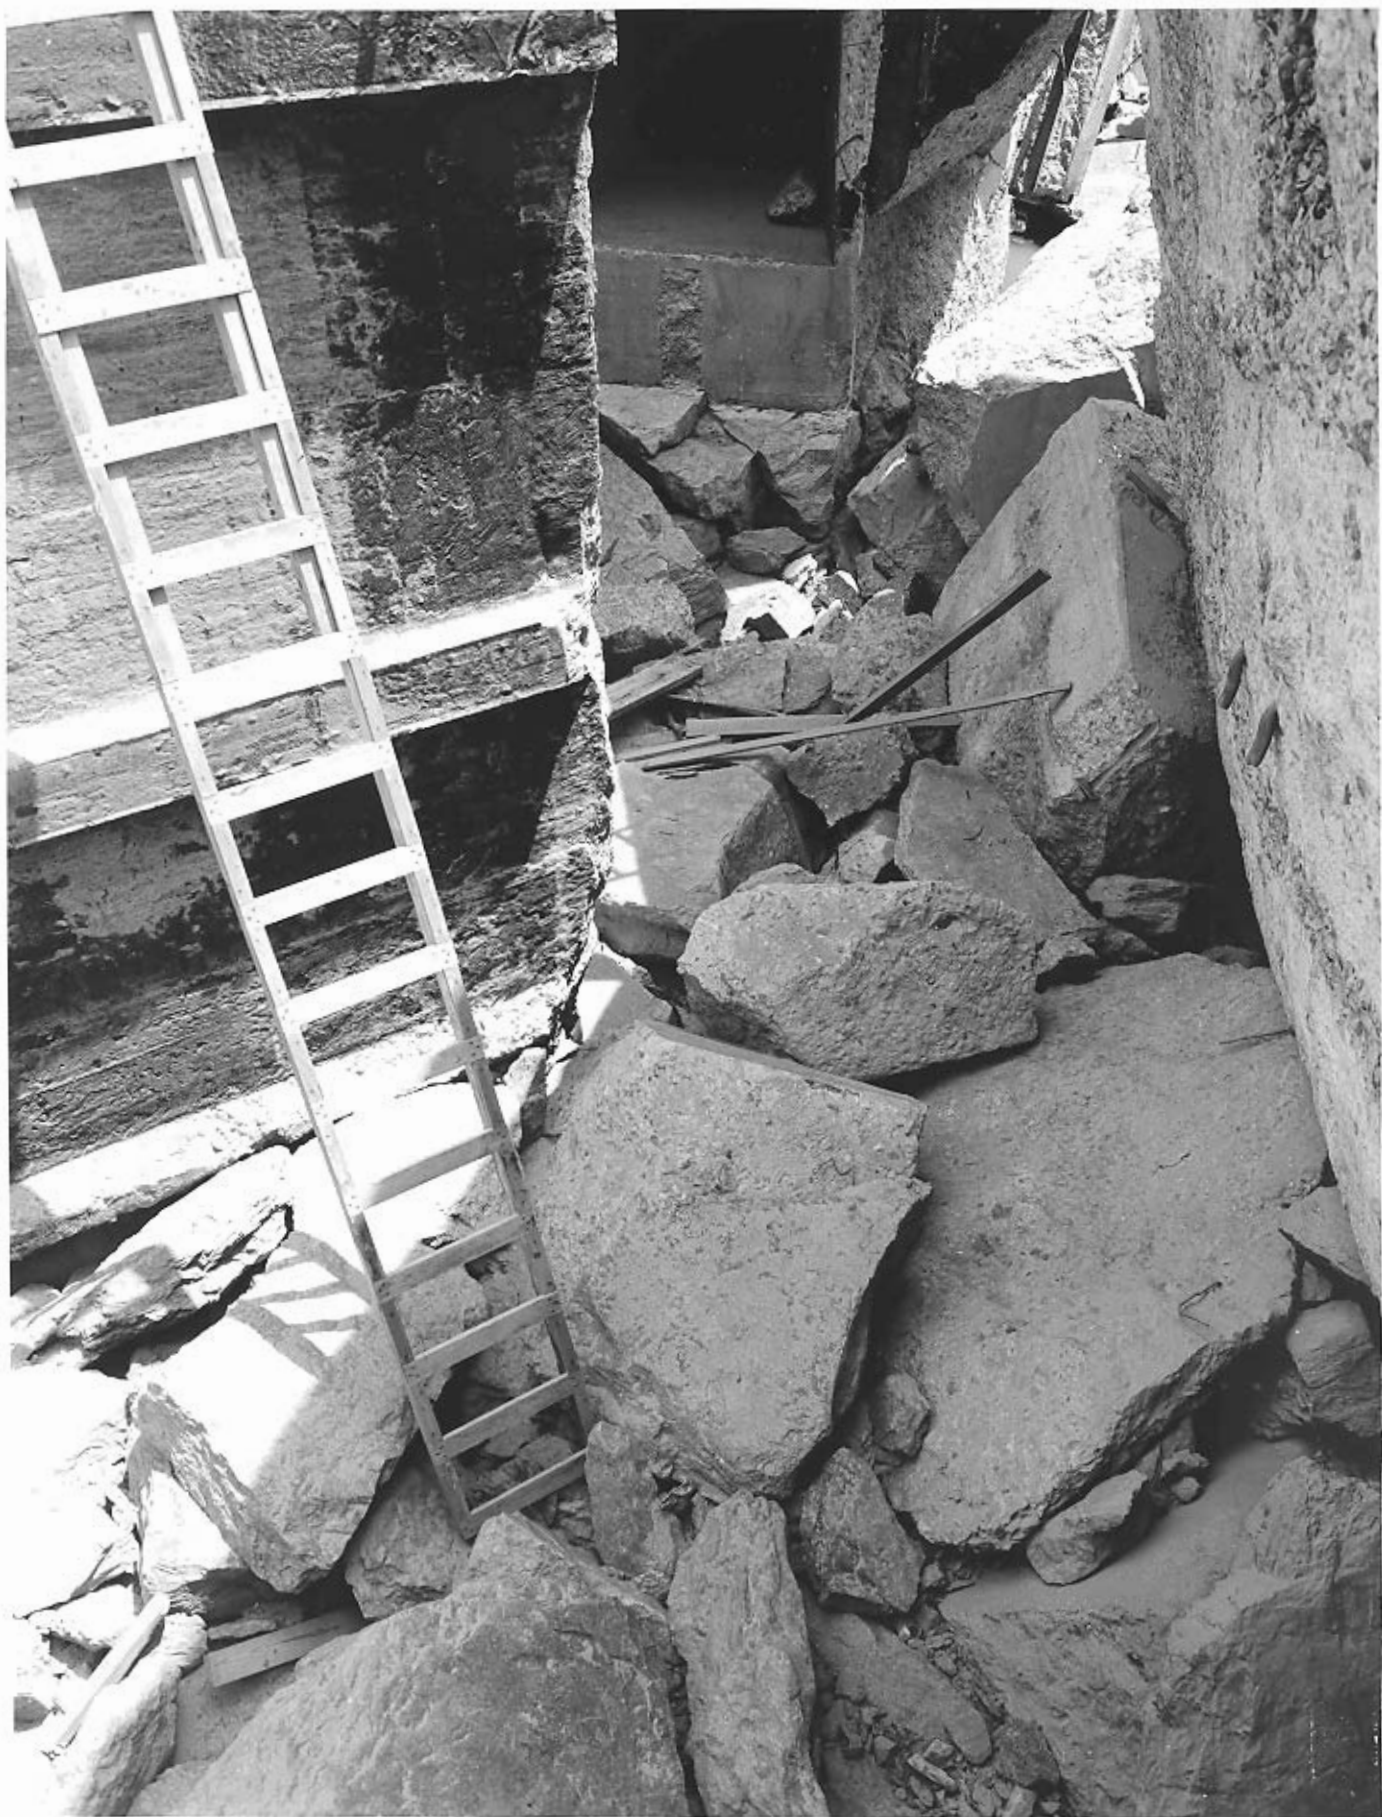
Auxiliary lock, concrete fragments downstream from block 12.

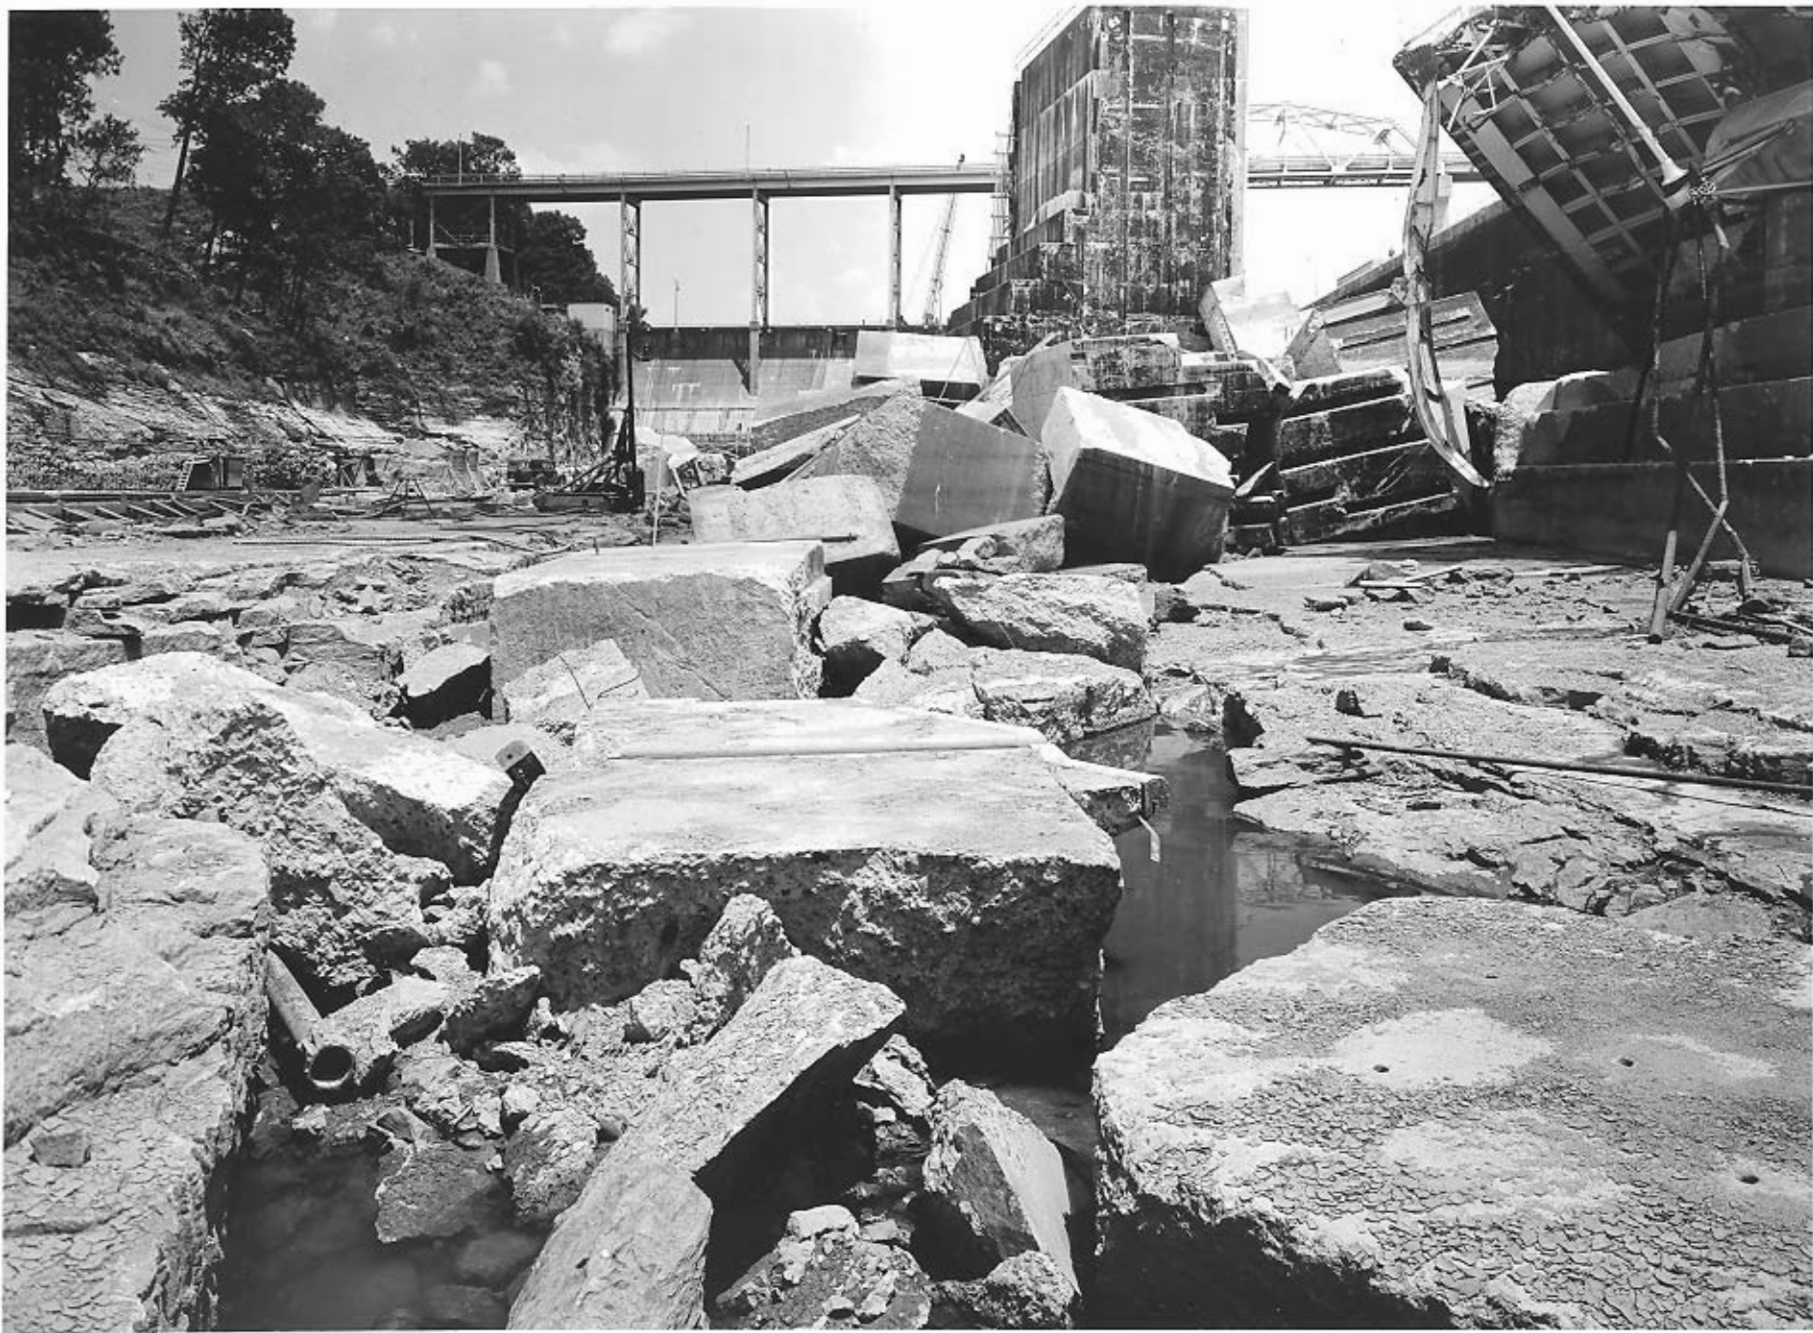
Auxiliary lock, collapsed land wall (looking upstream).
