TENNESSEE VALLEY AUTHORITY

SUBJECT: REPORT ON FAILURE OF WHEELER LOCK

REPORT ON FAILURE OF WHEELER LOCK

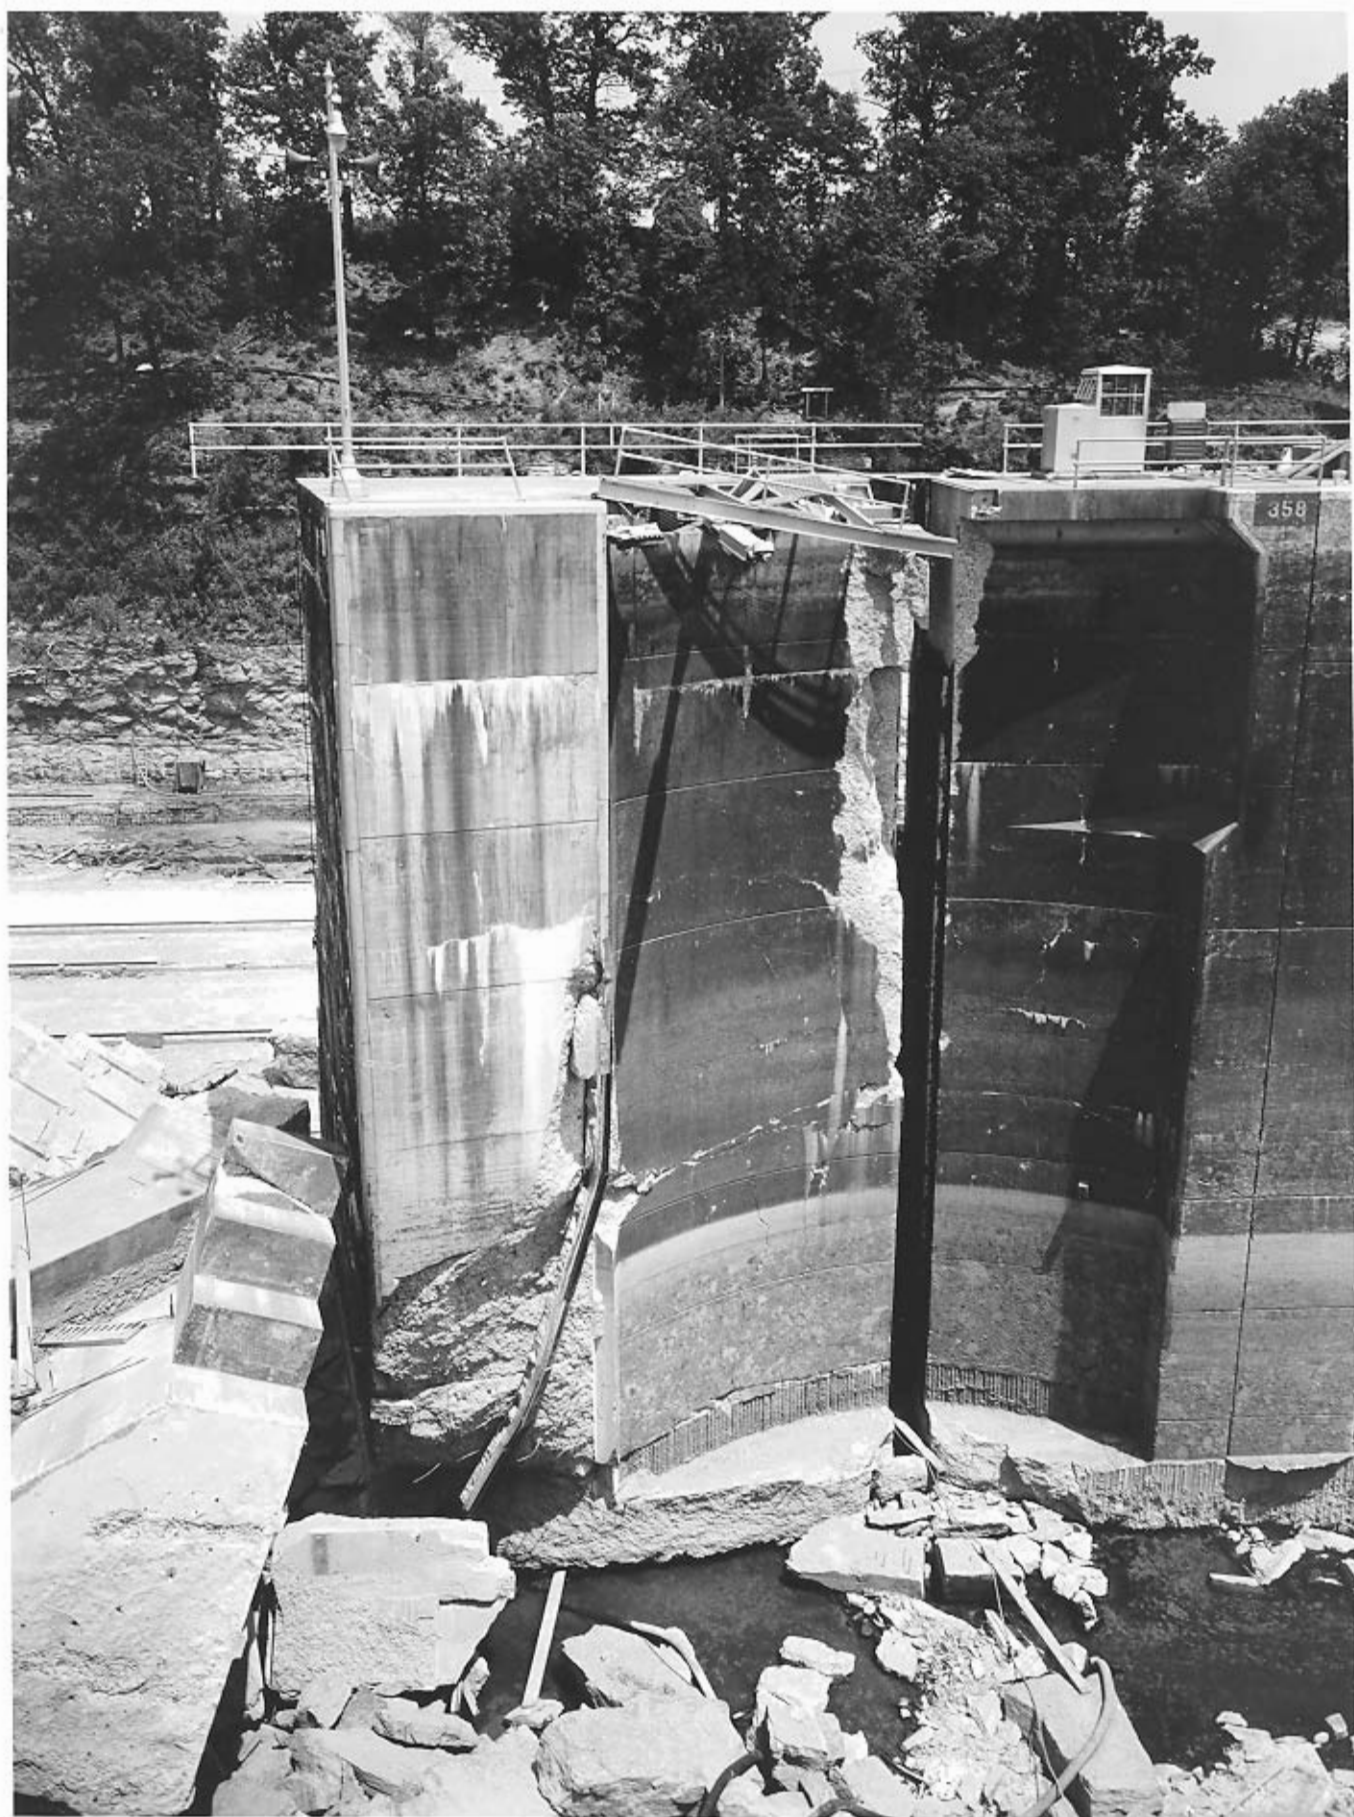
Auxiliary lock, blocks 12 and 11.

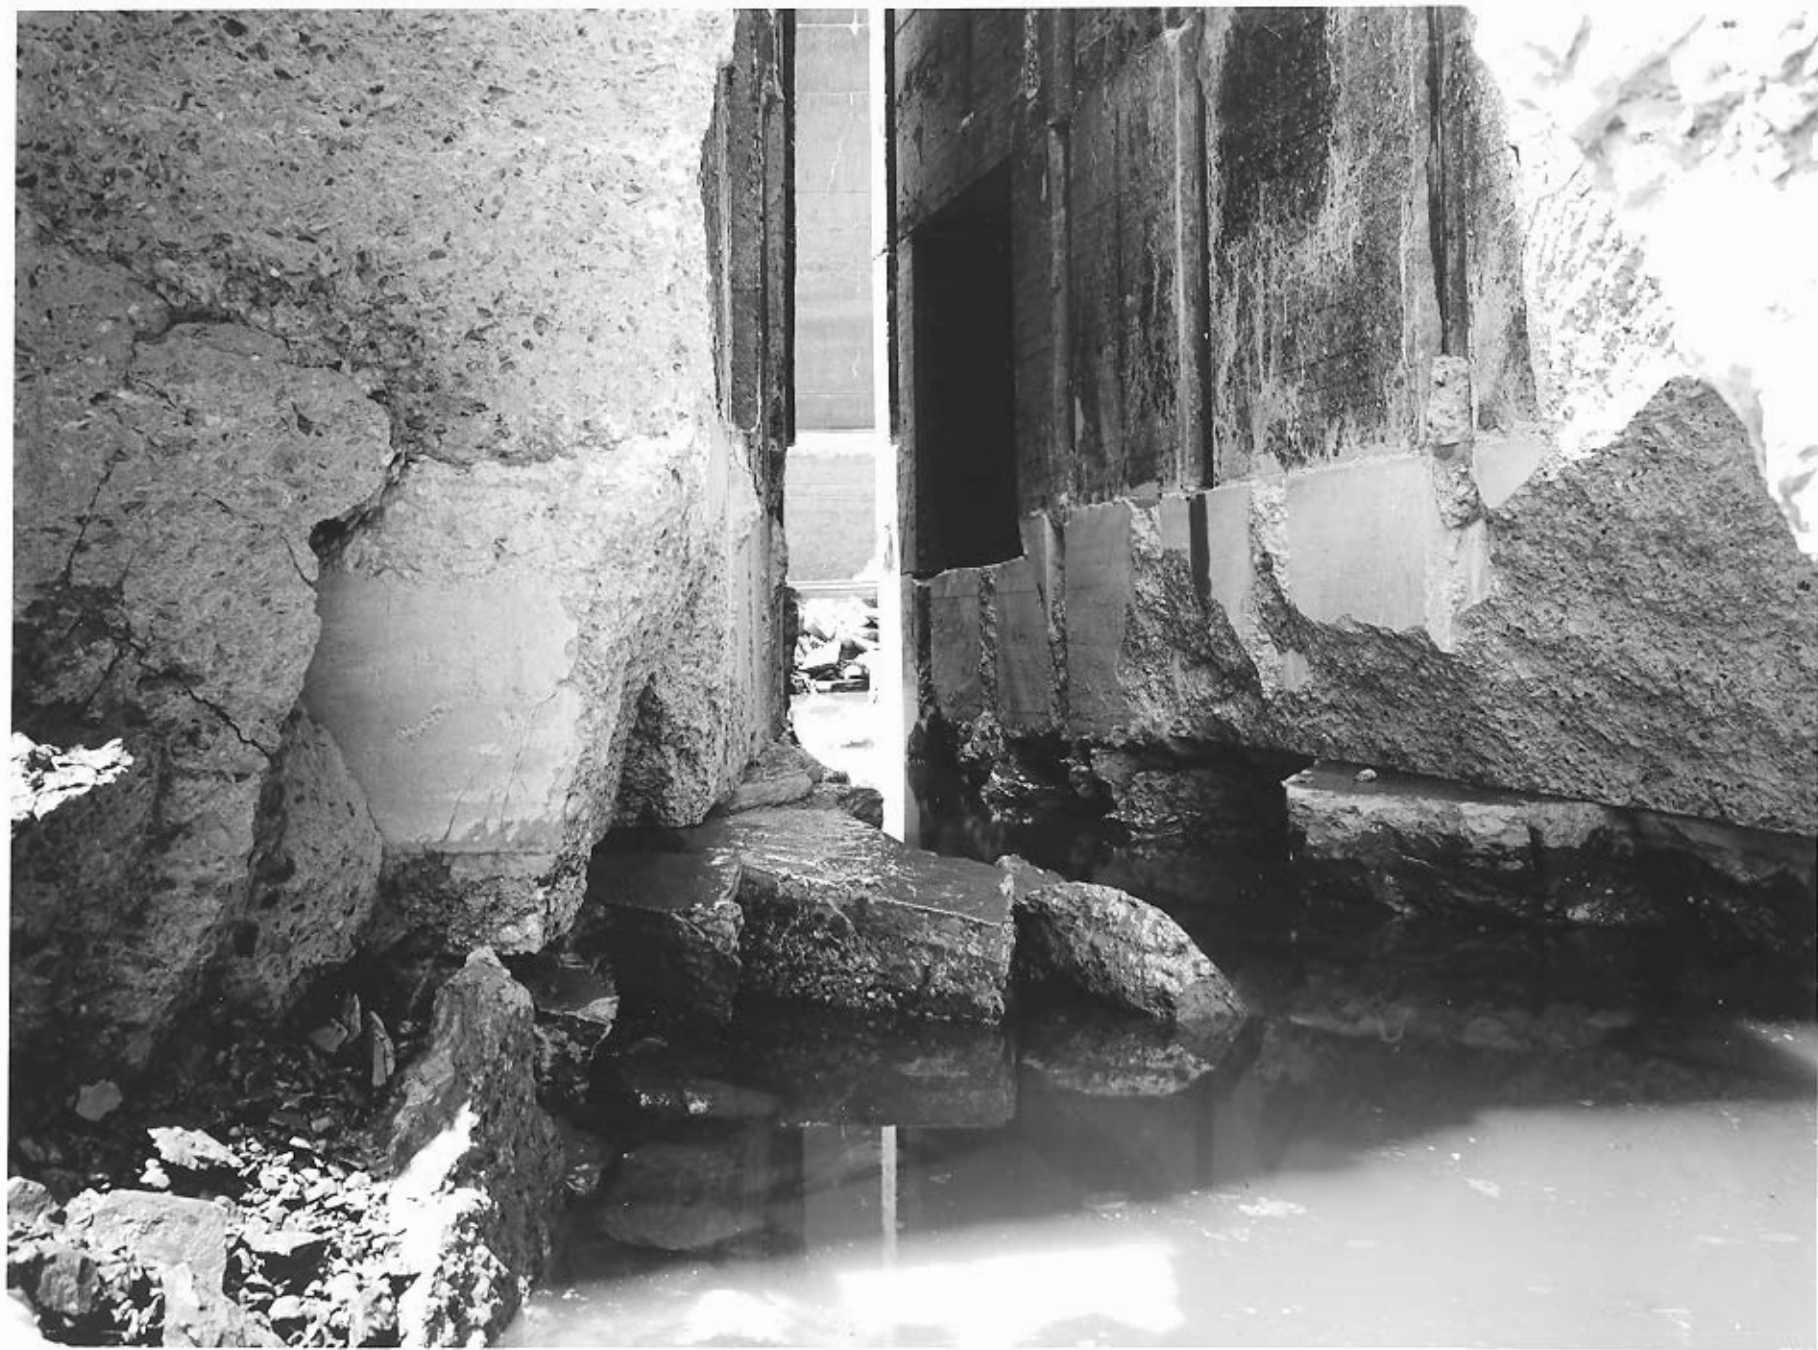
Auxiliary lock blocks 11 and 12, looking south.

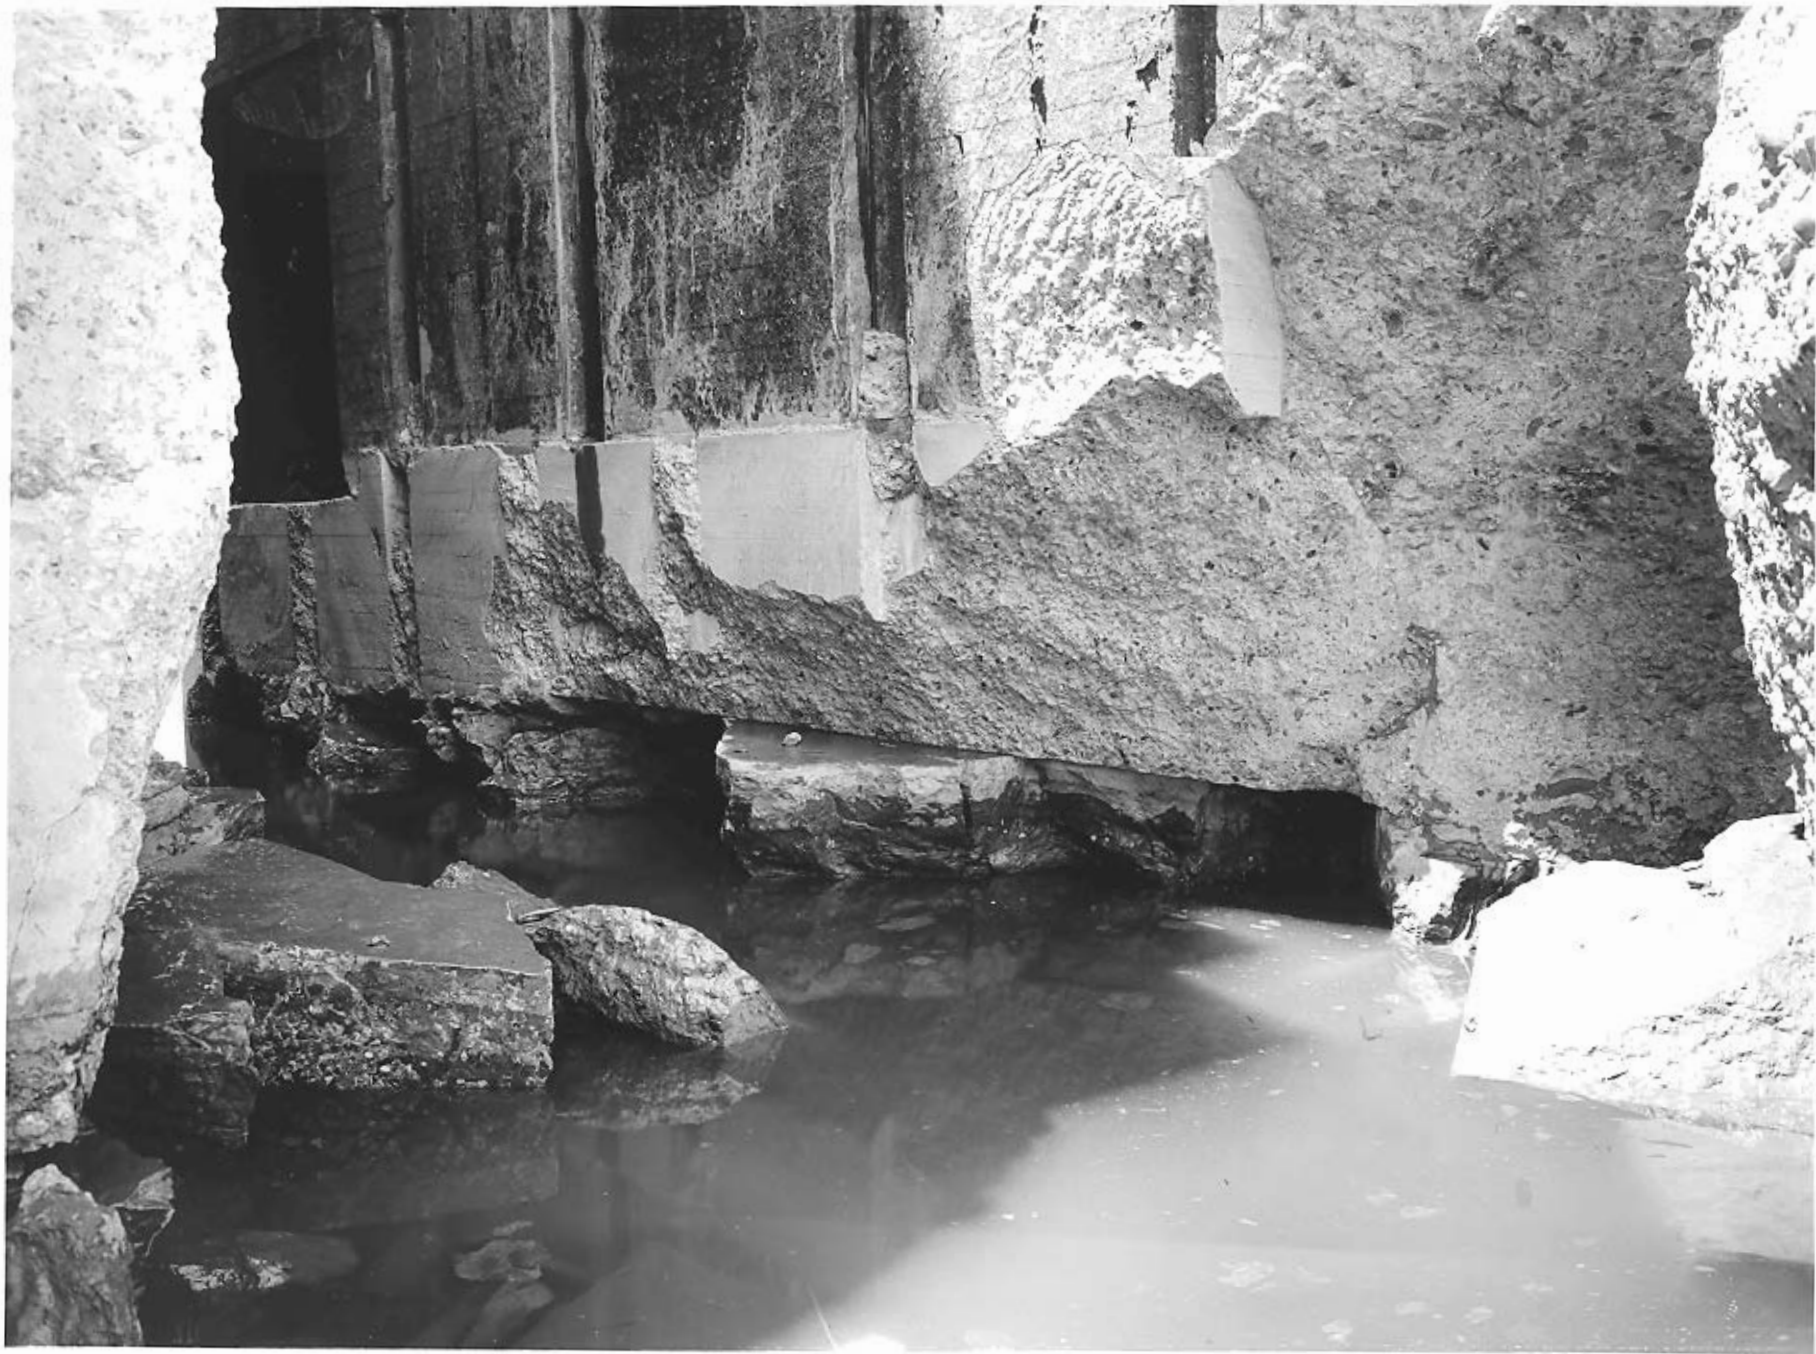
Auxiliary lock bottom of block 12 (upstream side).

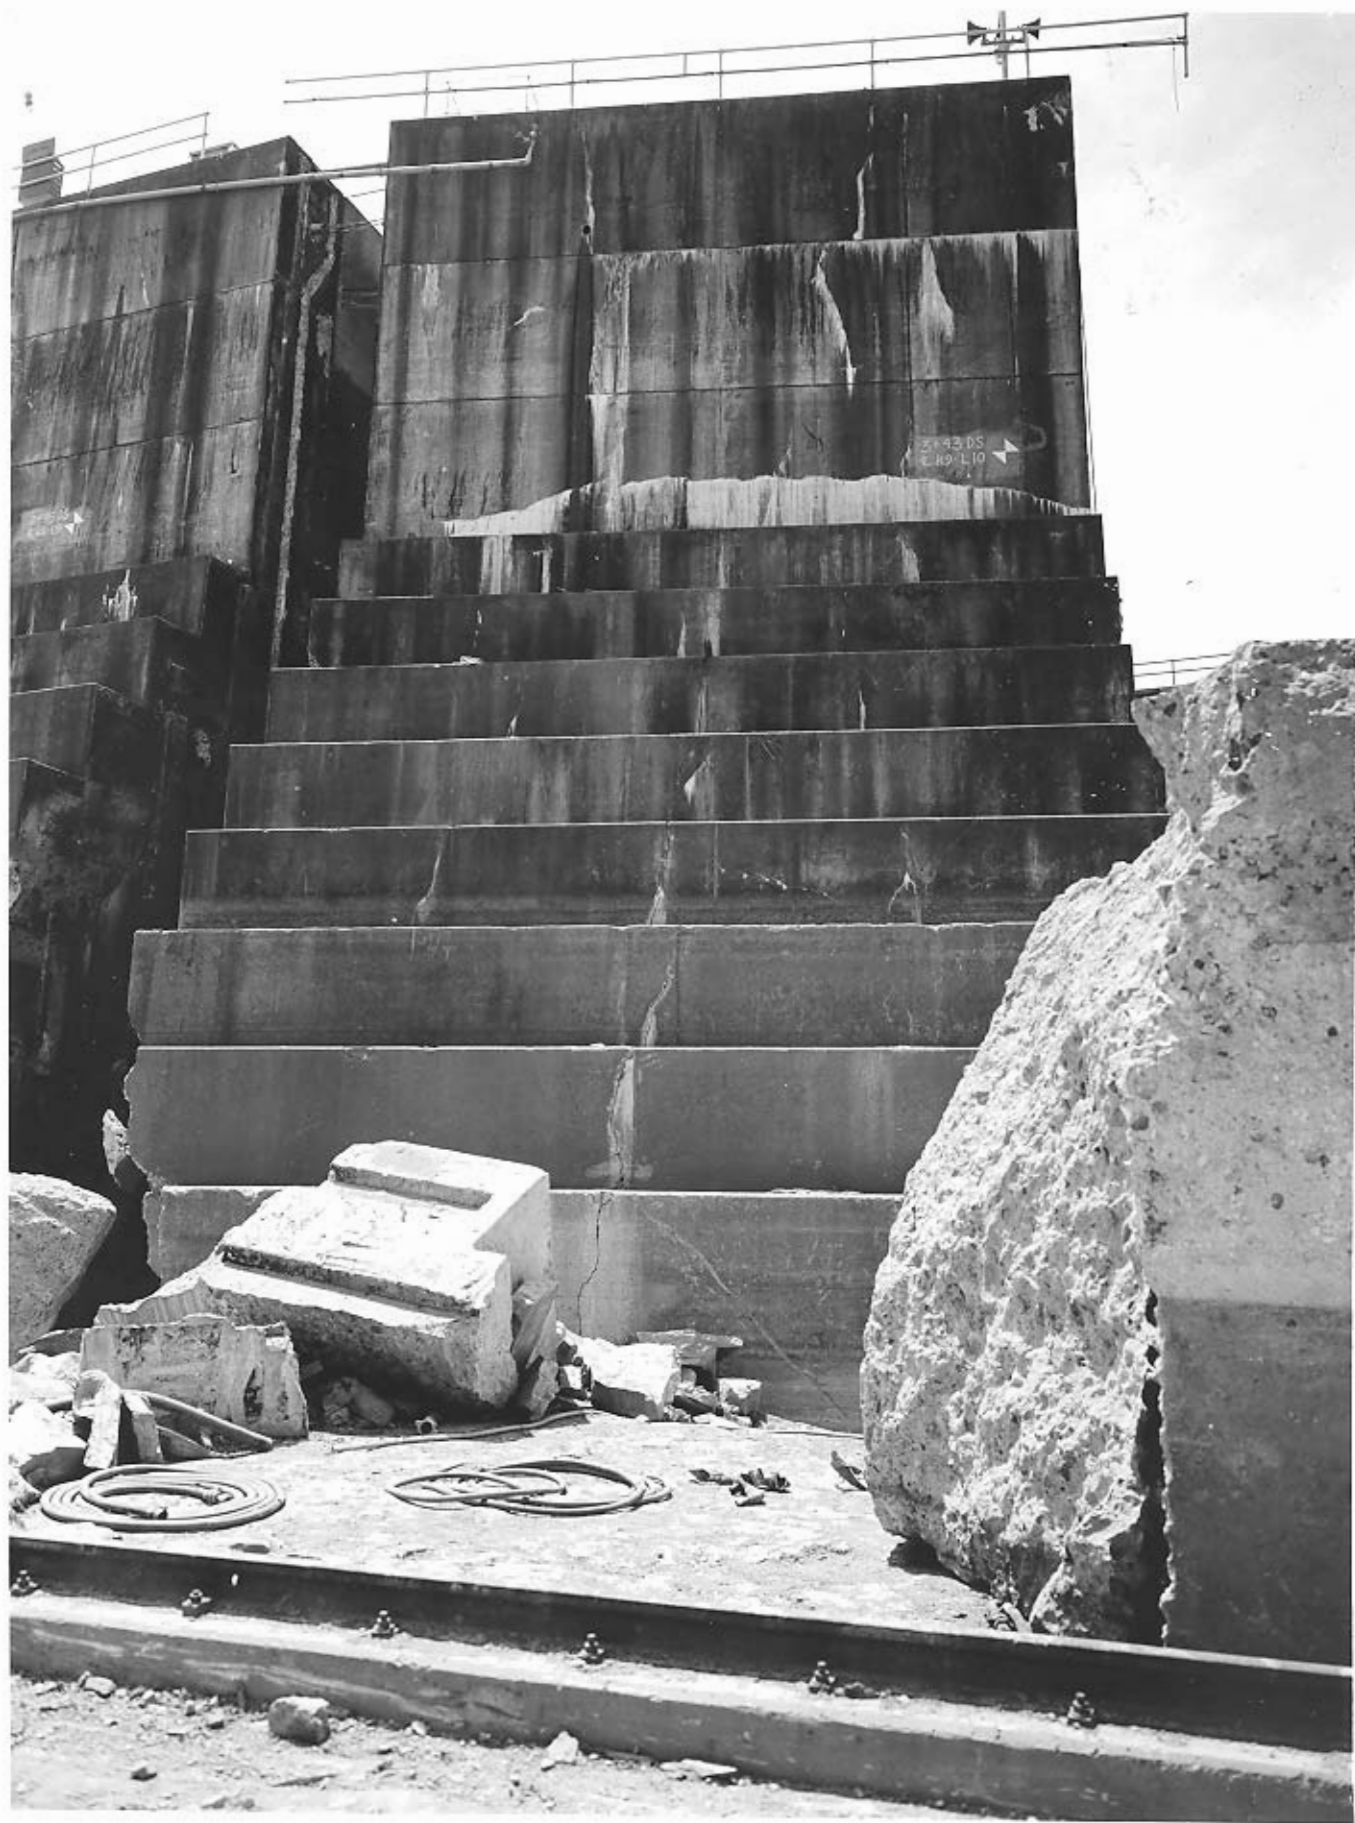
Auxiliary lock, block 12, north side.

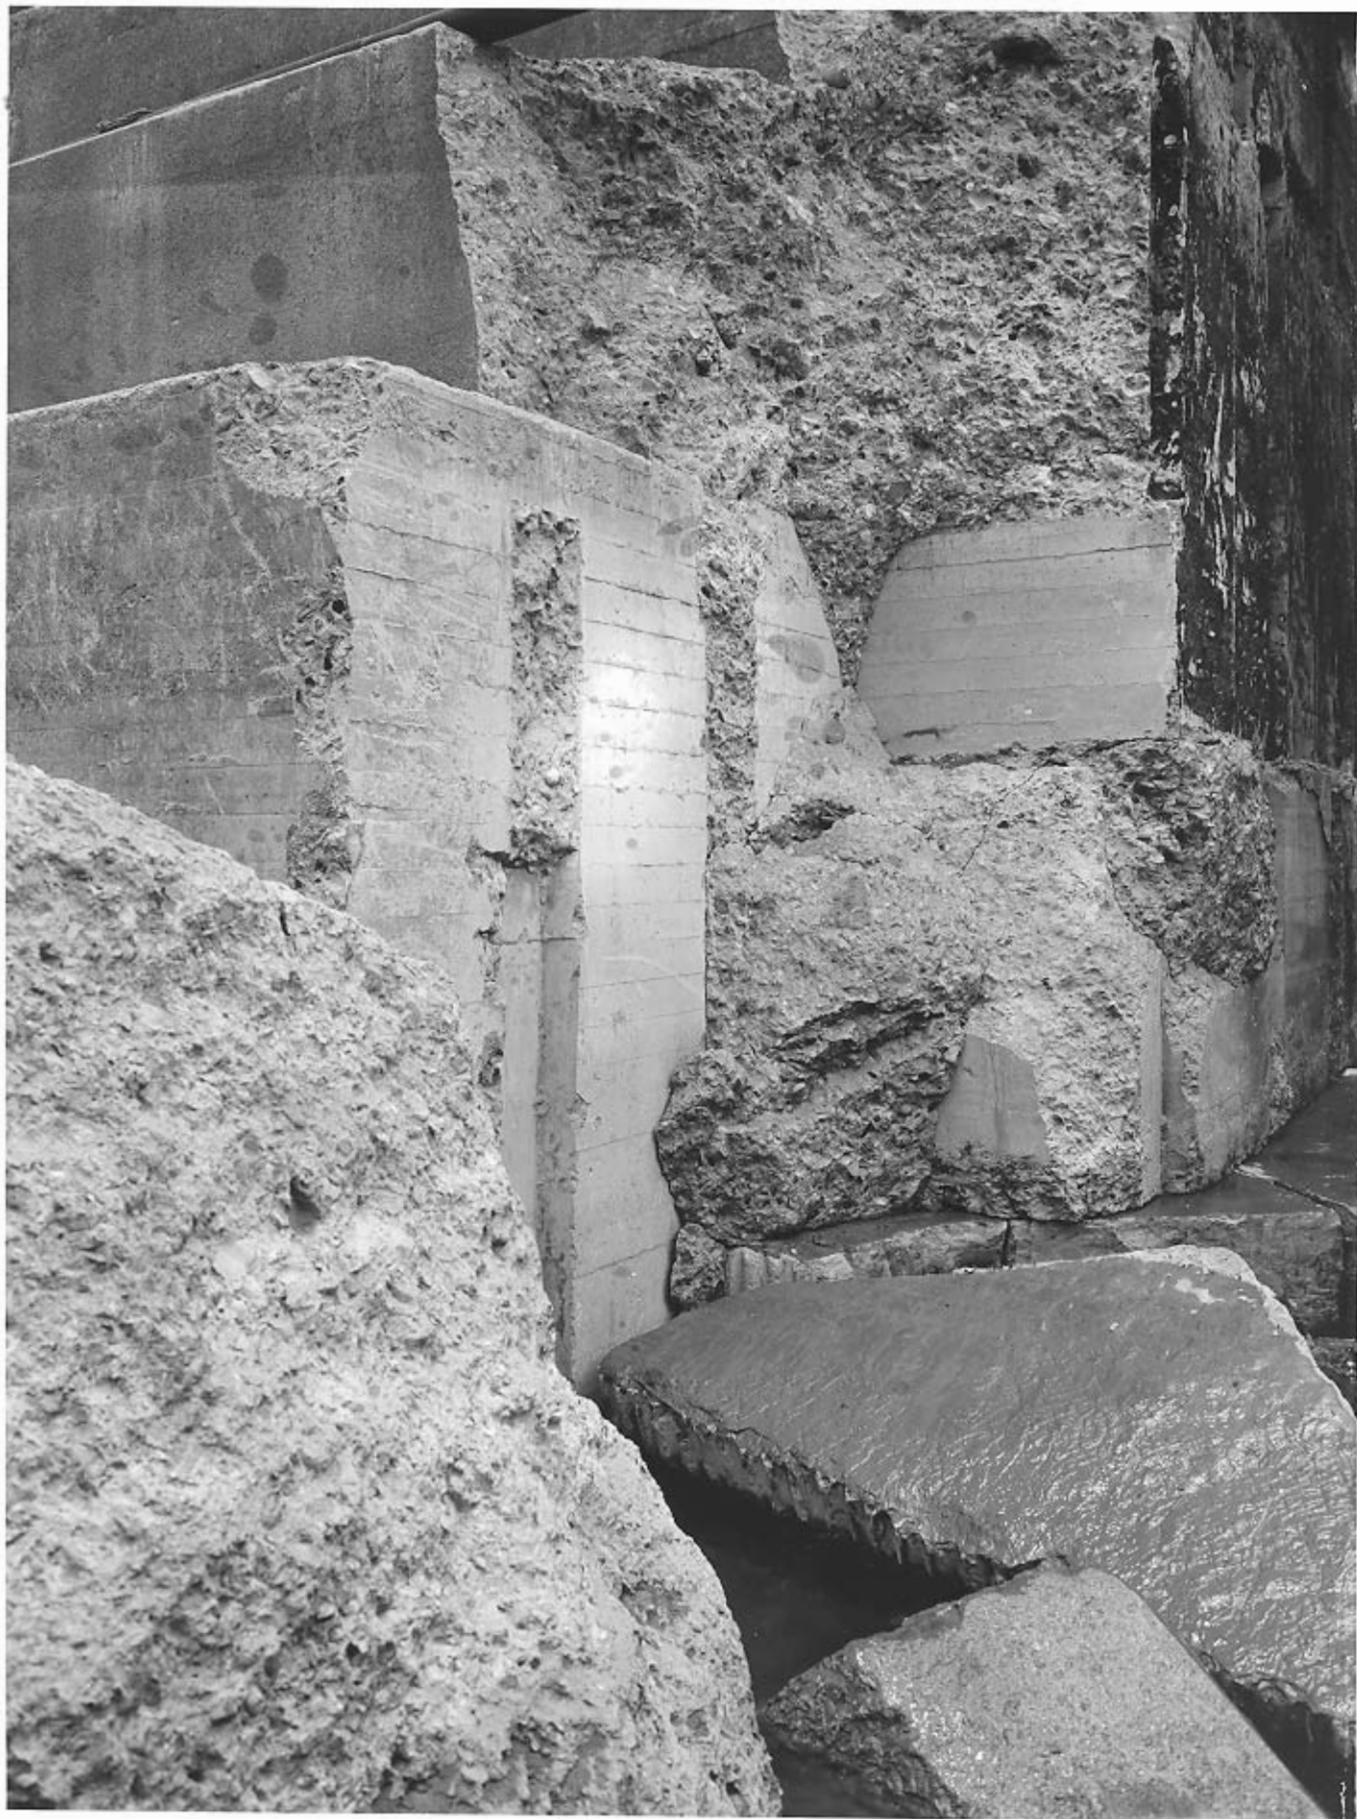
Auxiliary Lock, northwest corner of block 12.

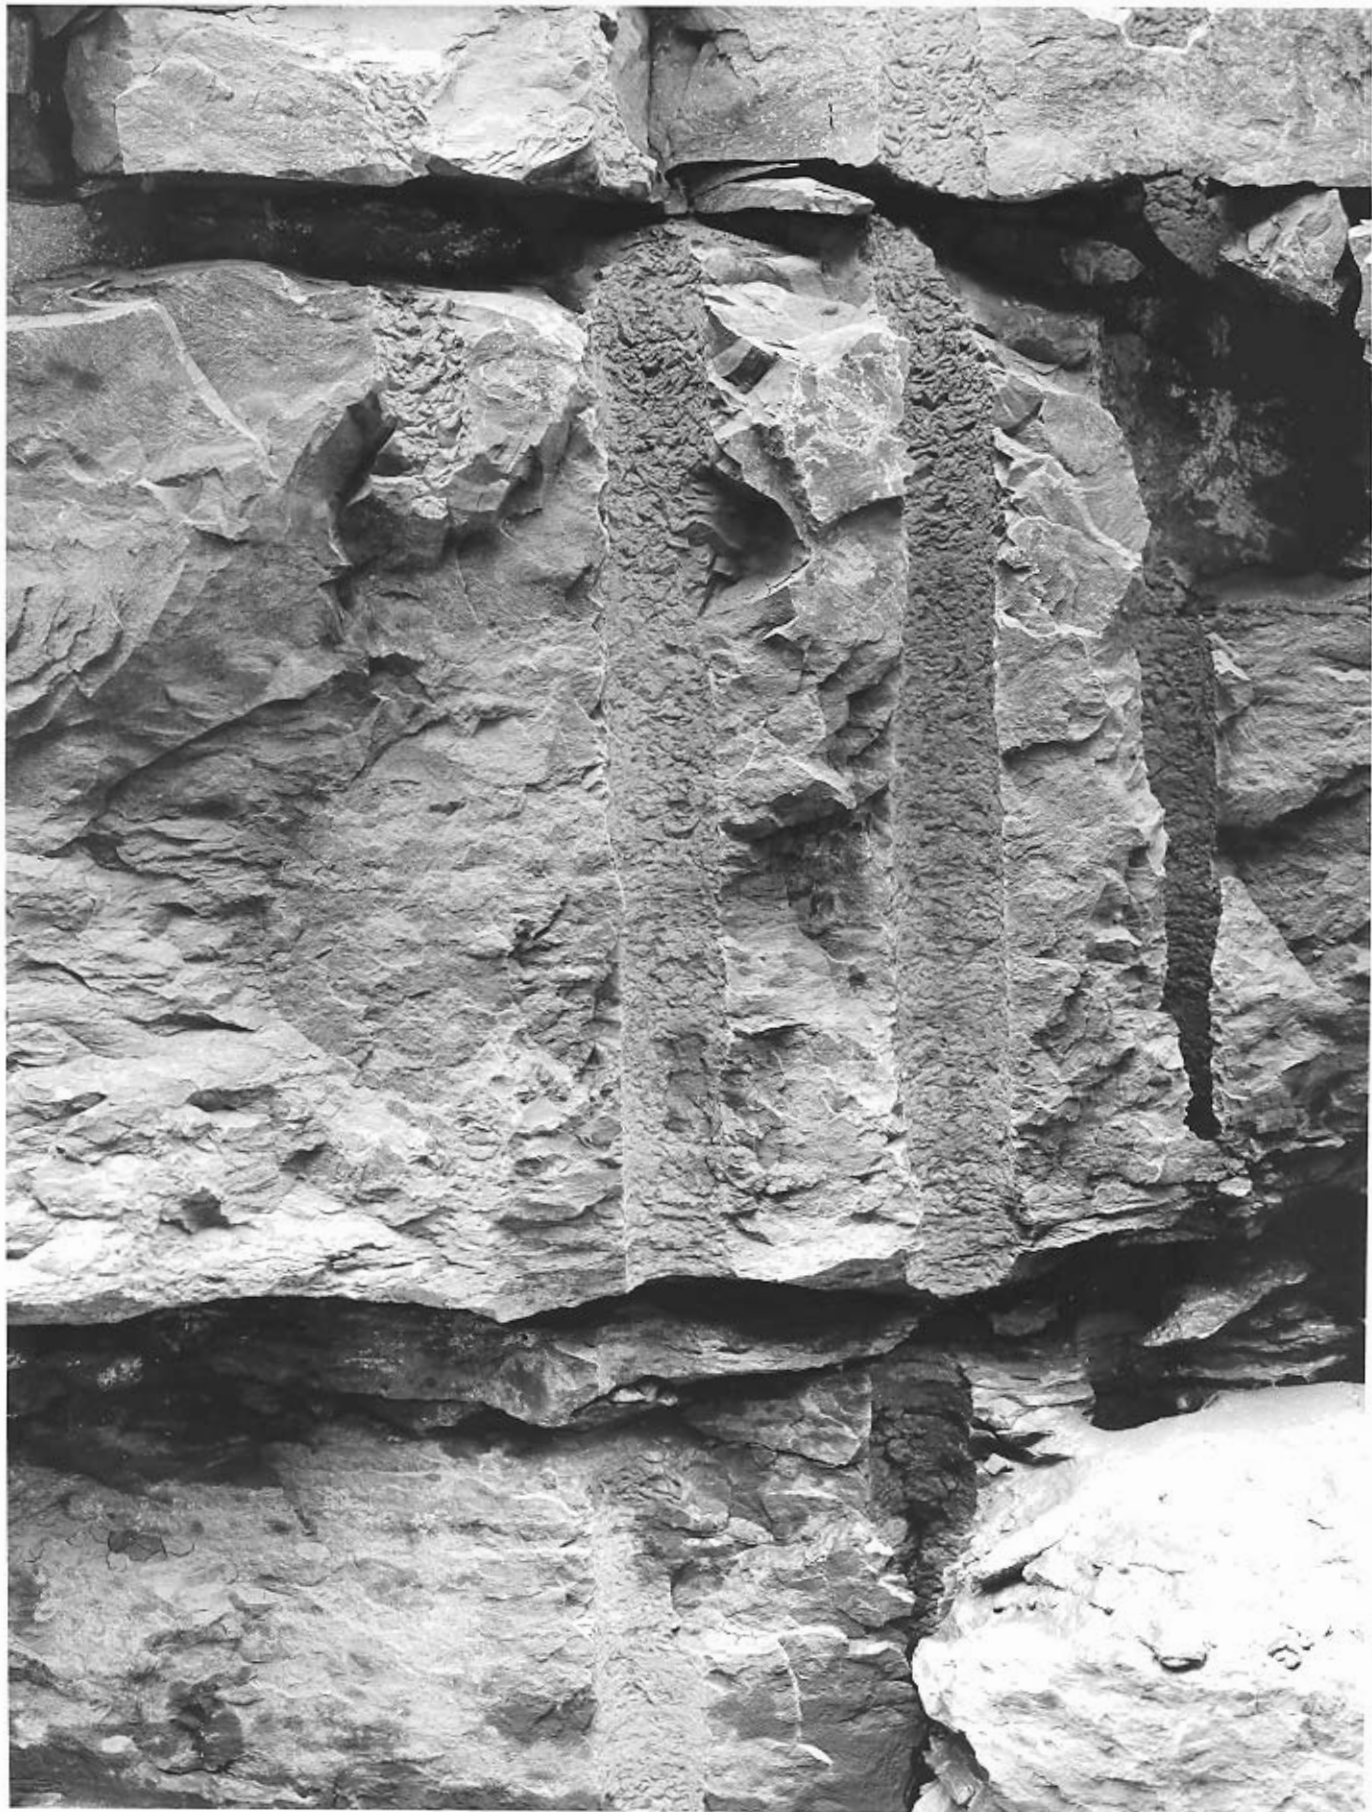
WHEELER LOCK
Tennessee Valley Authority
3L1099 June 15, 1961
C. Quillen, Wilson Dam

Looking south at line drill holes on north face of upper miter sill ledge.
