CITY OF TEMPE (STANTEC) / BRIDGESTONE

TEMPE TOWN LAKE DOWNSTREAM DAM FAILURE

Date of Loss: July 20, 2010

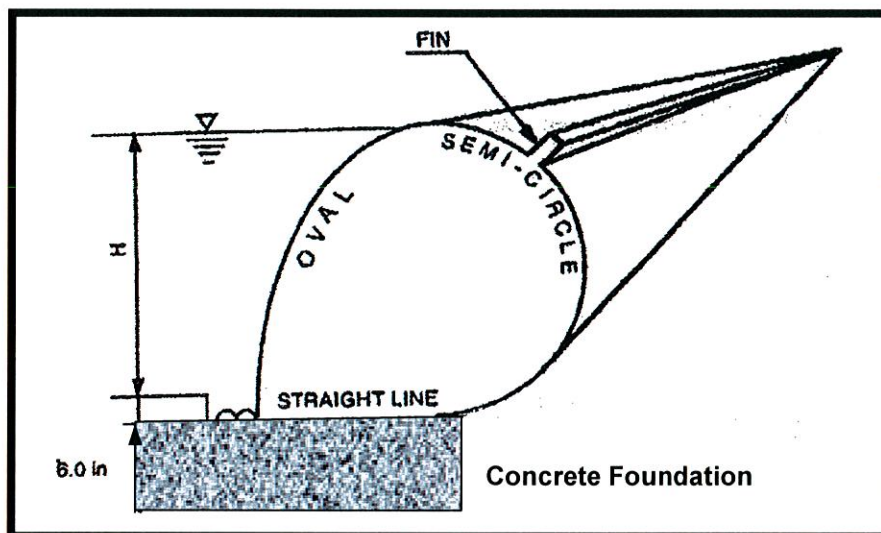
FIGURE 2: Schematic of constructed dam.

The bladders are made from eight layers of rubber that are bonded together into roughly rectangular sheets ~220' by ~25' by ~1" thick. Each bladder is made from two of these sheets. The sheets are joined along one of their long edges. This is an edge joint, not a lap joint, which forms a lip lengthwise along the dam and is configured into fins to direct the flow of water over the dam. The other long edges are brought together and mechanically fastened to one another and to the foundation that spans the river, by steel plates and bolts anchored into the foundation. **Figure 2** shows the shape of the dam in cross section.

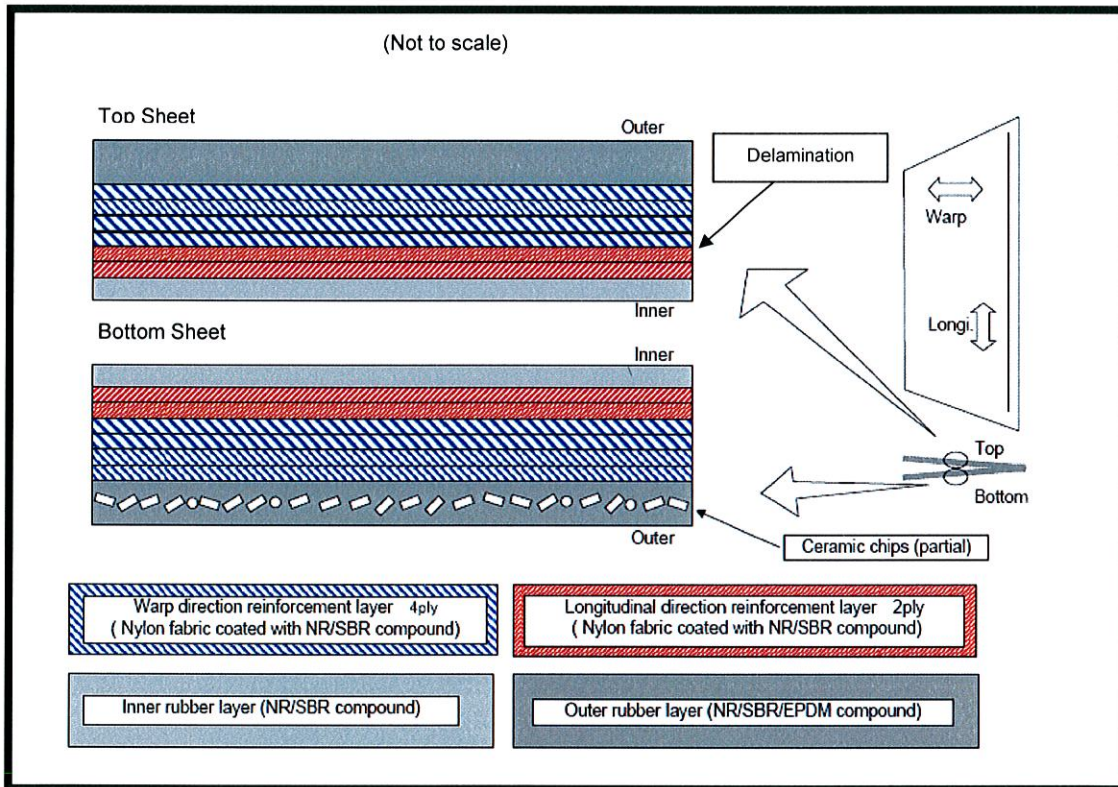
FIGURE 3: Cross-section of bladder rubber.

The outer layer of both the top and bottom sheets of the bladders are made from a compound of natural rubber (NR), styrene butadiene rubber (SBR), and ethylene propylene diene monomer (EPDM) rubber. A portion of the bottom section of the outer layer is filled with ceramic chips. The inner layer of both the top and bottom sheets are made from a compound of NR and SBR. The six intermediate layers are made from nylon fibers coated with NR /SBR. These six nylon fiber layers act as reinforcements for the rubber dam. **Figure 3** is a schematic of the typical bladder construction. **Figure 4** is a photograph of the cross section of the Bladder No. 2.
