**Bechtel Corporation**

**HEBGEN DAM, MONTANA POWER COMPANY**

**Effects of August 1959 Earthquake**

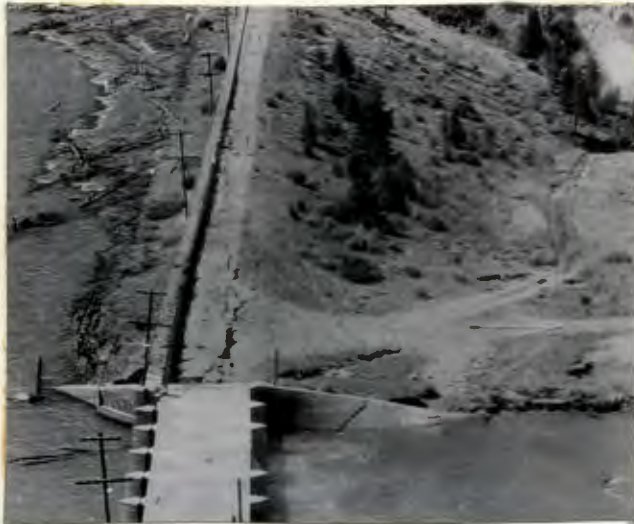
Embankment. Considerable settlement and cracking occurred in the earth embankment, generally small near the left abutment and a maximum from about the center of the dam northward to the right abutment. The crest settled approximately one foot for the first 300 feet from the left abutment, 1 to 2 feet in the next 300 feet, with a maximum of about 4 feet adjacent to the spillway.

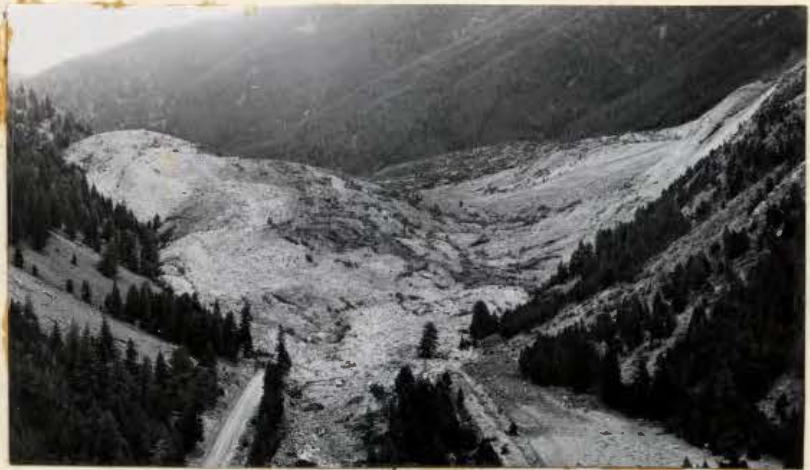
**Fig. 15**  
**AIR VIEW**  
**LOOKING DOWNSTREAM**  
**(M. P. Co. Photo)**

The slide filled the canyon to a depth of 220 feet above streambed at its low point and rode up the far side against the right canyon wall to a height of 400 feet above streambed, the furthest travel being nearly 5000 feet from the face. It filled the canyon for a length of approximately 4500 feet along the river.

with an upstream slope of approximately 7:1, a rather flat and gently rounded crest, and a downstream slope of about 12:1. In general, larger and tougher quartzite and dolomite rocks formed the downstream portion and rode up the far side of the canyon to the greatest height.

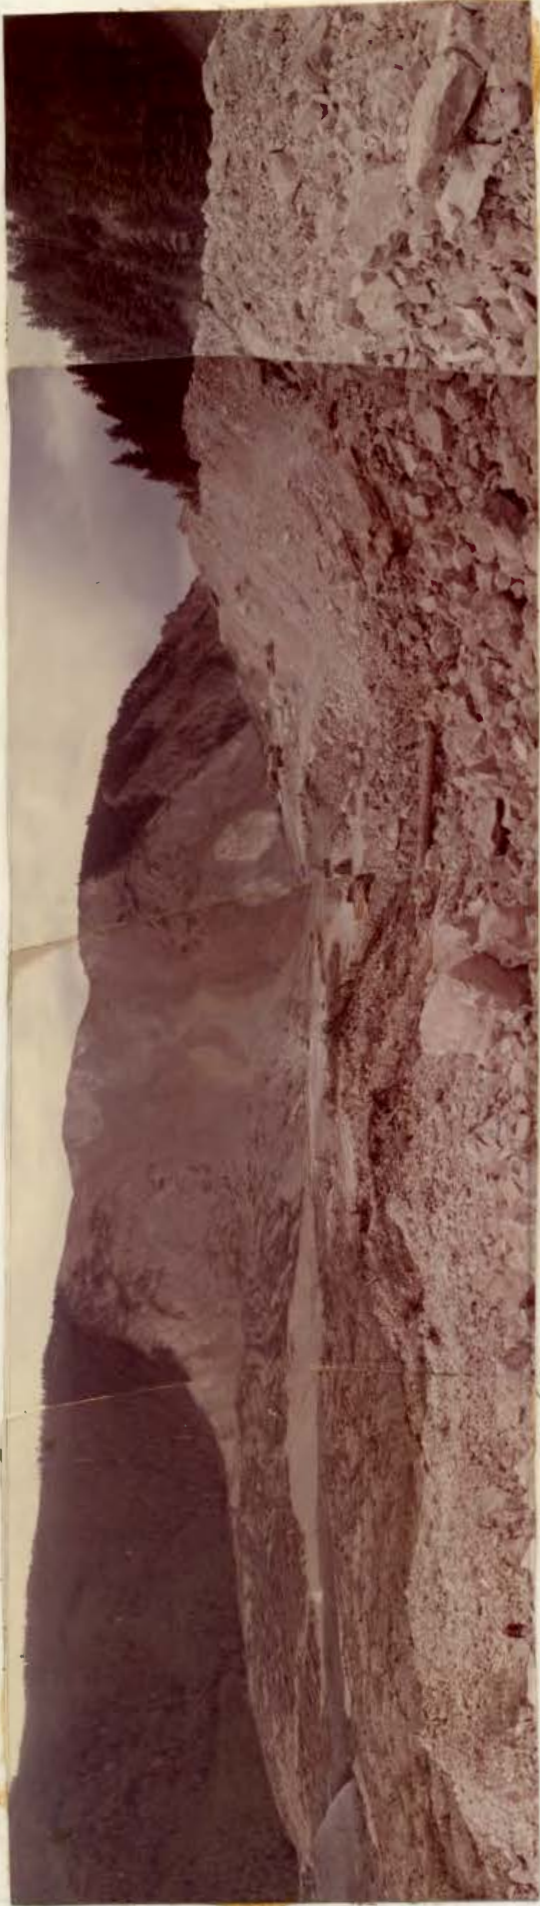
Fig. 17

PANORAMA OF LANDSLIDE FROM UPSTREAM HIGH POINT SHOWN IN FIGURE 16

The weaker schist materials were more finely ground and fanned out over the upstream slope, this phenomena possibly being abetted by a secondary slip. It should be noted that this resulted in a roughly zoned embankment, generally graded from fairly fine materials upstream to larger and more open rock in the body of the slide and the downstream slope.

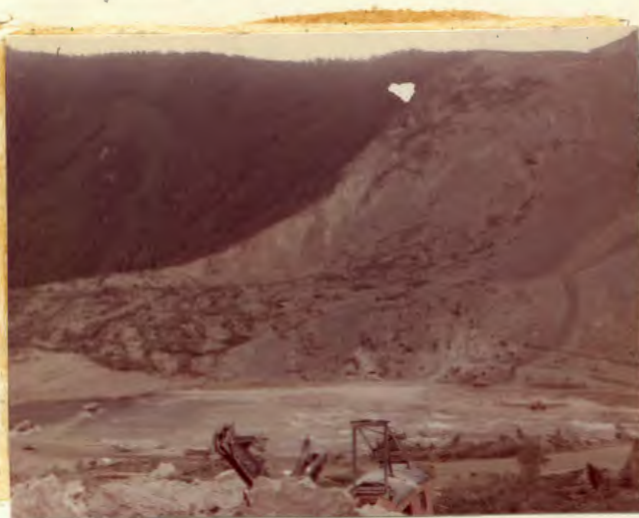
**Fig. 20**  
**INTAKE SECTION OF SPILLWAY**

On September 12, a controlled flow of approximately 700 cfs was flowing through the spillway. This was regulated at Hebgen Dam, releases from which were being controlled by the Corps of Engineers. Velocity in the flat gradient crest section was low, the water flowing without riffles. As the velocity increased down the back slope, considerable erosion was taking place, developing a series of small cascades.

Acting under emergency orders, the Corps of Engineers, with the advice of several consultants, mobilized a large amount of equipment and began excavating a spillway over the top of the slide to safely conduct the flow. This was cut into the low part of the slide to a depth of 30 feet, reducing the maximum

water depth to 190 feet and the volume of the lake to approximately 70, 000 acre-feet. The spillway channel has a 250-foot bottom width and extends on a flat gradient for approximately 1000 feet through the crest into a long vertical curve ending in a 10 percent grade down the back slope. The channel has a total length of about 3500 feet.
