The Norwegian Water Resources and Energy Directorate
nve@nve.no

Investigation of adverse event at Braskereidfoss Dam, Våler Municipality

On 09/08/2023, an adverse event occurred at Braskereidfoss Power Station where the embankment dam failed.

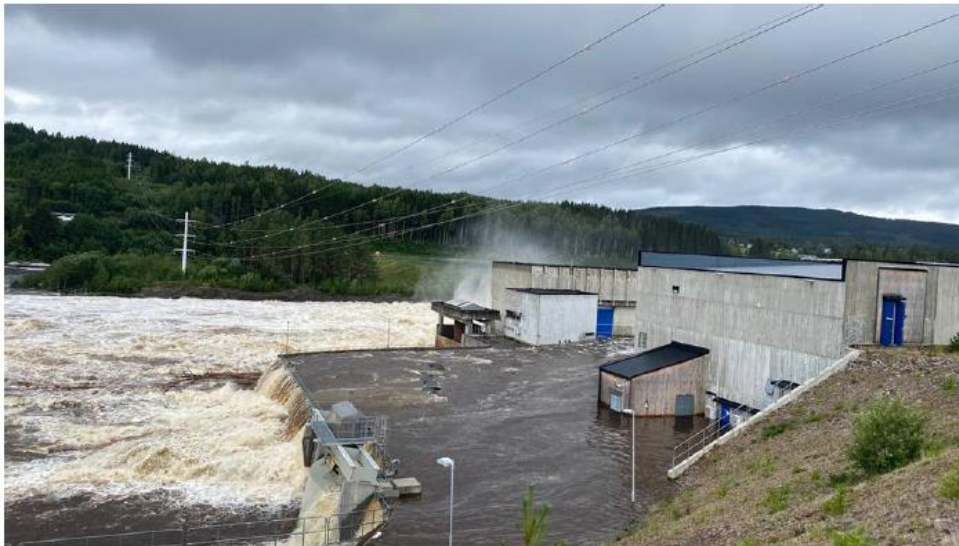
Photo 9: Braskereidfoss Power Station, morning of 09/08/2023 (Source HEV)

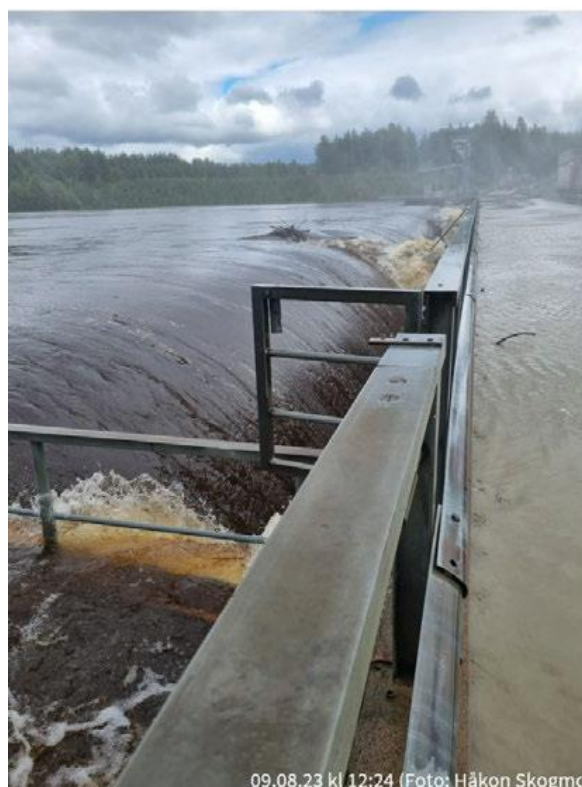
Photo 10: Overtopping of the floodgates at 12:24 (Photo: Håkon Skogmo/Source NVE)

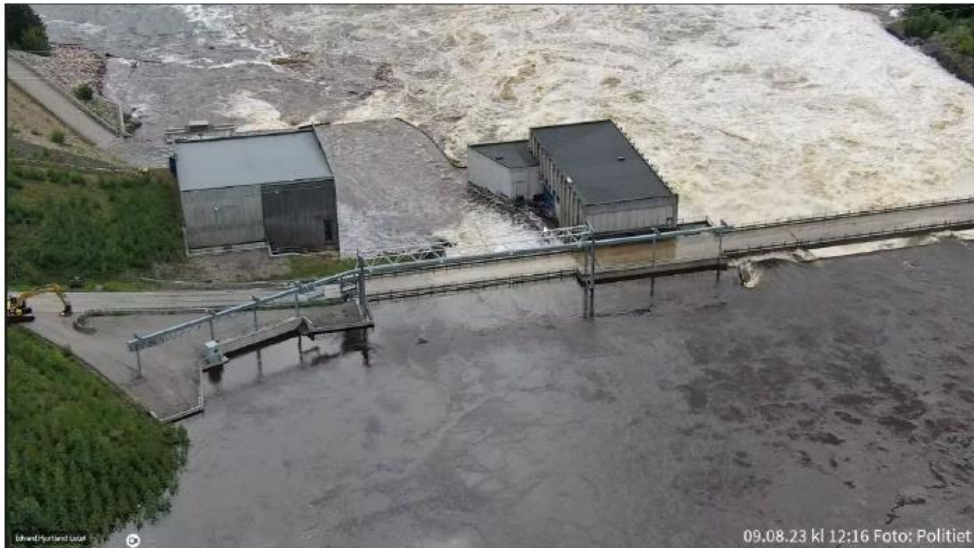
Photo 11: Power plants and gated dam at 12:16 (Photo: Police/Source NVE)

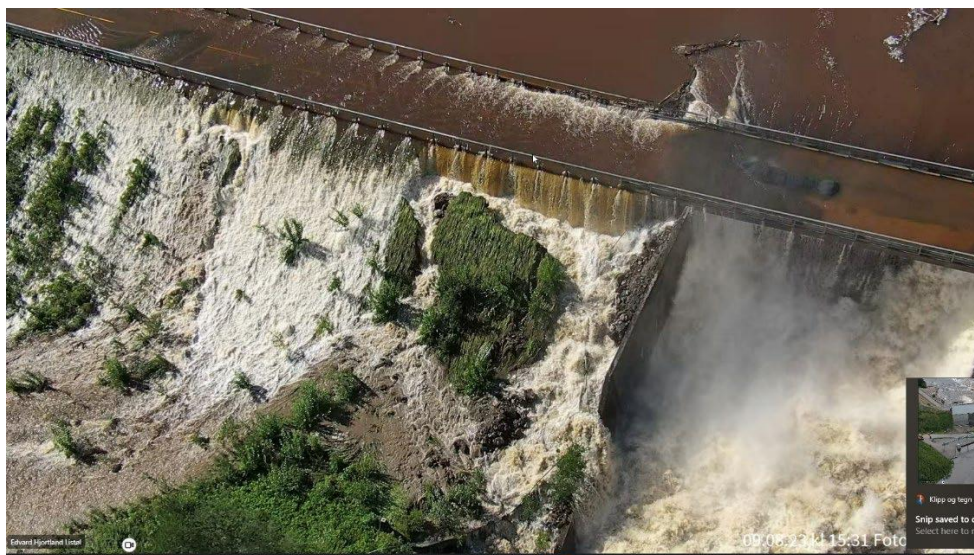
Photo 12: Overtopping of road bridge, embankment dam and gated dam at 15:31 (Photo: Police/Source NVE)

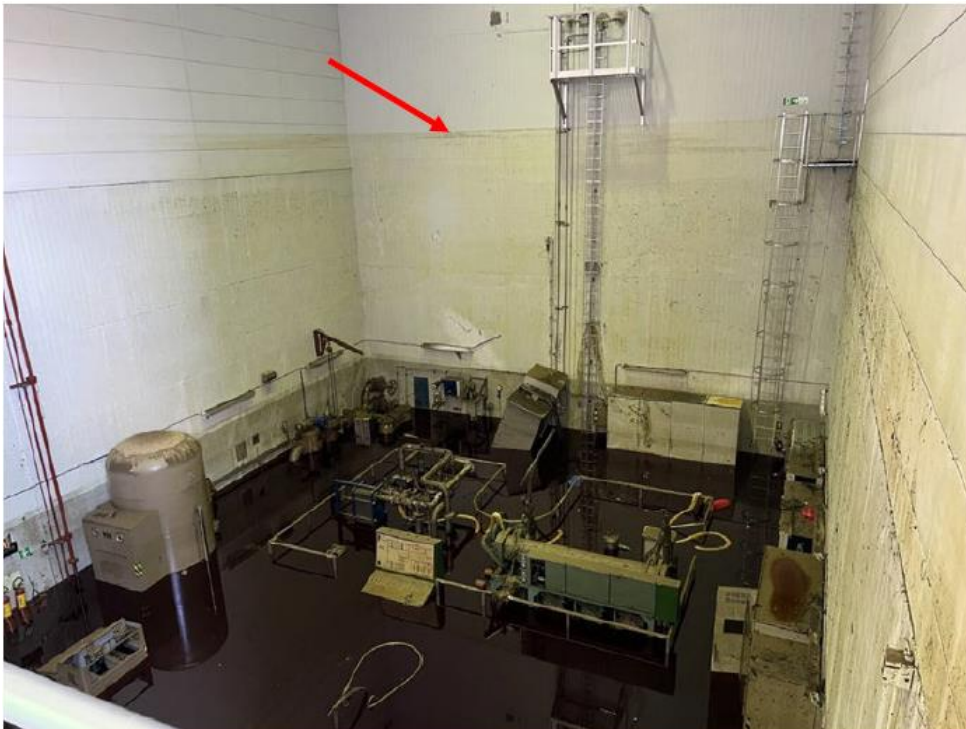
**Photo 16: Generator 1 submerged. The photo was taken after most of the water had been pumped out.
At the top of the photo you can see the line where the water reached at its peak,
marked with a red arrow (Photo DNV)**

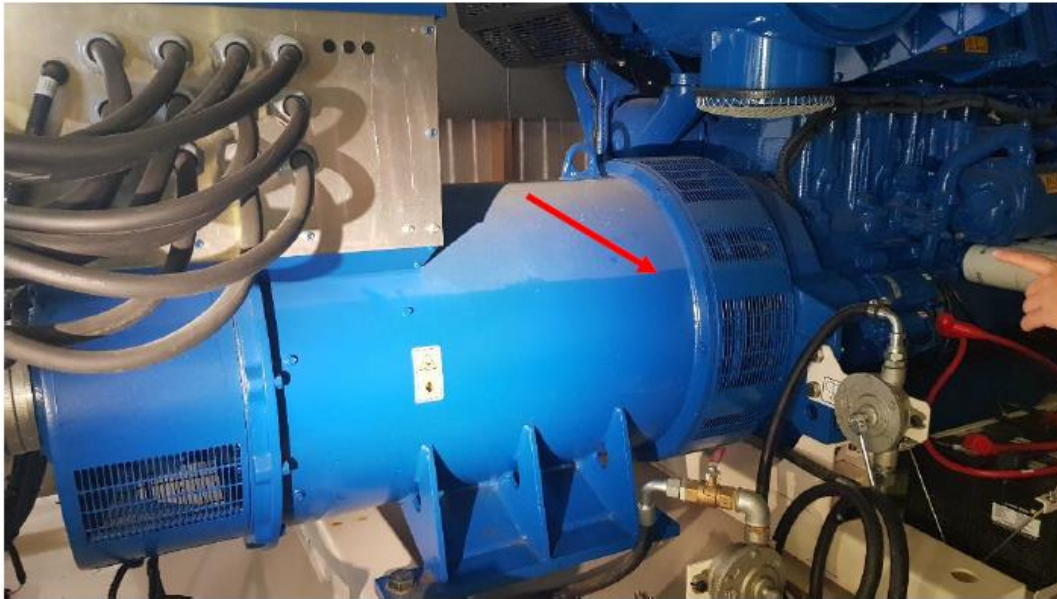
Photo 17: Submerged emergency generator. The line near the top of the generator cover shows where the water reached at its peak, marked with a red arrow (Photo DNV)

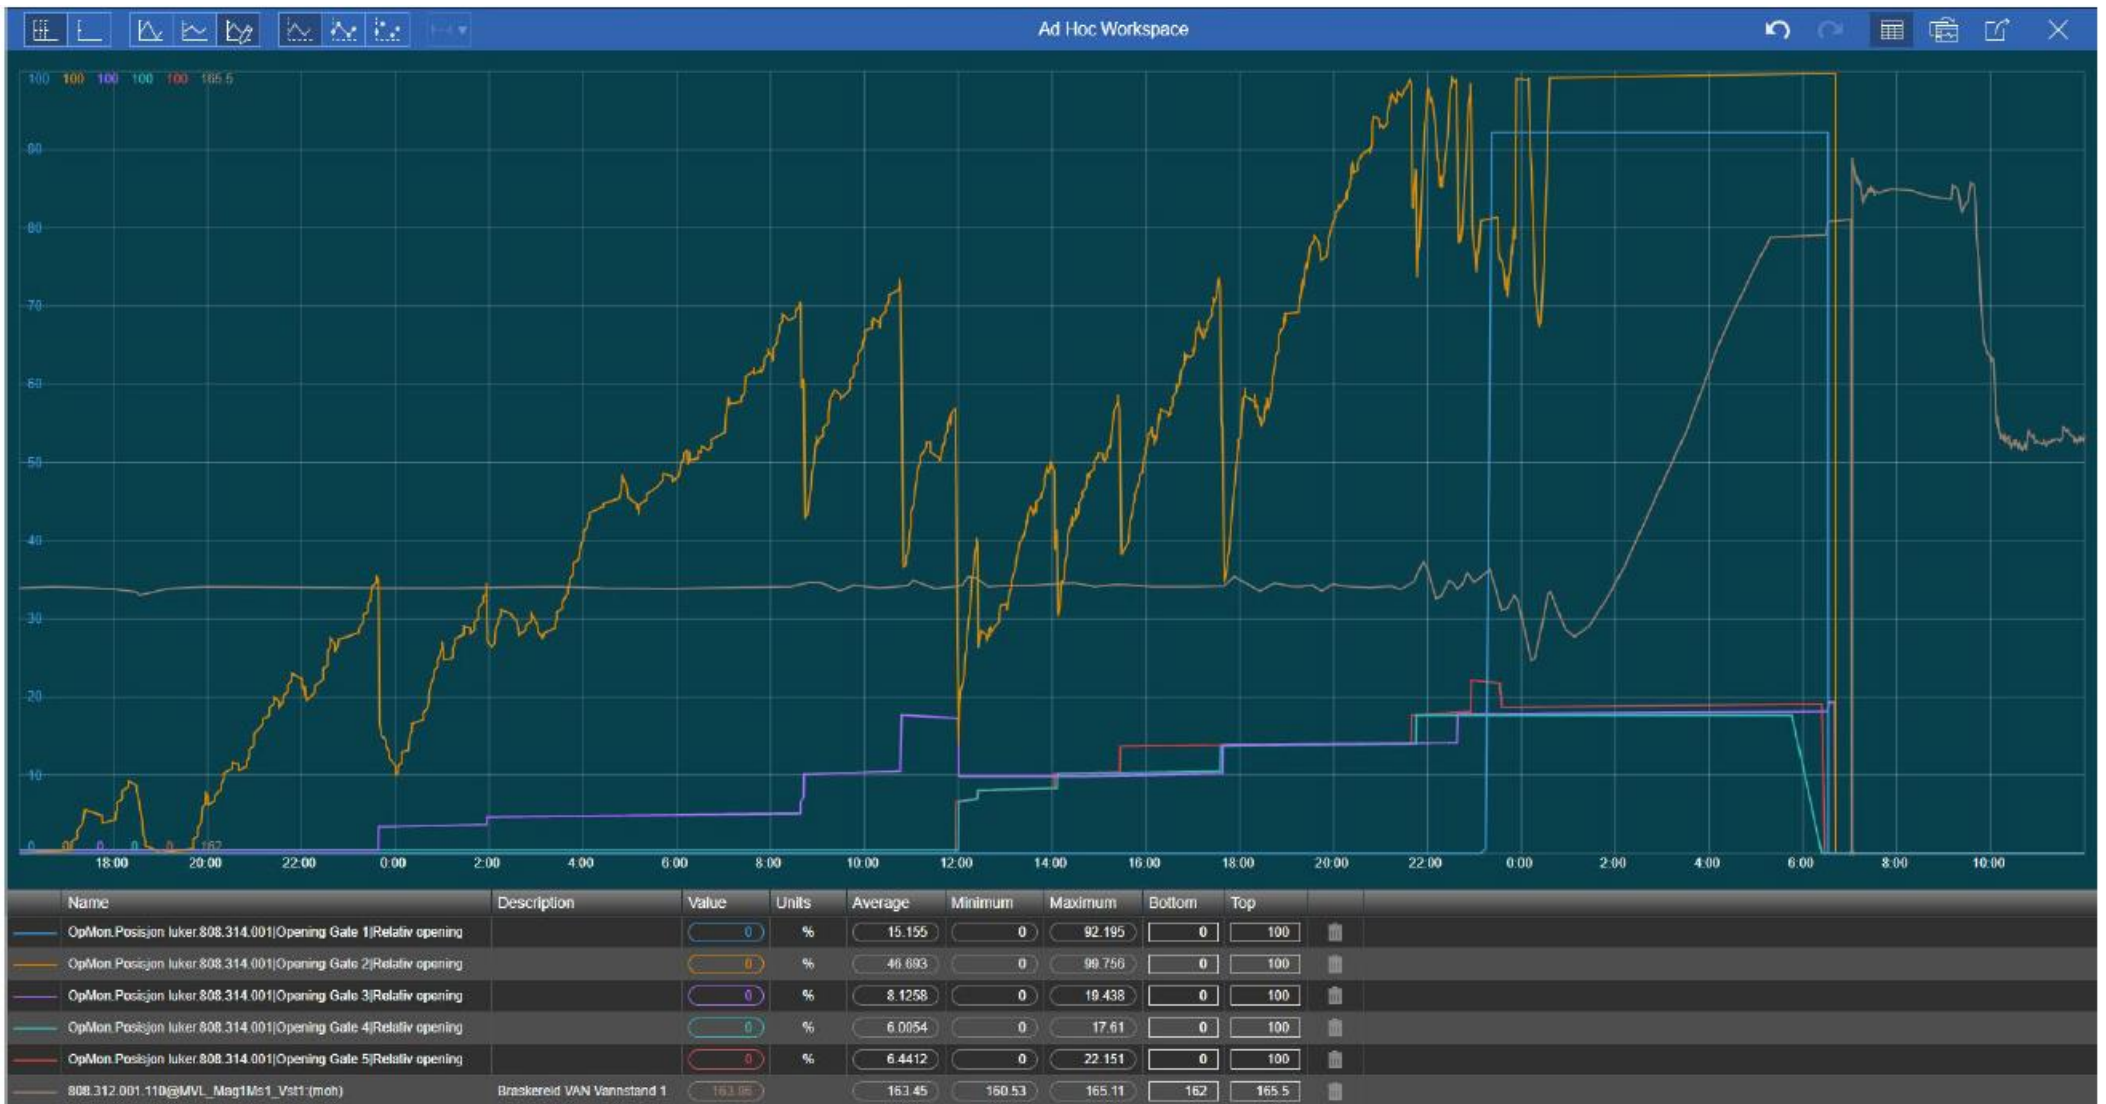
Figure 11: Diagram showing Braskereidfoss gate openings (%) and surface water level (metres above sea level) during the period 07/08/2023 from 18:00 to 09/08/2023 at 10:00

Up to around 23:30 on 08/08/2023, it is clear that the bottom gate, which was set to automatic, was constantly fine-tuning the water level such that it was at HRWL (163.20 metres above sea level). The three floodgates were being operated from the operations centre and were being opened gradually as the rate of flow rose. Every time one of the floodgates was opened a bit, you can see that the bottom gate was adjusted downwards slightly. The timber gate was closed during this period.

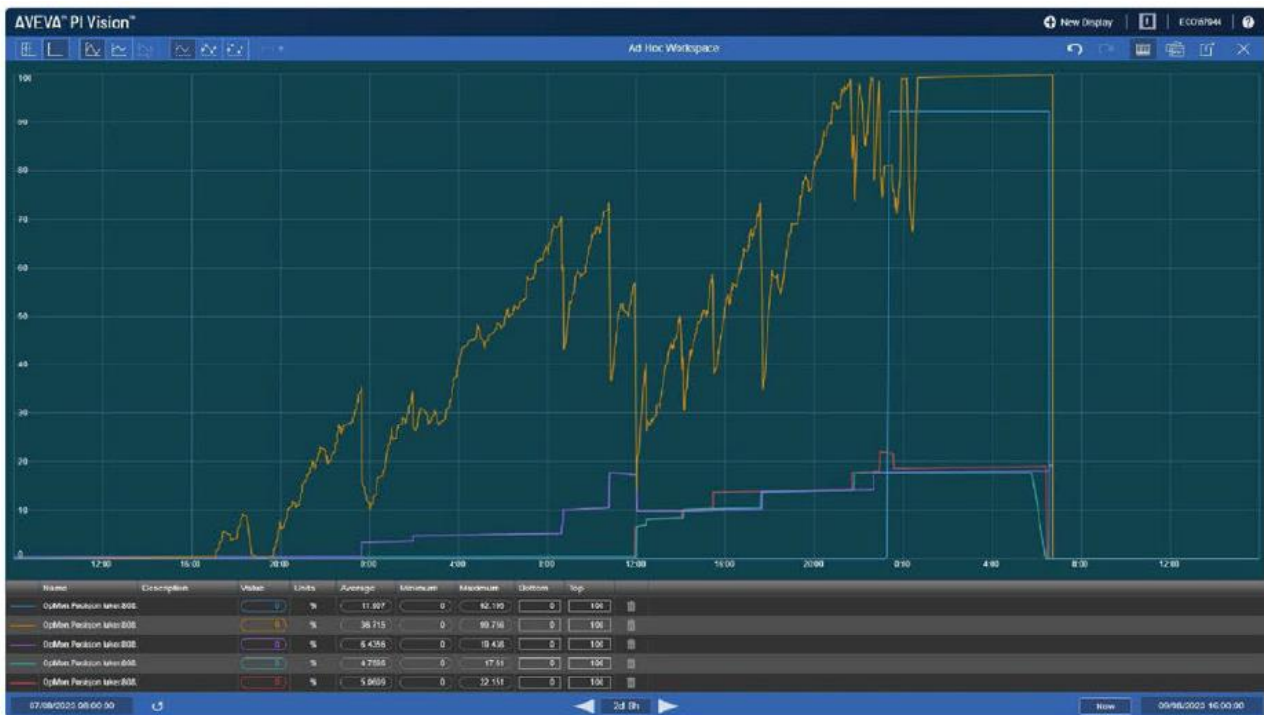
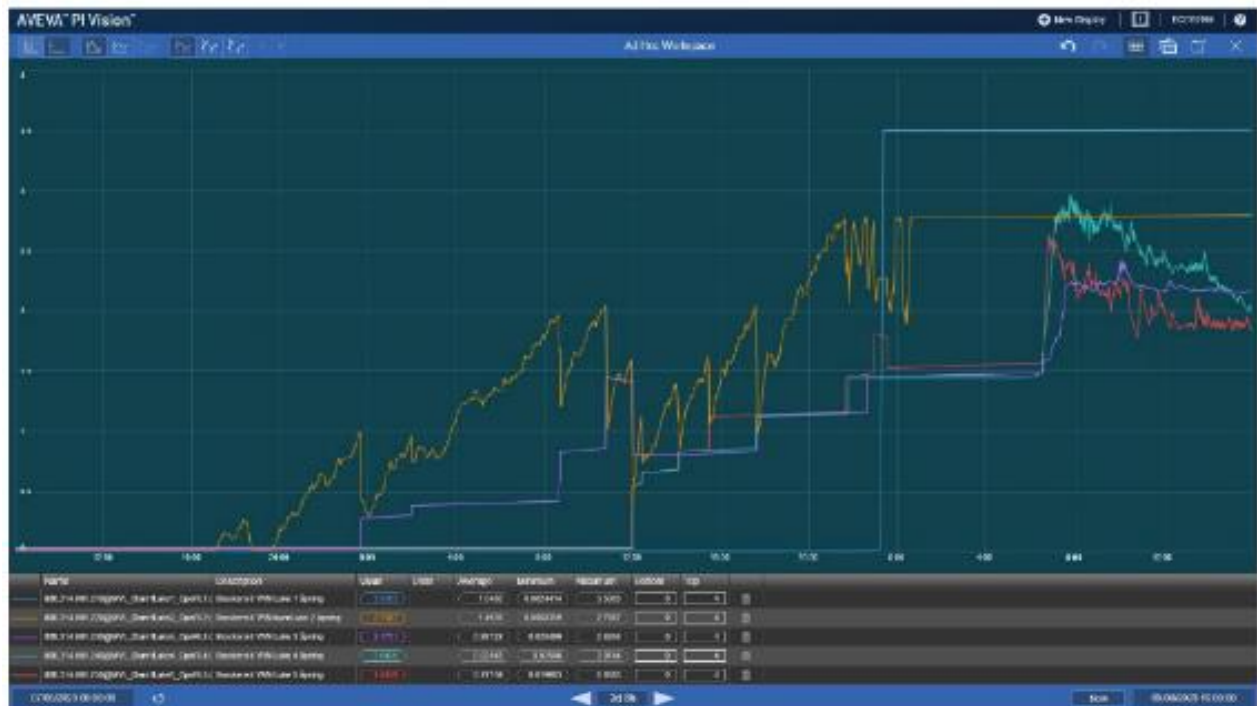
Figure 13: Gate positions as a percentage for the period 08/08/2023 at 16:00 to 09/08/2023 at 10:00

Figure 14: Gate positions indicated in metres for the period 08/08/2023 at 16:00 to 09/08/2023 at 10:00

Timber gate, Gate 1: The timber gate is represented by the blue graph and was opened 100% at approx. 23:30. As the graph confirms, this gate remained constantly open throughout the night. As a consequence of the timber gate being opened, the event log shows that the situation at the dam was turbulent and that the bottom gate was regulating to reduce fluctuations in the water level.

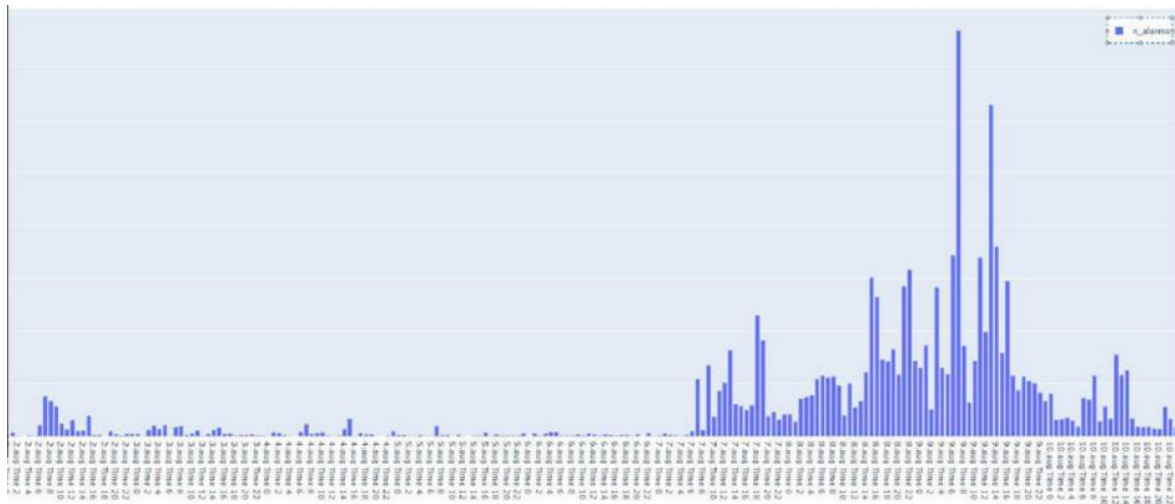
Figure 16: Number of acoustic alarms at the operations centre from 02/08/2023 to 10/08/2023 (total limit alerts and alarms/signals, minus blocked alarms)

From 00:00 to 06:00, the total was closer [REDACTED] alarms at the operations centre. Between 02:00 and 03:00 there were around [REDACTED] alarms in the operations centre. It must be assumed that this created a very high level of stress and that it was difficult to get an overview of and act on all alarms.

- **Improve the operations control system's user interface at the operations centre:** The recommendation is to carry out an overall assessment of the alarms and signals list with a view to simplifying and improving the ability to prioritise based on criticality and/or response times. Suggestions have also been made concerning some specific alarms that ought to be changed, especially for warnings concerning high and critically high water levels.

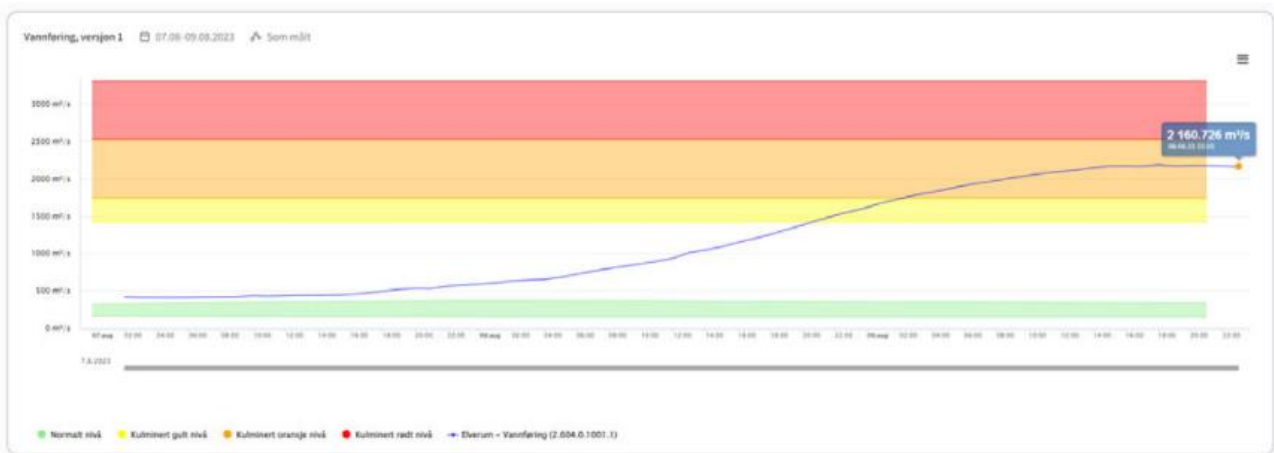
A mobile on-call watch (also called a 'roaming watch') was organised for the three Elverum stations on the evening of 08/08/2023. This meant that operational staff were at Braskereidfoss around midnight, before moving on to the next plant. A permanent watch at Braskereidfoss was not considered necessary. Naturally, the staffing situation was also taken into account. The operating organisation has limited staff and at the same time as the staff were expected to see a heavy workload in the next few days. When the operational staff left Braskereidfoss and moved on to Skjefstadfoss at around 00:40, the rate of flow was around 1600 m³/s and rising. This is shown in the figure below.

Figure 17: Rate of flow in the Glomma River near Elverum 07/08/2023 to 09/08/2023 (Source: NVE, Sildre)

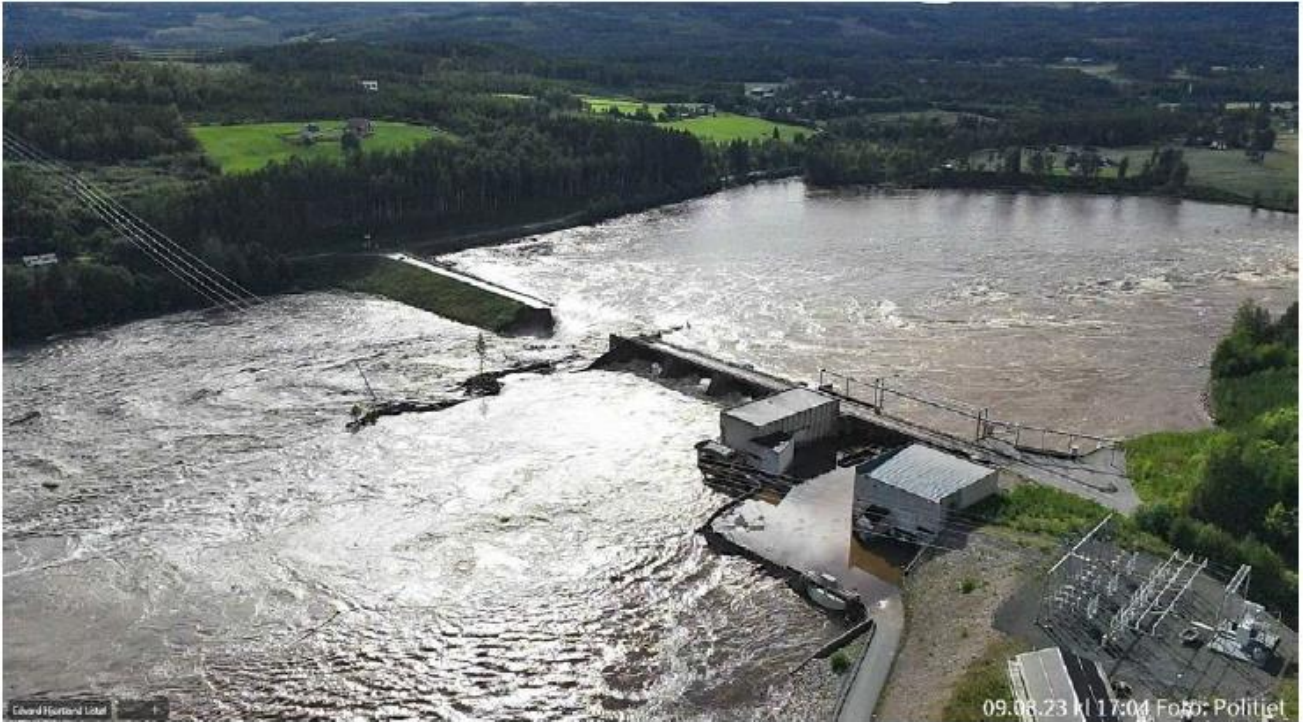
Braskereidfoss during Storm Hans. Photo: Innlandet Police.

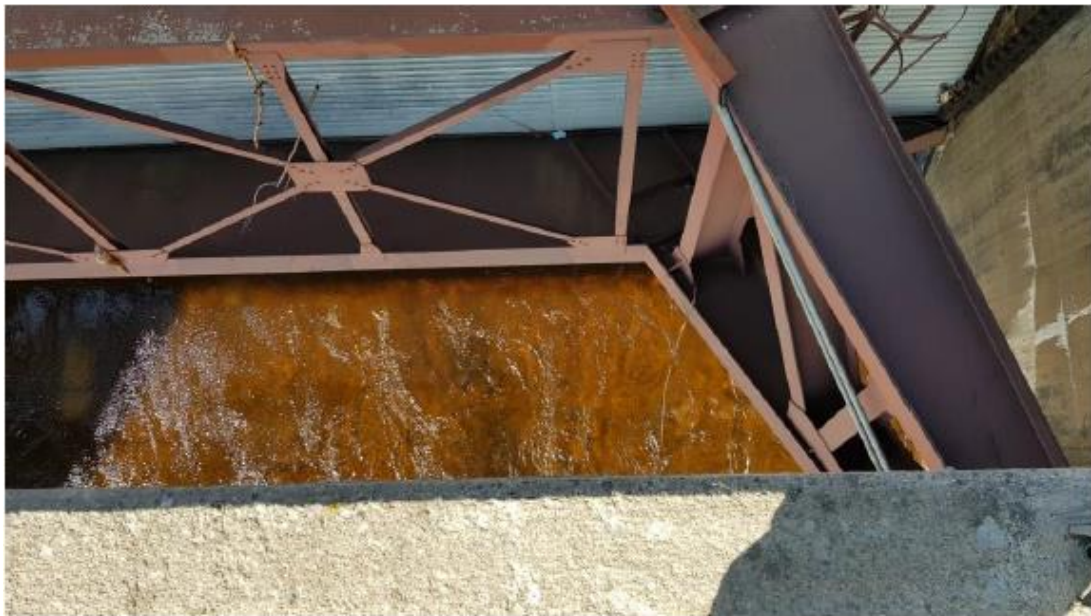
The water load on a segment gate has a radial effect against the shield and this force is transmitted onwards to the gate bearing. The actual weight of the water therefore does not affect the raising mechanism, as in the case of a sector gate or folding gate.

When the plate girders and gate struts are 'filled' with water, this results in a significant additional load on the raising mechanism.

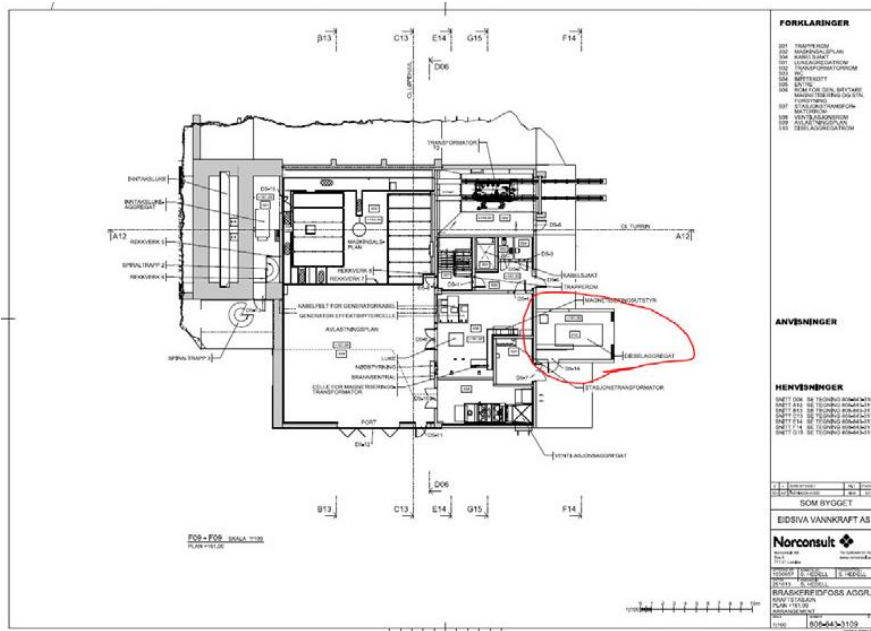
Drawing showing the location of the emergency generator at the station for generator 2 – the new Braskereidfoss.

The generator has been installed on the floor at contour line 161.0. When the water overflowed the buttress dam (contour line 165.0) and eventually penetrated the power station, the generator room was also partially filled with water.

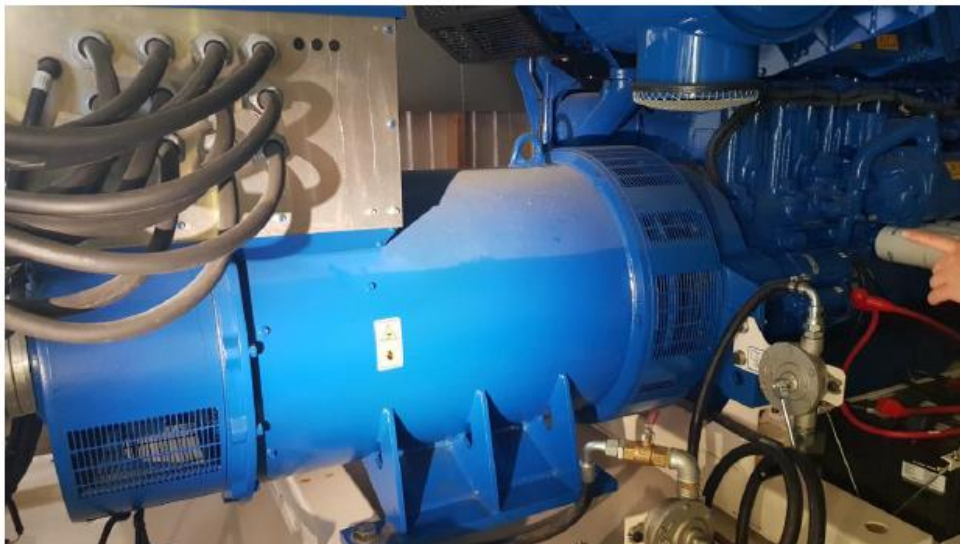
Photos show that the water rose to a level corresponding to slightly above the middle of the generator.

Water level, generator set – emergency power system. Photo: DNV

According to staff at the station, the emergency generator was operational until approx. 09:05 on 09/08/2023.

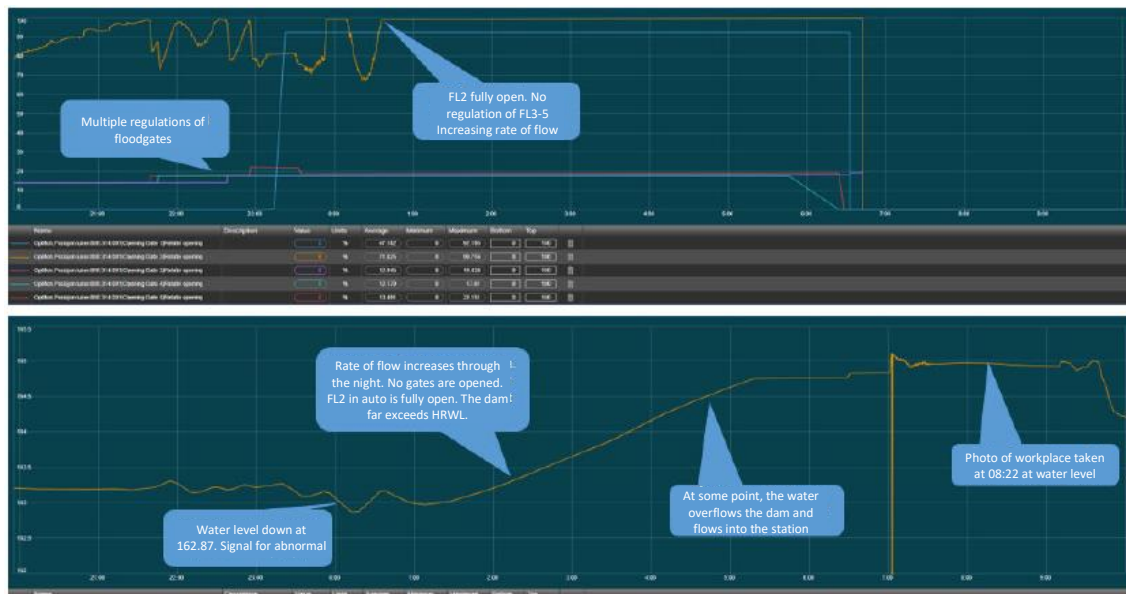
Gate openings and water level 08/08/2023 20:00 – 09/08/2023 10:00

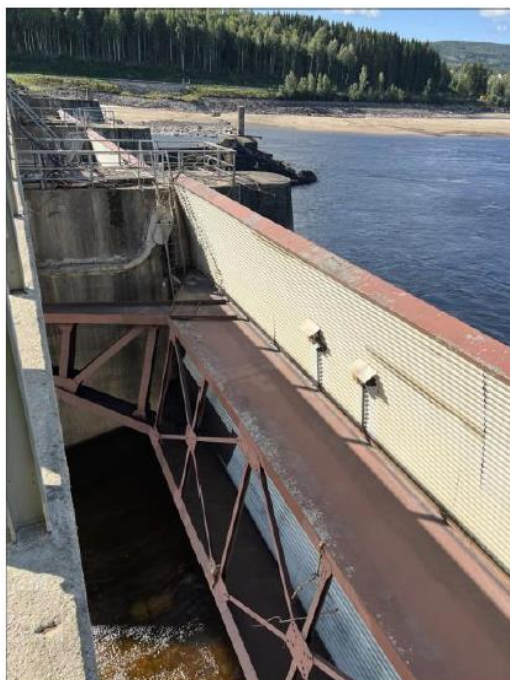
- The machine room in the right gate pillar for Gate 5 has a measuring tube with the top of the tube at contour line 164.4. When this is overtopped, the machine room will be flooded in addition to water flowing in through personnel access hatches at the top.

- The machine room on the left pillar of Gate 3 has better drainage than the other gate pillars, and therefore this machinery was operational for somewhat longer than the others.

Photo showing the gate positions as they were during the flood. The tops of the gates are flush with the pillars. Photo: DNV.

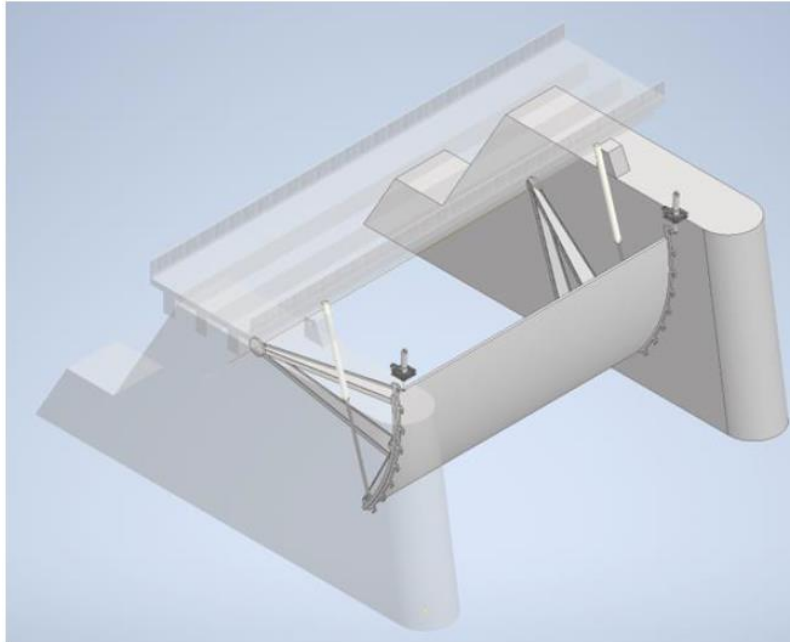
Model of Braskereidfoss floodgate showed hydraulic raising mechanisms, as well as emergency raising mechanisms. Multiconsult

Hydraulic single-acting cylinders instead of chain raising mechanisms on existing floodgates will require the addition of a cylinder mounting pillar, and careful checks need to be made in relation to space vis-à-vis the road bridge across the dam. Our preliminary assessment based on the model shows that there should be sufficient space without coming into conflict with the road bridge.

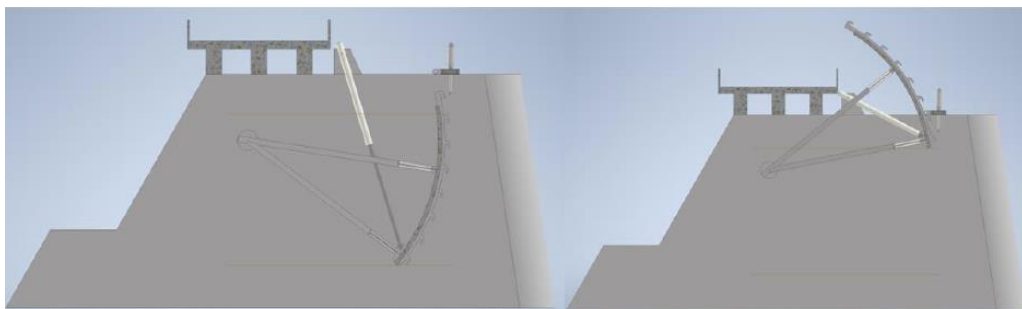
Gate, W x H = 20 x 8.0 metres in closed and open positions with placement of cylinders on the pillar. Multiconsult

Hydraulic cylinders are also vulnerable in the event of overtopping and water above the gates if they are not shielded. This can be solved with screens on the top of the gate blades that would control the flow of water somewhat in the event of overtopping. However, segment gates such as floodgates of this type should, preferably, not be overtopped. Nevertheless, a new hydraulic raising mechanism could be dimensioned to withstand a certain amount of overtopping, if the gate body otherwise allows it.
