Subject: Fwd: FW: EST Activation IOR, Space Shuttle Columbia Disaster

This report describes the first phase of a study designed to improve the management and the safety of the black tiles of the Space Shuttle orbiter. This study is based on the coupling of a probabilistic risk assessment (PRA) model and relevant organizational factors. In this first-phase report, a first-order PRA model is developed and used to design a risk-based criticality scale combining the probabilities and the consequences of tile failures. This scale can then be used to set priorities for the maintenance and gradual replacement of the black tiles.

# **Orbiter Assessment of STS-107 ET Bipod Insulation Ramp Impact**

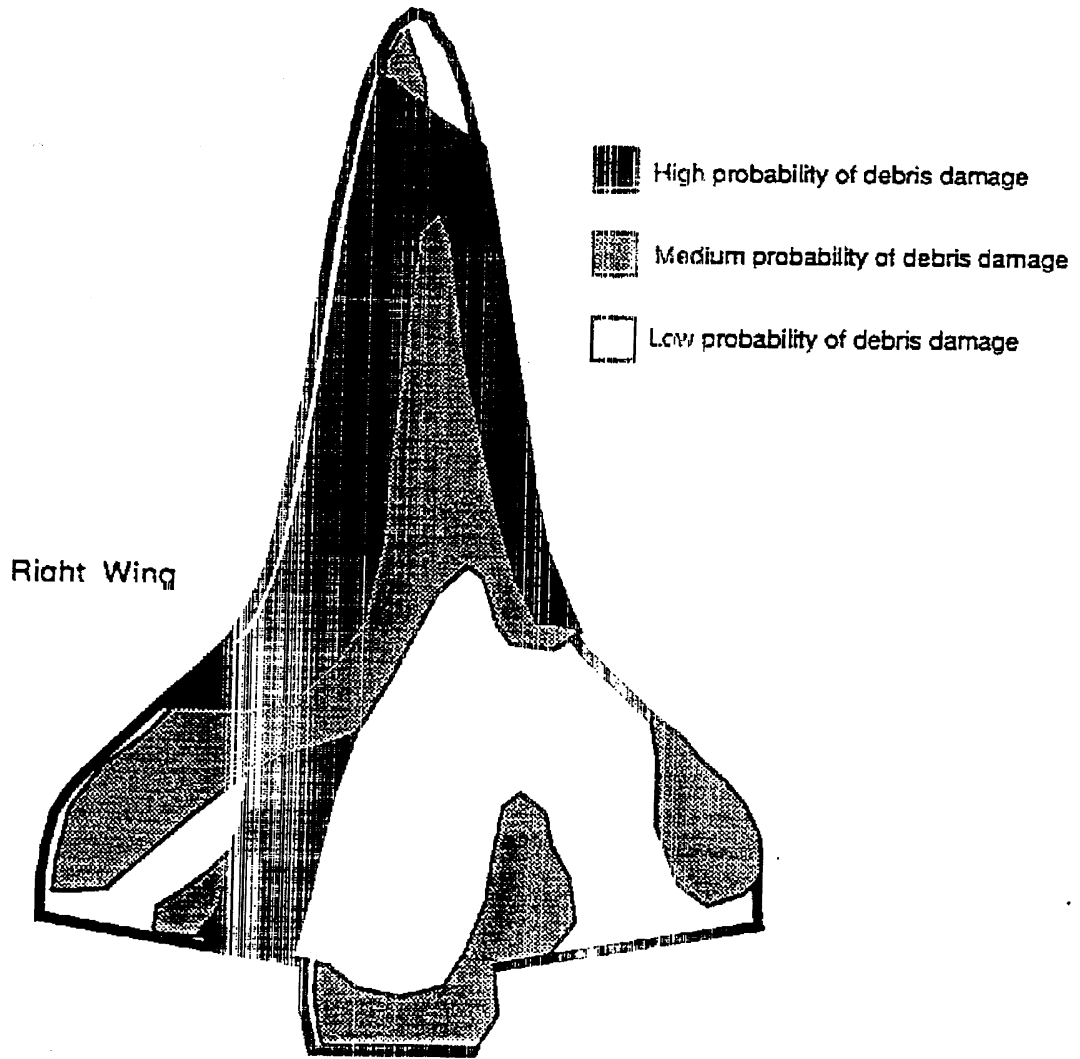
Figure 10: Partition of the orbiter's surface into three types of debris zones (index: h)

To define the debris zones, we plotted all known debris damage from the first 33 flights on a single shuttle layout (see Figure 6.) These data came from J. W. McClymonds (1989) at Rockwell in Downey. Areas with similar damage intensity were grouped together into high, medium, and low debris damage areas (see Figure 10.) An estimated probability of tile damage due to debris per flight was determined by dividing the number of hits by the number of tiles in each area and by the number of flights. A similar plot and calculation was done for all damage to black tiles over one inch in size. (Historically about one fourth of the damage has been greater than one inch in size.) It should be noted that the only missing tile to date caused by debris is in one of the "high debris damage areas".

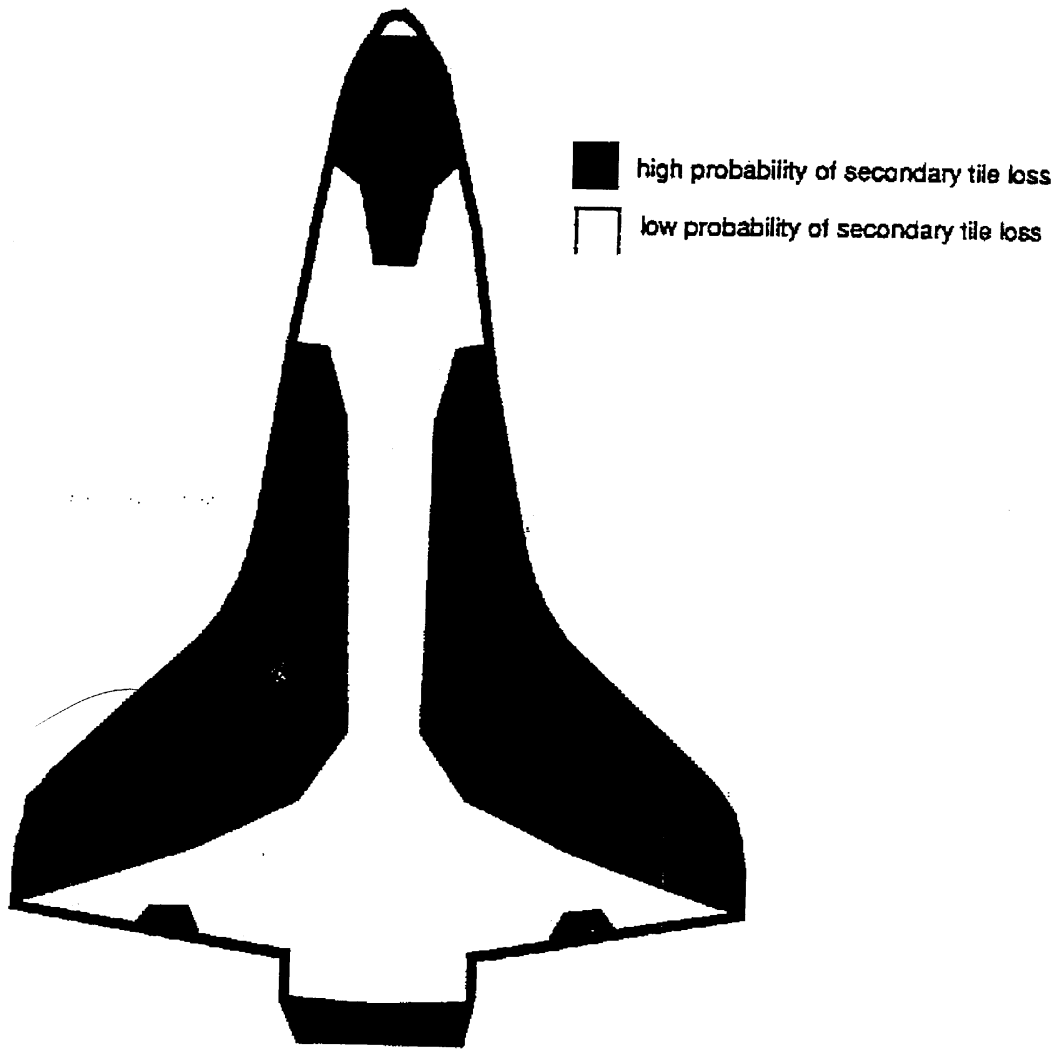
Figure 12: Partition of the orbiter's surface into two types of secondary tile loss zones (index: I)

In order to account for the potential of a single tile causing the loss of adjacent tiles, the orbiter is divided into two *secondary tile loss areas* (see Figure 12.) The probability of additional tile loss depends on the aerodynamic forces and on the magnitude and duration of the increased reentry temperatures that occur around a missing tile due to the disruption of the laminar flow. This increase of temperature also depends on the ability of the skin to dissipate the heat build-up. The RTV bond will fail above 500°F. Because of this, the secondary tile loss areas are related to the temperature areas used in the burn-through analysis above. In this study, the two secondary tile loss areas will be defined by the probability of adjacent tile loss shown in Table 5. These values were estimated from information provided by Robert Maria from NASA in JSC.

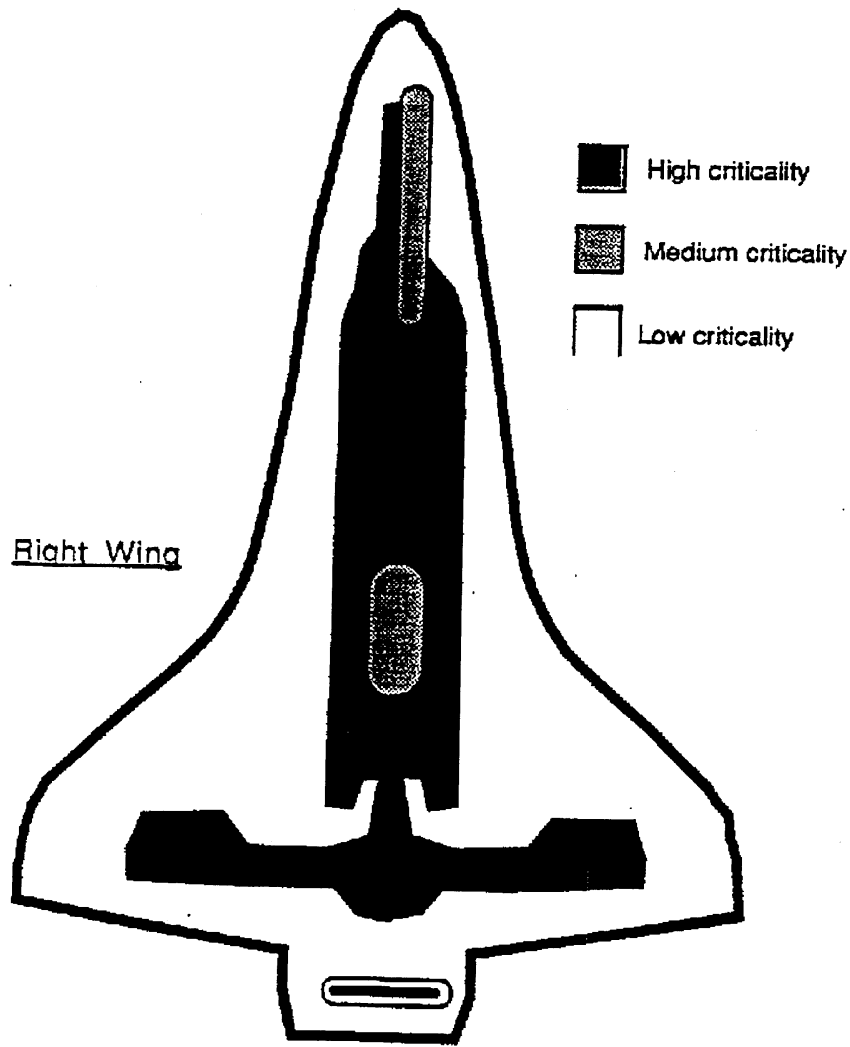
Figure 15: Partition of the orbiter's surface into three types of zones of functional criticality (index: j)

The varying criticality of the subsystems of the orbiter located under the aluminum skin is handled by partitioning the tiles into three *functional criticality areas*. Once a burn-through has occurred, various systems would be exposed to extreme heat and would fail. If those systems were essential for flight, their failure could lead to the loss of the orbiter. By examining the location of critical systems (electrical, hydraulic, fuel, etc. as shown in Figures 13 and 14), three areas were identified (Figure 15). The following probabilities were estimated by assuming that a burn-through would cause an area of four square feet around the hole to be exposed to hot gases.

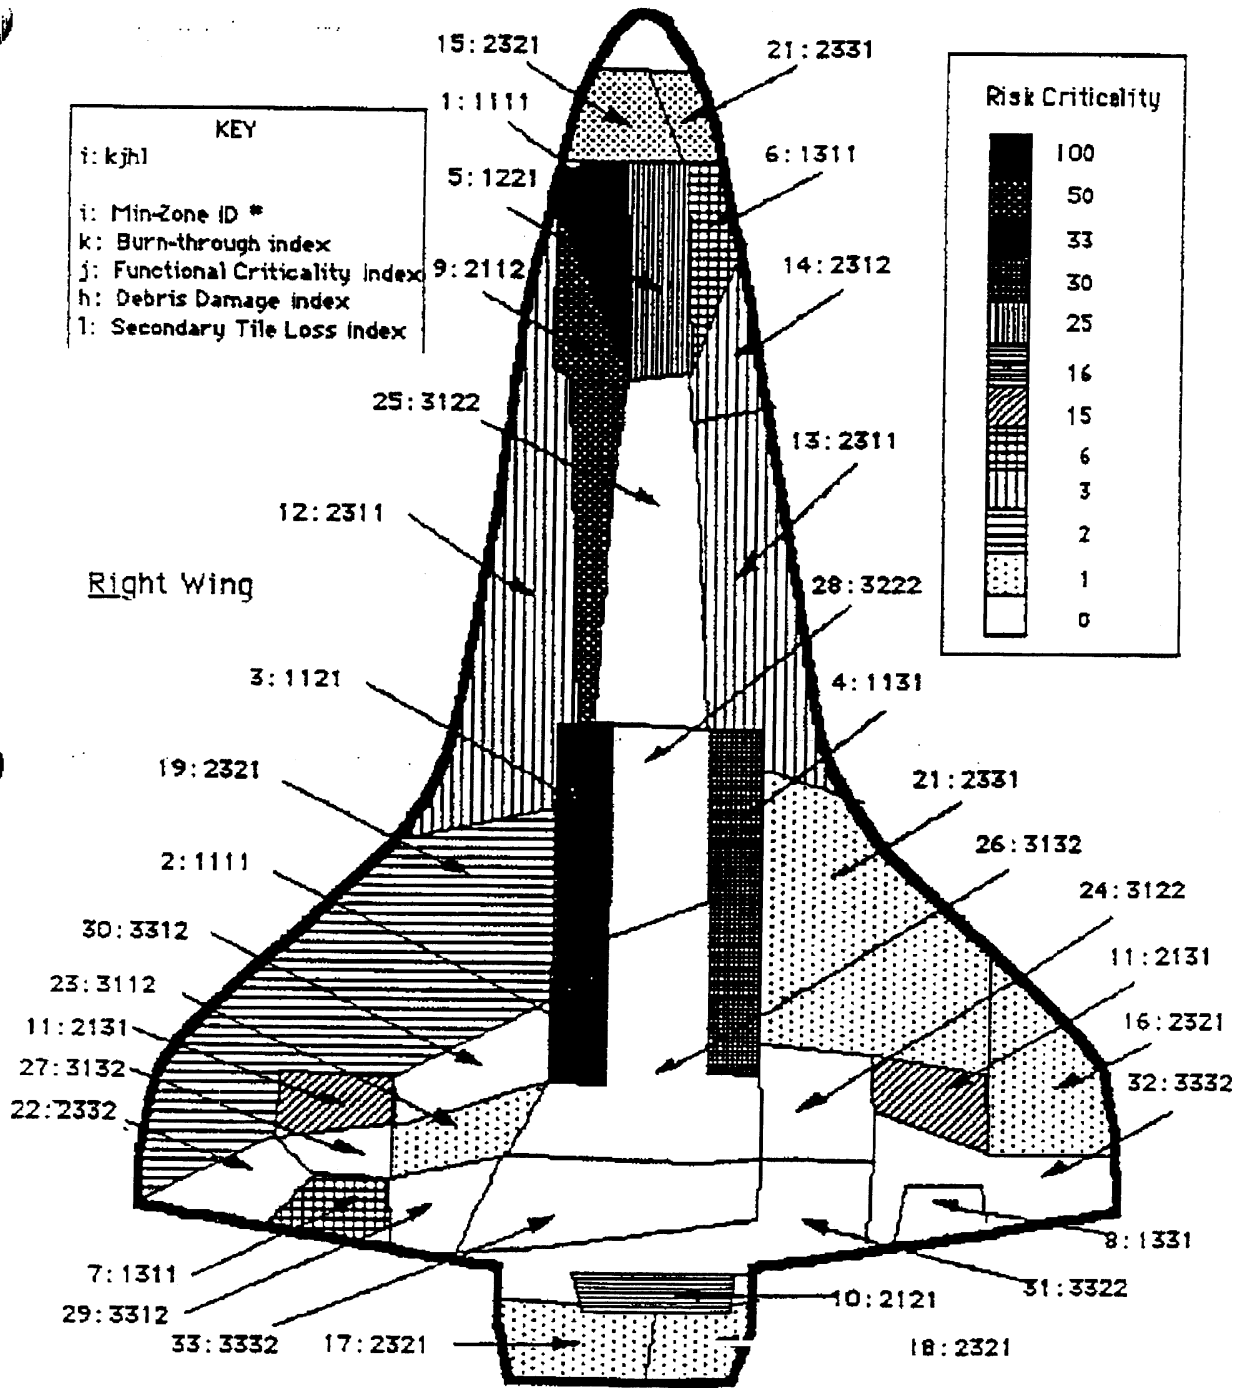
Figure 23: Partition of the orbiter's surface into 33 min-zones (index: i)

Table 8 lists the min-zones, and shows the number of tiles in each zone and the probability of failure of the orbiter attributable to this zone. This value was determined by calculating this probability for both initiating events and then summing to obtain the results. The boundaries of the min-zones have been simplified: the number of tiles in each area is only an approximation and is not based on an actual count. The location description is only intended to provide a rough placement of the

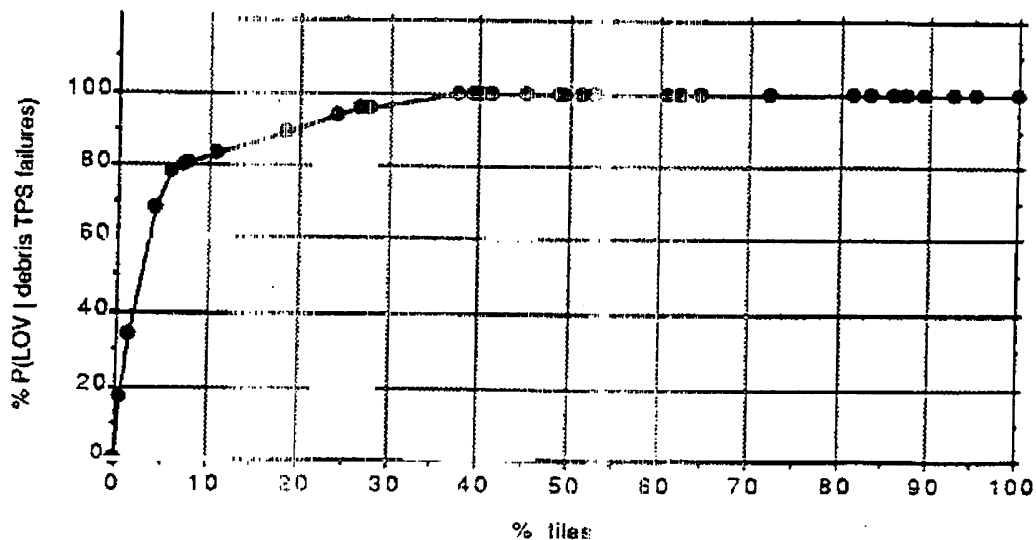
Figure 24: Relative risk of LOV due to debris-initiated TPS damage

the zone. Several small min-zones contain a large part of the risk (those with the steepest slope), whereas several very large min-zones carry only a small part of the risk (those with zero slope). Figure 23 shows the contribution of increasing percentages of the tiles to the risk for debris-initiated damage. Note that, for failures initiated by debris, *80% of the risk is due to only 8% of the tiles*. For debonding problems that are not caused by debris, the contribution of increasing percentages of tiles are shown in Figure 24: *80% of the risk is due to 13% of the tiles*. Finally, the overall result is shown in Figure 25: for the total risk, including both initiating events, *80% of the risk can be attributed to 14% of the tiles*. It is important to remember that the same tiles do not necessarily appear in the same order in each graph. Clearly, some zones pose a much higher risk for one type of initiating event than for the other. For example, min-zone # located near the left main gear has not historically experienced significant debris damage and is not on the obvious trajectory of tractable debris; so, the probability of LOV due to TPS debris damage in that zone is basically zero. There are, however, some critical components that are temperature sensitive under the skin in that area; so, the risk of LOV due to *debonding* is non negligible ( $1.07 \times 10^{-4}$ ).
