COLUMBIA

ACCIDENT INVESTIGATION BOARD

REPORT VOLUME I
AUGUST 2003

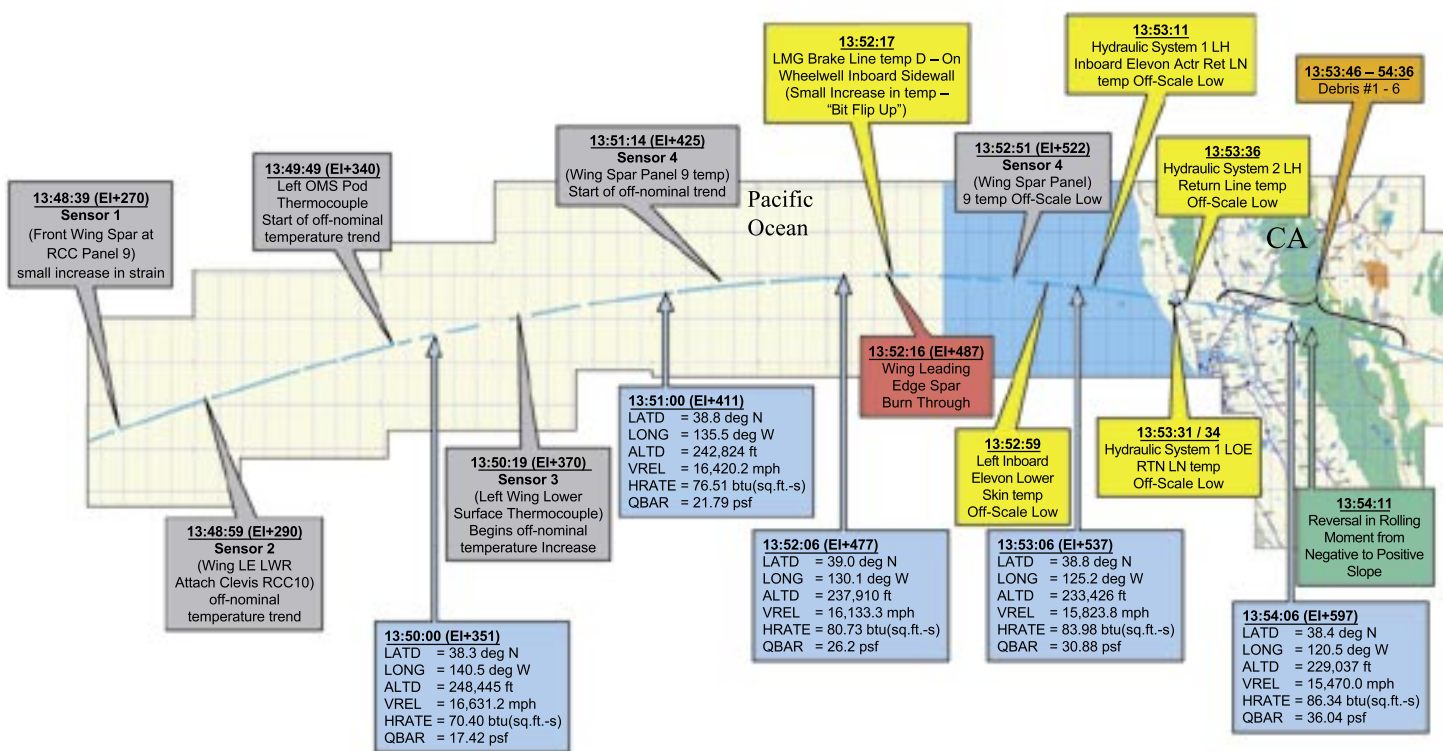
At 8:48:39 a.m. (EI+270), a sensor on the left wing leading edge spar showed strains higher than those seen on previous *Columbia* re-entries. This was recorded only on the Modular Auxiliary Data System, and was not telemetered to ground controllers or displayed to the crew (see Figure 2.6-1).

Figure 2.6-1. This simplified timeline shows the re-entry path of Columbia on February 1, 2003. The information presented here is a composite of sensor data telemetered to the ground combined with data from the Modular Auxiliary Data System recorder recovered after the accident. Note that the first off-nominal reading was a small increase in a strain gauge at the front wing spar behind RCC panel 9-left. The chart is color-coded: blue boxes contain position, attitude, and velocity information; orange boxes indicate when debris was shed from the Orbiter; green boxes are significant aerodynamic control events; gray boxes contain sensor information from the Modular Auxiliary Data System; and yellow boxes contain telemetered sensor information. The red boxes indicate other significant events.

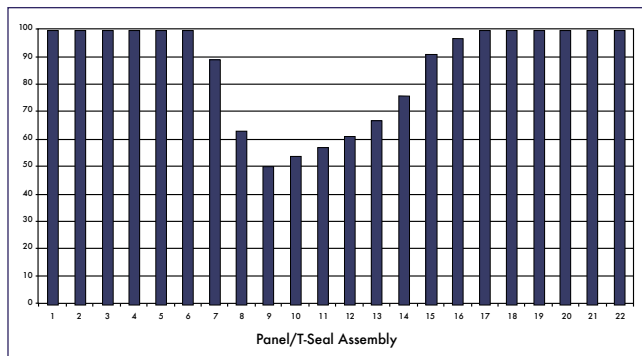
For the first five missions of *Columbia*, the RCC components were not coated with Type A sealant, and had shorter mission service lives than the RCC components on the other Orbiters. (*Columbia*'s panel 9 has the shortest mission service life of 50 flights as shown in Figure 3.3-4.) The predicted life for panel/T-seals 7 through 16 range from 54 to 97 flights.⁷

Figure 3.3-4. The expected mission life for each of the wing leading edge RCC panels on Columbia. Note that panel 9 has the shortest life expectancy.

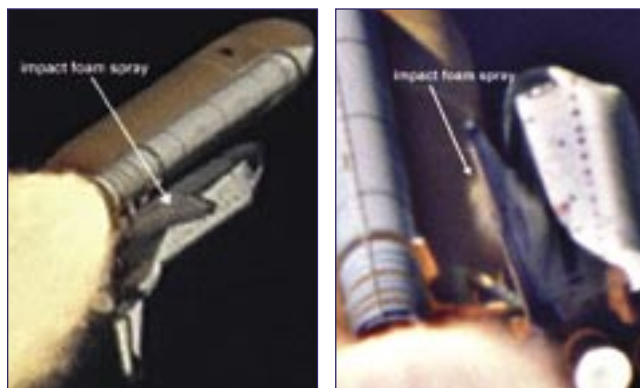
Figure 3.4-1 (color enhanced and "de-blurred" by Lockheed Martin Gaithersburg) and Figure 3.4-2 (processed by the National Imagery and Mapping Agency) are samples of the type of visual data used to establish the time of the impact (81.9 seconds), the altitude at which it occurred (65,860 feet), and the object's relative velocity at impact (about 545 mph relative to the Orbiter).

A 35-mm film camera, E212, which recorded the foam strike from 17 miles away, and video camera E208, which recorded it from 26 miles away, provided the best of the available evidence. Analysis of this visual evidence (see Figures 3.4-1 and 3.4-2) along with computer-aided design analysis, refined the potential impact area to less than 20 square feet in RCC panels 6 through 9 (see Figure 3.4-3), including a portion of the corresponding carrier panels and adjacent tiles. The investigation image analysis team found no conclusive visual evidence of post-impact debris flowing over the top of the wing.

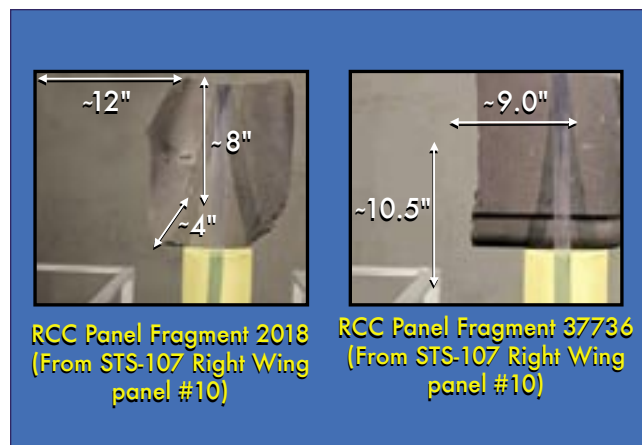
Figure 3.5-1. These representative RCC acreage pieces matched the radar cross-section of the Flight Day 2 object.

In the Advanced Compact Range at the Air Force Research Laboratory in Dayton, Ohio, analysts tested 31 materials from the Orbiter's exterior and payload bay. Additional supercomputer radar cross-section predictions were made for Reinforced Carbon-Carbon T-seals. After exhaustive radar cross-section analysis and testing, coupled with ballistic analysis of the object's orbital decay, only a fragment of RCC panel would match the UHF radar cross-section and ballistic coefficients observed by the Space Surveillance network. Such an RCC panel fragment must be approximately 140 square inches or greater in area to meet the observed radar cross-section characteristics. Figure 3.5-1 shows RCC panel fragments from *Columbia*'s right wing that represent those meeting the observed characteristics of object 2003-003B.¹⁰

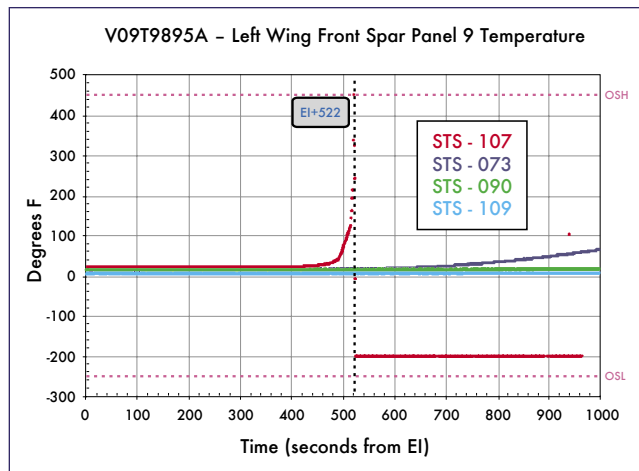
Sensor 4 also recorded a rise in temperature that ended in an abrupt fall to off-scale low. Figure 3.6-7 shows that an abnormal temperature rise began at EI+425 and abruptly fell at EI+525. Unlike Sensor 2, this temperature rise was extreme, from an expected 20 degrees Fahrenheit at EI+425 to 40 degrees at EI+485, and then rising much faster to 120 degrees at EI+515, then to an off-scale high (a reading that climbs off the scale at the high end of the range) of 450 degrees at EI+522. The failure pattern of this sensor likely indicates destruction by extreme heat.

Figure 3.6-7. Sensor 4 also began reading significantly higher than previous flights before it fell off-scale low. The relatively late reaction of this sensor compared to Sensor 2, clearly indicated that superheated air started on the outside of the wing leading edge spar and then moved into the mid-wing after the spar was burned through. Note that immediately before the sensor (or the wire) fails, the temperature is at 450 degrees Fahrenheit and climbing rapidly. It was the only temperature sensor that showed this pattern.

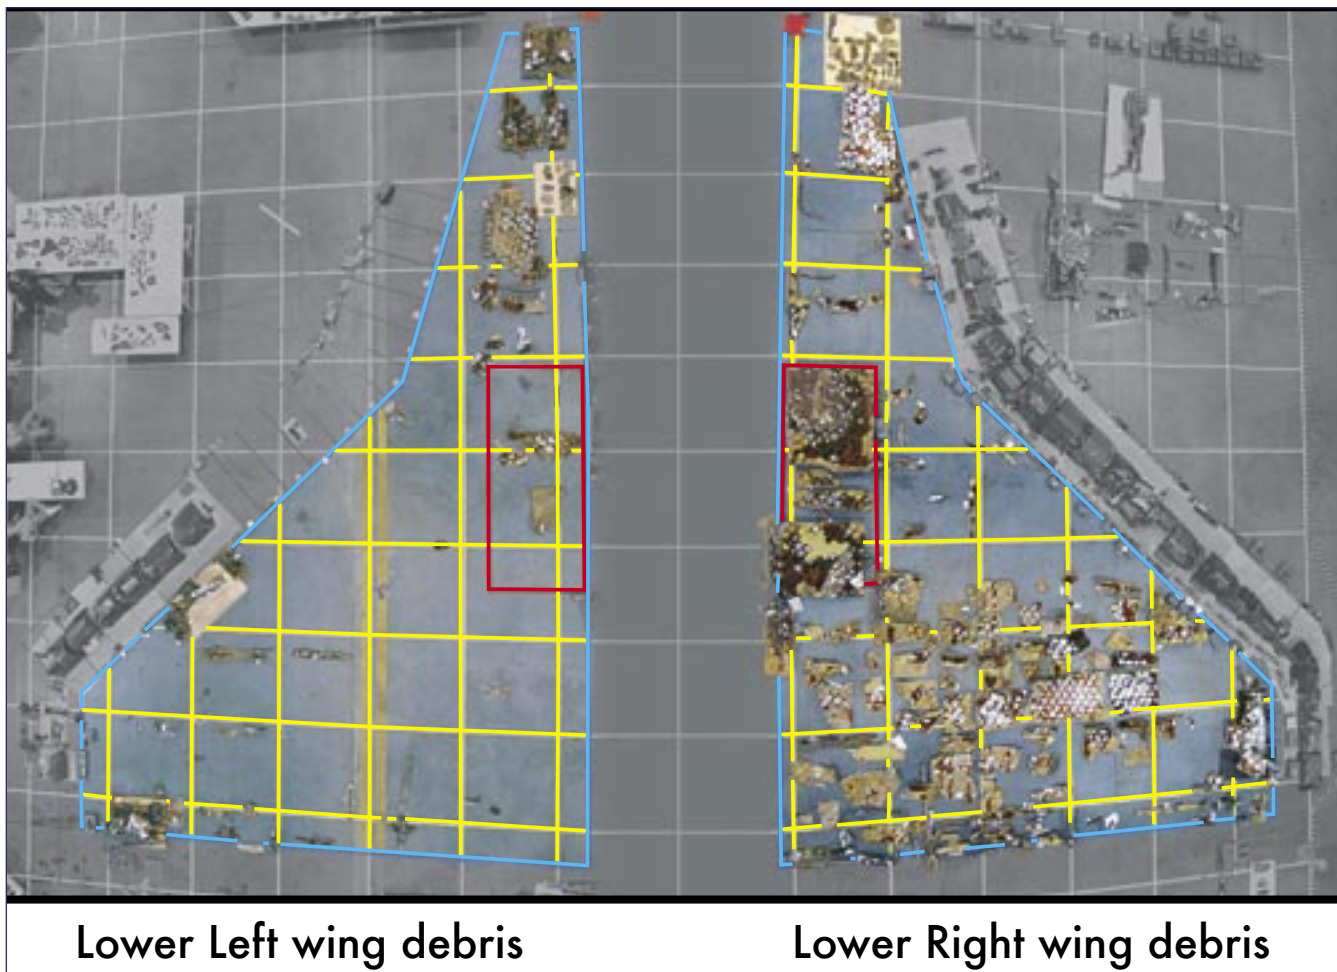
Figure 3.7-1. Comparison of amount of debris recovered from the left and right wings of Columbia. Note the amount of debris recovered from areas in front of the wheel well (the red boxes on each wing) were similar, but there were dramatic differences in the amount of debris recovered aft of each wheel well.

Detailed analysis of the debris revealed unique features and convincing evidence that the damage to the left wing differed significantly from damage to the right, and that significant differences existed in pieces from various areas of the left wing. While a substantial amount of upper and lower right wing structure was recovered, comparatively little of the upper and lower left wing structure was recovered (see Figure 3.7-1).

The difference in recovered debris from the Orbiter's wings clearly indicates that after the breakup, most of the left wing succumbed to both high heat and aerodynamic forces, while the right wing succumbed to aerodynamic forces only. Because the left wing was already compromised, it was the first area of the Orbiter to fail structurally. Pieces were exposed to higher heating for a longer period, resulting in more heat damage and ablation of left wing structural material. The left wing was also subjected to superheated air that penetrated directly into the mid-body of the wing for a substantial period. This pre-heating likely rendered those components unable to absorb much, if any, of the post-breakup heating. Those internal and external structures were likely vaporized during post-breakup re-entry. Finally, the left wing likely lost significant amounts of the Thermal Protection System prior to breakup due to the effect of internal wing heating on the Thermal Protection System bonding materials, and this further degraded the left wing's ability to resist the high heat of re-entry after it broke up.

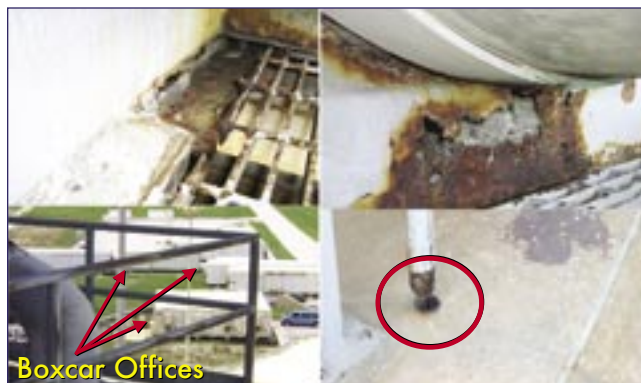
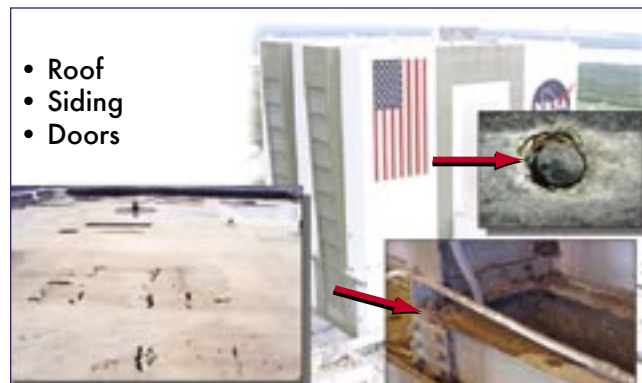
Board investigators have identified deteriorating infrastructure associated with the launch pads, Vehicle Assembly Building, and the crawler transporter. Figures 5.5-5 and 5.5-6 depict some of this deterioration. For example, NASA has installed nets, and even an entire sub-roof, inside the Vehicle Assembly Building to prevent concrete from the building’s ceiling from hitting the Orbiter and Shuttle stack. In addition, the corrosion-control challenge results in zinc primer

on certain launch pad areas being exposed to the elements. When rain falls on these areas, it carries away zinc, runs onto the leading edge of the Orbiter’s wings, and causes pinholes in the Reinforced Carbon-Carbon panels (see Chapter 3).

Figure 5.5-5 and 5.5-6. Examples of the seriously deteriorating infrastructure used to support the Space Shuttle Program. At left is Launch Complex 39A, and at right is the Vehicle Assembly building, both at the Kennedy Space Center.

In Fiscal Year 2002, Congress added \$25 million to NASA’s budget for Vehicle Assembly Building repairs. NASA has reallocated limited funds from the Shuttle budget to pressing infrastructure repairs, and intends to take an integrated look at infrastructure as part of its new Shuttle Service Life Extension Program. Nonetheless, like Space Shuttle upgrades, infrastructure revitalization has been mired by the uncertainty surrounding the Shuttle Program’s lifetime. Considering that the Shuttle will likely be flying for many years to come, NASA, the White House, and Congress alike now face the specter of having to deal with years of infrastructure neglect.

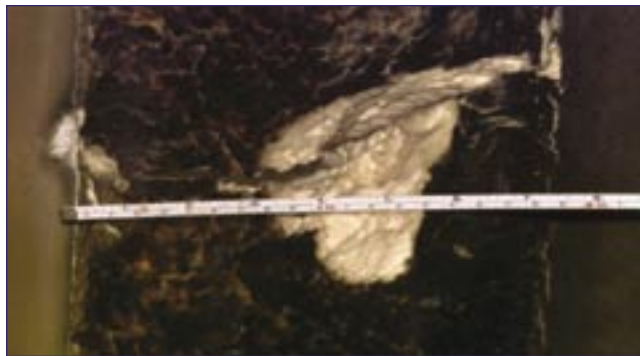
The sixth and final bipod ramp event before STS-107 occurred during STS-112 on October 7, 2002 (see Figure 6.1-3). At 33 seconds after launch, when *Atlantis* was at 12,500 feet and traveling at Mach 0.75, ground cameras observed an object traveling from the External Tank that subsequently impacted the Solid Rocket Booster/External Tank Attachment ring (see Figure 6.1-4). After impact, the debris broke into multiple pieces that fell along the Solid Rocket Booster exhaust plume.¹⁵ Post-mission inspection of the Solid Rocket Booster confirmed damage to foam on the forward face of the External Tank Attachment ring. The impact was approximately 4 inches wide and 3 inches deep. Post-External Tank separation photography by the crew showed that a 4- by 5- by 12-inch (240 cubic-inch) corner section of the left bipod ramp was missing, which exposed the super lightweight ablator coating on the bipod housing. This missing chunk of foam was believed to be the debris that impacted the External Tank Attachment ring during ascent. The post-launch review of photos and video identified these debris events, but the Mission Evaluation Room logs and Mission Management Team minutes do not reflect any discussions of them.

Figure 6.1-4. On STS-112, the foam impacted the External Tank Attach ring on the Solid Rocket Booster, causing this tear in the insulation on the ring.

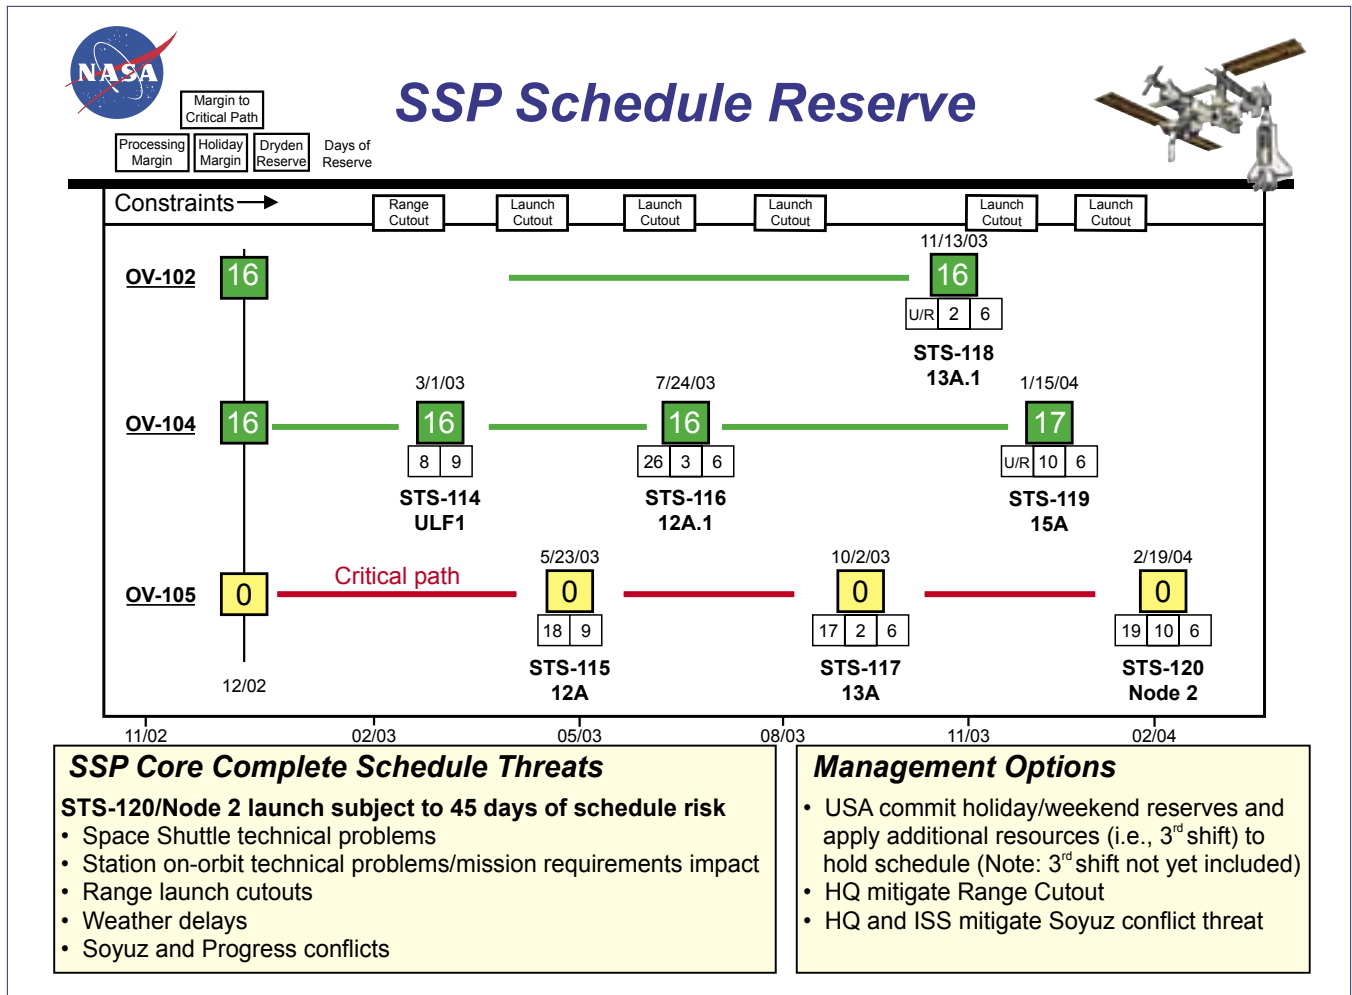
Figure 6.2-5 shows the margin for each vehicle (*Discovery*, OV-103, was in extended maintenance). The large boxes indicate the “margin to critical path” (to Node 2 launch date). The three smaller boxes underneath indicate (from

Figure 6.2-5. This slide shows the margin for each Orbiter. The large boxes show the number of days margin to the Node 2 launch date, while the three smaller boxes indicate vehicle processing margin, holiday margin, and the margin if a Dryden landing was not required.

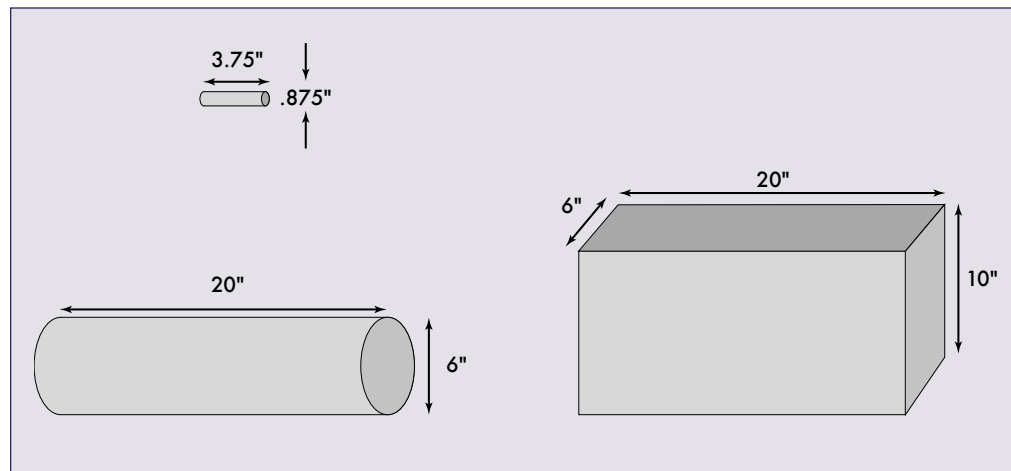
Until STS-107, Crater was normally used only to predict whether small debris, usually ice on the External Tank, would pose a threat to the Orbiter during launch. The use of Crater to assess the damage caused by foam during the launch of STS-107 was the first use of the model while a mission was on orbit. Also of note is that engineers used Crater during STS-107 to analyze a piece of debris that was at maximum 640 times larger in volume than the pieces of debris used to calibrate and validate the Crater model (the Board’s best estimate is that it actually was 400 times larger). Therefore, the use of Crater in this new and very different situation compromised NASA’s ability to accurately predict debris damage in ways that Debris Assessment Team engineers did not fully comprehend (see Figure 6.3-1).

Figure 6.3-1. The small cylinder at top illustrates the size of debris Crater was intended to analyze. The larger cylinder was used for the STS-107 analysis; the block at right is the estimated size of the foam.

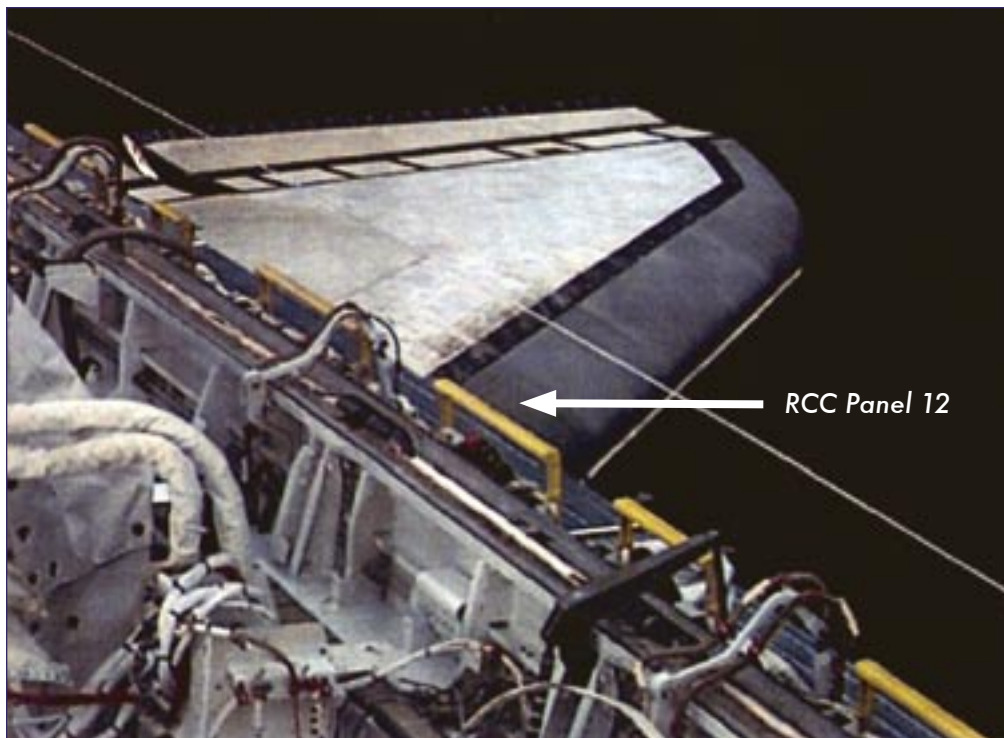
This photo from the aft flight deck window of an Orbiter shows that RCC panels 1 – 11 are not visible from inside the Orbiter. Since Columbia did not have a manipulator arm for STS-107, it would have been necessary for an astronaut to take a spacewalk to visibly inspect the inboard leading edge of the wing.

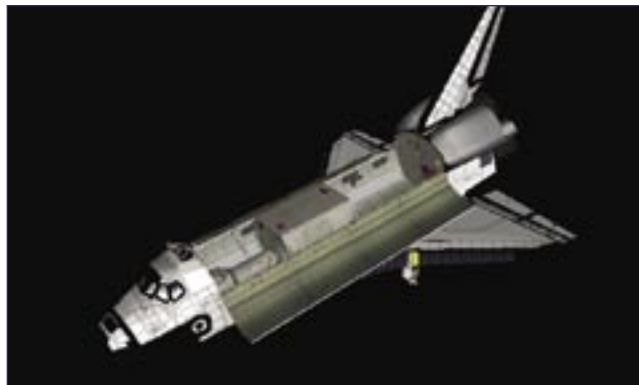
Figure 6.4-1. The speculative repair option would have sent astronauts hanging over the payload bay door to reach the left wing RCC panels using a ladder scavenged from the crew module.

The repair option (see Figure 6.4-1), while logistically viable using existing materials onboard *Columbia*, relied on so many uncertainties that NASA rated this option "high risk." To complete a repair, the crew would perform a spacewalk to fill an assumed 6-inch hole in an RCC panel with heavy metal tools, small pieces of titanium, or other metal scavenged from the crew cabin. These heavy metals, which would help protect the wing structure, would be held in place during

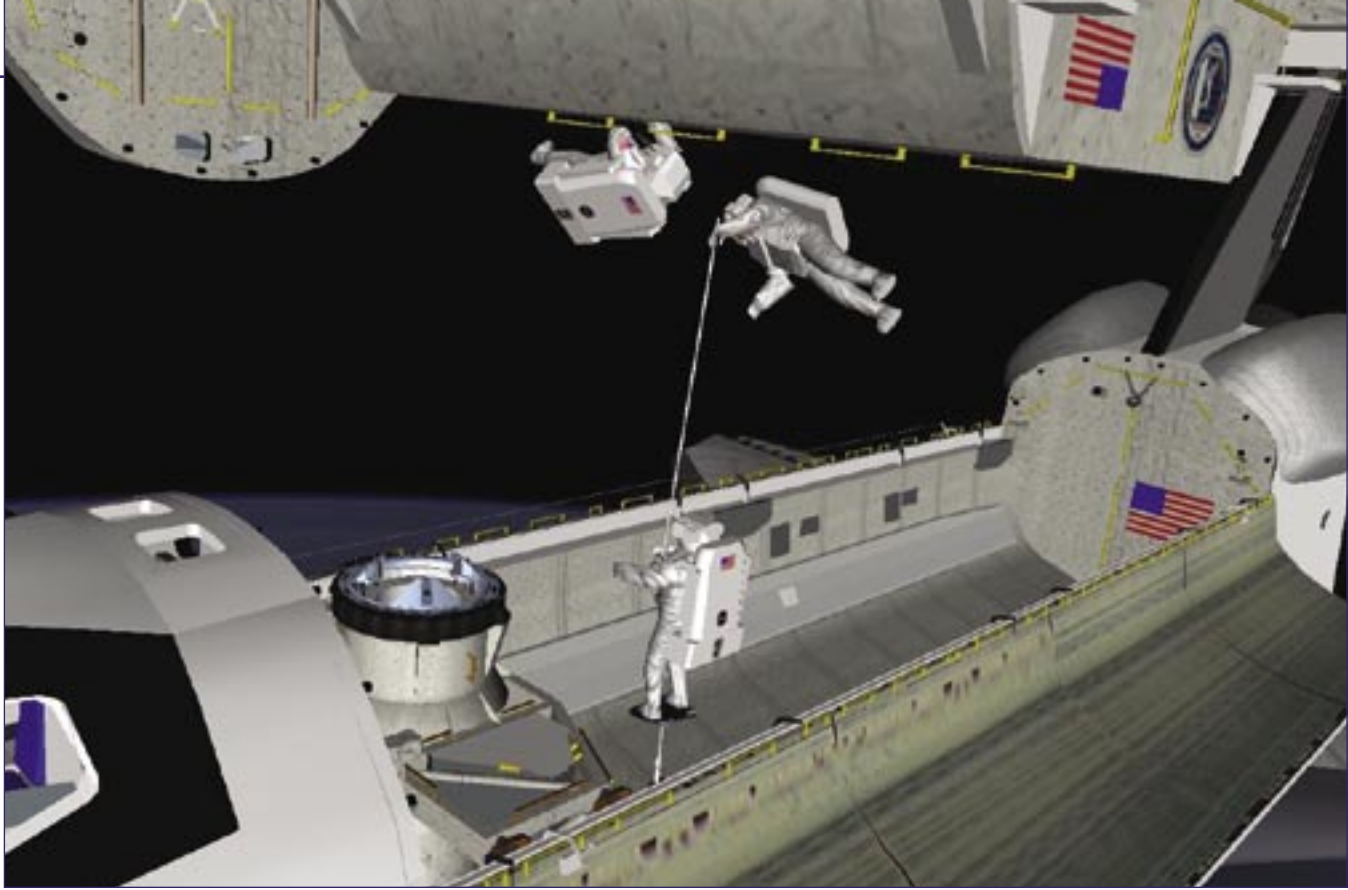
Figure 6.4-2. The rescue option had Atlantis (lower vehicle) rendezvousing with Columbia and the STS-107 crew transferring via ropes. Note that the payload bay of Atlantis is empty except for the external airlock/docking adapter.

er, pilot, and two astronauts trained for spacewalks. In January, seven commanders, seven pilots, and nine spacewalk-trained astronauts were available. During the rendezvous on Atlantis's first day in orbit, the two Orbiters would maneuver to face each other with their payload bay doors open (see Figure 6.4-2). Suited Columbia crew members would then be transferred to Atlantis via spacewalks. Atlantis would return with four crew members on the flight deck and seven in the mid-deck. Mission Control would then configure Columbia for a de-orbit burn that would ditch the Orbiter in the Pacific Ocean, or would have the Columbia crew take it to a higher orbit for a possible subsequent repair mission if more thorough repairs could be developed.

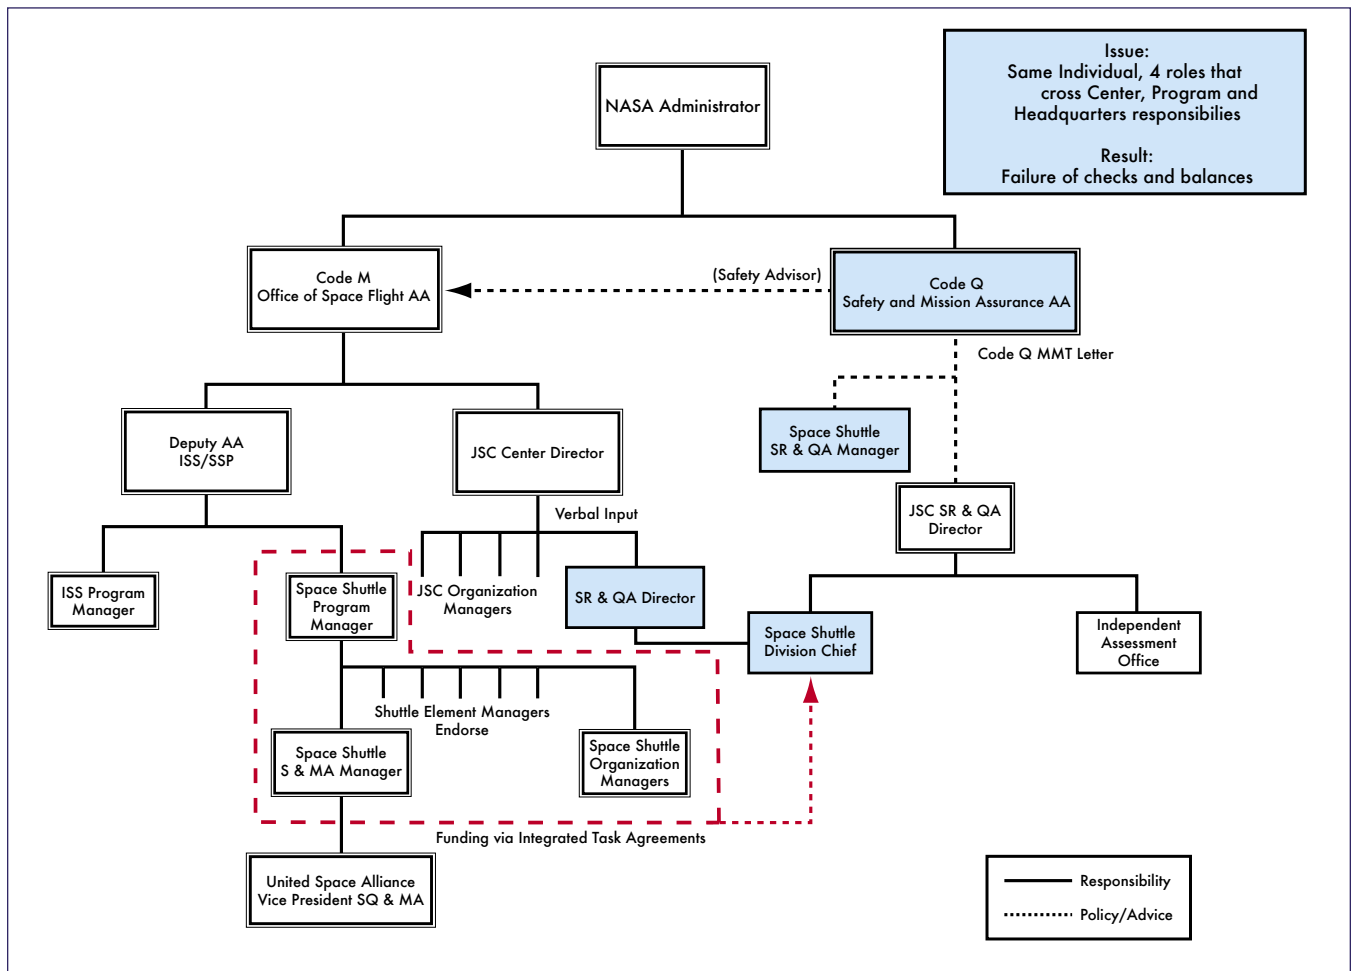
Figure 7.4-1. Independent safety checks and balance failure.

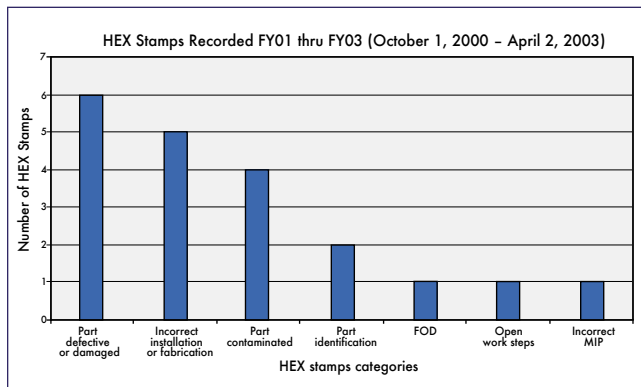
Of the 141,127 inspections subject to rejection from October 2000 through March 2003, only 20 rejections, or "hexes," were recorded, resulting in a statistically improbable discrepancy rate of .014 percent (see Figure 10.4-4). In interviews, technicians and inspectors alike confirmed the dubiousness of this rate. NASA's published rejection rate therefore indicates either inadequate documentation or an underused system. Testimony further revealed incidents of quality assurance inspectors being played against each other to accept work that had originally been refused.

Figure 10.4-4. Rejection, or "Hex" stamps issued from October 2000 through April 2003.
