Report of a Level 3 (formal) Investigation

Network Rail

Margam East Junction, South Wales: Death of two track workers who were struck by a
Swansea to London Paddington train: 3 July 2019

SMIS2317549

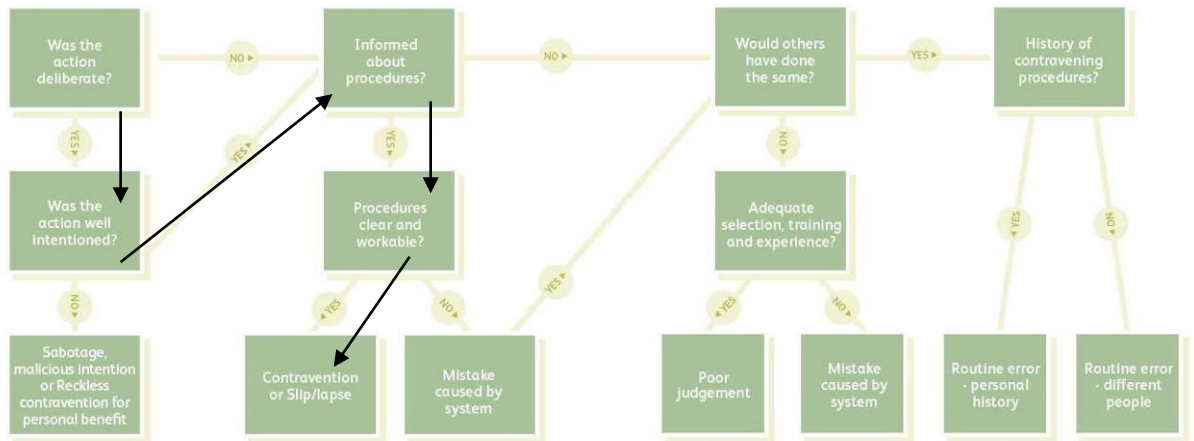
H1. Section Manager (Track)

Unsafe act:	The Section Manager (Track) did not adequately monitor and lead compliance checks within the depot.
--------------------	---

influenced his belief that his team were compliant enough. Evidence of SWPs checks by the SM seemed to focus on the completion of the form rather than compliance with 019 or the Rule Book. This probably led the SM to believe that by correcting these errors compliance was in place. With the Line Managers Self-Assurance Questionnaire being reported as 100% compliant and so failing to thoroughly verify the process against actual outputs meant that compliance with 019 and GE/RT9000 HB3&7 was allowed to deteriorate.
Foresight:		
Informed about procedures?	Yes	The SM was aware of what responsibility his role carried and the various processes that should be followed.
Procedures clear and workable?	Yes	The procedures within NR/L2/OHS/019 are clear as to how the plan and SWP should be developed. These processes were not being applied fully and had become an accepted way of working. Routine work was not documented because it was something that should be done anyway, and in turn other work was not documented because it evolved from unforeseen maintenance or equipment failures. The SWP contained work such as vegetation clearance which in the event was not done, though did <u>not</u> contain nut running or IRJ inspection and repairs. These discrepancies should have been identified and highlighted in the SM's Self-Assurance checks.

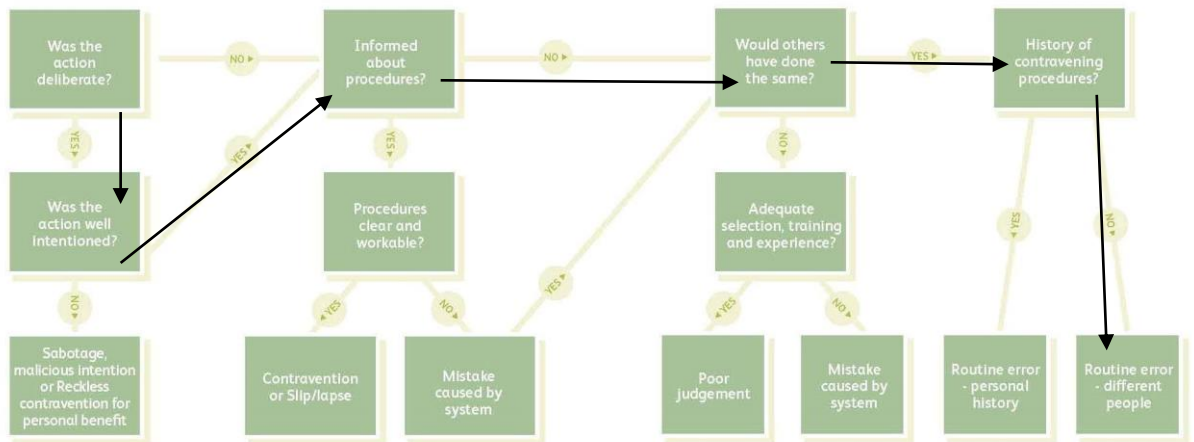
H2. Section Supervisor 1

Unsafe act:	Section Supervisor 1 did not carry out his duties as a 'responsible manager' correctly and had authorised (signed) the SWP as the 'responsible manager' without fully checking the content and before the PIC had verified the pack. The SWP was not fit for purpose.
--------------------	---

Y/N	Rationale
Deliberate harm: Routine error different people		
Was the action deliberate?	Yes	The section supervisor (SS) had developed a system where he would sign the packs created by the planner almost as soon as they had been printed, this had become common practice and was based on his belief that the planners knew what they were doing.
Was the action well intentioned?	Yes	The SS had done this to save time and provide a pack that allowed the teams to work both red and green zone and with generic information that allowed a degree of flexibility in the work planned and the actual work to be completed. This was evidenced from the existence of a handwritten note that detailed work to be completed, with additional tasks. Had the SS fully understood the requirements of 019 and his responsibility as a 'responsible manager' he may have read the pack more thoroughly and considered the work at the point of him receiving it. He may also have involved the PIC to verify the pack before authorising it. The actions of the SS were not unique to this particular date and had become a way of working that up to the date of the incident had given only positive results and become an accepted practice within the depot. This had not been picked up through self-assurance or from FAP/Internal audits.

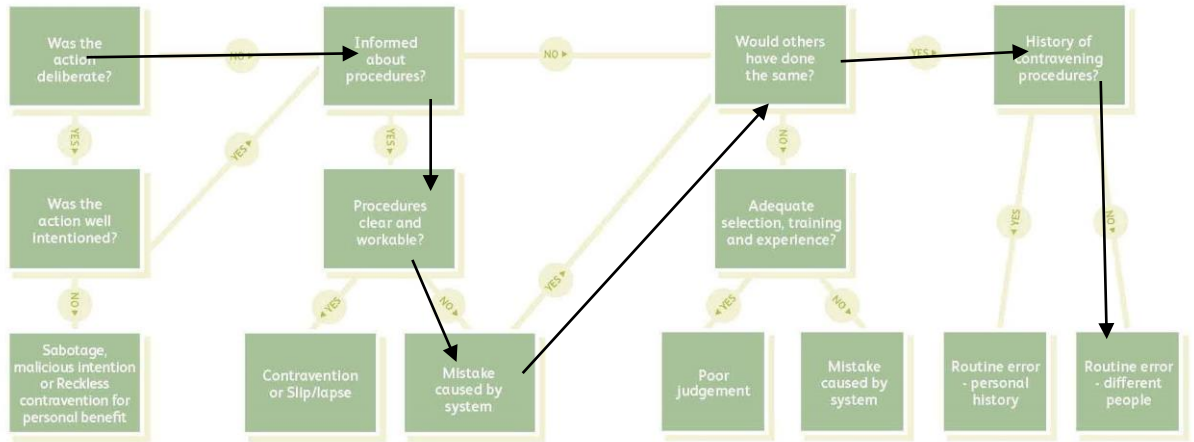
H3. Technician 1

Unsafe act:	Technician 1 did not challenge the instruction given by the unofficial PIC to restart work on an open line without adequate protection
--------------------	--

Y/N	Rationale
Deliberate harm: Routine error different people		
Was the action deliberate?	No	<p>Technician 1 was an experienced railway technician but considered himself quite junior in light of the “older guys” he worked with.</p> <p>Technician 1 described these relationships as being like “father figures” whom he looked up to and wanted to please. His understanding of the intention at the time, was to finish the last remaining bolt before having a tea break with the rest of the team.</p> <p>The investigation team agreed that Technician 1, did not think or consciously consider that this was putting himself - and the team were putting themselves in danger.</p> <p>The investigation team believed Technician 1 would have done what he was asked because of the ways of working that he had become so accustomed to. He trusted the decisions made by his peers and whilst all those involved knew working on the railway had risk associated they had become so familiar with the location that their risk perception was much lower.</p>

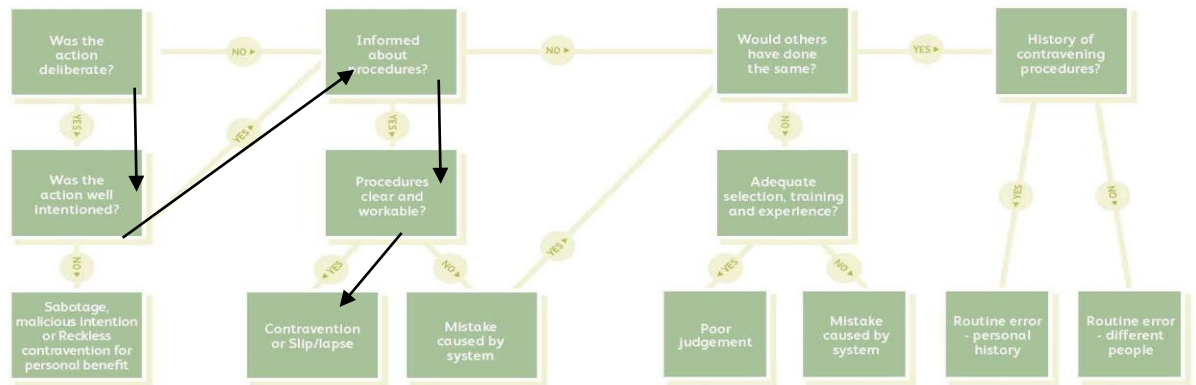
H4. Technician 2

Unsafe act:	Team Leader decided not to work at Margam East Junction as intended by Section Supervisor
--------------------	---

Y/N	Rationale
Deliberate harm: Contravention		
Was the action deliberate?	Yes	The TL was intended to be the PIC, (albeit they had not verified the pack as the PIC this was done by the other TL the previous day) and be part of the team of seven at Margam East that morning. However, the TL decided that they would go to Diesel depot instead and work 'on the tools' as an extra pair of hands. This was done without the agreement of SS1 who believed the TL had gone to his intended site.
Was the action well intended?	Yes	The TL had thought he could provide an additional pair of hands at the other site where the work was more involved. Had the TL fully understood the work and reviewed the pack for Margam East he may have realised that he was in fact needed. And his attendance would have given the COSS a sufficient number of staff to work in that location with only red zone protection. He would also have assumed the role of PIC instead of delegating this to a technician.

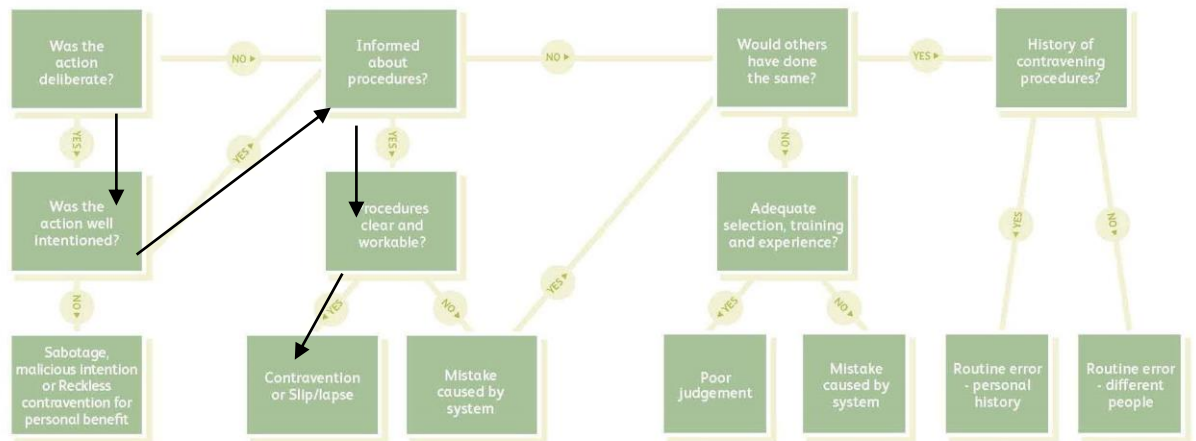
H5. The COSS

Unsafe act:	The COSS did not deploy the distant lookout as he intended.
--------------------	---

Y/N	Rationale
Deliberate harm: Contravention		
Was the action deliberate?	Yes	The COSS had completed the paperwork and had intended to use a site and distant lookout, both of which had been appointed and signed the Safe Work Pack (SWP)
Was the action well intended	Yes	. The COSS had intended to deploy a distant lookout and had asked a member of the team to "run him round" to the access point however uncorroborated witness evidence suggests that the unofficial PIC is understood to have said the distant lookout wasn't needed. The COSS being quite mild in his character may have been influenced by the unofficial PIC and so tested and agreed to using only one site lookout. This was probably also influenced by the relatively easy tasks, familiarity with one another and their perception of risk.
Foresight:		
Informed about procedures?	Yes	The COSS knew about the 019 standard, the rule book and the requirements of a COSS.

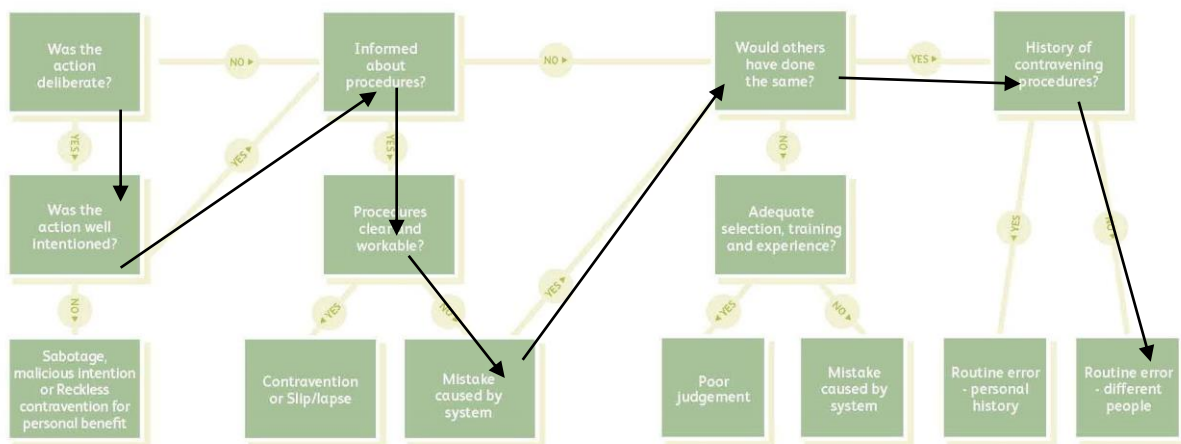
H6. The COSS

Unsafe act:	The COSS allowed the group of six to split into smaller sub groups who became separated by distance.
--------------------	--

Y/N	Rationale
Deliberate harm: Routine error different people		
Was the action deliberate?	Yes	The COSS was used to larger work groups splitting or being split into smaller sub groups and so splitting the jobs had become a normal practice when larger groups were working together and completing several smaller jobs/tasks
Was the action well intentioned?	Yes	The COSS had been appointed on the morning of the shift and had received a SWP which gave generic tasks to be completed along with an additional handwritten note from Supervisor 1, information from my work APP and verbal communication from the unofficial PIC as to what work was being carried out. The COSS was taking work direction from the unofficial PIC regarding the work and agreed the protection arrangements with the unofficial PIC who was also acting as Team Leader. Witness evidence suggested that when larger groups were working together it was not unusual for them to split up and this way of working appeared to have become customary and served the purpose of getting the work done

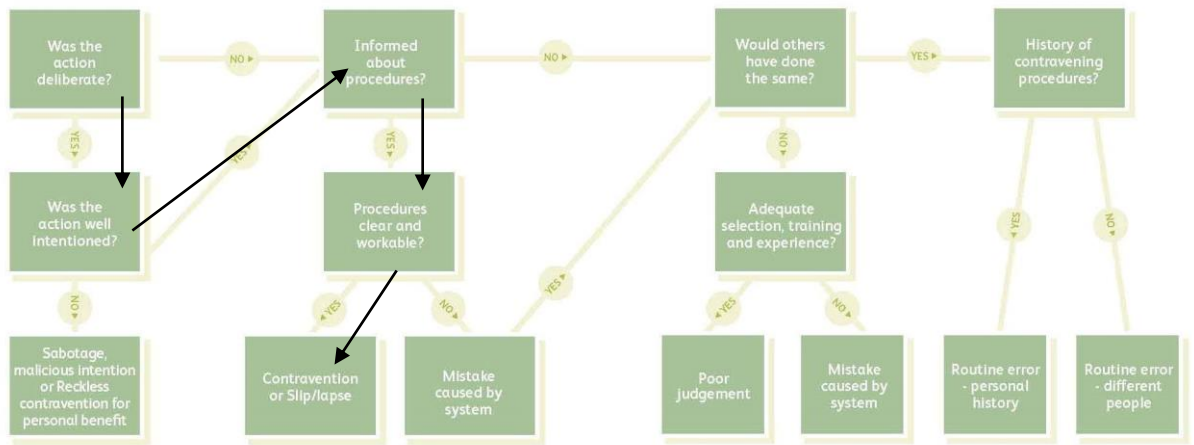
H7. Technician 1, 3, 4

Unsafe act:	None of the team on the day at Margam East Junction challenged any unsafe practices.
--------------------	--

Y/N	Rationale
Deliberate harm: Contravention		
Was the action deliberate?	No	The investigation team concluded that the team on the day would not have raised unsafe working practices that were occurring. This was due to these working methods being so ingrained within this depot
Foresight:		
Informed about procedures?	Yes	The group of six were used to working with one another and had worked together in the depot for many years. Witness evidence and CCTV footage on the day would suggest that the ways of working had not been isolated to July 3rd and had been custom and practice for a significant period.
Procedures clear and workable?	Yes	The work safe procedure is very clear and would have understood by all the team.
