**NYC Department of Education  
Building Condition Assessment Survey 2023-2024**

**Architectural Inspection**

**M132**

**Asset:** P.S. 132 - MANHATTAN, 185 WADSWORTH AVENUE, MANHATTAN, NY, 10033

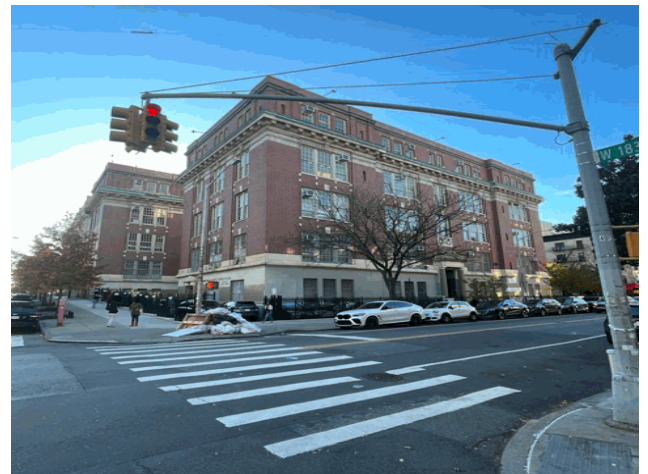
Weather	Fair
Facade Photo

Corner of West 183rd Street and Wordsworth Avenue - South View

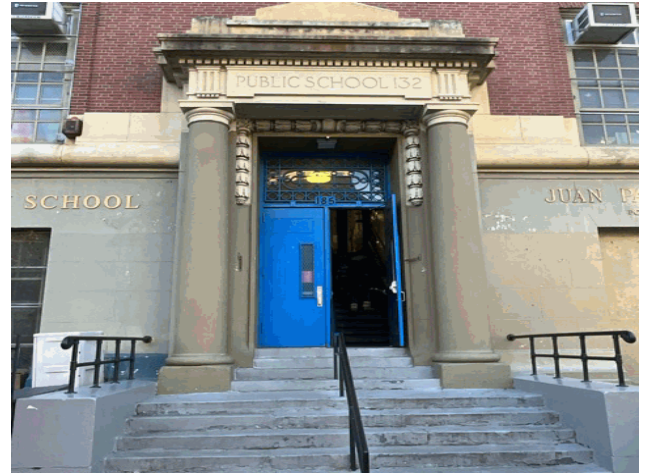
Main Entrance Photo

Facade A - Wordsworth Avenue

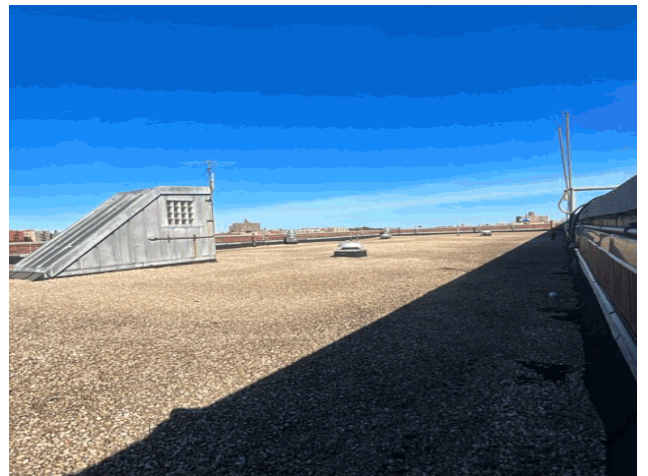
Roof Photo

Roof 5 - Northeast View
