**NYC Department of Education
Building Condition Assessment Survey 2023-2024**

Architectural Inspection

M451

Asset: LIBERTY HS - MANHATTAN, 250 WEST 18 STREET, MANHATTAN, NY, 10011

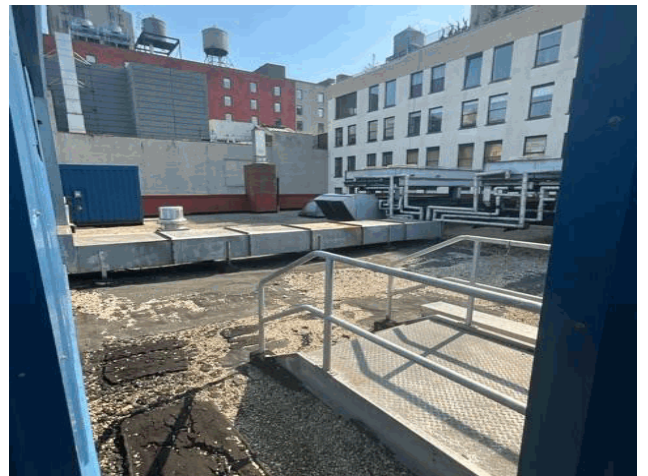
Roof Photo

Roof 1 - South View

Roof 1
Instance Condition	3- Fair
Instance Quantity	6,000
Instance Quantity Uom	S.F.
Does the roof have major mechanical equipment sitting on Dunnage Steel less than 18" above the Roofing?	No
Does this Roof Instance have a Sustainable Roof System?	No
Do solar panels exist on these roofs?	No
Is/Are the roof(s) suitable for Solar Panel installation?	No

Installation Year	1997
Source of Installation Year	Custodial Staff
Deficiency	BUILT-UP:ROOFING:LOSS OF GRAVEL
Deficiency Location/Instance
