**NYC Department of Education
Building Condition Assessment Survey 2023-2024**

Architectural Inspection

M807

Asset: HARVEY MILK SCHOOL - MANHATTAN, 2-10 ASTOR PLACE, MANHATTAN, NY, 10003

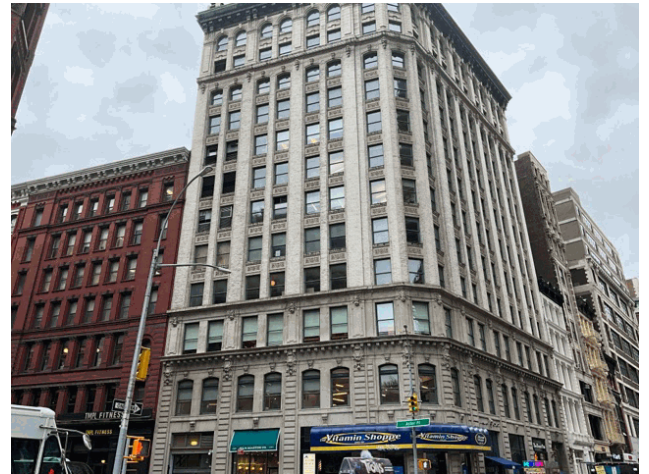
| Question | Answer |
|--|---|
| Facade Photo | |

Corner of Astor Place and Broadway

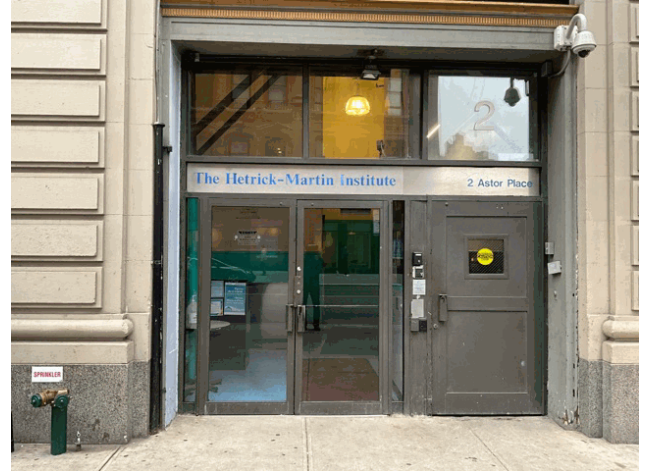
Main Entrance Photo

Facade A - Astor Place
