**NYC Department of Education
Building Condition Assessment Survey 2023-2024**

Architectural Inspection

M837

Asset: WEST END SECONDARY SCHOOL - MANHATTAN, 227-243 WEST 61 STREET, MANHATTAN, NY, 10023

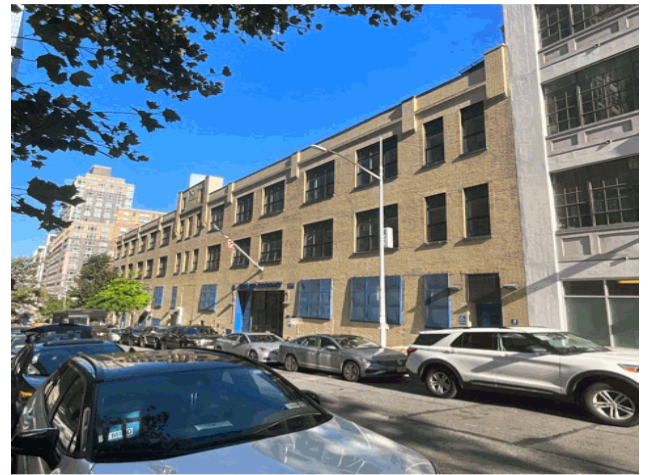
61st Street - Northwest View
