**NYC Department of Education  
Building Condition Assessment Survey 2023-2024**

**Architectural Inspection**

**M895**

**Asset: YOUNG WOMEN'S LEADERSHIP HS - MANHATTAN, 105 EAST 106 STREET, MANHATTAN, NY, 10029**

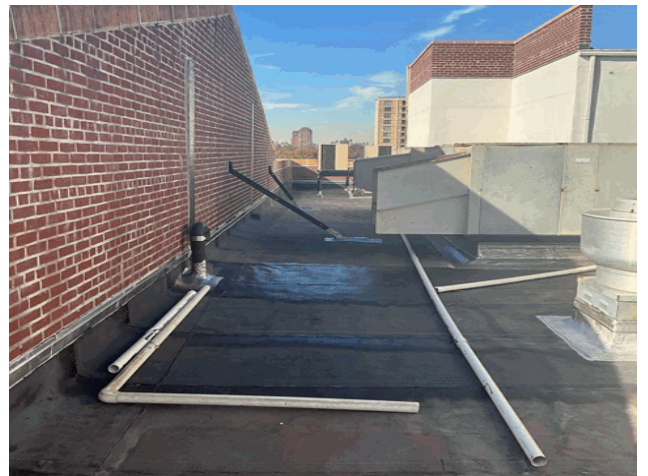
Roof Photo

Roof 1 - West View

Roof 1
Instance Condition	3- Fair
Instance Quantity	8,000
Instance Quantity Uom	S.F.
Does the roof have major mechanical equipment sitting on Dunnage Steel less than 18" above the Roofing?	No
Does this Roof Instance have a Sustainable Roof System?	No
Do solar panels exist on these roofs?	No

Is/Are the roof(s) suitable for Solar Panel installation?	No
Installation Year	1996
Source of Installation Year	Inspector Estimate
Deficiency	MODIFIED BITUMEN:ROOFING:DELAMINATION
Deficiency Location/Instance
