**NYC Department of Education
Building Condition Assessment Survey 2023-2024**

Architectural Inspection

Asset: P.S. 32 - STATEN ISLAND, 232 BARLOW AVENUE, STATEN ISLAND, NY, 10308

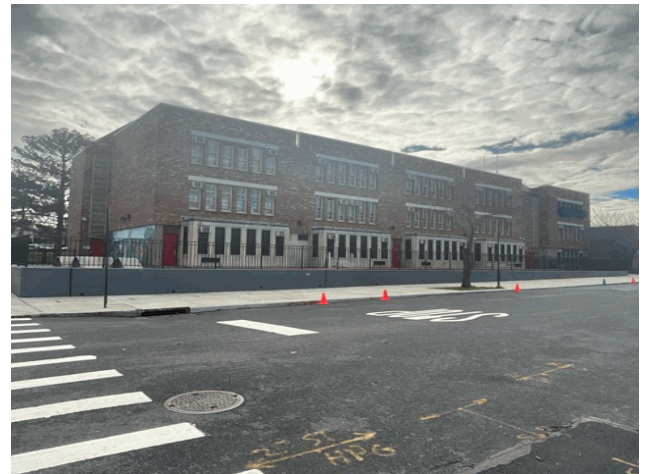
Comments on the Number of Classrooms	40
Weather	Fair
Facade Photo

Corner of Barlow Avenue and Elverton Avenue - East View

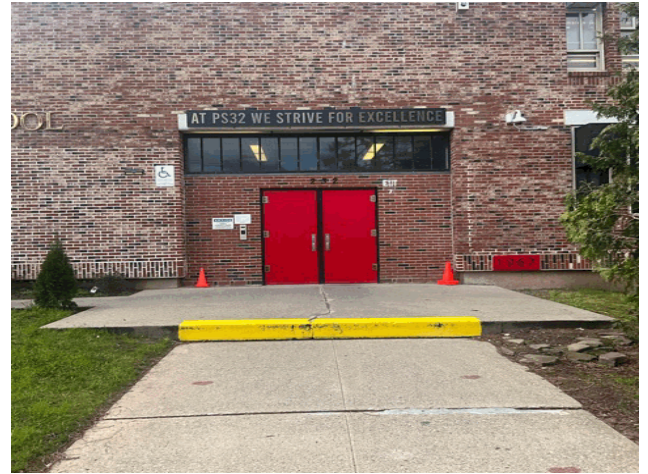
Main Entrance Photo

Facade A - Barlow Avenue

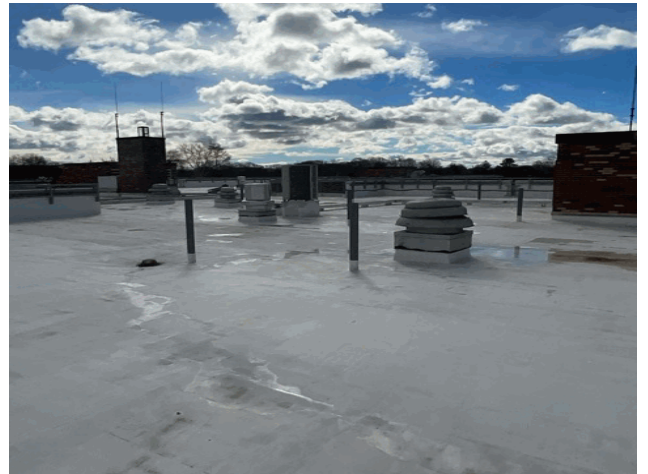
Roof Photo

Roof 1 - East View

Systems: Exterior Wall repointing; New roofing installation at Roofs 1 and 2; Bulkhead repair.
