**NYC Department of Education
Building Condition Assessment Survey 2023-2024**

Architectural Inspection

R091

Asset: THE RICHMOND PRE-K CENTER @ 20 EBBITTS STREET - STATEN ISLAND, 20 EBBITTS STREET, STATEN ISLAND, NY, 10306

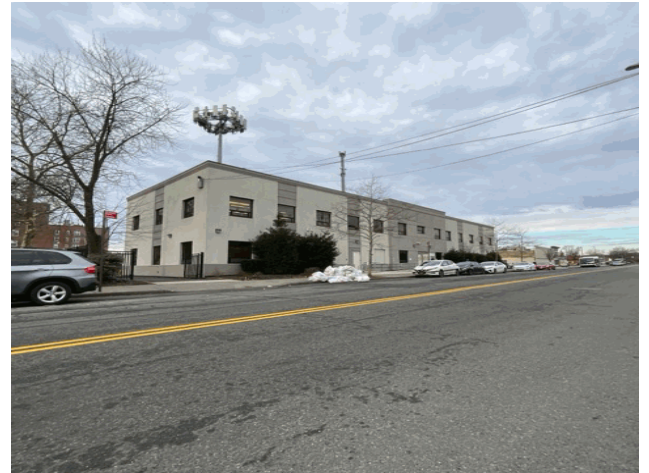
Question	Answer
Was the Building Fully Accessible for Inspection?	Yes
Principal(s) Information	
Principal Name	Dr. Joy Abrams
Principal Organization	The Richmond Pre-K Center - Staten Island
Meeting with Principal?	No
Principal Feedback	The Principal returned the questionnaire with no comments or concerns regarding the condition of the asset.
Custodian	Thomas Maddocks
Was the Custodian Present?	Yes
Fireman	Vincent Niemiec
Was the Fireman Present?	Yes
Building Square Footage	16,000
Comments on the Area (for Athletic Field, Playing Surfaces, Leased Spaces)	None
Comments on the Stories (Floors) plus Basements	2 (No Basement)
Comments on the Year Built	1968
Student Population	107
Staff Population	25
Comments on the Number of Classrooms	7
Weather	Fair
Facade Photo

Ebbitts Street - West View

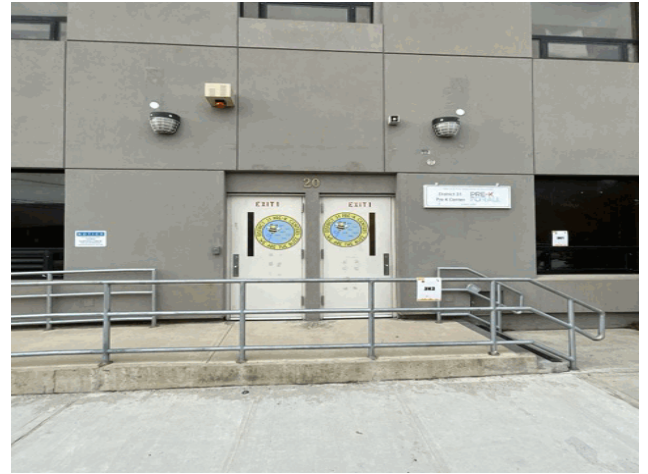
Main Entrance Photo

Facade A - Ebbits Street

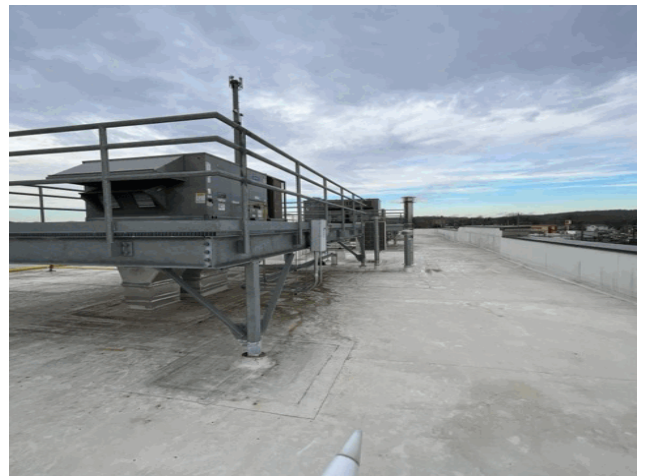
Roof 1 - West View

Question	Response
EXTERIOR	
ROOF	
ROOFING	
ROOFING	
Replacement Quantity	7,500
Replacement Uom	S.F.
Instance on Single Ply, Fully Adhered Roof:Roof 1	Inspected
Instance Roof Photo

Roof 1
Instance Condition	1- Good
Instance Quantity	7,500
Instance Quantity Uom	S.F.
Does the roof have major mechanical equipment sitting on Dunnage Steel less than 18" above the Roofing?	No
Does this Roof Instance have a Sustainable Roof System?	Yes
Sustainable Roof System Type	White Roof
Sustainable Roof System Location (Roof Number)	Roof 1
Do solar panels exist on these roofs?	No
Is/Are the roof(s) suitable for Solar Panel installation?	Yes
Installation Year	2019
Source of Installation Year	Documented
Deficiency	No deficiencies recorded
ROOFING DRAINS	Inspected
Condition	1- Good
Deficiency	No deficiencies recorded
SPECIALTIES	Inspected
BULKHEAD/PENTHOUSE	Does not exist
CUPOLA/ SPIRES/ TOWERS	Does not exist
DORMER	Does not exist
DUNNAGE STEEL	Inspected
