**NYC Department of Education
Building Condition Assessment Survey 2023-2024**

Architectural Inspection

R453

Asset: CURTIS HIGH SCHOOL ANNEX - STATEN ISLAND, 105B HAMILTON AVENUE, STATEN ISLAND, NY, 10301

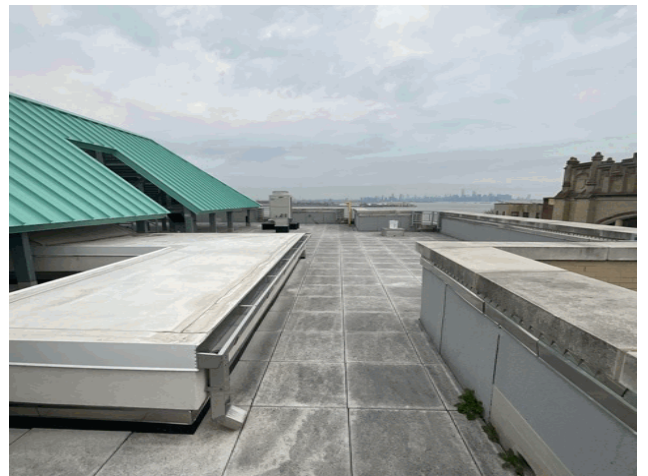
Roof 1 - North View

Question	Response
EXTERIOR	
ROOF	
ROOFING	
LEADERS, GUTTERS, DOWNSPOUTS, SCUPPERS	Inspected
Condition	2- Between Good and Fair
Deficiency	No deficiencies recorded
ROOF BARRIER/FENCE	Does not exist
ROOF CAGE	Does not exist
ROOFING	Inspected
Replacement Quantity	10,000
Replacement Uom	S.F.
Instance on IRMA:All Roofs	Inspected
Instance Roof Photo	 
	Roof 1
Instance Condition	1- Good
Instance Quantity	10,000
Instance Quantity Uom	S.F.
Does the roof have major mechanical equipment sitting on Dunnage Steel less than 18" above the Roofing?	No
Does this Roof Instance have a Sustainable Roof System?	No
Do solar panels exist on these roofs?	No
Is/Are the roof(s) suitable for Solar Panel installation?	No
Installation Year	2017
Source of Installation Year	Documented
Deficiency	No deficiencies recorded
ROOFING DRAINS	Inspected
Condition	2- Between Good and Fair
Deficiency	No deficiencies recorded
SPECIALTIES	Inspected
BULKHEAD/PENTHOUSE	Inspected
