**NYC Department of Education  
Building Condition Assessment Survey 2023-2024**

**Architectural Inspection**

**Asset: P.S. 74 - STATEN ISLAND, 211 DANIEL LOW TERRACE, STATEN ISLAND, NY, 10301**

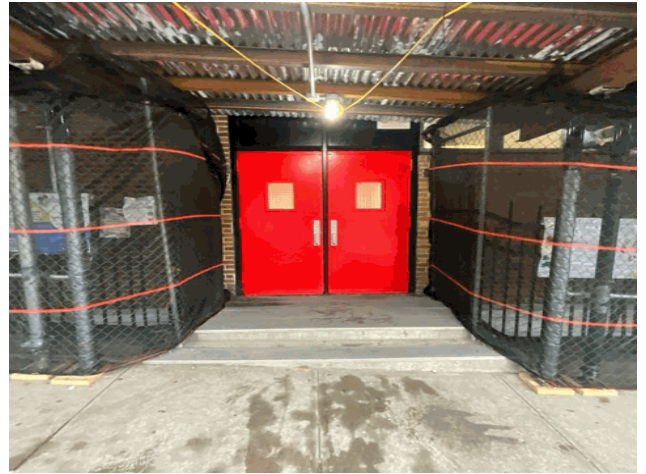
Facade A - Daniel Low Terrace

Main Entrance Photo

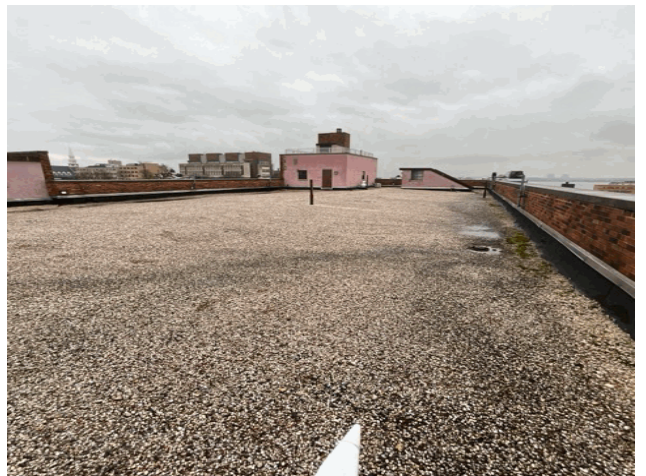
Roof 1 - North View

Roof Photo

Replacement Quantity	9,000
Replacement Uom	S.F.
Instance on Built-Up:All Roofs	Inspected
Instance Roof Photo	 
Instance Condition	Roof 1 3- Fair
Instance Quantity	9,000
Instance Quantity Uom	S.F.
Does the roof have major mechanical equipment sitting on Dunnage Steel less than 18" above the Roofing?	No
Does this Roof Instance have a Sustainable Roof System?	No
