**NYC Department of Education
Building Condition Assessment Survey 2023-2024**

Architectural Inspection

X008

Asset: P.S. 8 - BRONX, 3010 BRIGGS AVENUE, BRONX, NY, 10458

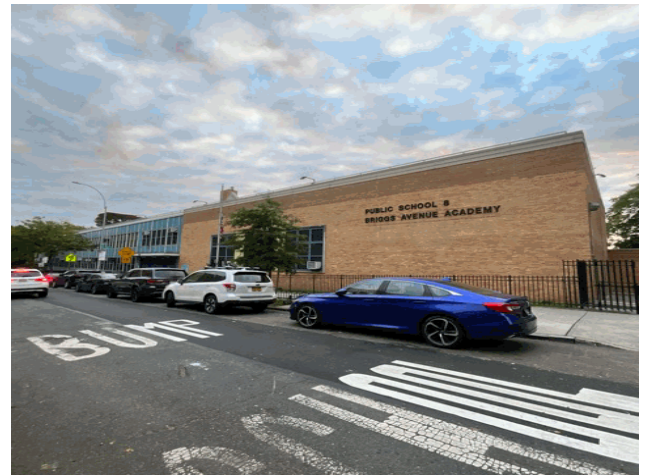
Briggs Avenue - West View

Question	Answer
Was the Building Fully Accessible for Inspection?	Yes
Principal(s) Information	
Principal Name	Claudia TahirajSadrija
Principal Organization	P.S. 8 - Bronx
Meeting with Principal?	Yes
Principal Feedback	The Principal had the following comment: The PA system is always malfunctioning and this poses a safety risk to the entire school community and needs to be addressed.
Custodian	Miguel Crespo
Was the Custodian Present?	Yes
Fireman	Vincent Precelli
Was the Fireman Present?	Yes
Building Square Footage	79,000
Comments on the Area (for Athletic Field, Playing Surfaces, Leased Spaces)	None
Comments on the Stories (Floors) plus Basements	3+B
Comments on the Year Built	1958
Student Population	552
Staff Population	107
Comments on the Number of Classrooms	29
Weather	Fair
Facade Photo

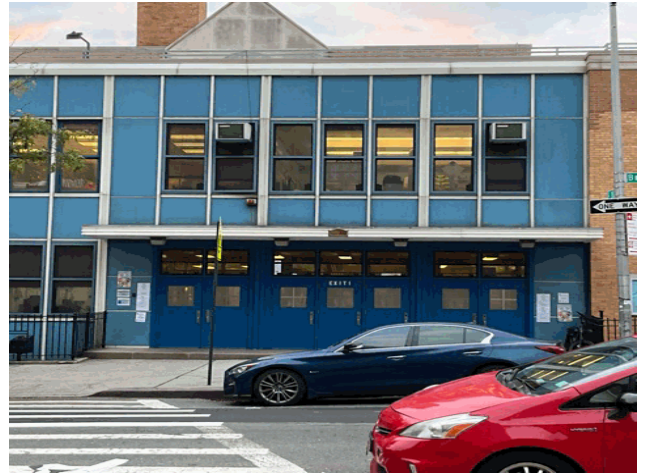
Facade A - Briggs Avenue

Main Entrance Photo

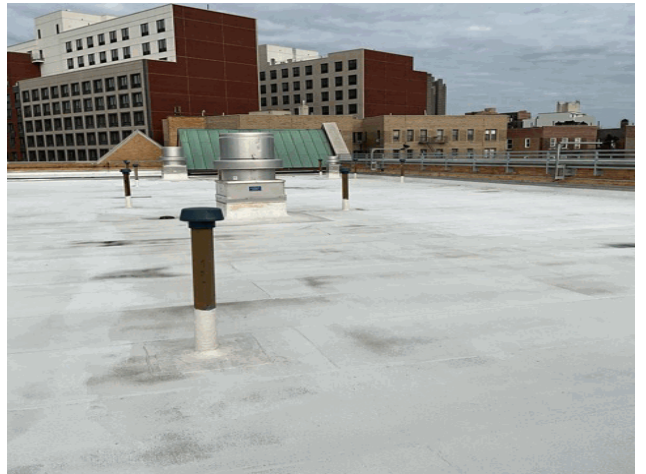
Roof 3 - Northwest View

Roof Photo

Systems: New windows at 3rd Floor, Stairwells and Gymnasium.
Complete Roofing replacement. New Parapets, Roof
Drains and Coping. Bulkhead repair.
