**NYC Department of Education  
Building Condition Assessment Survey 2023-2024**

**Architectural Inspection**

**X015**

**Asset:** P.S. 15 - BRONX, 2195 ANDREWS AVENUE, BRONX, NY, 10453

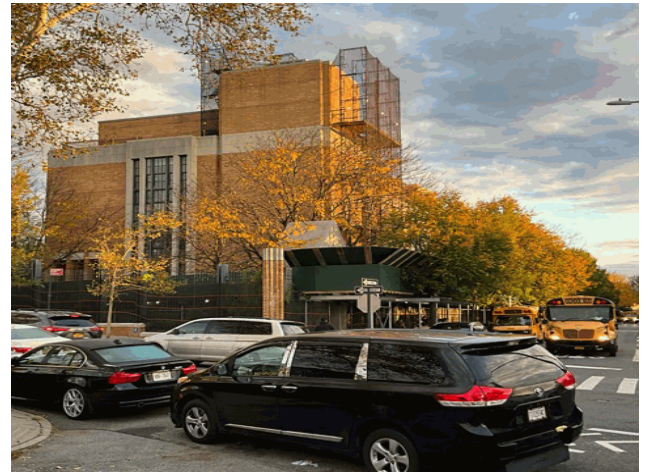
Comments on the Stories (Floors) plus Basements	4+B+PH
Comments on the Year Built	1995
Student Population	864
Staff Population	140
Comments on the Number of Classrooms	69
Weather	Fair
Facade Photo

Corner of Andrews Avenue and Hall of Fame Place - North View

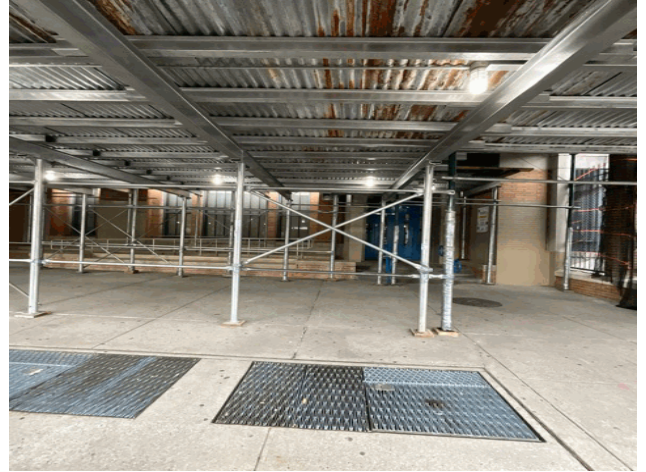
Main Entrance Photo

Facade A - Andrews Avenue

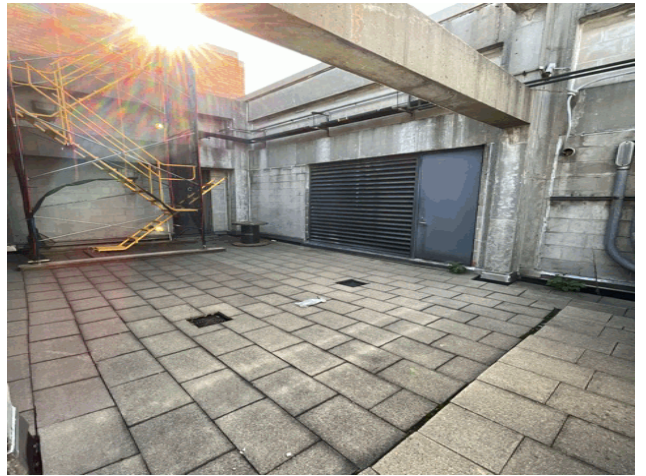
Roof 16 - West View

Question	Response
<b>EXTERIOR</b>	
<b>ROOF</b>	
<b>ROOFING</b>	
<b>ROOFING</b>	
Instance Roof Photo	 
	Roof 16
Instance Quantity	30,000
Instance Quantity Uom	S.F.
Instance on Modified Bitumen:Roofs 5 and 13	Under construction
Instance Roof Photo	 
	Roof 13
Instance Quantity	4,000
Instance Quantity Uom	S.F.
Deficiency	MODIFIED BITUMEN:ROOFING:BEYOND USEFUL LIFE
Deficiency Location/Instance	Modified Bitumen:Roofs 5 and 13
Deficiency Quantity	4,000
Quantity Uom	S.F.
Potential Action	REPLACE
Urgency of Action	PRIORITY 1
Purpose of Action	LEVEL 2
Deficiency Photo 2	No photo recorded
Violations	No violations recorded
<b>ROOFING DRAINS</b>	Under construction
<b>SPECIALTIES</b>	Inspected
<b>BULKHEAD/PENTHOUSE</b>	Inspected
Condition	3- Fair
Deficiency	BULKHEAD/PENTHOUSE WALLS/INTERIOR:CMU DETERIORATED JOINTS
Deficiency Location/Instance	X015  
Deficiency Quantity	25
Quantity Uom	S.F.
Potential Action	REPOINT
Urgency of Action	PRIORITY 3
