**NYC Department of Education
Building Condition Assessment Survey 2023-2024**

Architectural Inspection

X055

Asset: P.S. 55 - BRONX, 450 ST PAULS PLACE, BRONX, NY, 10456

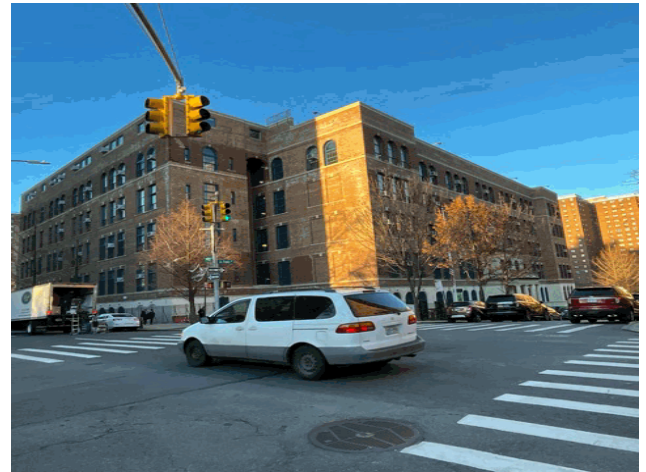
Comments on the Year Built	1916
Student Population	1200
Staff Population	130
Comments on the Number of Classrooms	55
Weather	Fair
Facade Photo

Corner of St Paul's Place and Washington Avenue - Southwest View

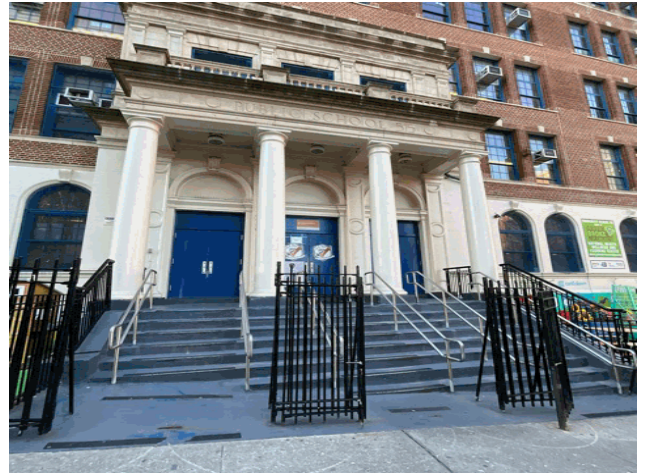
Main Entrance Photo

Facade A - St. Pauls Place
