**NYC Department of Education
Building Condition Assessment Survey 2023-2024**

Architectural Inspection

Asset: P.S. 67 - BRONX, 2024 MOHEGAN AVENUE, BRONX, NY, 10460

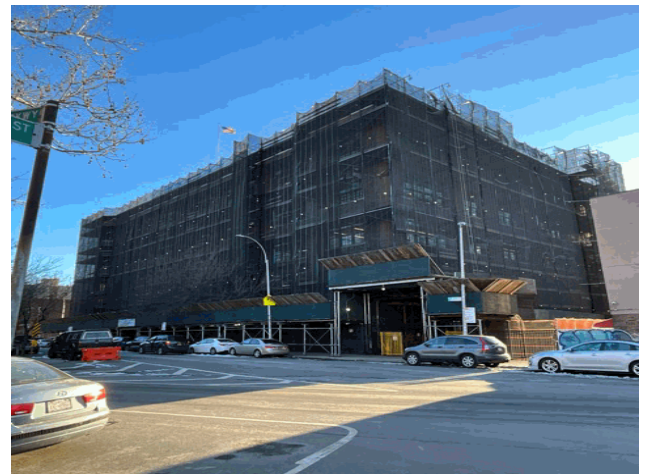
| Question | Answer |
|--|--|
| Facade Photo | |

Corner of Mohegan Avenue and East 178th Street - Northwest View

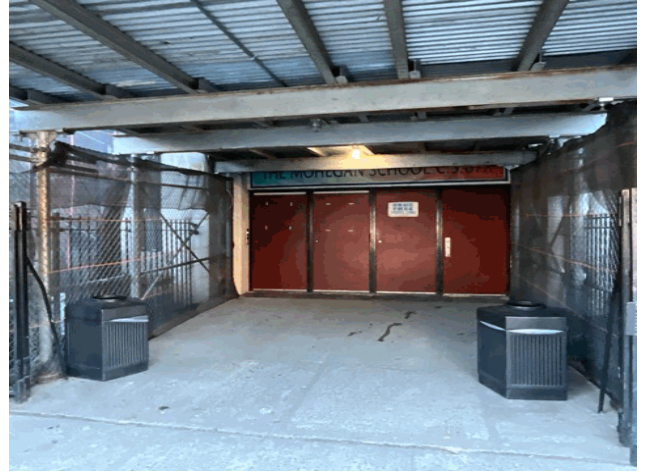
Main Entrance Photo

Facade A - Mohegan Avenue

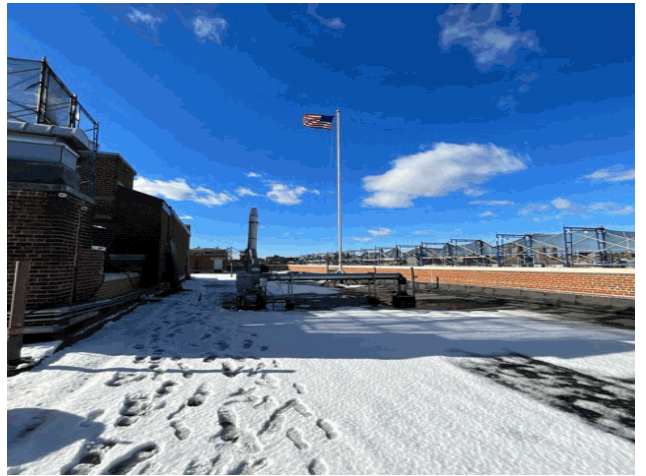
Roof Photo

Roof 1 - South View
