**NYC Department of Education
Building Condition Assessment Survey 2023-2024**

Architectural Inspection

X089

Asset: P.S. 89 - BRONX, 980 MACE AVENUE, BRONX, NY, 10469

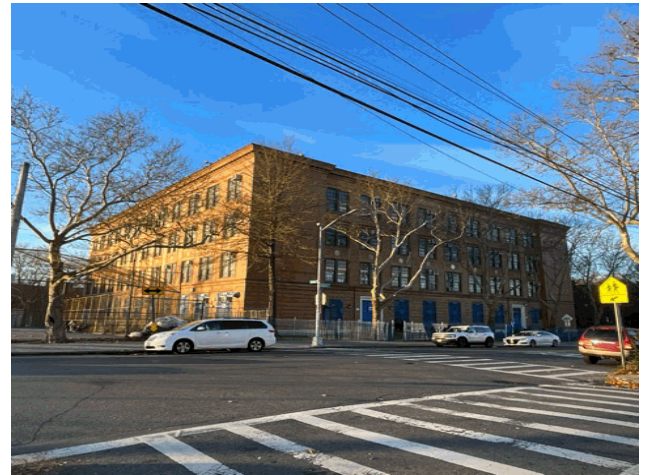
Question	Answer
Was the Building Fully Accessible for Inspection?	No
Inspection Inaccessible Comment	Areaways AW5 and AW6 (construction activity)
Principal(s) Information	
Principal Name	Ralph Martinez
Principal Organization	P.S. 89 - Bronx
Meeting with Principal?	No
Principal Feedback	The Principal had no comments about the condition of the building at this time.
Custodian	Norman Moncrieffe
Was the Custodian Present?	Yes
Fireman	John Plunkett
Was the Fireman Present?	Yes
Building Square Footage	98,000
Comments on the Area (for Athletic Field, Playing Surfaces, Leased Spaces)	Now
Comments on the Stories (Floors) plus Basements	4+B
Comments on the Year Built	1927
Student Population	993
Staff Population	143
Comments on the Number of Classrooms	69
Weather	Fair
Facade Photo

Corner of Mace Avenue and Willamsbridge Road - Northeast View

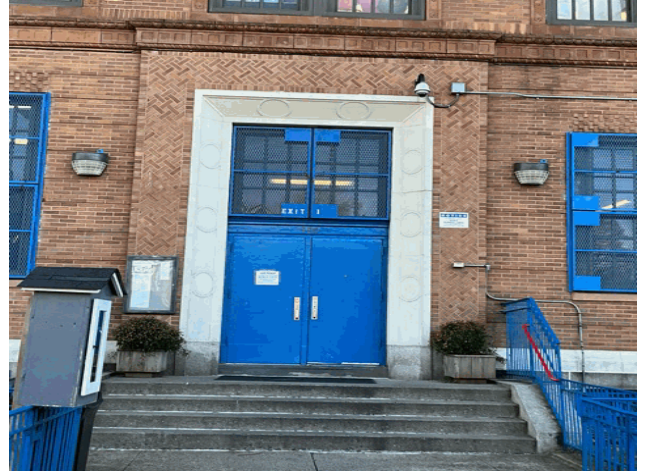
Main Entrance Photo

Facade A - Mace Avenue

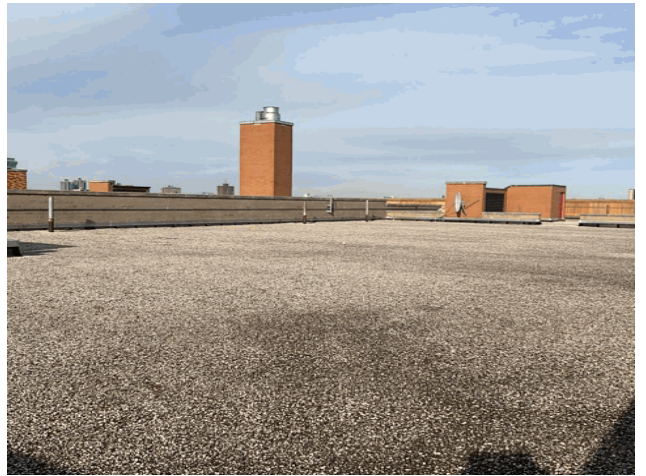
Roof Photo

Roof 1 - Northwest View

Systems: Complete roofing replacement and Parapet reconstruction, complete Exterior Masonry modernization project, partial Coping replacement.
