**NYC Department of Education
Building Condition Assessment Survey 2023-2024**

Architectural Inspection

Asset: P.S. 236 ANNEX (P173 ECC) - BRONX, 499 EAST 175 STREET, BRONX, NY, 10457

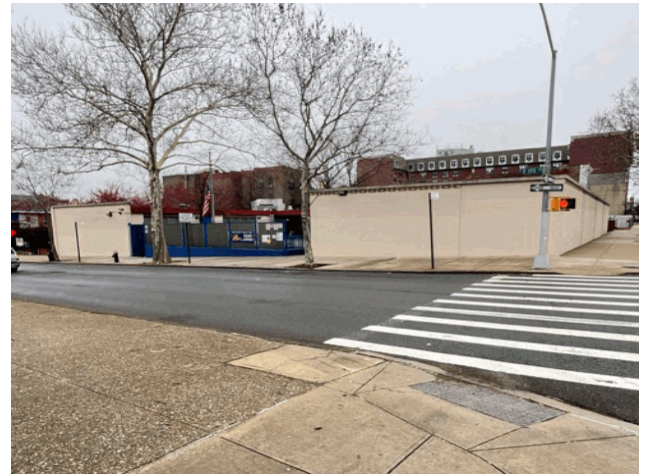
Comments on the Year Built	1971
Student Population	97
Staff Population	23
Comments on the Number of Classrooms	4
Weather	Fair
Facade Photo

East 175th Street - Northwest View

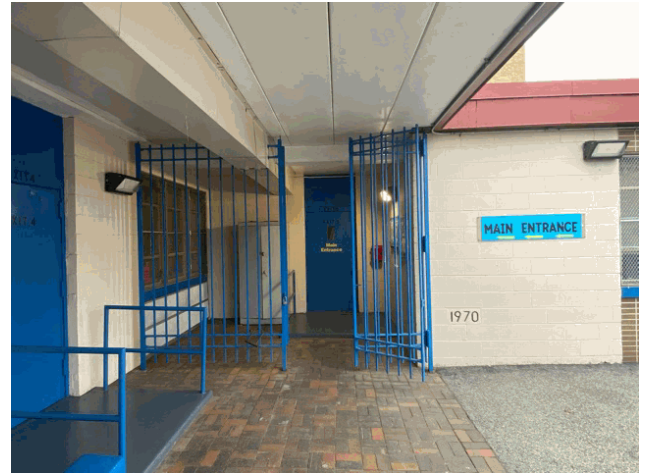
Main Entrance Photo

Facade A - East 175th Street

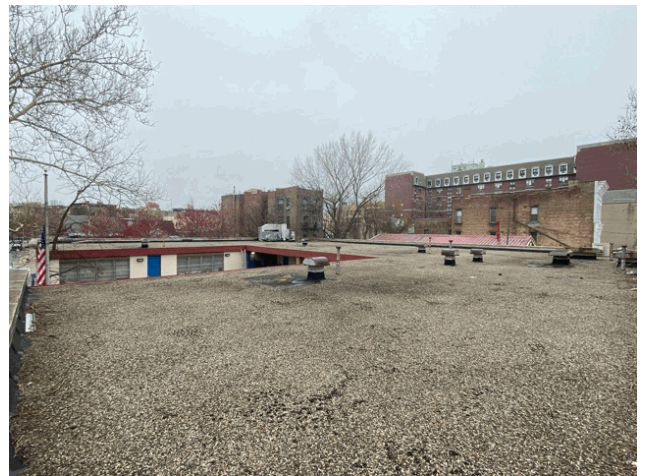
Roof Photo

Roof 1 - Northwest View

Systems: Roof repair at Cafeteria

Systems: Partial Roofing repairs

Systems: Complete Roofing replacement.
