**NYC Department of Education
Building Condition Assessment Survey 2023-2024**

Architectural Inspection

X283

Asset: JONAS BRONCK ACADEMY - BRONX, 400 EAST FORDHAM ROAD, BRONX, NY, 10458

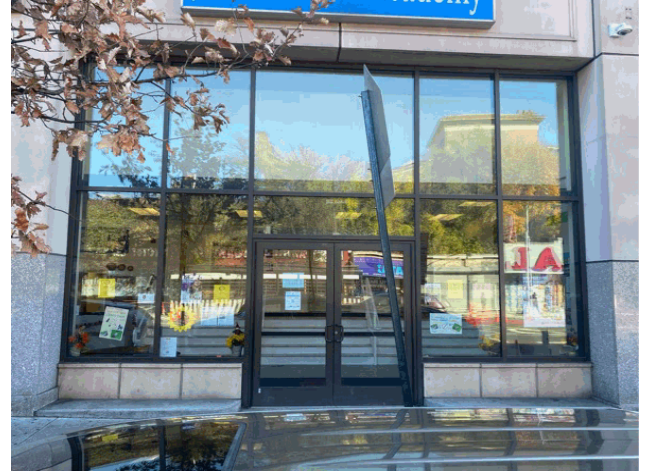
Facade A - Webster Avenue

Main Entrance Photo

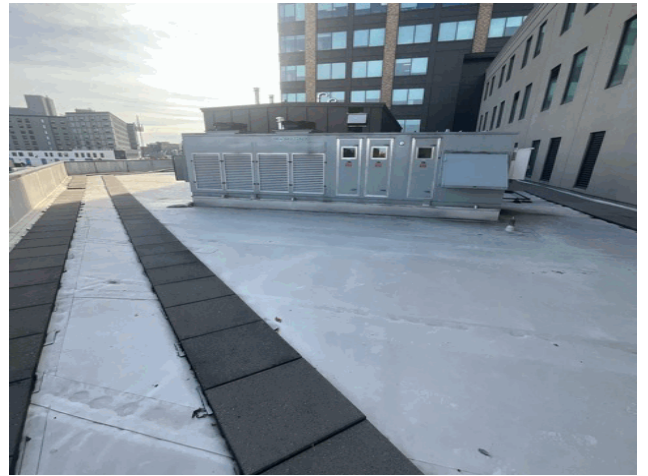
Roof 4 - Southeast View

Roof Photo

Systems: Minor Roofing repairs (Roof above Main Office)
