**NYC Department of Education
Building Condition Assessment Survey 2023-2024**

Architectural Inspection

X306

Asset: P.S. 306 - BRONX, 40 WEST TREMONT AVENUE, BRONX, NY, 10453

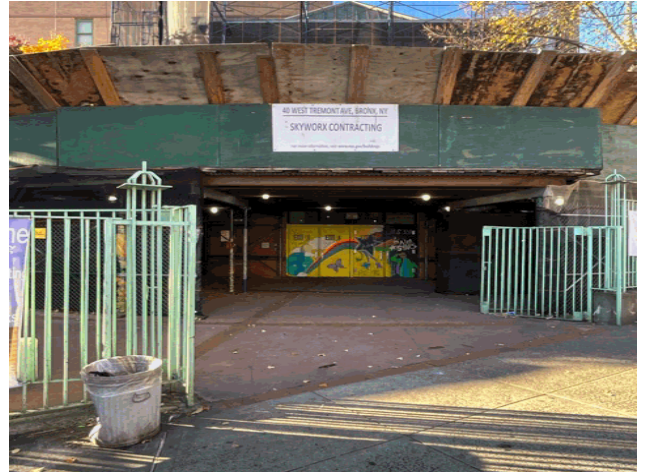
Main Entrance Photo

Corner of West Tremont Avenue and Davidson Avenue - Southwest View

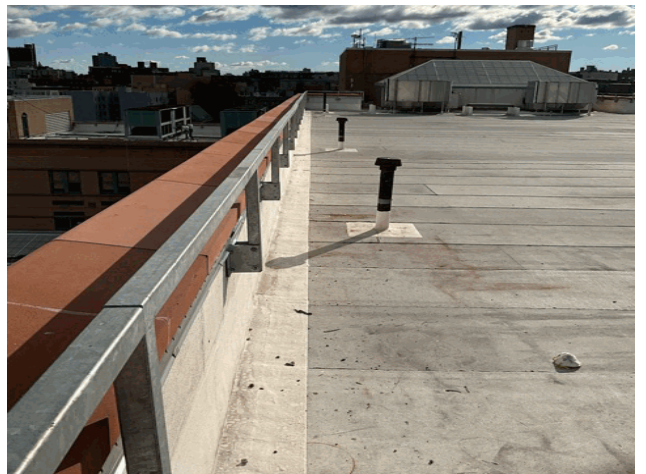
Roof Photo

Facade A - West Tremont Avenue
