**NYC Department of Education
Building Condition Assessment Survey 2023-2024**

Architectural Inspection

X451

Asset: STEVENSON HS AF - BRONX, 1980 LAFAYETTE AVENUE, BRONX, NY, 10473

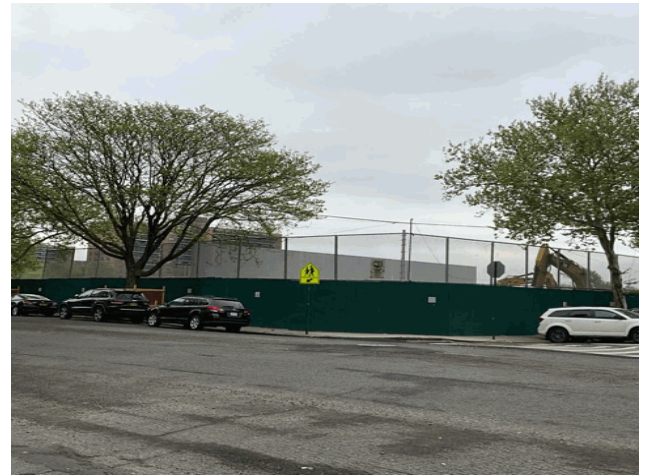
Weather	Fair
Facade Photo

Corner of Seaward Avenue and Stickball Avenue - Southeast View

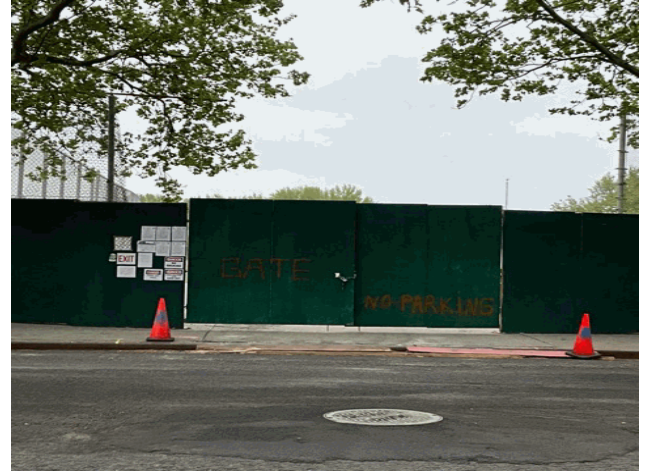
Main Entrance Photo

Seward Avenue - South View
