**NYC Department of Education  
Building Condition Assessment Survey 2023-2024**

**Architectural Inspection**

**X484**

**Asset: DISTRICT 12 PRE-K CENTER AT 1946 BOSTON ROAD - BRONX, 1946 BOSTON ROAD, BRONX, NY, 10460**

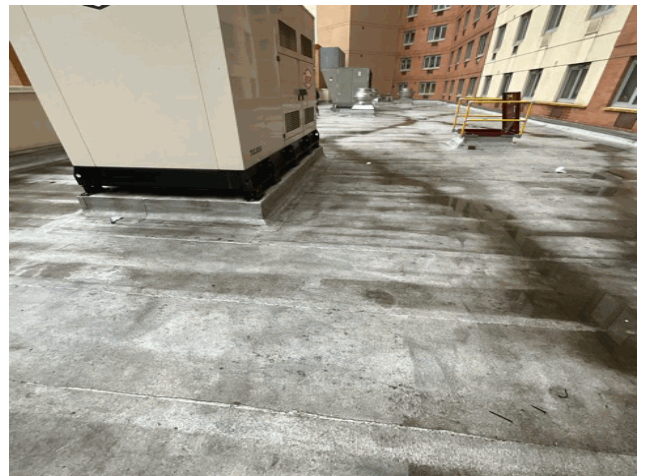
Roof 2 - North View

<b>ROOF CAGE</b>	Does not exist
<b>ROOFING</b>	Inspected
Replacement Quantity	4,000
Replacement Uom	S.F.
Instance on Modified Bitumen:Roof 2	Inspected
Instance Roof Photo

Roof 2
Instance Condition	2- Between Good and Fair
Instance Quantity	4,000
Instance Quantity Uom	S.F.
Does the roof have major mechanical equipment sitting on Dunnage Steel less than 18" above the Roofing?	No
