**NYC Department of Education
Building Condition Assessment Survey 2023-2024**

Architectural Inspection

X582

Asset: PRE-K CENTER @ 1434 OGDEN AVENUE - BRONX, 1434 OGDEN AVENUE, BRONX, NY, 10452

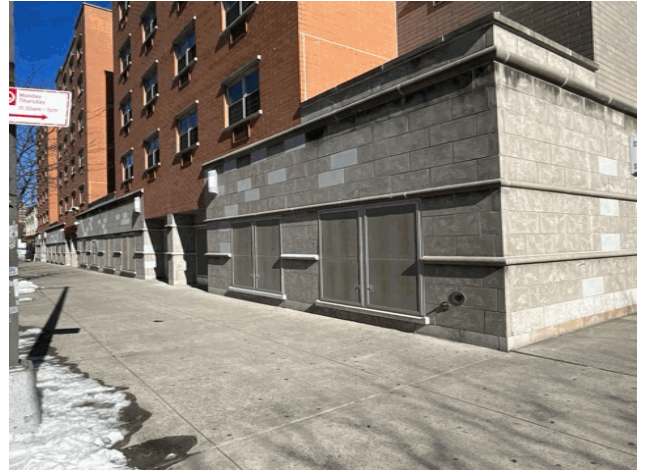
Ogden Avenue - Northeast View

Question	Answer
Was the Building Fully Accessible for Inspection?	Yes
Principal(s) Information	
Principal Name	Vincenzo Rosignano
Principal Organization	Garden of Learning and Discovery Pre-K Center
Meeting with Principal?	Yes
Principal Feedback	The Principal had no comments about the condition of the building at this time.
Custodian	Vinny Zadrma
Was the Custodian Present?	No
Fireman	Ivan Crispin (Handyman)
Was the Fireman Present?	Yes
Building Square Footage	11,000
Comments on the Area (for Athletic Field, Playing Surfaces, Leased Spaces)	None
Comments on the Stories (Floors) plus Basements	6+B
Comments on the Year Built	2015
Student Population	76
Staff Population	30
Comments on the Number of Classrooms	5
Weather	Fair
Facade Photo

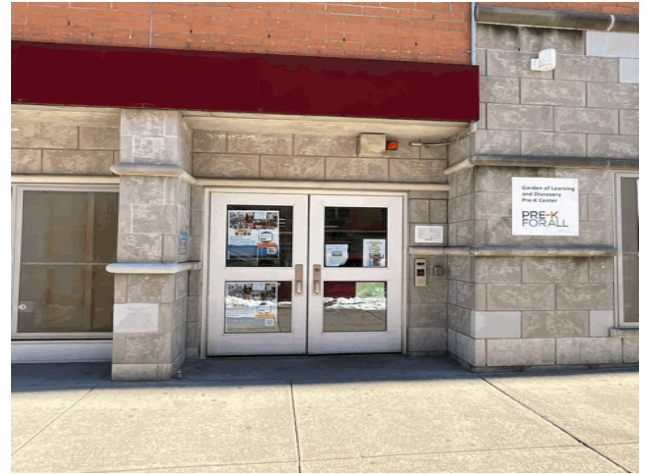
Facade A - Ogden Avenue

Main Entrance Photo
